**ENVIRONMENTAL AUDIT REPORT FOR MINING LICENCE 130 IN KARAS  
REGION, NAMIBIA.**

**CLEAR SUN CONTRACTING SERVICES (PTY) LTD**

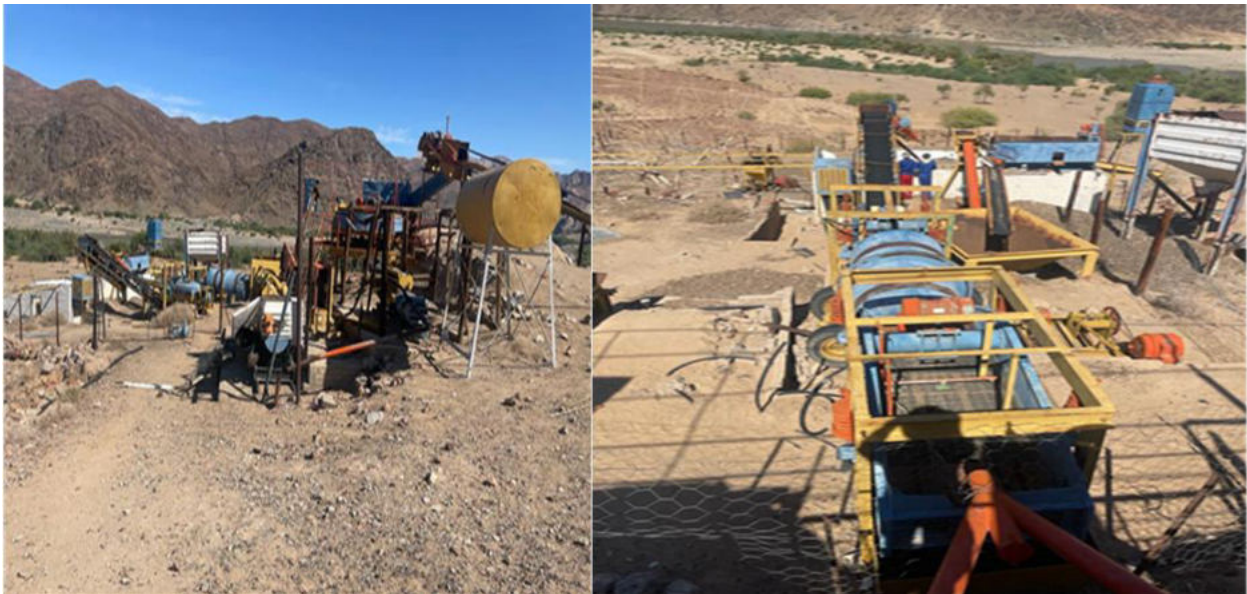
There is equipment onsite which comprise mainly of crushers, conveyance systems, diesel tanks and wet screens which can be refurbished for use. On the north eastern side of the processing plant are the brick walls and an empty container showing the remains of the residential camp.

Figure 2: Plant and equipment left onsite by the previous mining company, VI. Source: Own photograph.

The site is not in operation and there is no one to take care of the equipment which has been severely vandalized.

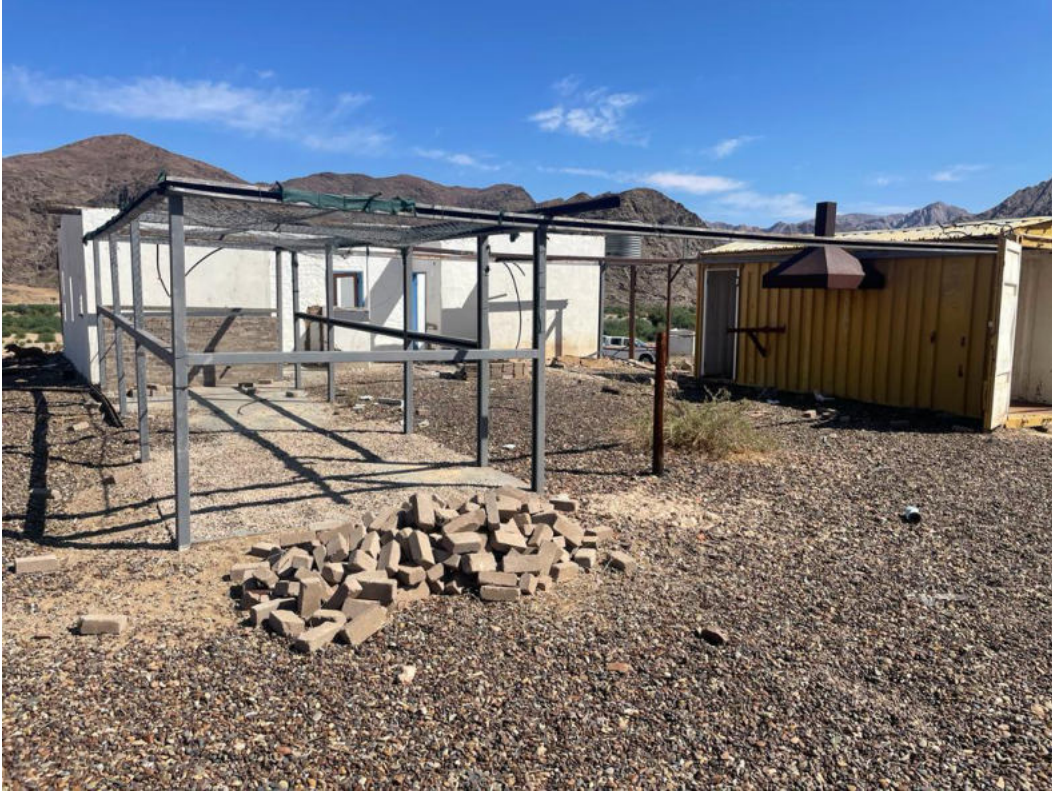
Figure 3: The remains of the residential house and storage container on ML 130. Source: Own photograph

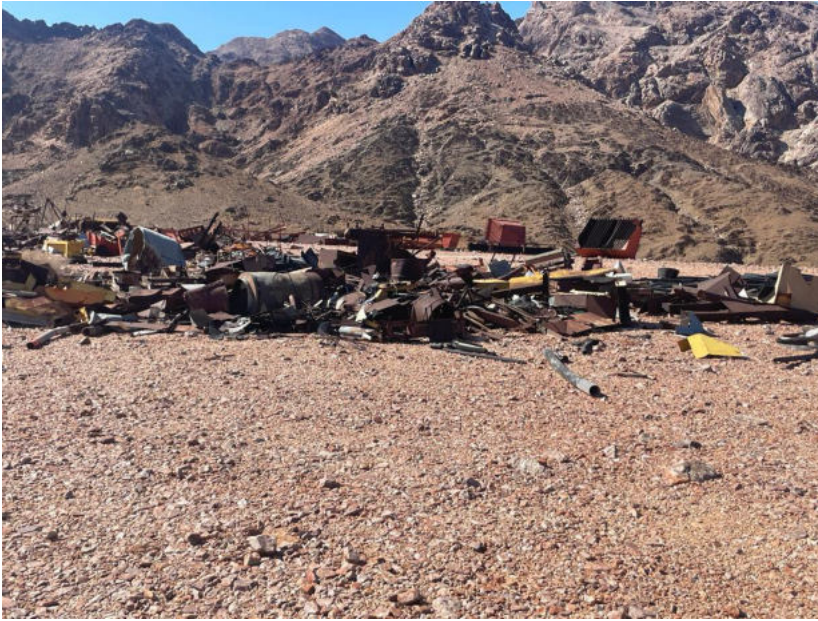
<b>Instrument</b>	<b>Regulated Activity</b>	<b>Responsible Authority</b>	<b>Status and / or Comment</b>
EMA Act (2007) and it Regulations of 2012	Waste management	MEFT	Non-Compliant, most scrap metal can be seen lying around onsite

**Figure 6: Scrap metal stock piled onsite by the previous mining company. Source: Own photograph.**

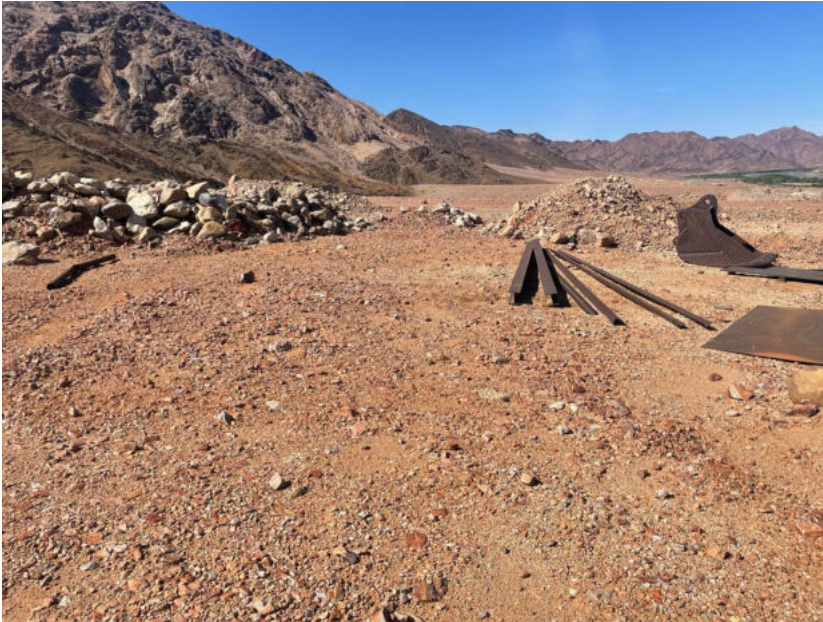
**Figure 7: Abandoned equipment and unprocessed material. Source: Own photograph.**

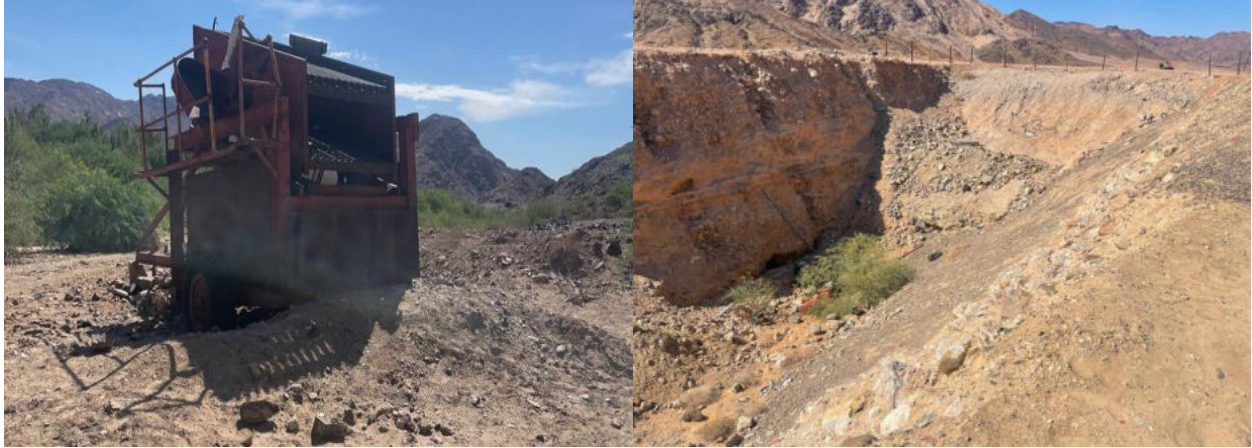
<b>Instrument</b>	<b>Regulated Activity</b>	<b>Responsible Authority</b>	<b>Status and / or Comment</b>
EMA Act (2007) and its Regulations of 2012	Mining and exploration	MEFT	Partial compliance – Previous Operator left behind open pits.

**Figure 8: Abandoned equipment (right) and un-rehabilitated mining pit (left). Source: Own photograph.**

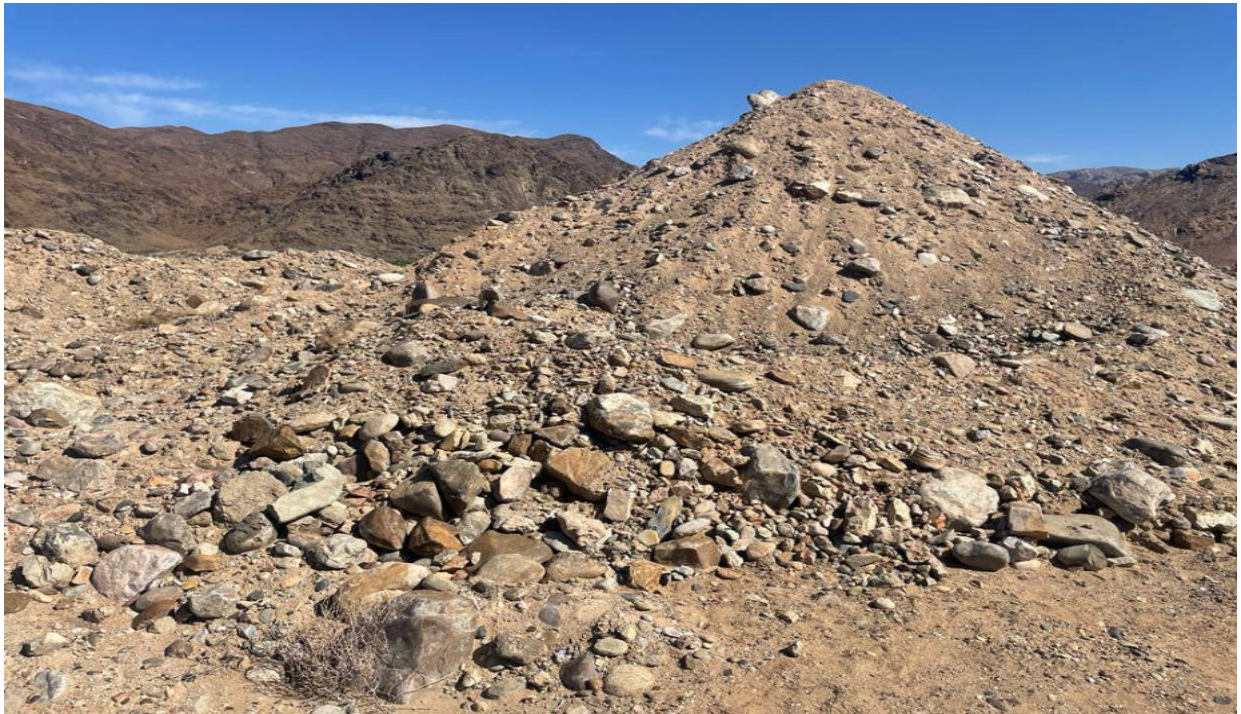
**Figure 9: Abandoned unprocessed ore. Source: Own photograph.**
