## OTJIOZONDU MINE ENVIRONMENTAL COMPLIANCE AUDIT

PROJECT NUMBER: ECC-102-350-REP-02-A

DATE: 24 MAY 2023

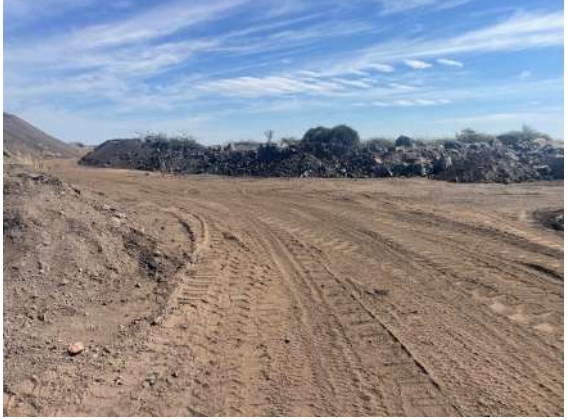
Findings	Visual evidence	Recommended actions
<p>Vehicular restrictions are not sensitised to road users, as there are no sufficient road signs withing the access and haul roads.</p> <p>Reverse parking is not enforced within the mine, however given the nature of mine operations, reverse parking is a basic mine safety practice the requires enforcement.</p>

<p>Traffic safety signs should be installed and be visible to all road users. These should cover speed restrictions, warning on heavy vehicles using the road, stop signs as well as parking area demarcation within the pit area.</p> <p>Reverse parking signages should be installed within the plant area and at visitors parking.</p>

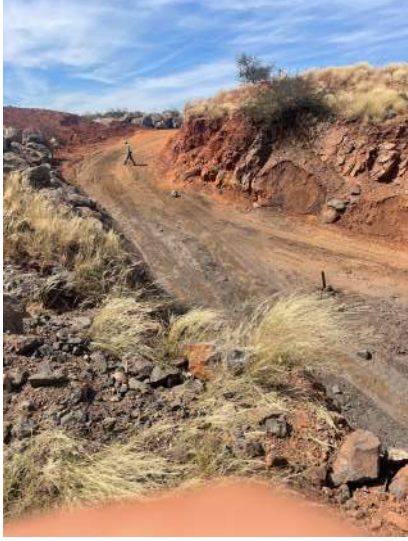
Findings	Visual evidence	Recommended actions
<p>The pit and mining area access road does not have enough traffic signage as well as warning signs on the nature of the mining pit one is entering into.</p>

<p>A traffic management system for the pit and mining area should be developed with enough planning for all areas that requires traffic signage.</p>
<p>At the Pit and mining safety area no induction is conducted to visitors on arrival; regarding their health and safety is not guaranteed.</p>		<p>There is need to ensure that all new employees and visitors to the mining site should undergo a rigorous HSE sensitisation session.</p>
<p>It is observed that the rocks from the pit walls are not stable which causes a safety concern for the people entering the pit area.</p>

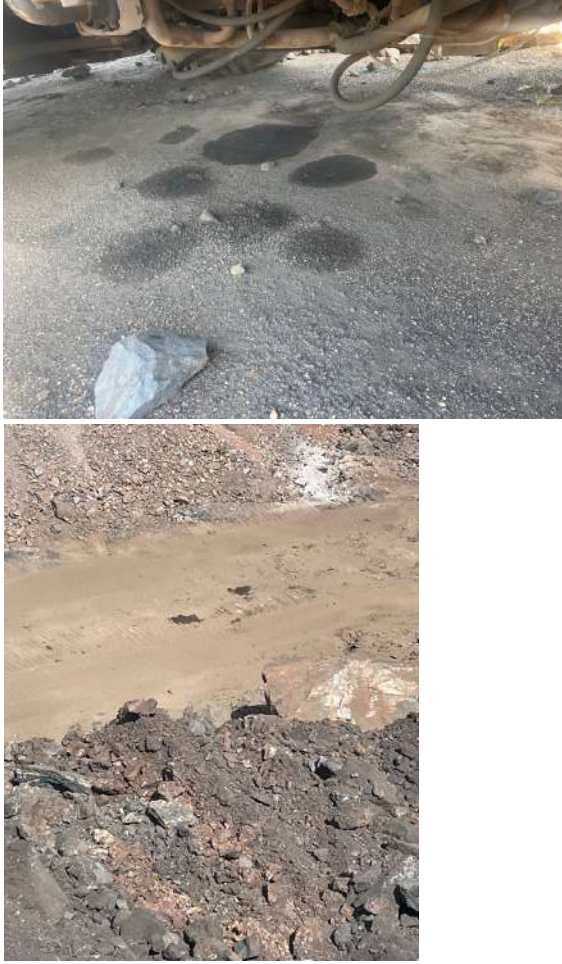
Findings	Visual evidence	Recommended actions
<p>Oil leakages from heavy equipment and machinery can be observed around the pit and mining area. The machinery has no drip trays to collect waste oil.</p>

<p>The pit and mine area does not have a workshop area; hence plant, equipment and vehicle repairs and servicing should be conducted at a designated workshop area.</p> <p>All idle equipment should have oil collection trays, to ensure that there are is no localised ground contamination.</p>
<p>There are no shower and toilet facilities designated for the pit and mine area.</p>		<p>Designated ablution facilities should be commissioned at the pit area.</p>
<p>There is no firefighting equipment for fire suppression within the pit area, as there is a risk of firebreak but there are no fire suppression alternatives in place.</p>		<p>There should be firefighting equipment installed at the pit area, including a fire hydrant located in proximity to the pit and vehicle parking area.</p>

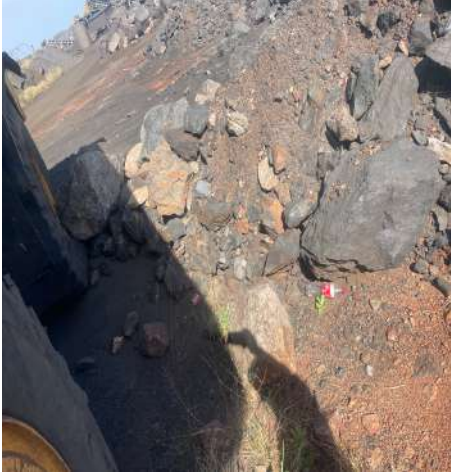
<b>Findings</b>	<b>Visual evidence</b>	<b>Recommended actions</b>
monitor pit and mining dust.		generated dust. Hence there is need to site dust collection buckets downwind.
There is no defined waste management system in place within the domain as general housekeeping is not being done with plastics lying around.

The waste management SOP needs to be set up and more waste drums should be placed around the mining and pit area
Emergency assembly, medical aid box and emergency exit map are not clearly marked.		A pit area should have a clearly marked emergency assembly point, and an information board at the assembly point clearly showing emergency escape routes. These should be implemented on site.

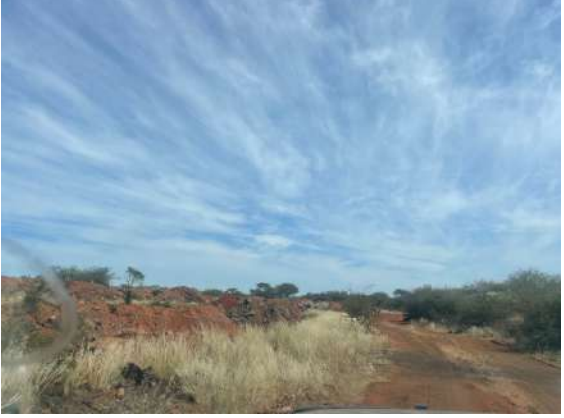
Findings	Visual evidence	Recommended actions
<p>Waste rock dump inspection is not being conducted frequently, where the mixing of waste rock and topsoil material is taking place.</p>

<p>Topsoil conservation should be strictly enforced, and so this may be used for rehabilitation purposes.</p>
<p>Waste rock stockpiles are encroaching into the vegetated area.</p>

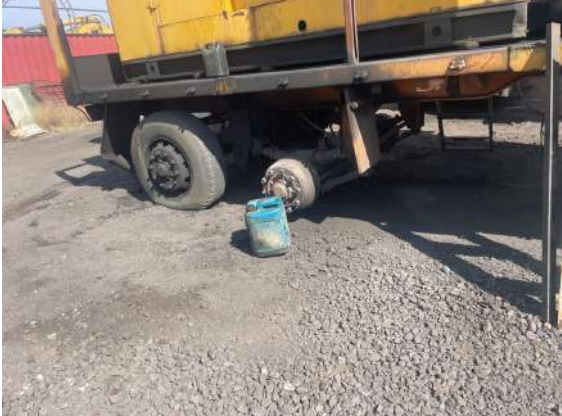
Findings	Visual evidence	Recommended actions
<p>The generator powering the processing plant area is still not bunded adequately. Hydrocarbon spills from the generator have been noted, and contaminated soil and water remediation have not been employed.</p>

<p>A bunded generator facility needs to be installed</p>
<p>There is inadequate firefighting equipment on the processing plant, and some fire extinguishers is still not serviced.</p>

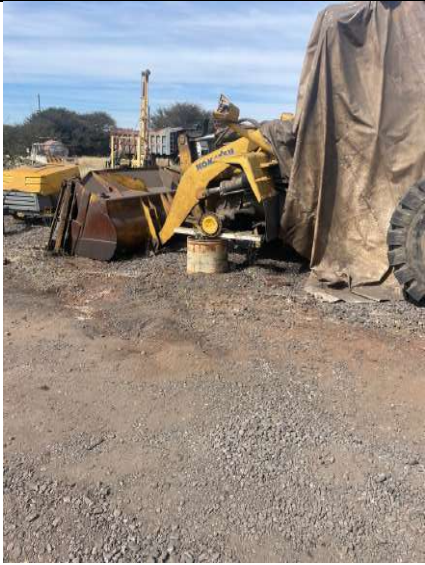
Findings	Visual evidence	Recommended actions
<p>The solid waste disposal site is not well managed and there are no adequate waste collection and separation mechanisms in place.</p>

<p>A solid waste management plan has to be developed in order to have waste separation mechanisms in place.</p>

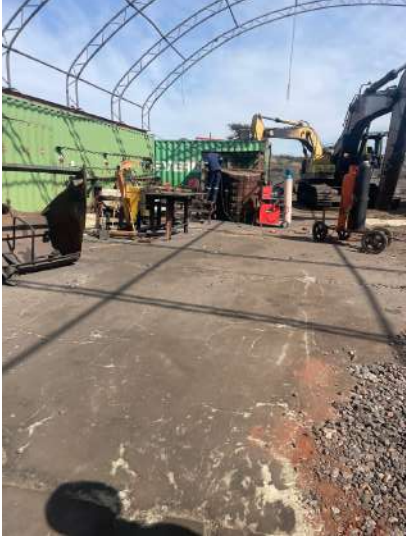
Findings	Visual evidence	Recommended actions
<p>The concrete slab is old and extremely cracked, such that it needs to be replaced as soon as possible. In addition, there is still possibility of prolonged soil contamination on the workshop area and contamination extend should be conducted on the soil profile.</p>

<p>Soil profile contamination extend should be conducted on the area around the workshop area. A new concrete slab should be installed on the workshop area.</p>
<p>There is no oil and wastewater collection and separation mechanism installed on the workshop area</p>		<p>It is recommended that an oil separator should be installed.</p>
<p>The fuel storage facility is self-bunded, but the dispensation area also requires a concrete slab installed on this area.</p>

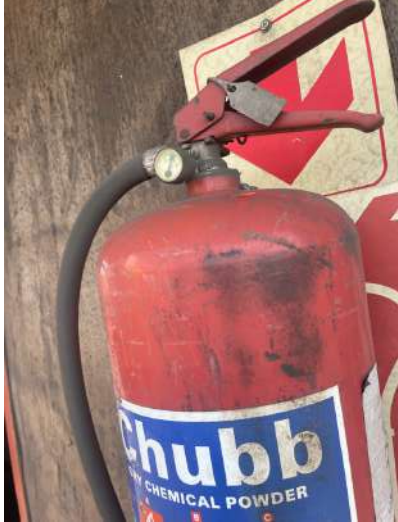
Findings	Visual evidence	Recommended actions
<p>There is general good housekeeping within the office and administration areas. The toilets are cleaned and in good working order. Firefighting equipment is insufficient in this area, and some fire extinguisher designated areas do not have any extinguishers installed.</p>

<p>Old firefighting equipment should be replaced and strategic areas for fire hydrants should also be identified.</p>
<p>Emergency assembly and map is still not visible to all visitors.</p>		<p>An emergency escape map should be drafted and installed on strategic areas within the mining facility.</p>
<p>There is insufficient waste collection system on the employee accommodation area.</p>		<p>Waste separation should be conducted, and adequate waste bins should be provided for, within the office area and employees accommodation facilities.</p>
<p>Employees from the old housing, must walk over 200 m to access shower and toilets, it is advisable that a closer toilet and</p>		<p>Adequate sanitation facilities should be provided for the employees' accommodation facilities.</p>

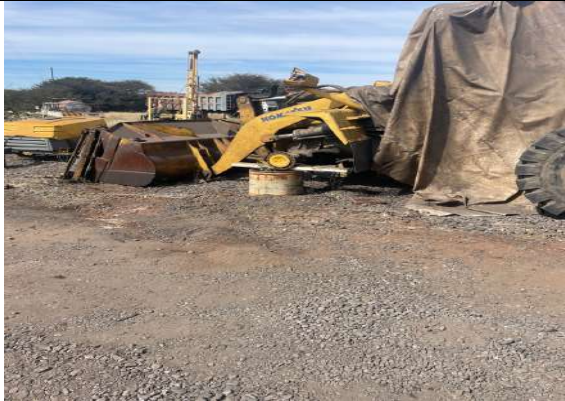
Findings	Visual evidence	Recommended actions
Stormwater management on the processing plant needs to be implemented and installed, with adequate control and designs		A stormwater management plan should be commissioned on the processing plant area as it is required.
A solid waste separation, storage, management and disposal plan should be implemented.		A review of all environmental related SOPs should be conducted, including the solid waste management SOP.
The workshop area will need to have a separate wash bay area and a repair area. All these areas should be bunded and spill controlled by an oil separator system. Old machines and equipment need to be removed from the workshop area and kept in a well bunded area or removed from site.

<ul style="list-style-type: none"> <li>- An upgrade of the workshop area will have to be conducted and the wash-bay and service bay should be separated.</li> <li>- An oil interceptor system should be installed to manage all waste oil before it is disposed of into the environment.</li> </ul>

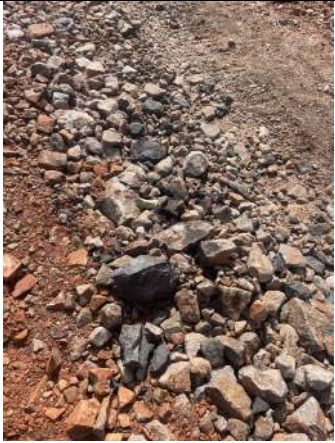
Findings	Visual evidence	Recommended actions
<p>the processing plant, waste disposal site and workshop area warrant for a full investigation on oil contamination on the soil profile and a remediation action suggested before upgrading/remodelling the existing workshop area.</p>		<p>below the cracked so a slab should be sampled and analysed, so that a decision for remediation can be made, before the workshop area upgrade is conducted.</p>
<p>There are no sanitation facilities (clean water, bathroom and toilet) in the pit area.</p>		<p>It is suggested that facilities should be provided for in the mining area.</p>
<p>Oil spills in the pit area are an indication of equipment repairs at undesignated areas and that equipment and vehicles could be operating whilst having leakages. This can contaminate the soil and water resources.</p>

<p>Heavy equipment, machinery and vehicles should be provided for with drip trays to minimised groundwater contamination.</p>
