Otjozondu Mining

## OTJIOZONDU MINE ENVIRONMENTAL COMPLIANCE AUDIT

PROJECT NUMBER: ECC-102-350-REP-02-A

DATE: 24 MAY 2023

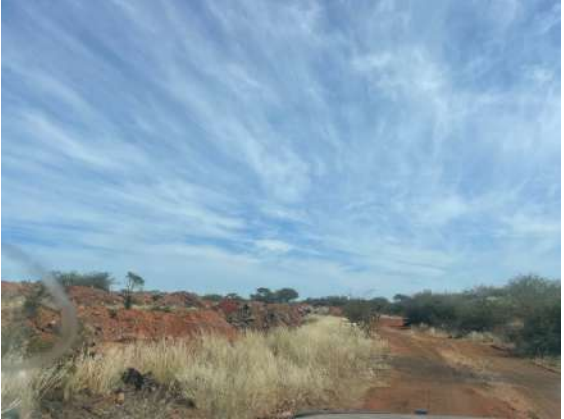
Findings	Visual evidence	Recommended actions
<p>Waste rock dump inspection is not being conducted frequently, where the mixing of waste rock and topsoil material is taking place.</p>

<p>Topsoil conservation should be strictly enforced, and so this may be used for rehabilitation purposes.</p>
<p>Waste rock stockpiles are encroaching into the vegetated area.</p>

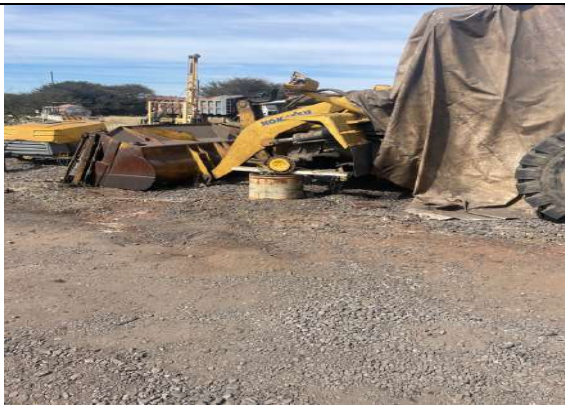
Findings	Visual evidence	Recommended actions
Stormwater management on the processing plant needs to be implemented and installed, with adequate control and designs		A stormwater management plan should be commissioned on the processing plant area as it is required.
A solid waste separation, storage, management and disposal plan should be implemented.		A review of all environmental related SOPs should be conducted, including the solid waste management SOP.
The workshop area will need to have a separate wash bay area and a repair area. All these areas should be bunded and spill controlled by an oil separator system. Old machines and equipment need to be removed from the workshop area and kept in a well bunded area or removed from site.

<ul style="list-style-type: none"> <li>- An upgrade of the workshop area will have to be conducted and the wash-bay and service bay should be separated.</li> <li>- An oil interceptor system should be installed to manage all waste oil before it is disposed of into the environment.</li> </ul>
