**ENVIRONMENTAL PERFORMANCE REPORT**

**FOR LODESTONE NAMIBIA**

**May 2023**

**Project No: NSP2023LS1**

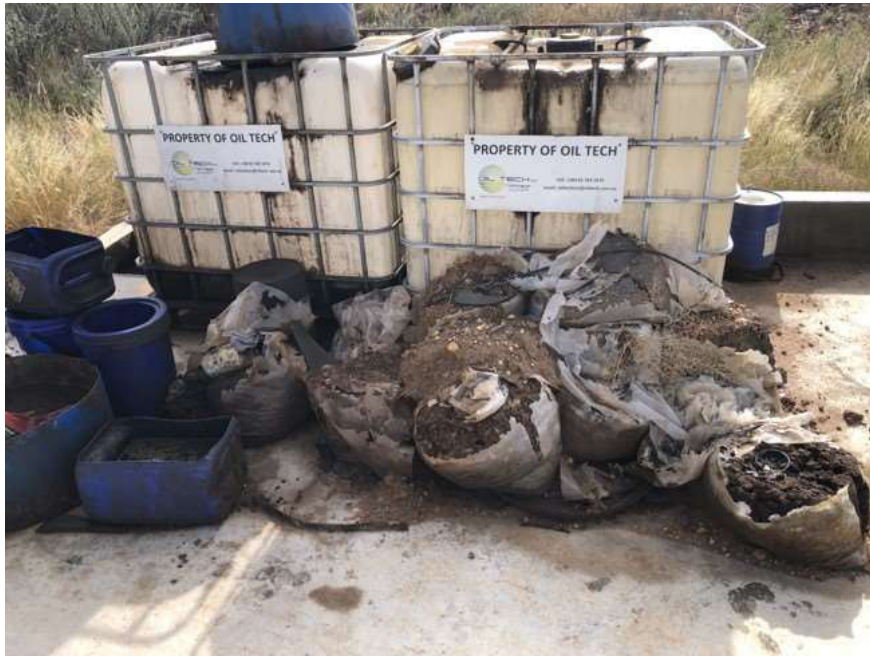
Hazardous waste (only hydrocarbon-contaminated soil) is collected and placed in a bunded area where oil-contaminated containers and used oil are stored (see Figure 4). Used oil is collected in containers of Oil Tech, and when full, the containers are emptied, and the waste oils is taken

**FIGURE 4: STORAGE OF USED OIL, EMPTY CONTAINERS AND HYDROCARBON-CONTAMINATED WASTE IN A SEALED, BUNDED AREA**

- No hazardous waste was taken offsite yet.
- Oil-contaminated soil is collected and temporary stored at the same bunded facility where waste oil is collected and stored (see Figure 4). A bioremediation facility is in place but not in use yet, and the oil-contaminated soil will be taken there for treatment.
- Spill kits are in place at the workplaces where vehicles and equipment are maintained and where hydrocarbons can be spilled or leaked.
- The fuel facility of Engen (see Figure 9) is commendable – no uncontained spill or leak is possible.
- On inspection the entire mine site was free from litter, wind-borne and discarded waste.
- No sign of animals scavenging for food and leftovers in the receptacles was observed.

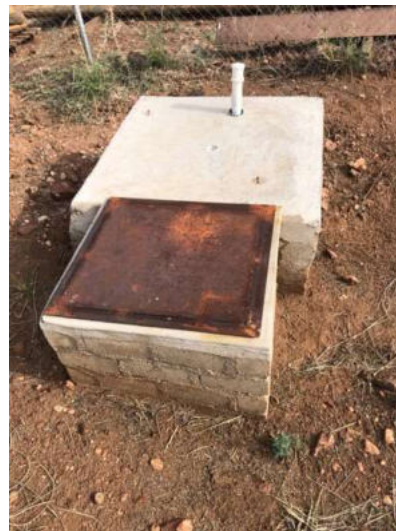
Sewage from the ablution facilities is contained and connected to French drains (see Figure 5).

**FIGURE 5: FACILITY FOR THE CONTAINMENT OF SEWAGE**

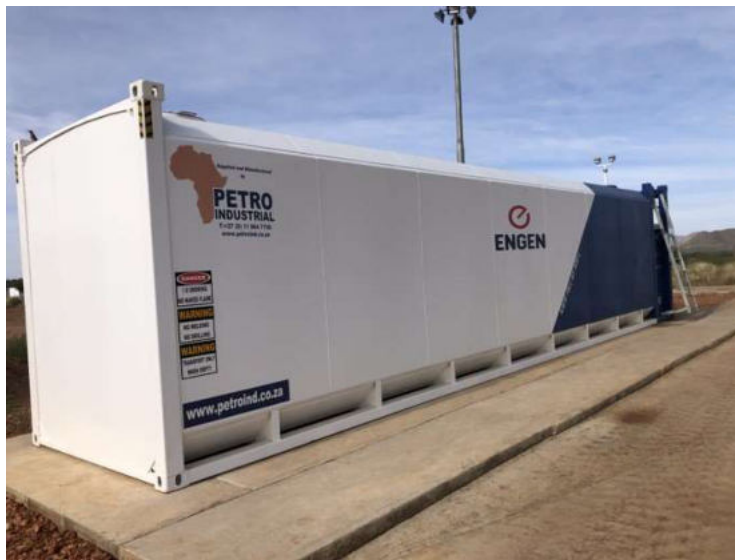
No empty drums for petrol and diesel are kept onsite as a containerised reservoir for fuel is supplied by Engen. The facility is completely closed, with its own second containment as part of the structure, meaning that no concrete bunded structure is required. Refilling of vehicles happen on a sealed surface at the fuel container (see Figure 9).

**FIGURE 9: THE DOUBLE-CONTAINERIZED FUEL TANK FACILITY OF ENGEN ONSITE**

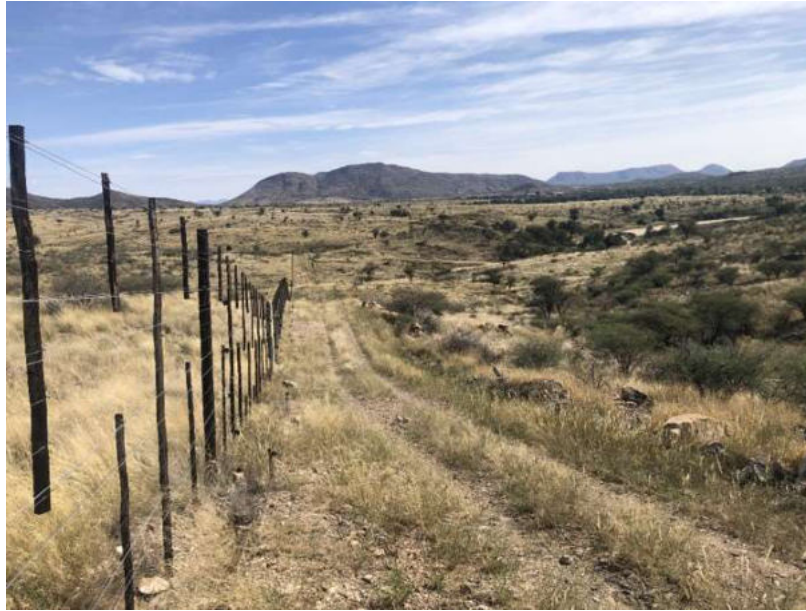
Security control and fences are in place at the main entrance to the mine to prevent uncontrolled vehicle and pedestrian access. Not all of the operational area is yet fenced, but the stockpiles, yards and water facilities are fenced. Warning signs are on the C23 road in vicinity of Lodestone' access road, in both directions. Fences are on the site boundary and the entrance to the farm (see Figure 10).

**FIGURE 10: GAME FENCE ON THE BOUNDARY WITH THE NEIGHBOURING FARM**

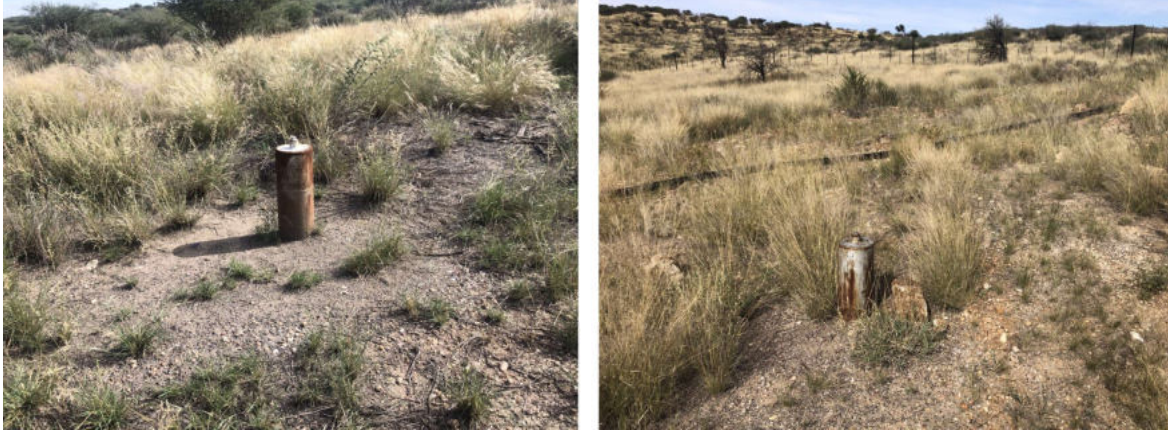
**FIGURE 11: UNLOCKED MONITORING BOREHOLES**

- On inspection it was noticed that the monitoring boreholes are not locked, but only closed with a nut (see Figure 11). Although no deed of vandalism occurred yet, it is recommended that the boreholes must be closed with lock-and-key instead.

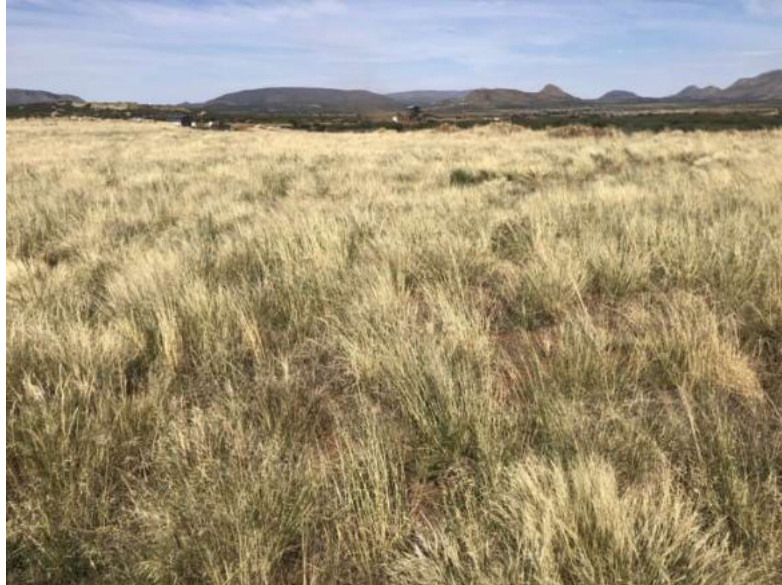
- No topsoil stockpiles exist currently, and no topsoil stripping was done yet. The EMP clearly stipulates that topsoil must be stripped and that the topsoil must be managed carefully.
- The deposition of rejects has not been shaped or landscaped but shows a dense cover of pioneer vegetation (see Figure 12). It clearly confirms that the current reject depository can be revegetated passively, without much effort.
- The passive revegetation of the reject depository happened by default, and without intervention. Although this is beneficial, more care must be given to the shaping of the

reject depository prior to its establishment of vegetation as it would do more harm than good to reshape revegetated manmade landforms later.

**FIGURE 12: PIONEER VEGETATION ON THE REJECT DEPOSITORY**

- The suitability of rejected material as a growth medium into which vegetation can re-establish must not be regarded as a replacement of the stripping of topsoil and the careful management of topsoil stipulated in the EMP. As topsoil acts as an important medium to contain seeds of perennials and captured nutrients, its value in establishing permanent vegetation must not be underestimated.

- The potential of passive revegetation on the depository and berms (as observed during the site visit), makes the early involvement of a mine rehabilitation specialist necessary and Lodestone must consider this opportunity seriously at this early stage. An early start on this front can have significant closure cost-savings.

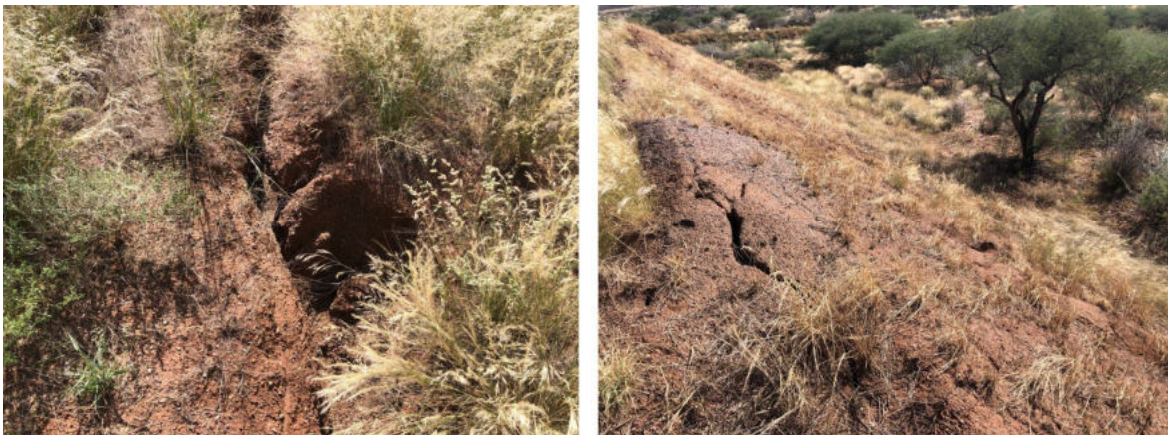
**FIGURE 13: GULLY EROSION ON THE REJECT DEPOSITORY**

- Remove invasive plants.
- Identify, remove and relocate plants that can be rescued.
- Prevent erosion through the early shaping of manmade landforms (see Figure 13).
- Apply for a plant removal permit which can be used and implemented site-wide with the necessary related work instruction / procedure / protocol.

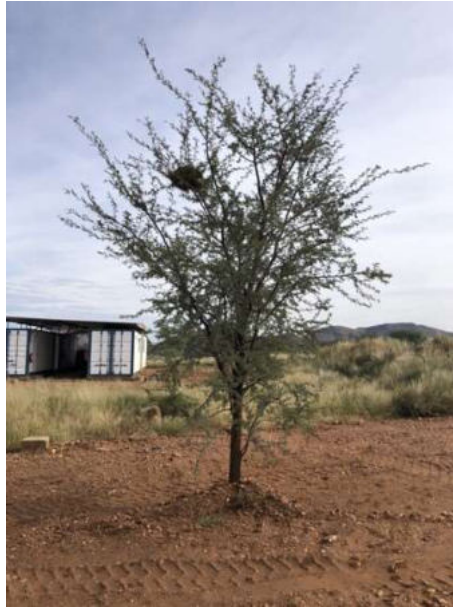
- Plant removal permits were also not in place for the removal / killing of protected species, which cannot be avoided during the clearing of land for roads – as was observed during the onsite visit. An example of a marked young camelthorn tree (*Acacia erioloba*), a protected species, which was saved during the clearing is commendable though (see Figure 14).

**FIGURE 14: A CAMELTHORN TREE THAT WAS SAVED DURING LAND CLEARING ONSITE**

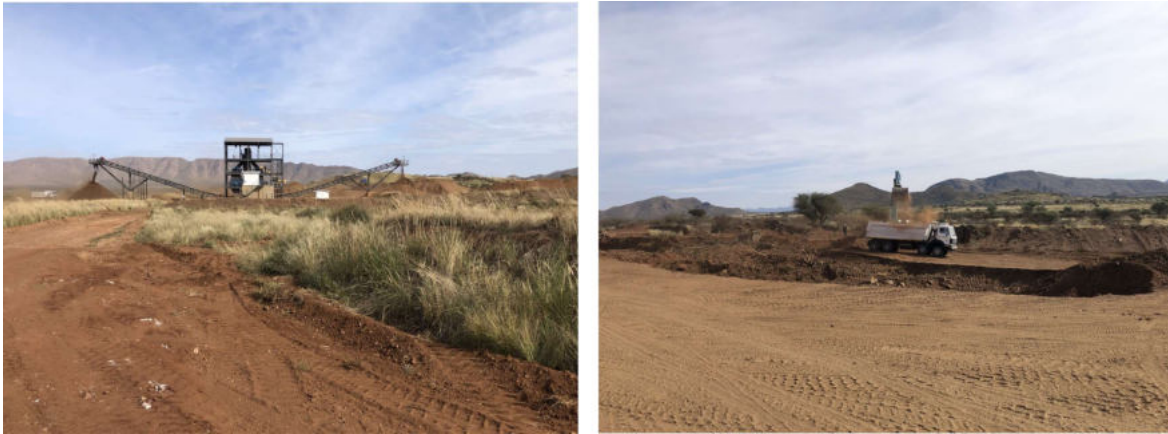
Although vehicle entrainment causes dust as well, the current mining activities – hauling and loading, screening and separation – are responsible for most of the dust generated onsite (see Figure 15). During the site visit it was clearly observed that the current mining activities, despite its low intensity, cause a dust plume that can be regarded as of concern and may cause a complaint.

- No dust-a-side is applied, and no water sprays are being done. Dust generated from the mining activities remains a concern, despite the low intensity activities currently.
- No dust monitoring is being done currently.
- No PM10 sampler has been installed, as the EMP requires.
- The weather station (Figure 16) is monitored, and the information is recorded for reporting purposes. However, this information is not applied for the purpose of managing dust.

**FIGURE 15: DUST GENERATED BY SCREENING, LOADING AND HAULING**
