ENVIRONMENTAL AUDIT REPORT FOR IMERYS GECKO OKANJANDE GRAPHITE (PTY) LTD

Okanjande graphite mine – Mine Waste Stockpile Area December 2017 to August 2020.

MINING LICENCE (ML)196 & EXCLUSIVE PROSPECTING LICENCE (EPL) 4717

2017- 2020

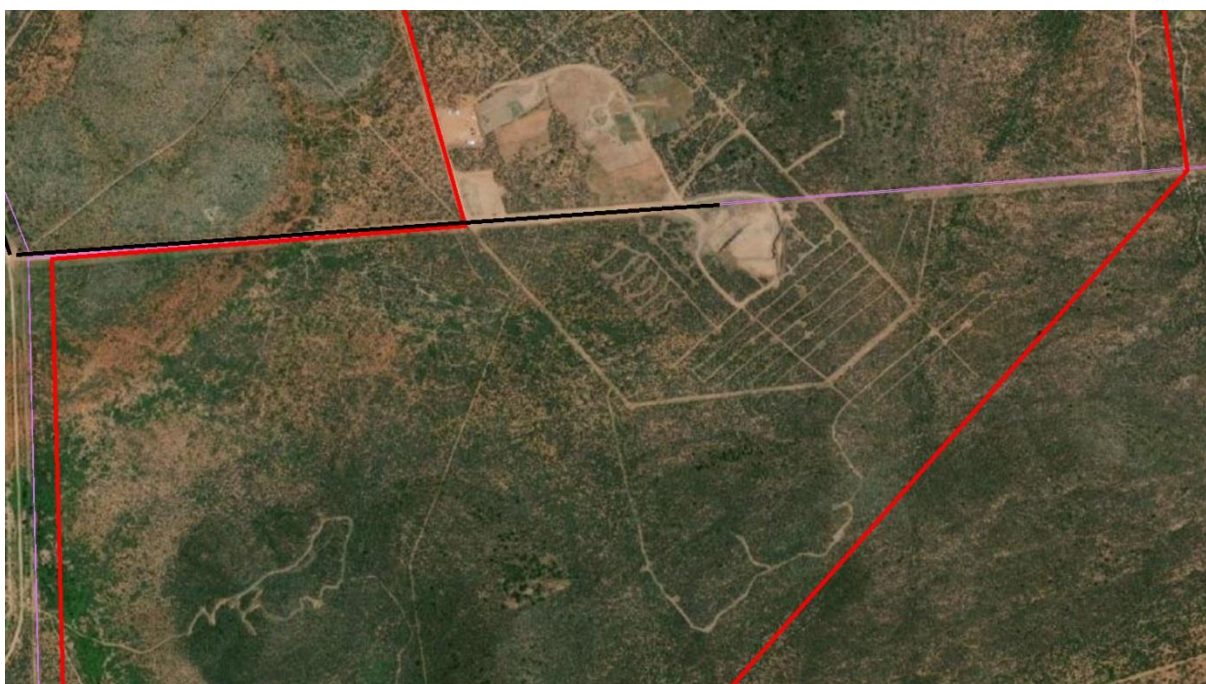
Exploration occurred within EPL4717 during 2017 and 2018 but stopped when the care and maintenance phase began in November 2018. All activities pertaining to exploration were carried out in accordance with the EMP and the permit requirements for bush clearing.

Figure 2. Exploration bush clearing along temporary drilling roads..

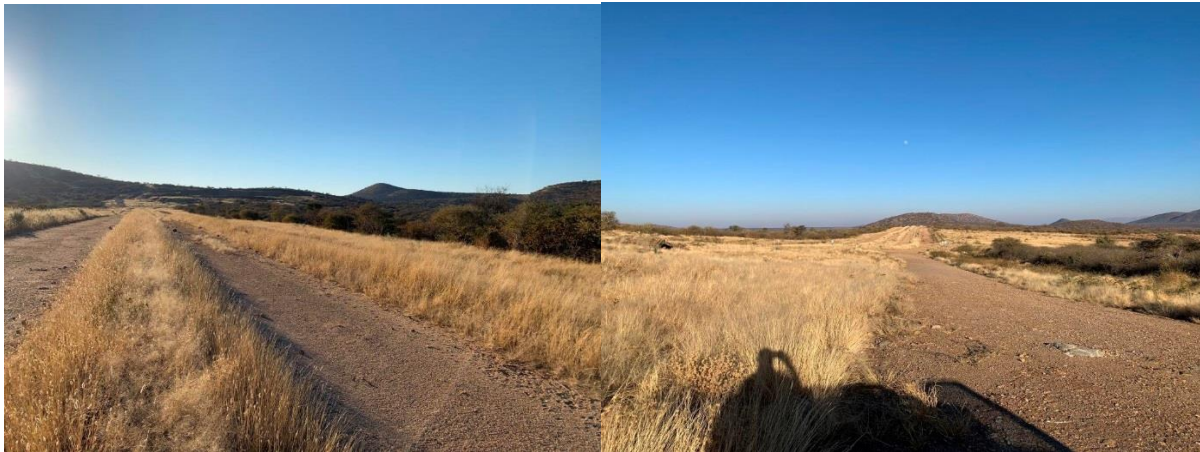
General maintenance and general housekeeping is ongoing for the Care & Maintenance phase. The roads are in good repair. Road verges are covered naturally by grasses, thus reducing the dusty conditions. Figure 3 renders images of the natural restoration of grasses on the road verges at the end of the 2020 first half reporting period. I am satisfied from the photographic survey that the EMP is being followed for this aspect.

Figure 3. Grass covered road verges (6.8.20)

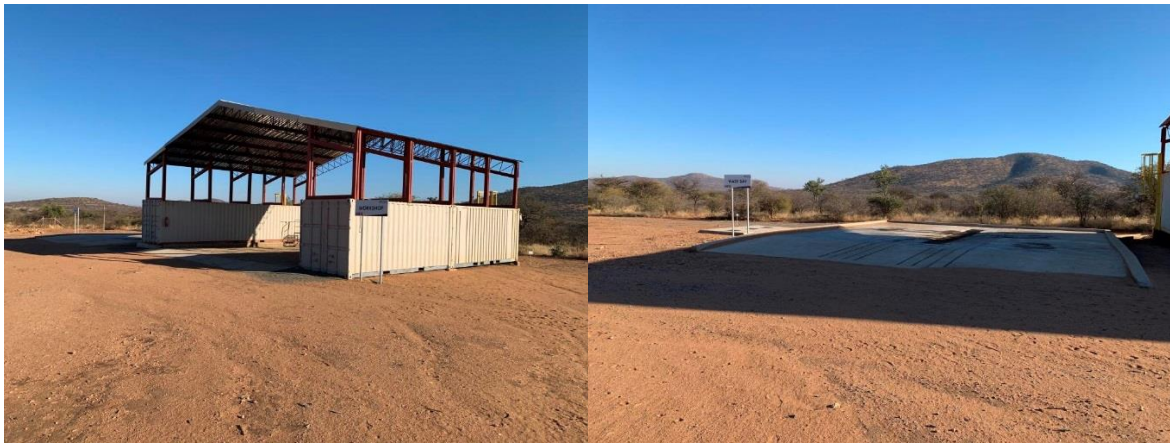
Figure 4 to Figure 6 renders images of these structures. Signage and the general housekeeping is being maintained well.

Figure 4. Vehicle workshop (left) and wash bay (right).(6.8.20)

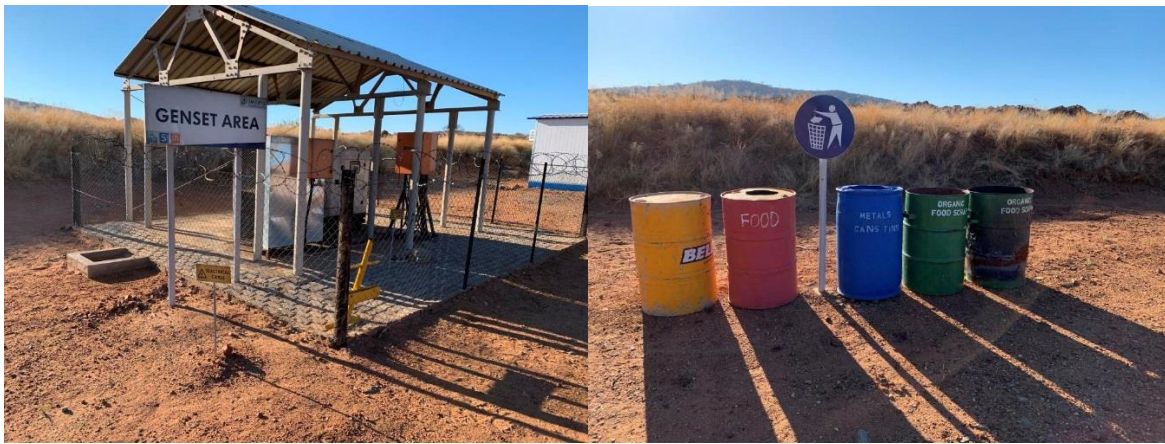
Figure 5. Generator room (left), and separate sorting waste drums (right)(6.8.20)

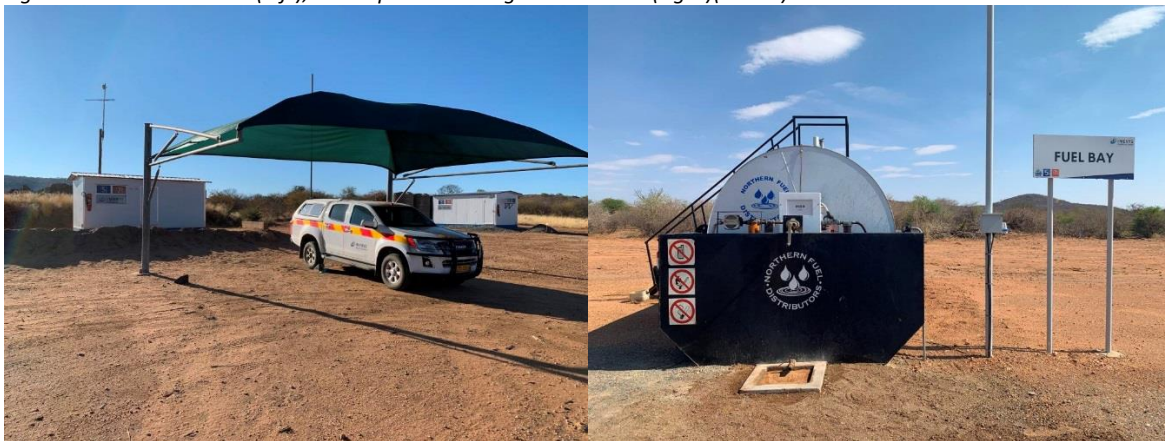
Figure 6. Parking and offices (left), and fuel bay (right)

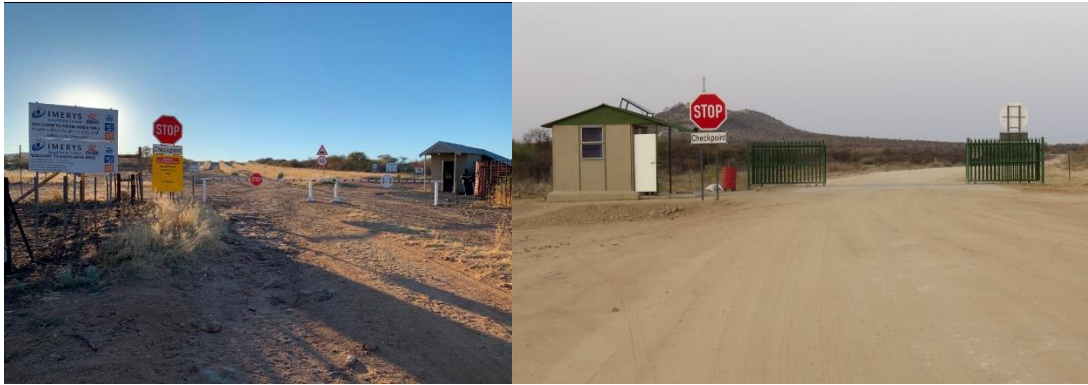
The company safety protocols were maintained well for the whole 3 year period. No major incidences were recorded. Both the EMP and Company requirements were met. Figure 7 renders images of the main entrance to the mine and the farm road checkpoint.

Figure 7. Guard house at main mine gate (left) and farm road check point (right)

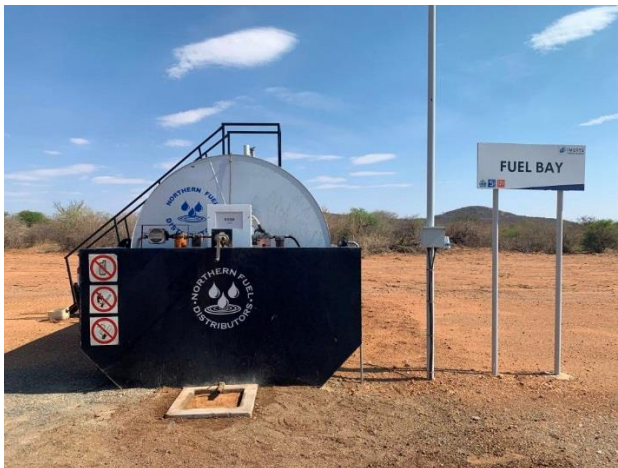
Spillage of fuel is unlikely to occur due to the bunded facility in place. (See Figure 8). The drainage tap for rain water is bunded in case any floating fuel leaks out at the end of a drainage exercise.

Figure 8. Self bunded fuel storage tank.

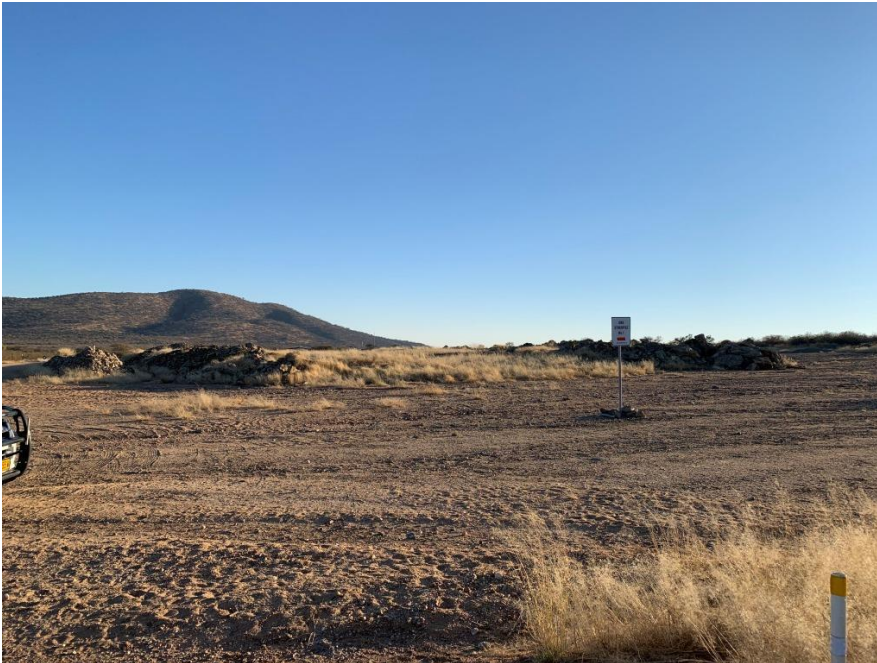
Inventory of all stored fuel and ore stockpiles was established at the start of the care and maintenance phase. Figure 9 renders an image of the ore stockpile area that was for the most part depleted at the end of 2018. Grasses have established themselves in this area showing inactivity at the mine.

Figure 9. Graphite ore stockpile (6.8.20)

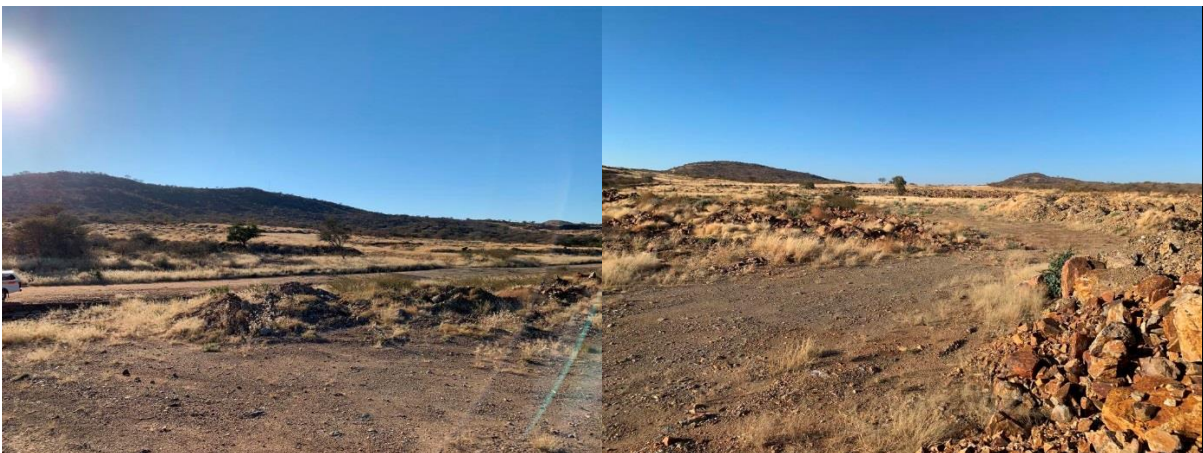
Regular checks of the soil stock piles and waste rock are carried out in case heavy rains shift the material and block the dry river that transects the dump/stockpile area. Flooding due to heavy rains should not impact the stock piles negatively. Figure 10 renders images of the various mineral material stockpiles. Grasses and other plants have re-established in these areas which reduces the dust fallout for the mining area.

Figure 10. Views of soil (left)(across the track) and waste rock (right) (both sides of track) stockpiles.
