# NAMIBIA MARBLE AND GRANITE (PTY) LTD

**Annual Operational Monitoring Report**

**14 September 2023**

Project Title: **EXPLORATION AND MINING AT ML142**

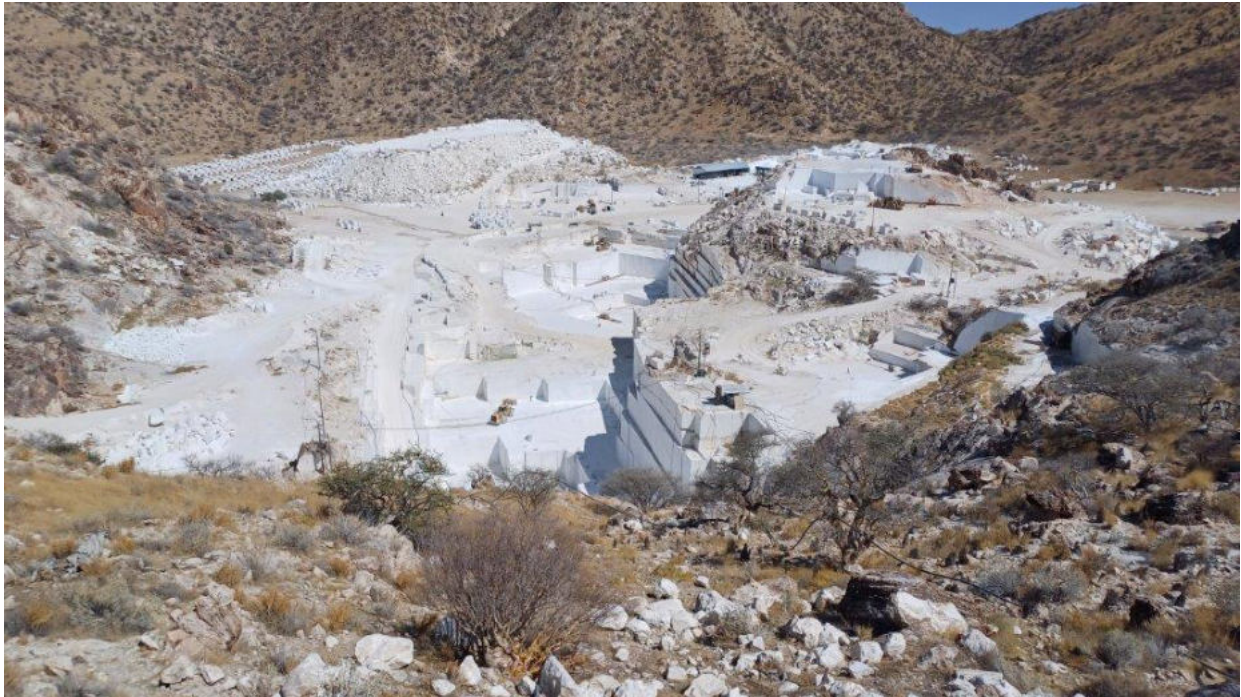
Photo 1 – View of larger mining area. The entire mining area is well layout providing for save and easy operations without risking any personnel health and/or safety.

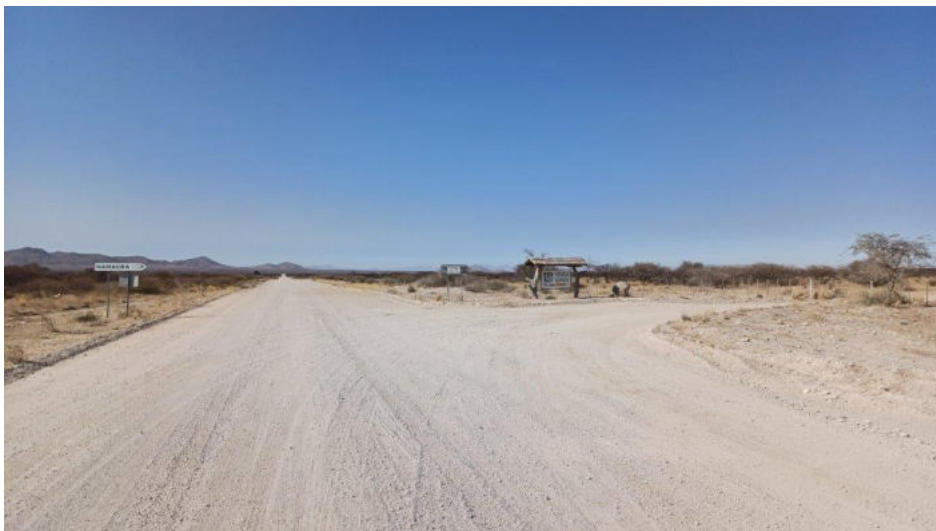
Photo 2 – View of turn-off to Namagra ML126 from the MR77 district road. Turn-off is shared with Etuses Lodge and roads are well maintained. District road MR77 requires attention from the side of the Ministry of Works and Transport.

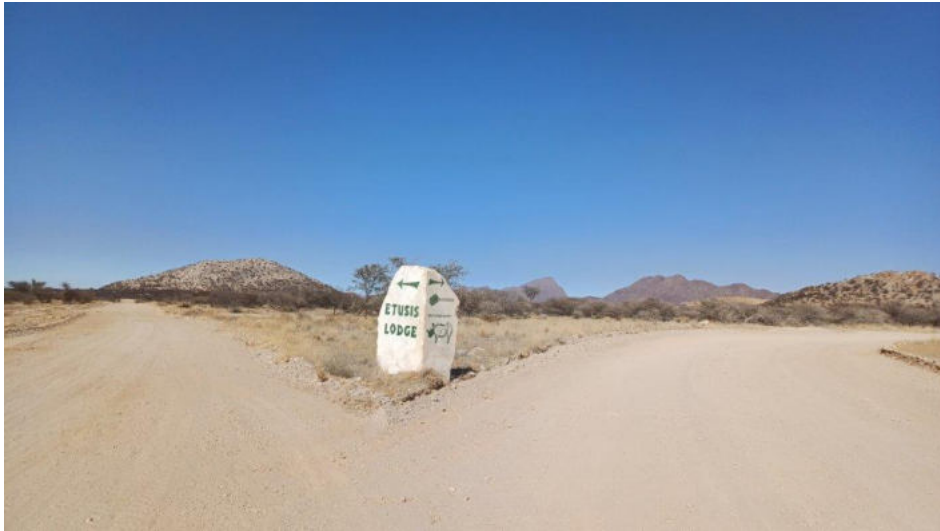
Photo 3 – View of the internal road and turn offs to Namagra ML126 (to the right) and Etusis Lodge (to the left). Internal roads are in good condition and well maintained.

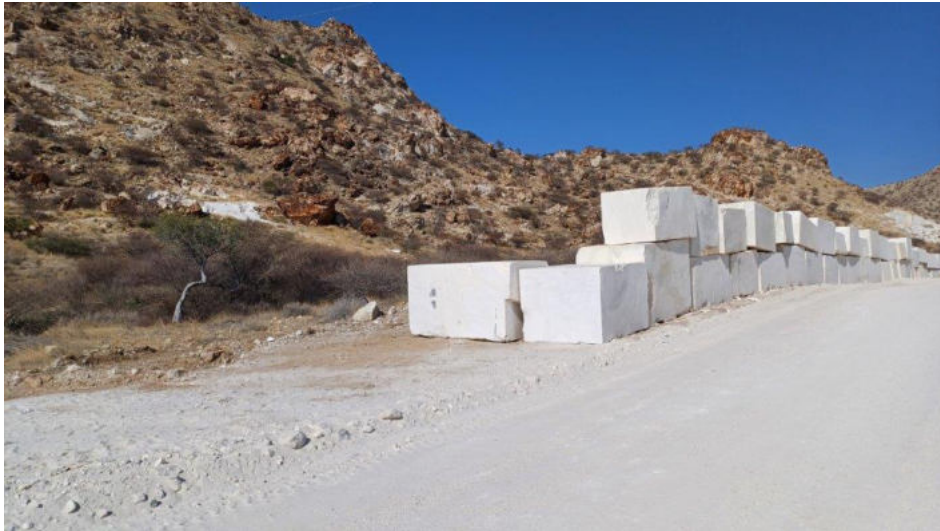
NAMAGRA has been informed of the archaeological find by the landowner and requested to proceed with the required registration of the site as a heritage site. During 2022 a heritage impact assessment was undertaken considering the larger mine area, during which time the bushman painting was investigated and recorded (Appendix C). As per the recommendations of the study, the site was excluded from the future mining area and a marble wall constructed to restrict access from the access road to the heritage site.

Photo 5 – View of marble wall constructed along the entrance road to the mine to restrict access to the adjacent restricted area (i.e., heritage remains – bushman paintings).

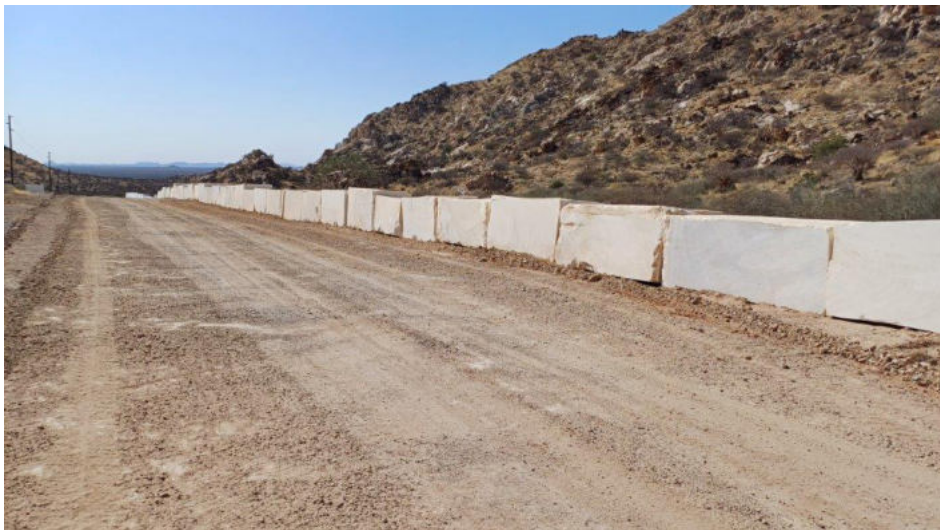
Photo 6 – View of well-maintained entrance road into the mining area.

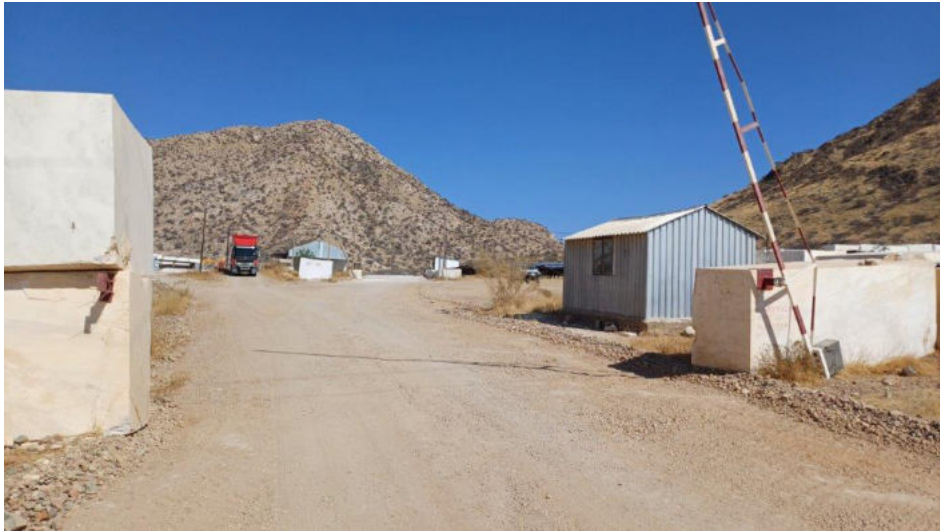
Photo 7 – View of internal entrance gate to mine, which is controlled.

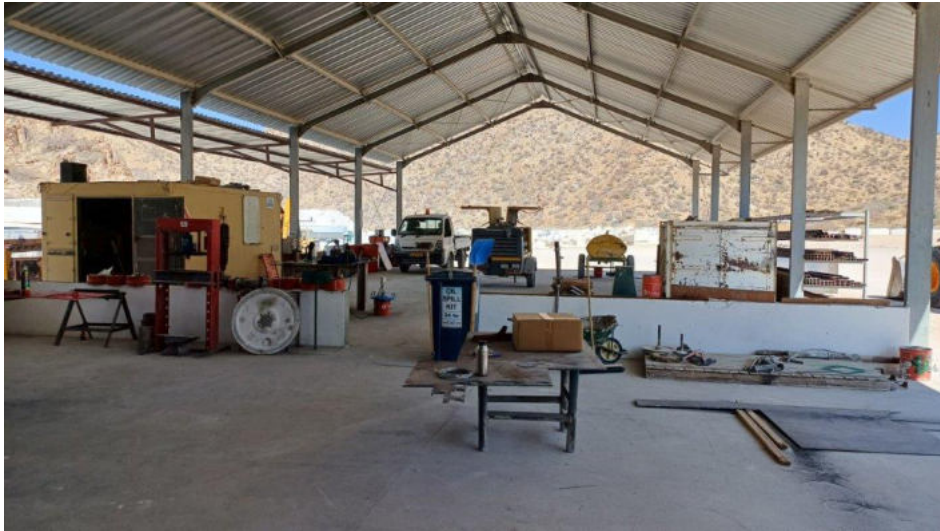
Photo 9 – View of workshop, within a neat and tidy state.

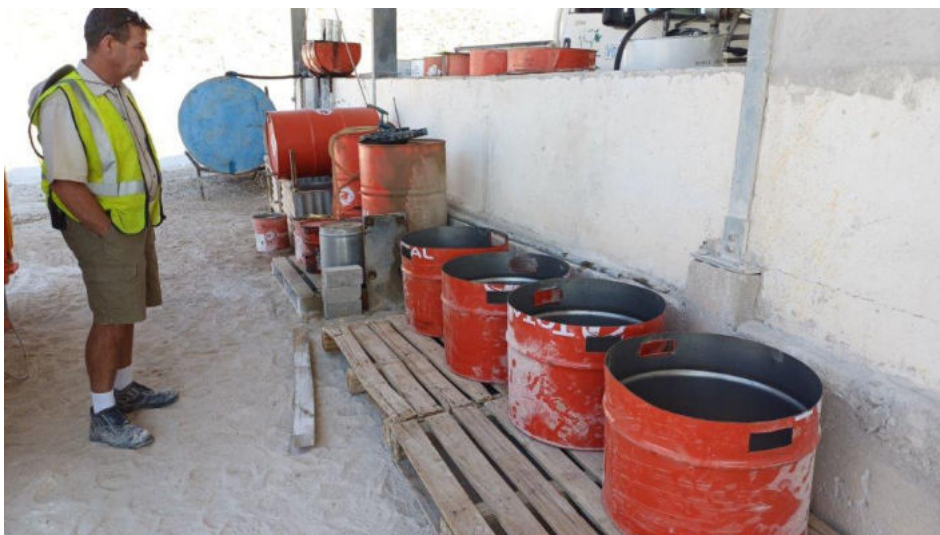
Photo 10 – View of experimental area where sawdust is used to clean polluted soil.

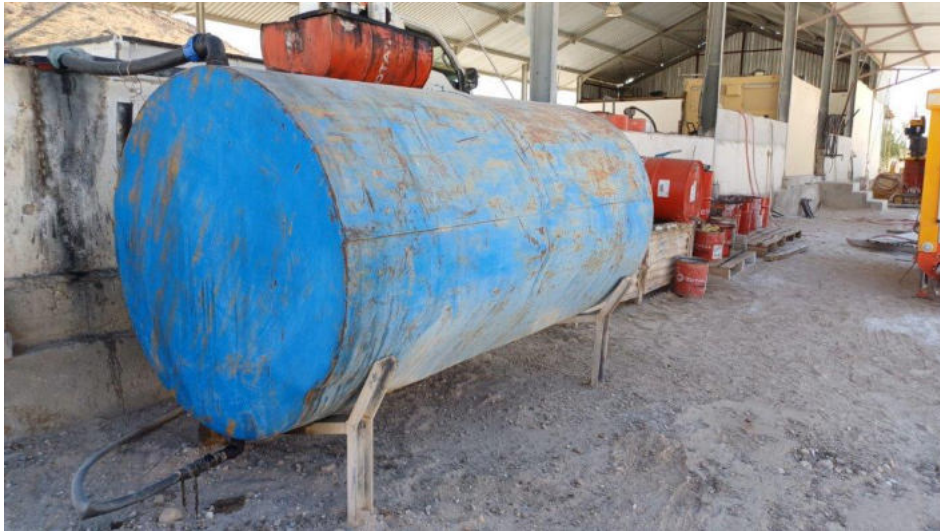
Photo 11 – View of storage tank for used oils and diesel, which is removed by external contractor for reuse.

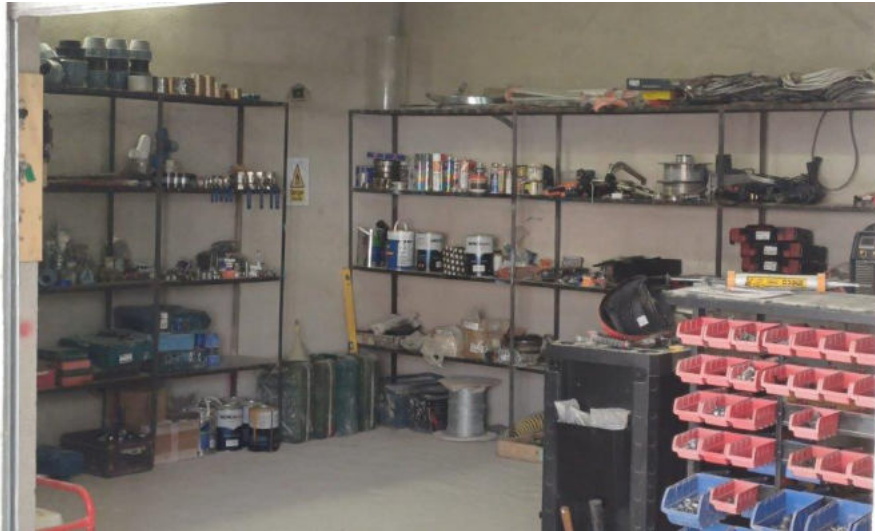
Photo 15 – View of store room at workshop, within a tidy and neat state.

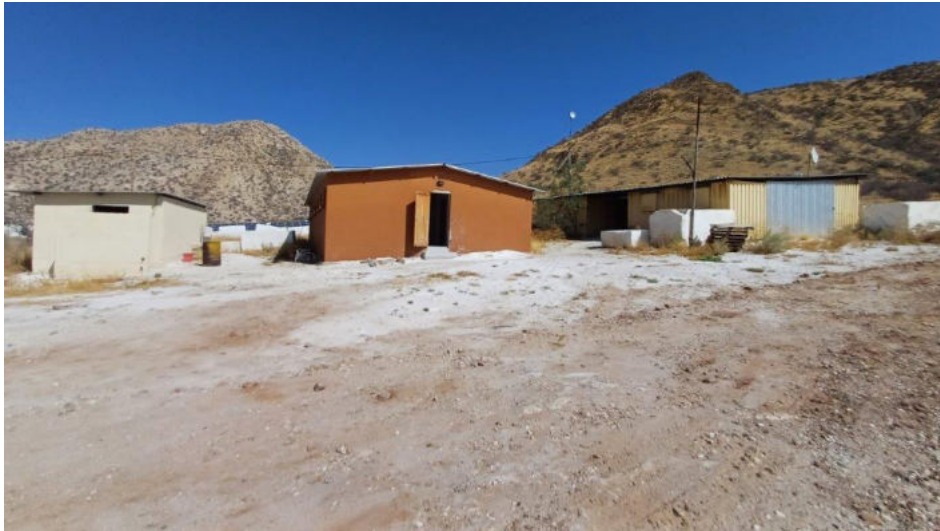
Photo 19 – View of staff accommodation, eating area and kitchen, and ablutions, which is kept within a clean and tidy state. The ablutions are used by the on-site personnel on a daily basis.

It is recommended that mobile toilet facilities be provided closer to where the personnel are working, which would also contribute to more productive working hours. The missing fire extinguisher at the fuel depot should be replaced.

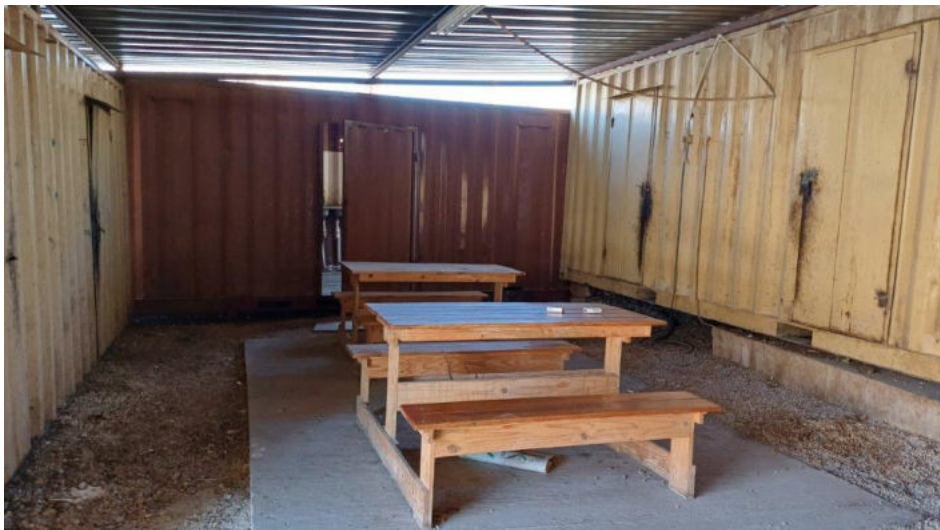
Photo 20 – View of tidy and neat personnel eating area.

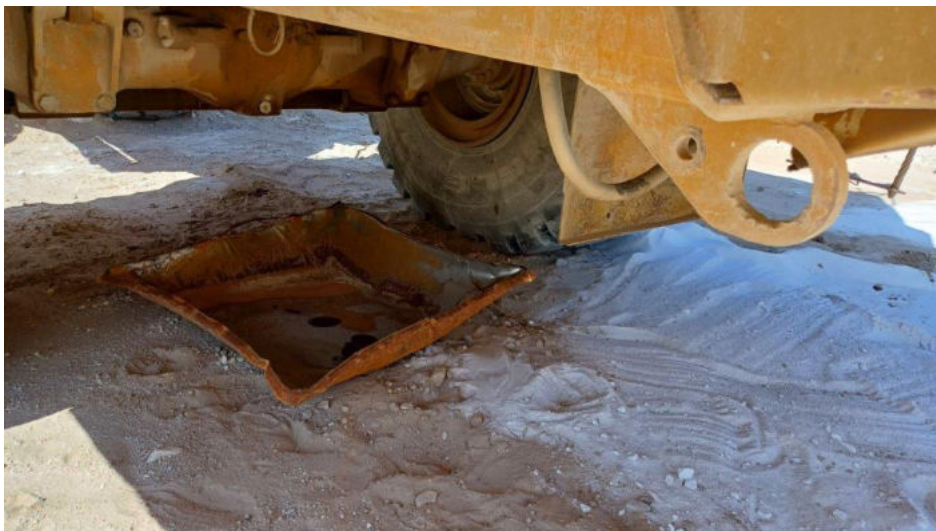
All stationary vehicles and machinery were equipped with drip trays, which are emptied at the workshop at the dedicated used oil reclamation facility (flagged as '*green*').

Photo 22 – View of drip tray underneath a stationary construction vehicle.

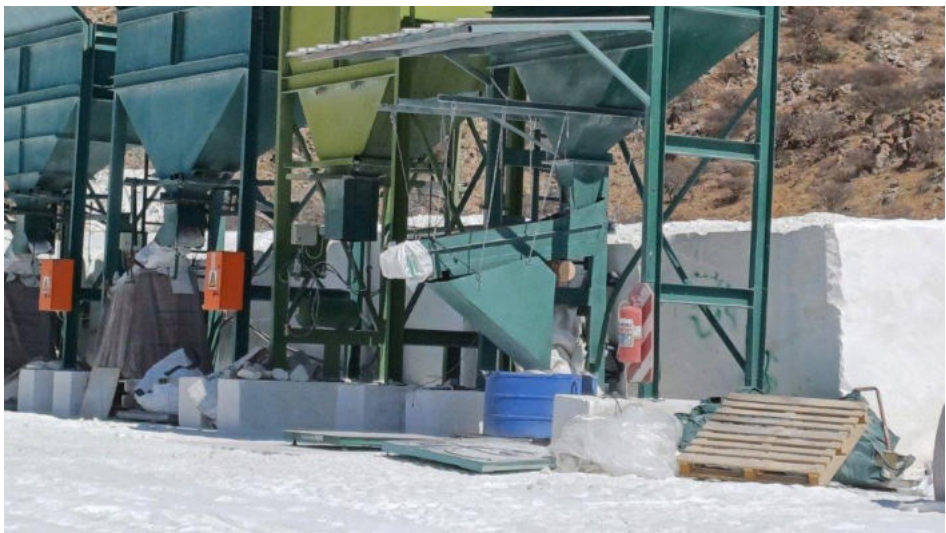
Photo 28 - View of process area which is well maintained and organised.

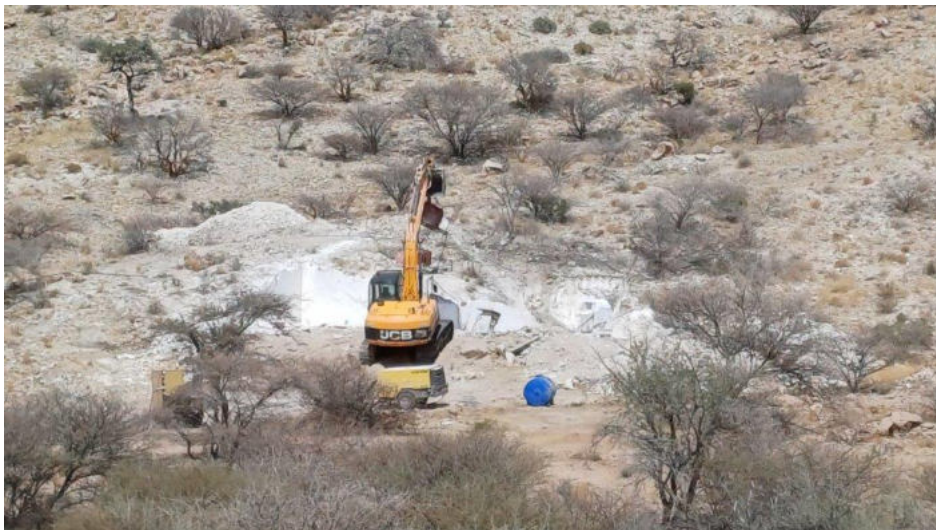
Photo 30 – View of new test pit located to the south-western edge of the larger mining area.

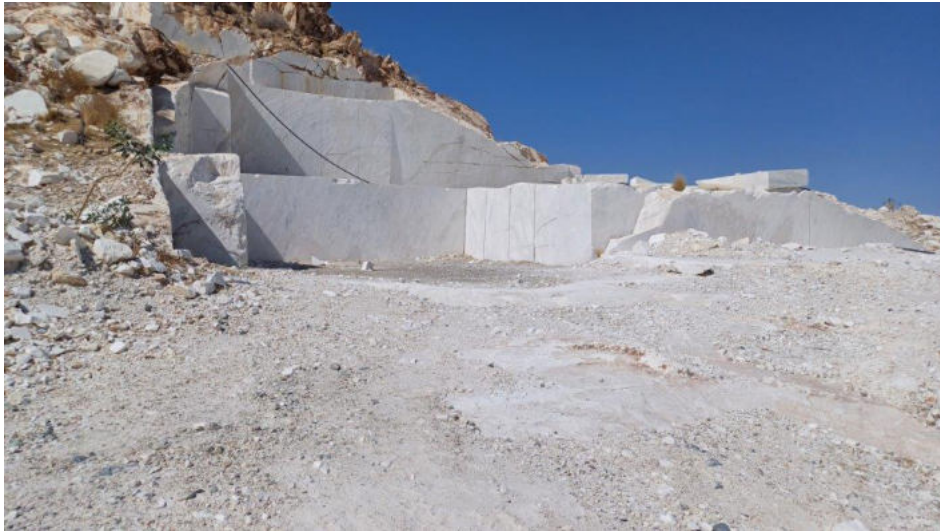
Photo 31 - View of one of the new test pits up the hill to the east of the main mining pit area.

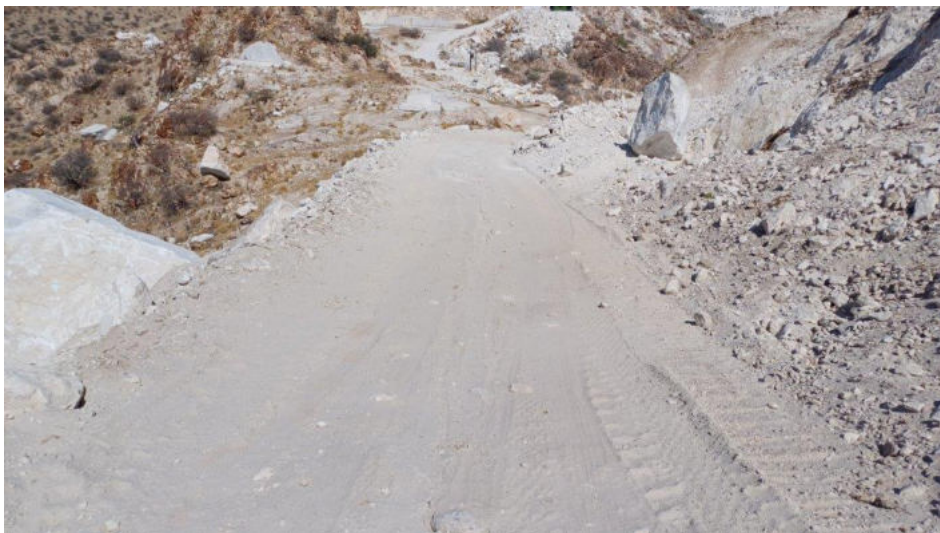
The construction of the new road and test sites up the hill eastwards from the existing mining pit and to the south-west of the larger mining area has resulted in removal of local and indigenous flora and is expected to further increase as the test pits increase in footprint. Considering the low diversity and endemism of birds, amphibians and plants, the impact is localised and small. The area affected by the road and test pits was kept to the necessary minimum to avoid any unnecessary destruction and removal of habitat.

Photo 32 – View of the newly constructed road providing access to the newly opened test pits located to the east of the main mining pit area.

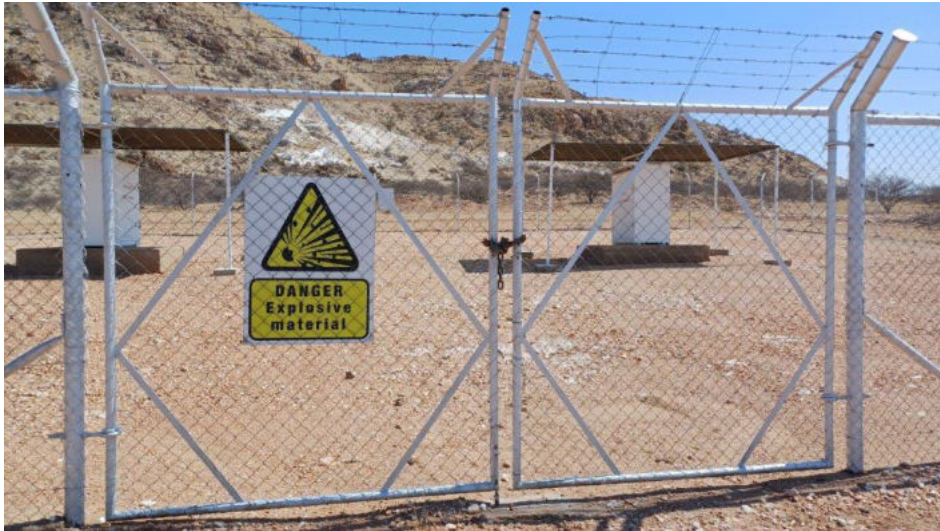
Photo 33 – View of fenced-in and controlled access to explosives holding area.
