NAMIBIA MARBLE AND GRANITE (PTY) LTD

Annual Operational Monitoring Report

17 August 2022

Project Title: **EXPLORATION AND MINING AT ML142**

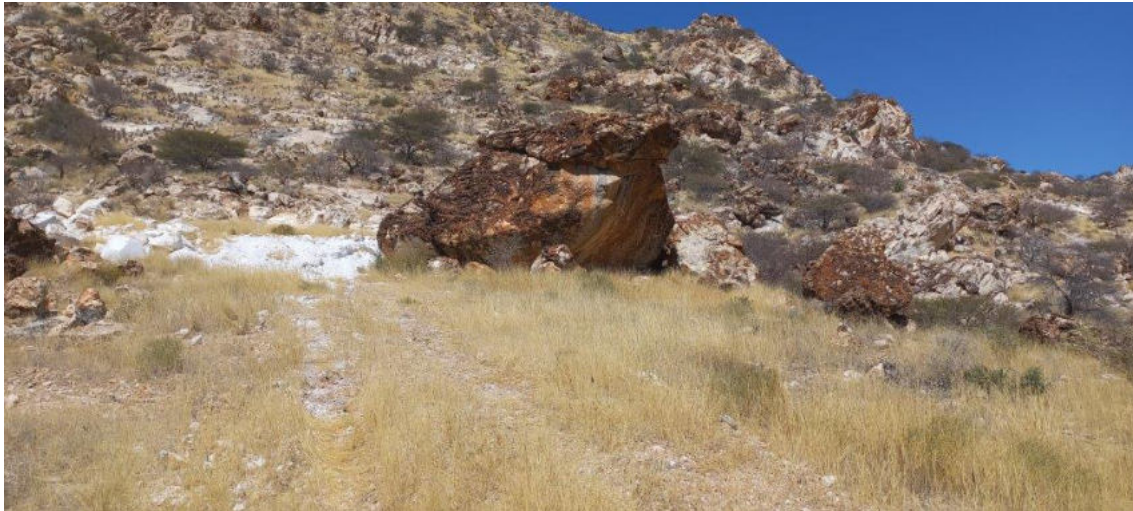
Contrary to the EIA Report (2014), which indicated that there are no known areas of heritage and cultural importance in the mining area, bushmen paintings were discovered during July 2022 outside of the active mining area to the north-eastern side of the main mining area.

Photo 1 – View of rock containing busman paintings (-22.102732° 15.818595°).

NAMAGRA has been informed of the archaeological find by the landowner and requested to avoid the site and not conduct any activity at or close to the archaeological find.

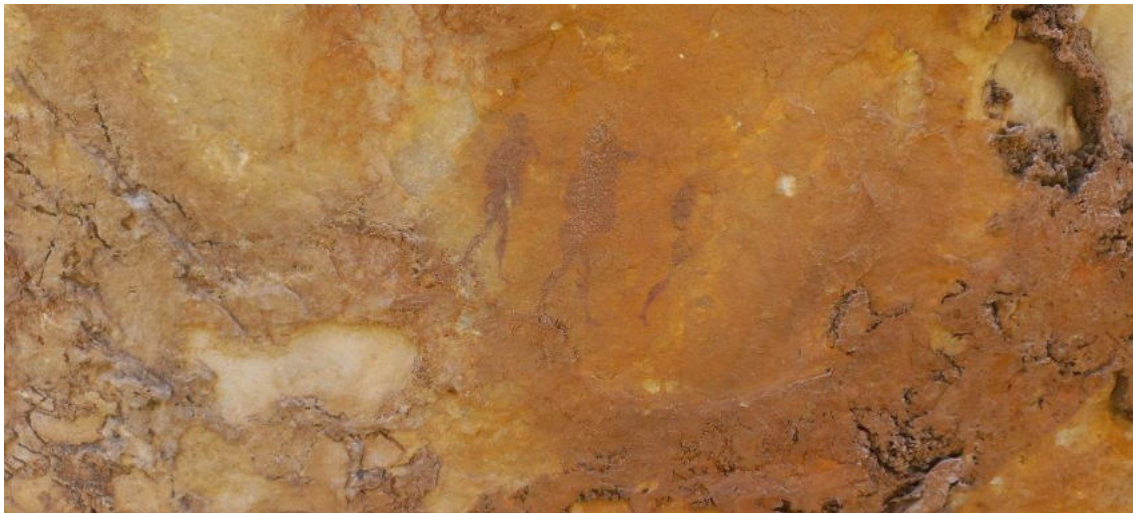
Photo 2 – View of bushman paintings.

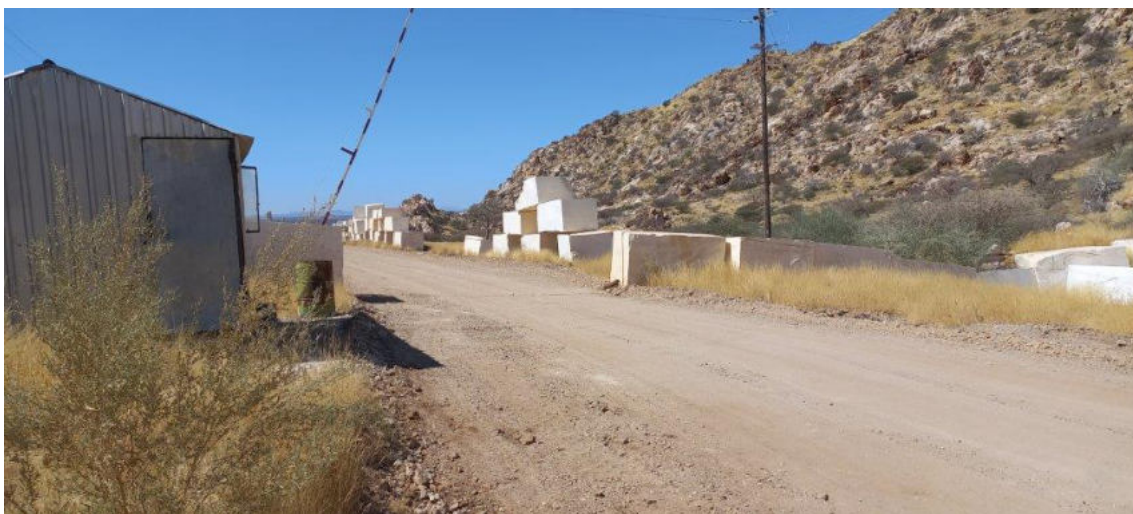
From the site visit it can be recorded that access to the larger mine area is controlled via access gate and fence, while access to the mining site itself is controlled with boom and security guard.

Photo 3 – View of guarded entrance to mining area with boom gate.

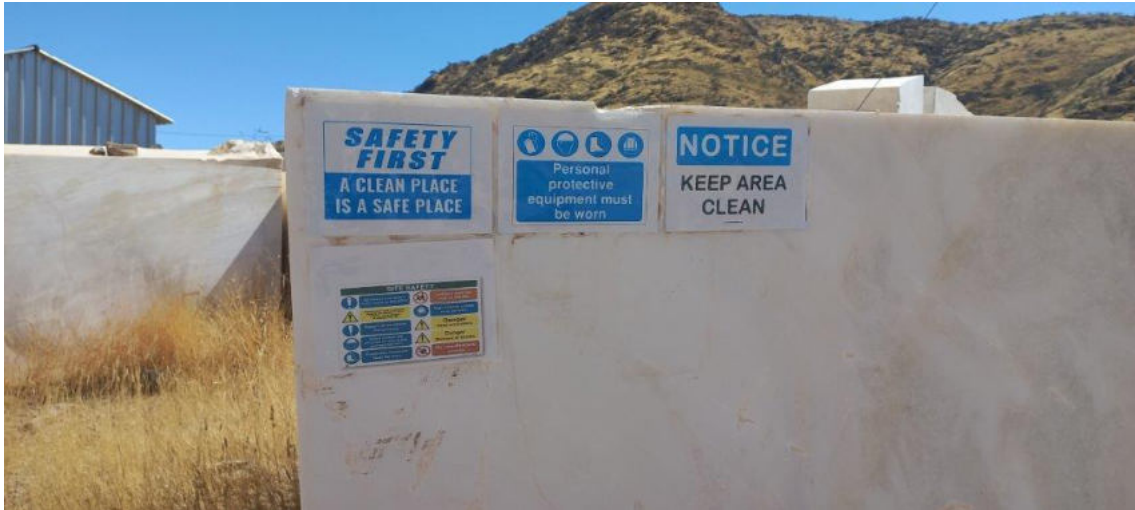
Photo 4 – View of safety warning signs at entrance to mining area.

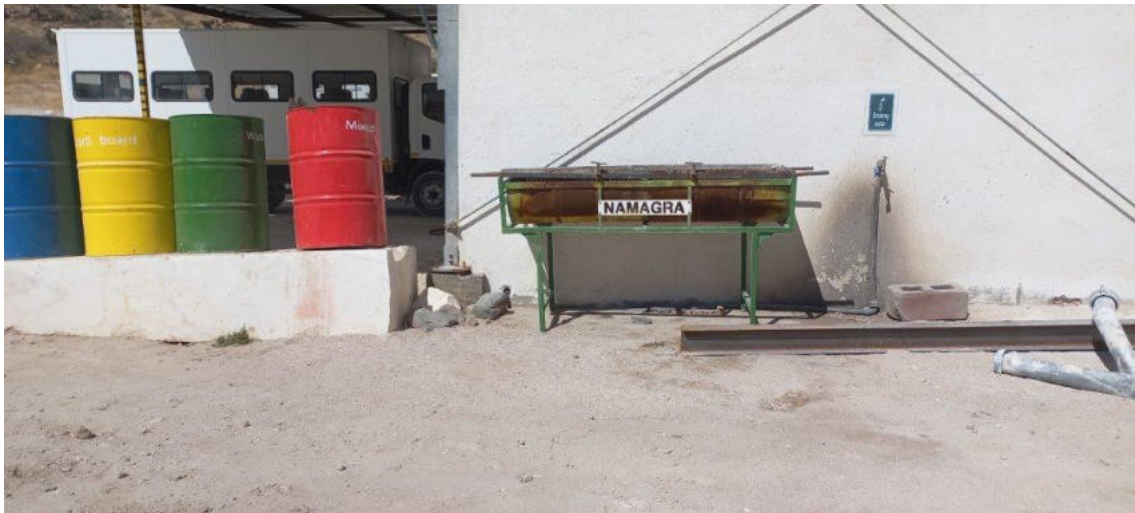
Photo 5 – View of separation recycling waste collection area.

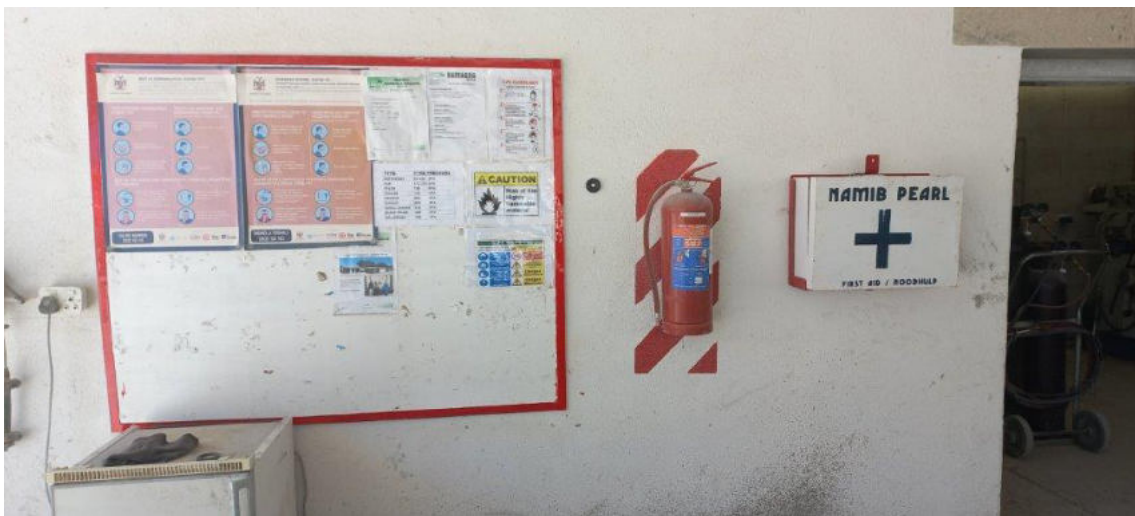
Photo 6 – View of information board, fire extinguisher and medical safety kit at workshop area.

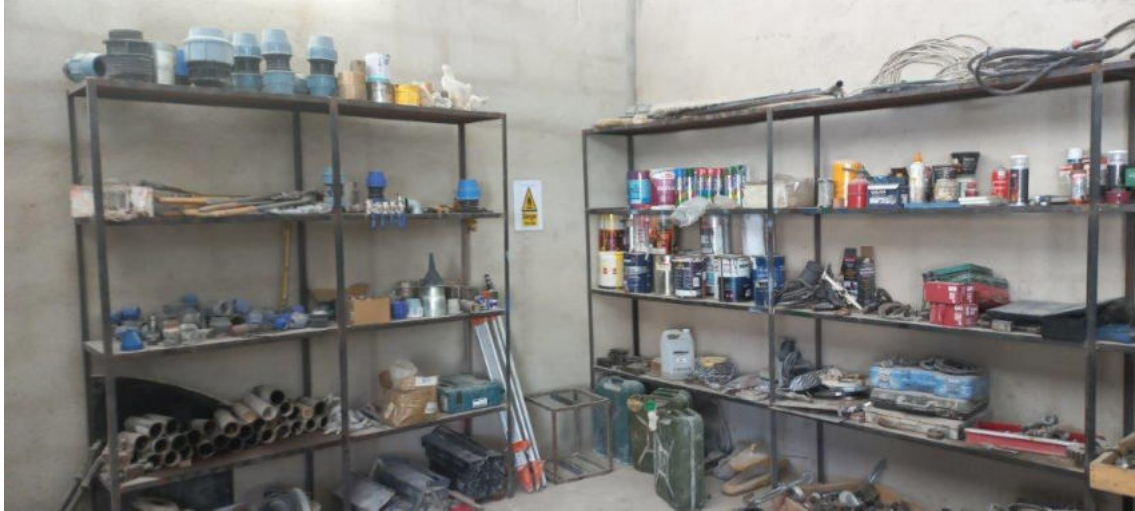
Photo 7 – View of storeroom, neat and tidy.

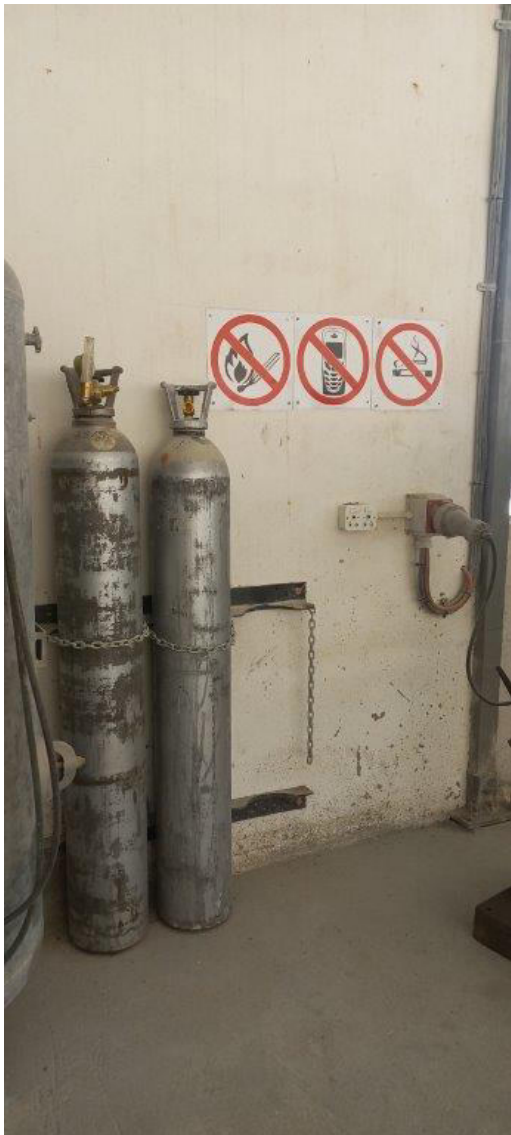
Photo 8 – View of safety and warning signs at workshop.

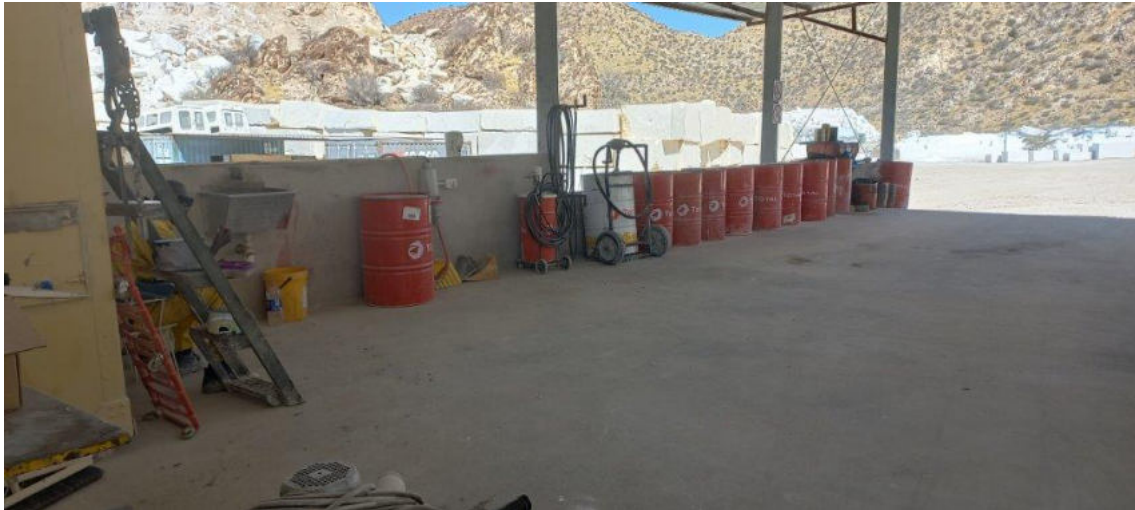
Photo 9 – View of workshop area.

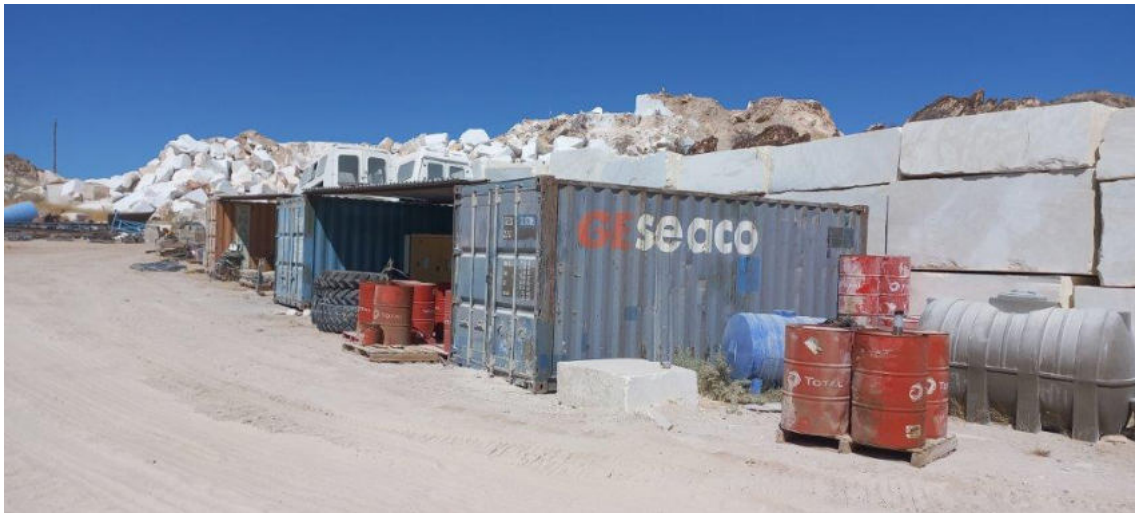
Photo 10 – View of container storage areas.

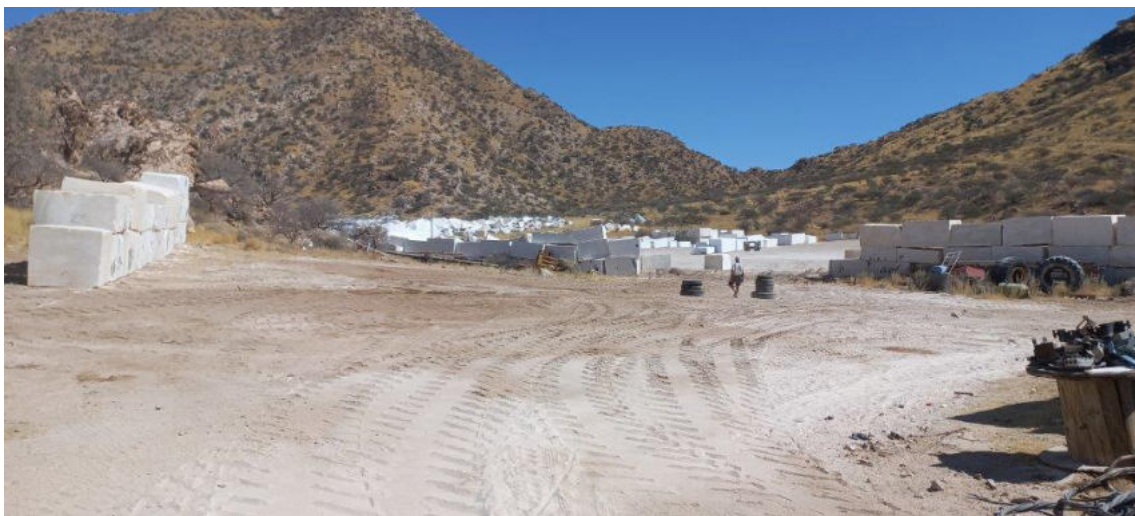
The mining waste dump site has been sorted and cleaned up moving the issue from the previous '*yellow*' to '*green*'. The remainder of the site is considering '*green*' with respect to successful compliance.

Photo 11 – View of cleaned-up mining waste dump site.

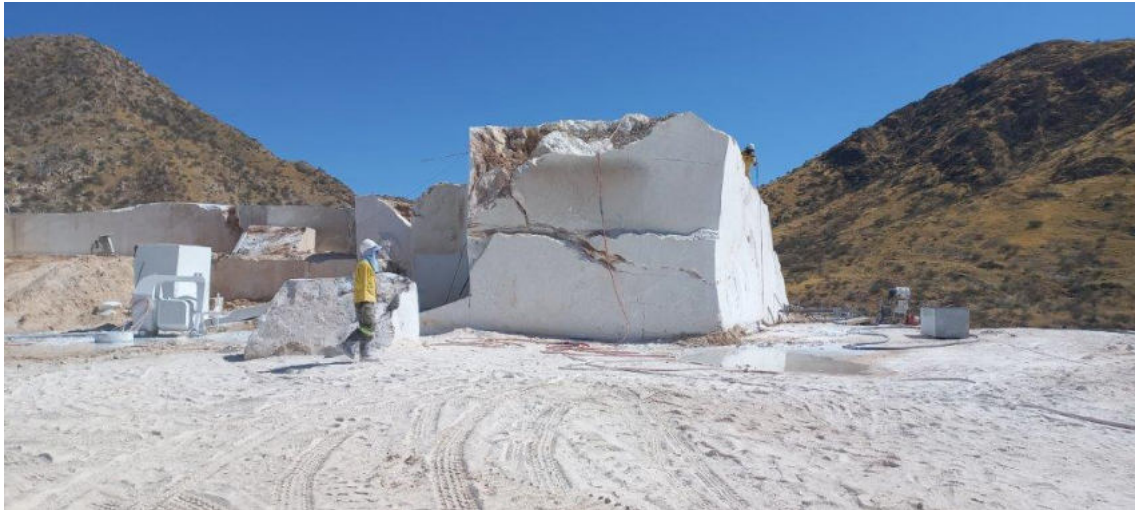
Photo 12 – View of worker equipped with protective gear and clothing at working site.

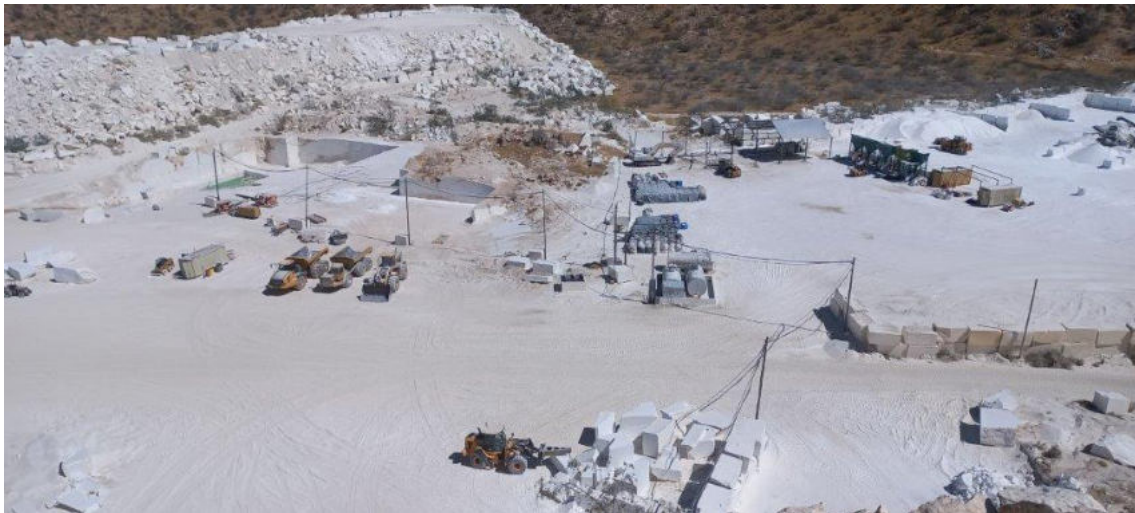
Photo 13 – View of well layout and neat mining site.

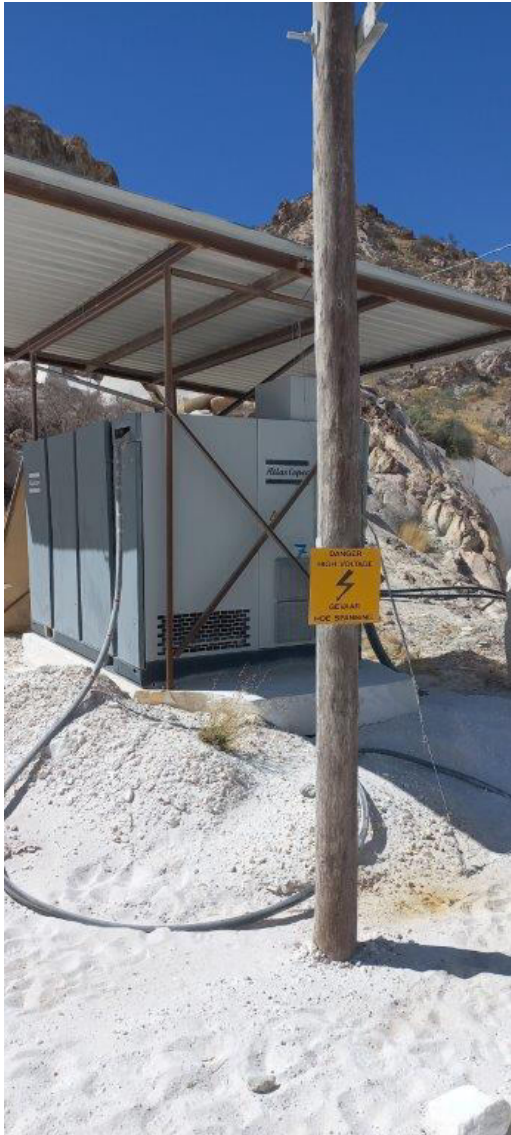
Photo 14 – View of warning sign at high voltage overhead power line and generator.

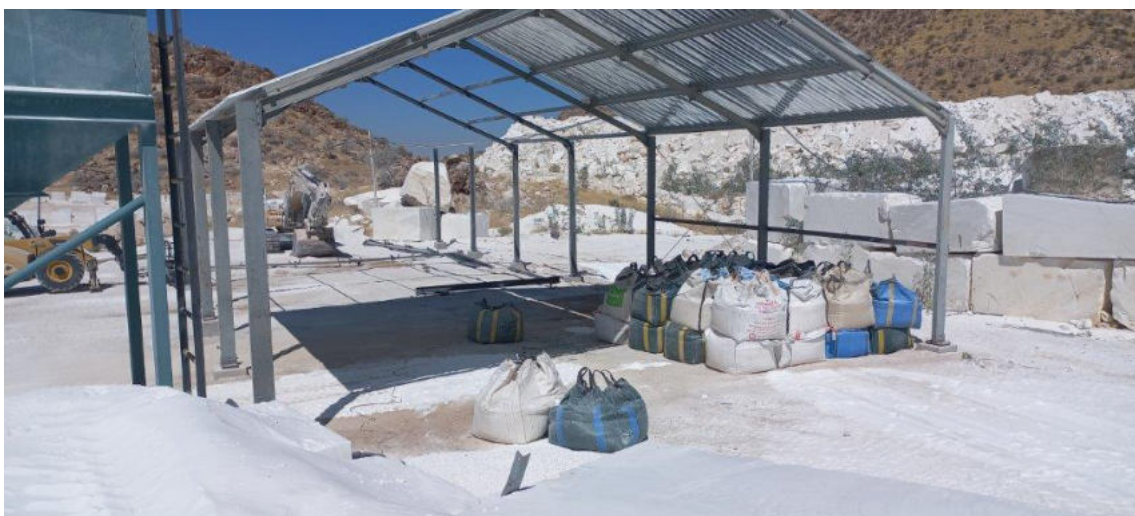
Photo 15 – View of under roof storage area.

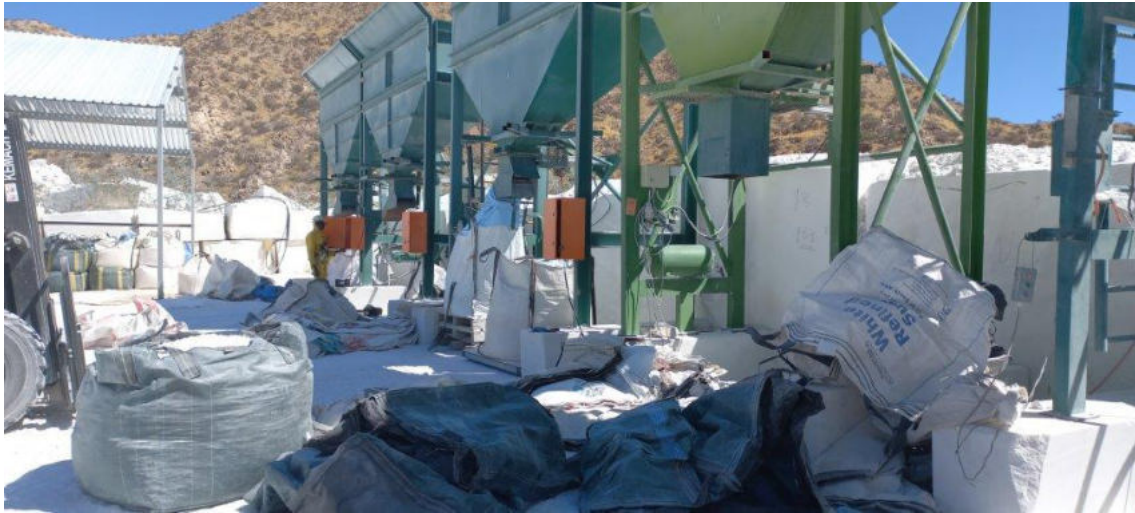
Photo 16 – View of stone bagging section.

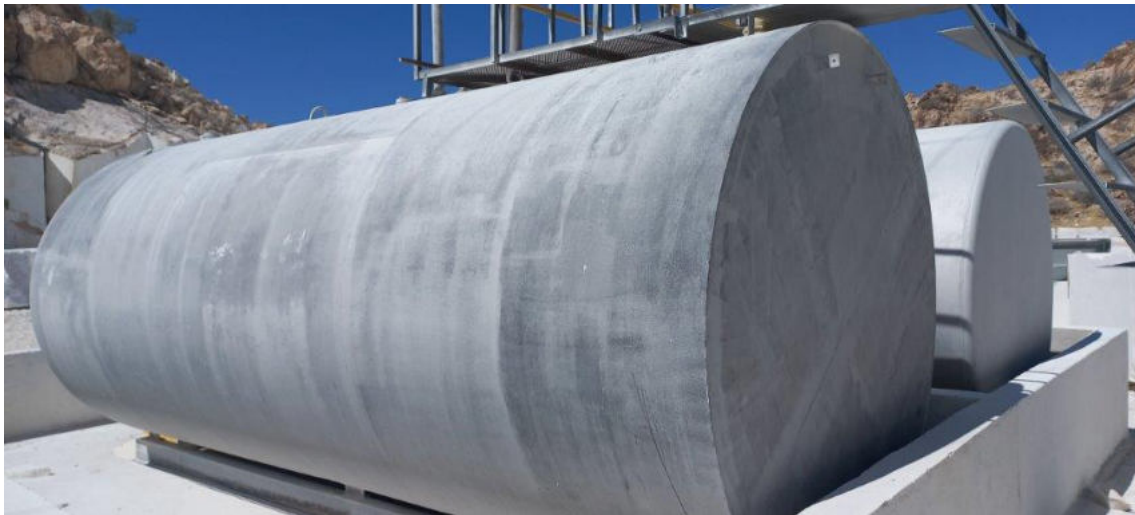
Photo 17 – View of fuelling area, well maintained.

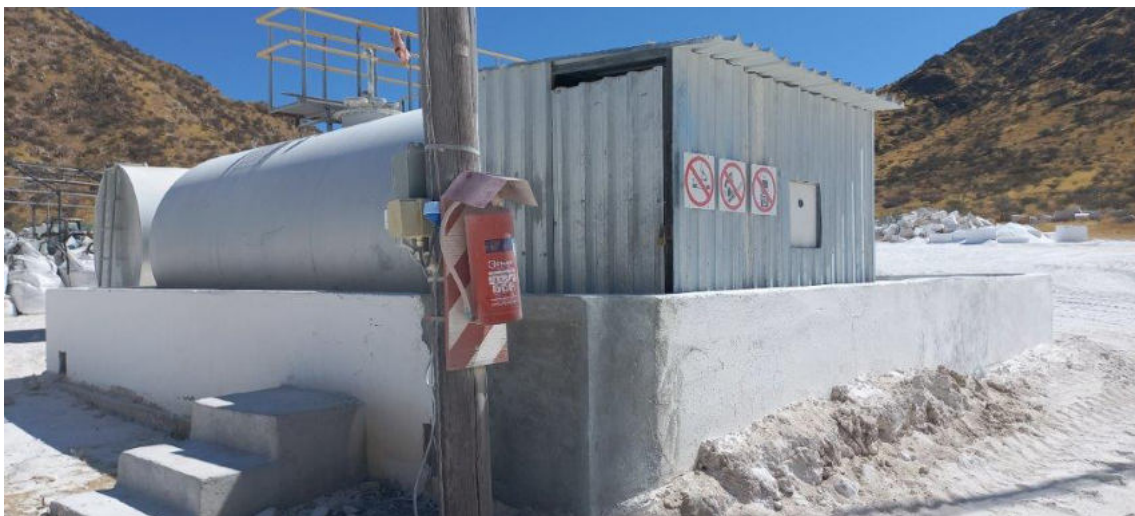
Photo 18 – View of fire extinguisher and warning signs at fuelling area.

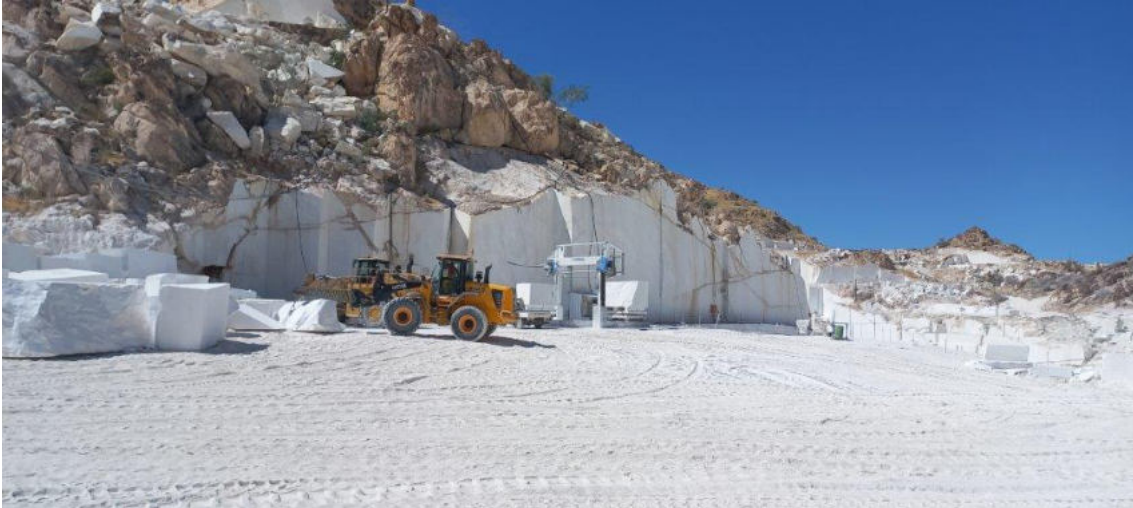
Photo 19 – View of mining machinery at work on-site. All machinery is well maintained and in good operational condition.

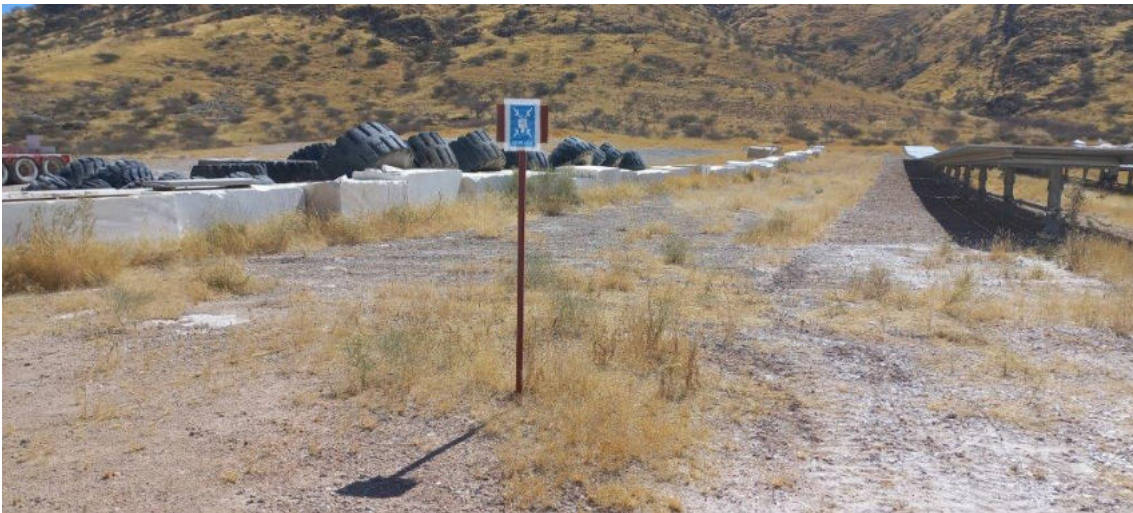
Photo 20 – Vie of emergency assembly point.

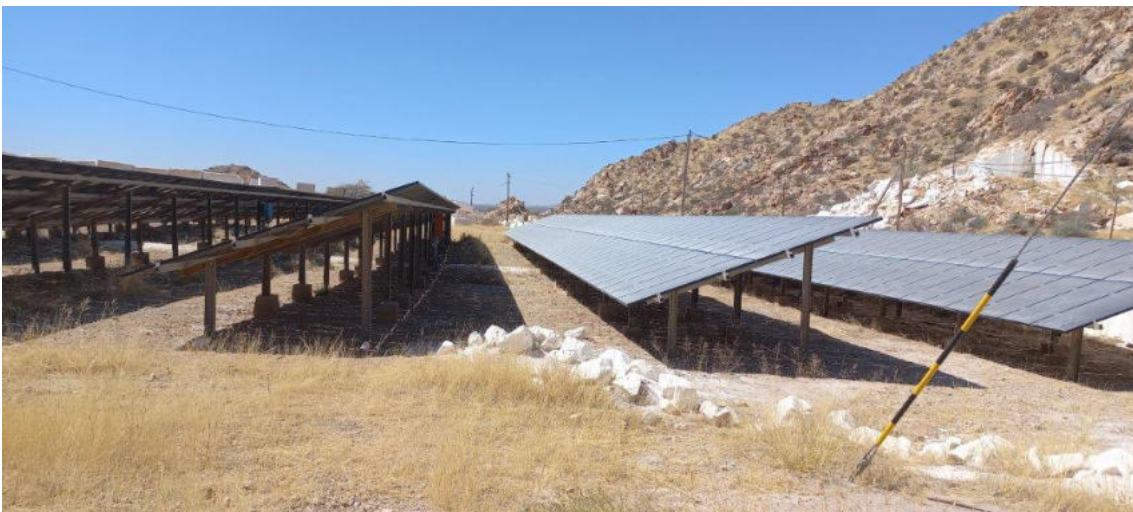
Photo 21 – View of solar plant, well maintained and operational.

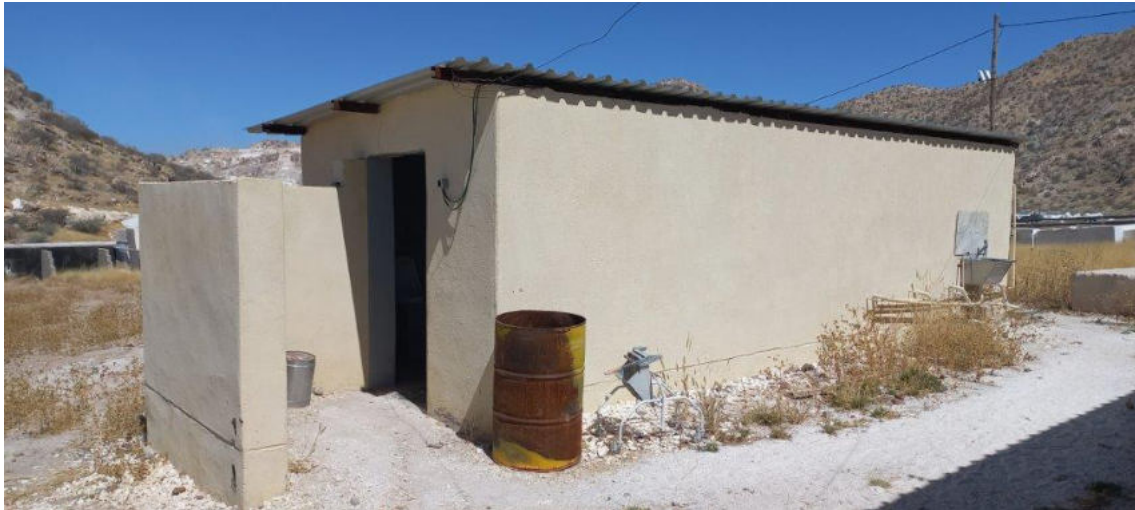
Photo 22 – View of ablutions on-site, well kept, tidy and neat.

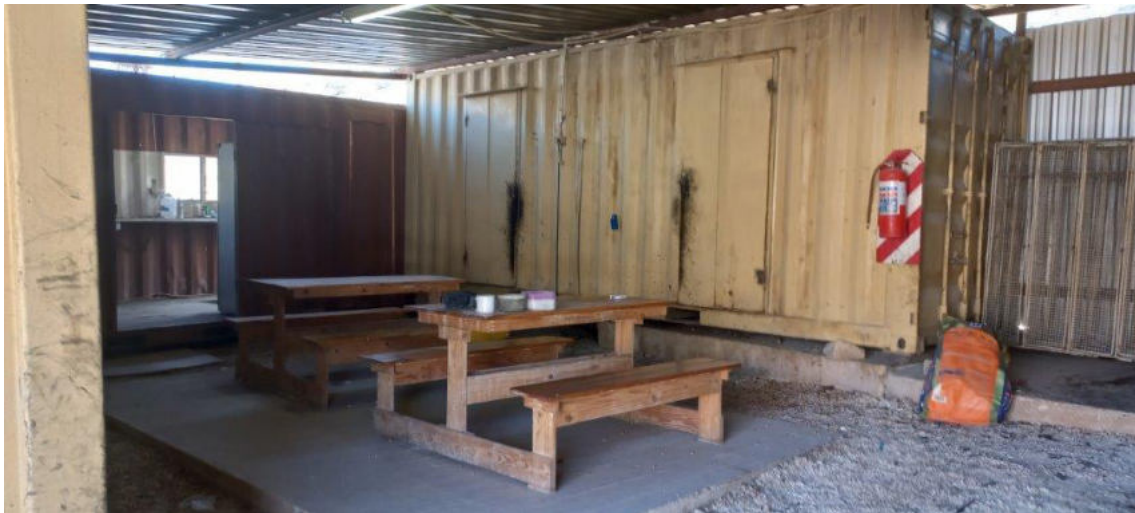
Photo 23 – View of on-site eating area. Neat and tidy with fire extinguisher.

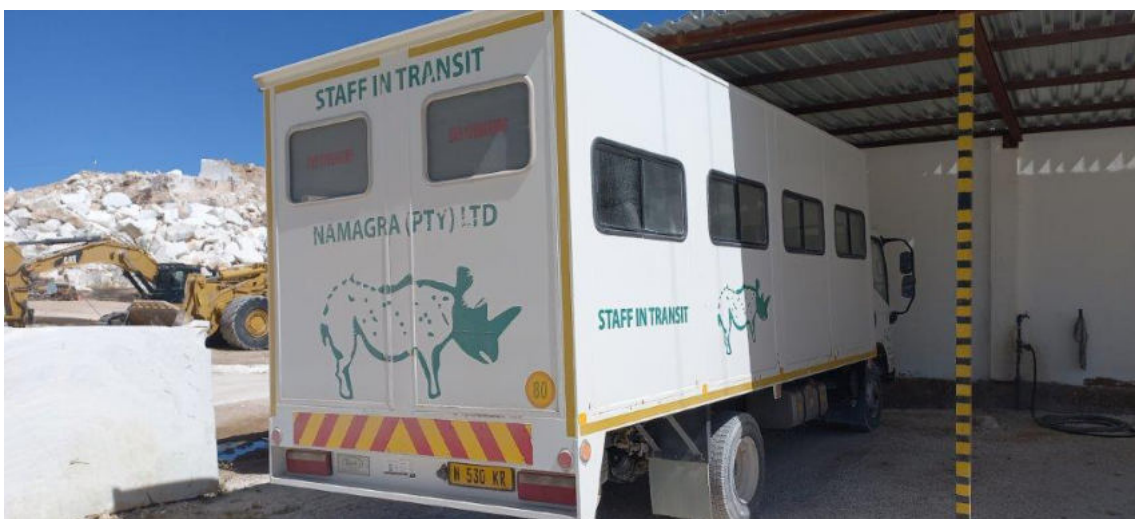
Photo 24 – View of staff transportation vehicle. Road worthy and in good operational condition.

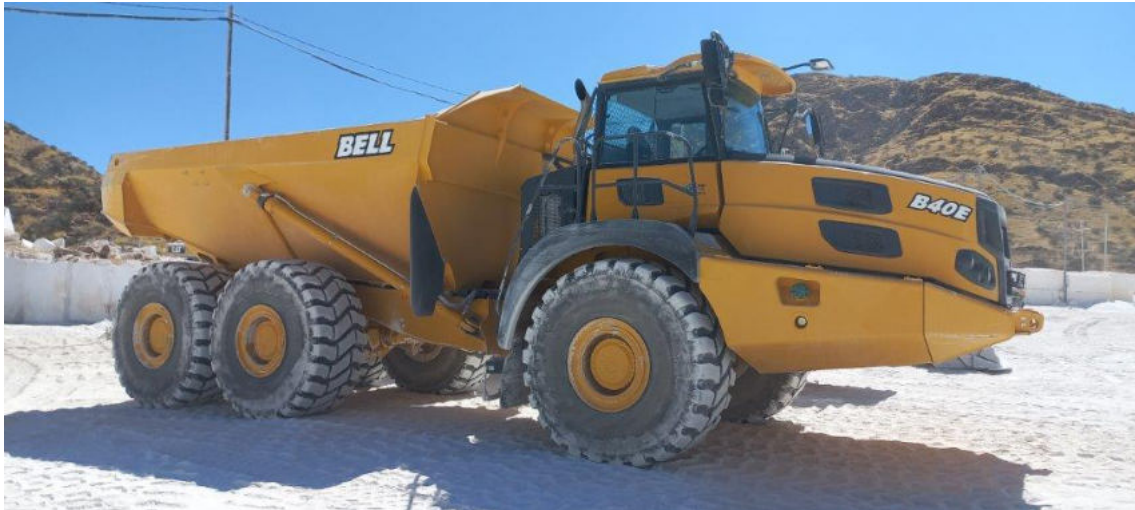
Photo 25 – View of mining machine, well maintained and good operational condition.

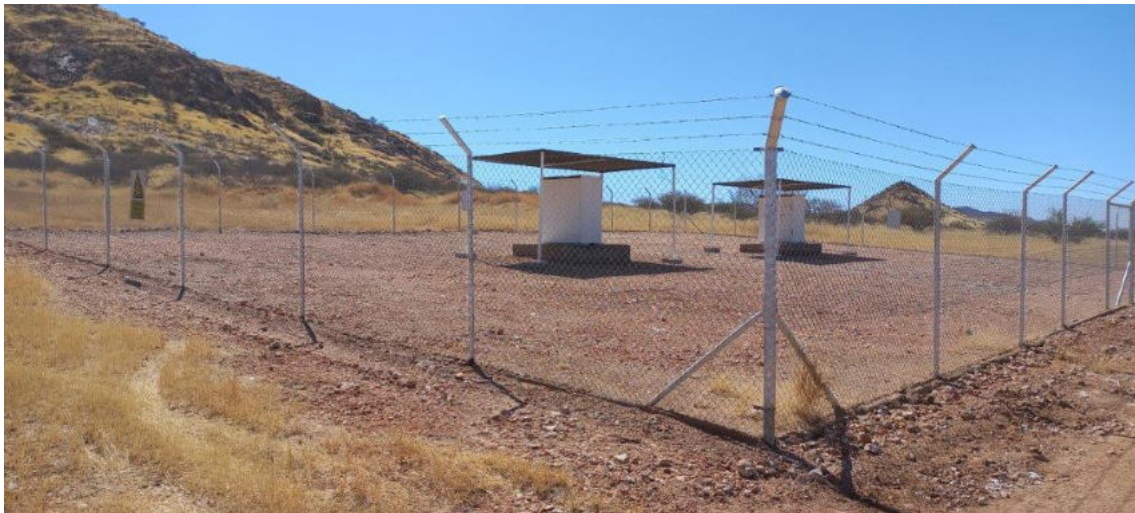
Photo 26 – View of dynamite store area, well maintained and kept safe.

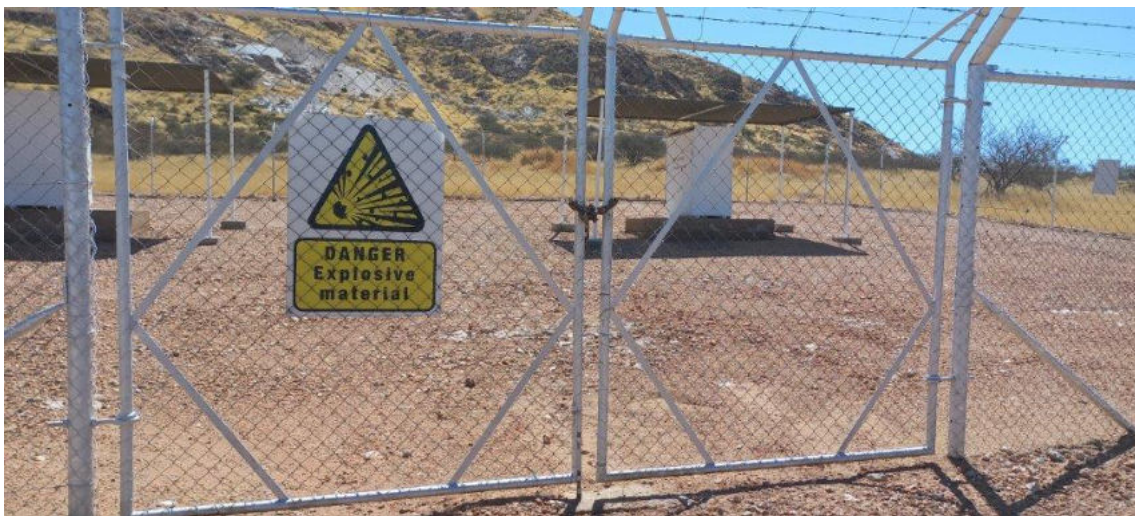
Photo 27 – View of locked gate with warning sign at dynamite store area.

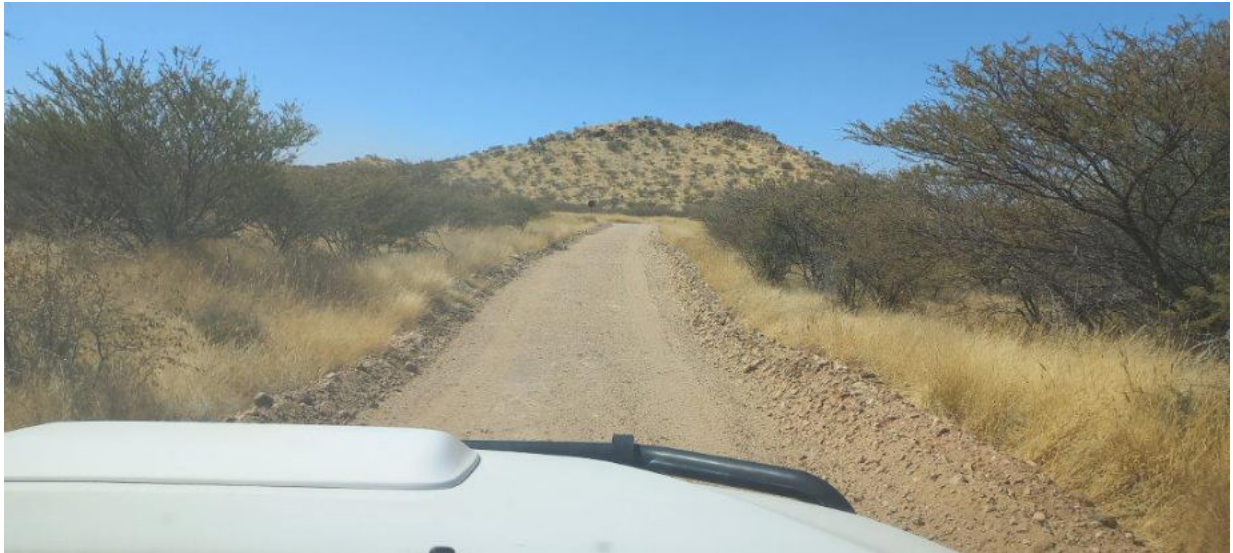
Photo 28 – View of internal road, which are well maintained. Vehicles remain on roads.
