ENVIRONMENTAL FIELD SURVEY

UPGRADE OF THE RAILWAY LINE IN BETWEEN
KRANZBERG STATION TO TSUMEB AND OTAVI TO
GROOTFONTEIN

PHASE 1 – RAILWAY LINE BETWEEN KRANZBERG
STATION AND OTJIWARONGO TOWN

April 2022

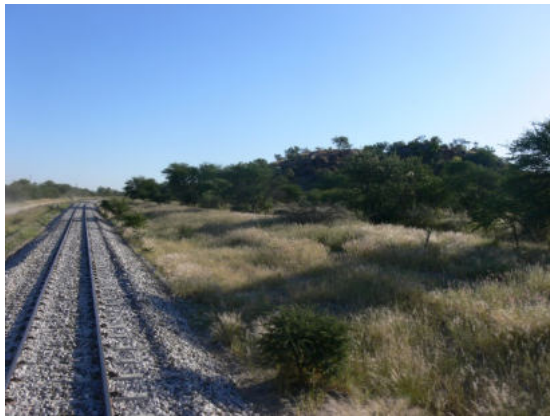
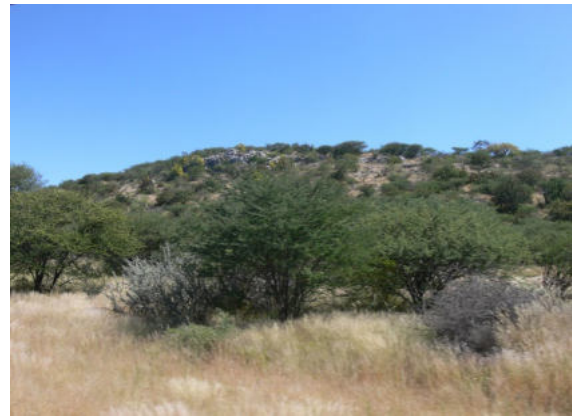
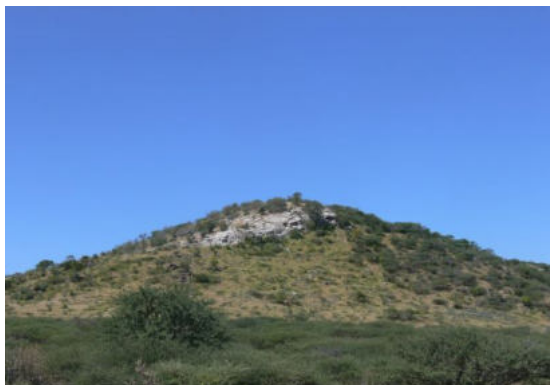
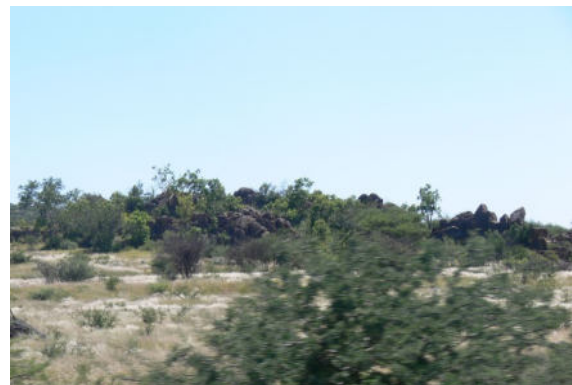
The railway line passes outcrops along its way in both Section 1 and 2. Deviations in the railway line in some places move towards some of these outcrops, but do not necessarily cross them. In other cases, outcrops may be partly in jeopardy.

These were marked for further investigation.

Photo 3.1.2 – Examples of outcrops along the railway line

Where possible rocky outcrops should be avoided during re-alignment of the railway line. This should happen automatically, due to the restricted gradient at which a railway line can operate. The outcrop areas have more sensitive ecology, with higher flora and fauna species biodiversity and endemism. Impacts on plains in the project area will cause less biodiversity loss and plains will recover more easily in a shorter period of time after a rainy season.

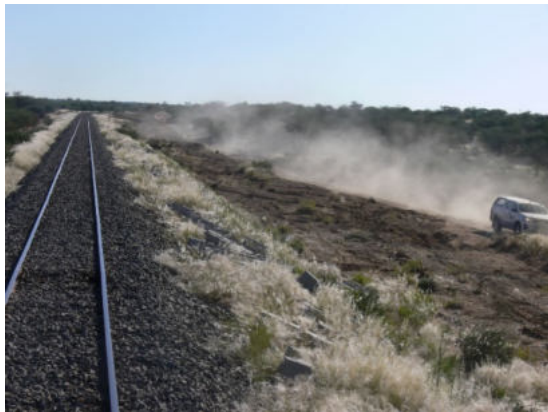
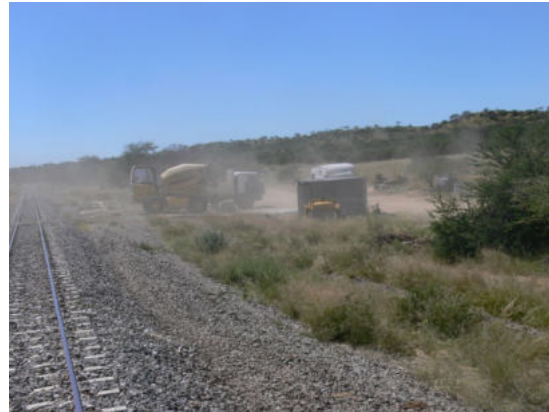
Photo 3.2.1 – Maintenance vehicles on the service road cause dust emissions

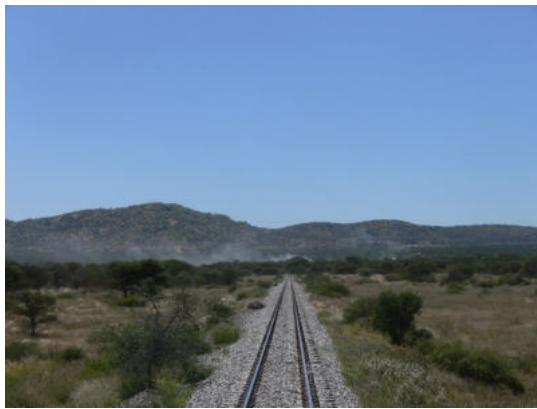
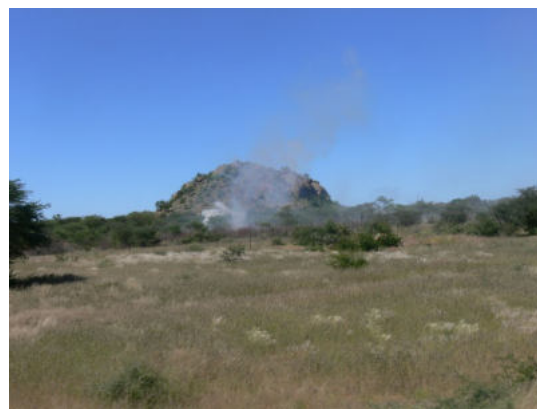
Photo 3.2.2 – Charcoal burning cause some form of air pollution on a small scale

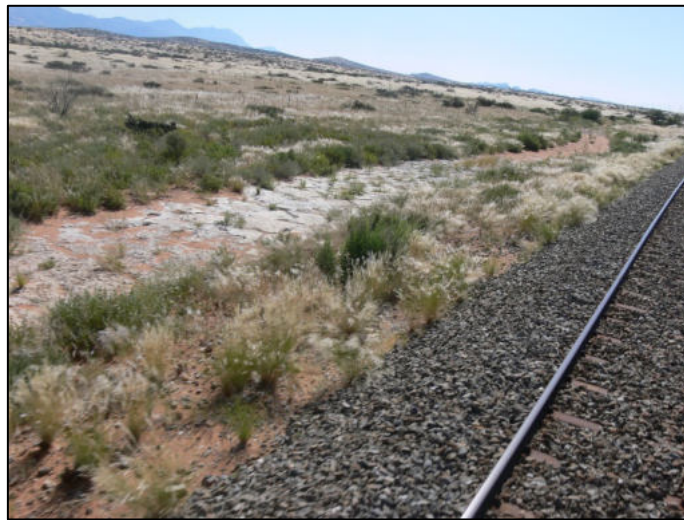
For most part of Section 1 and 2, the railroad runs over *Eutric Regosols*. This is relative fertile soil with high base saturation. Regosols are medium- or fine-textured soils of actively eroding landscapes. The thin layers lie directly above the rock surfaces from which they are formed. These soils do not reach depths of more than 50 cm and Photo 3.3.1 shows where the calcrete rock surfaces.

Photo 3.3.1 – Soil cover that expose underlying bedrock

Dust suppression will be required during construction for this soil type and where there is a degree of slope this soil type is susceptible to erosion.

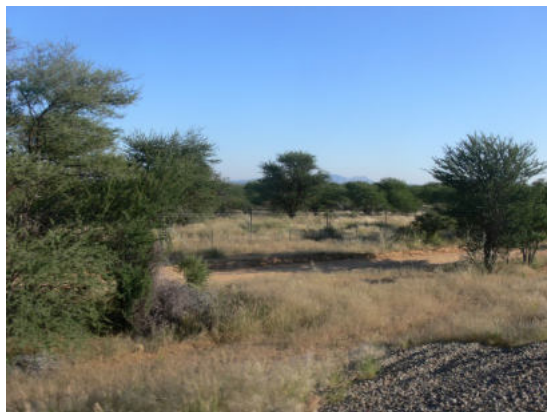
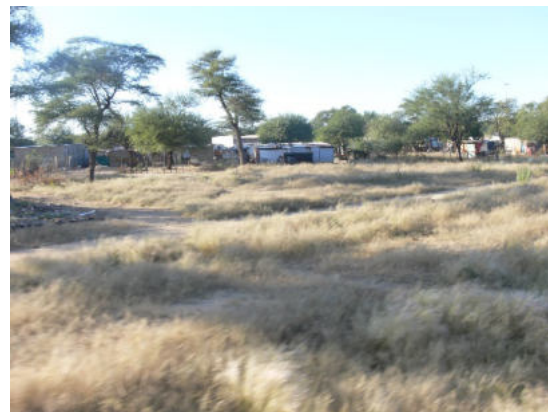
Closer to Omaruru Town the railway line deviates to the east towards a newly erected informal settlement that was not there previously when the initial plans were drawn up.

Photo 3.5.4 – Electrified game fence of an estate and an informal settlement south of Omaruru

This incidence was noted for possible re-alignment to prevent relocation of people.

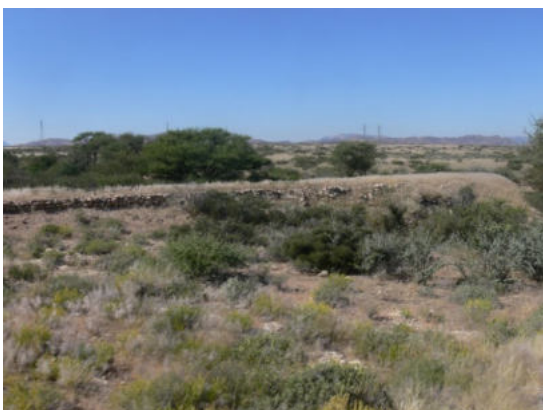
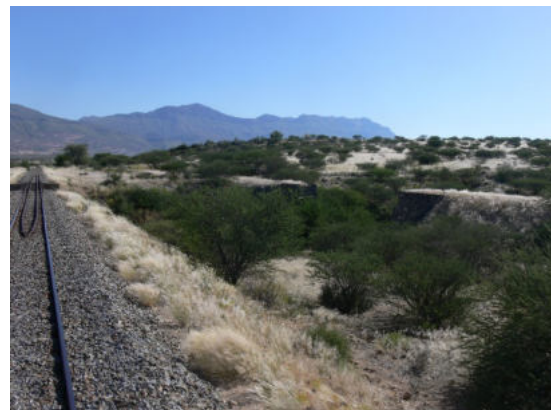
The servitude area can be described as an area that was previously disturbed and not in pristine condition any more. The railroad has been in existence for decades since early 1900 and was re-aligned and rebuilt already. The old embankment, with remains of culverts and bridge pillars are still visible in some places.

Photo 3.6.1 – Old embankment east of current railway line Section 1 Sample 1

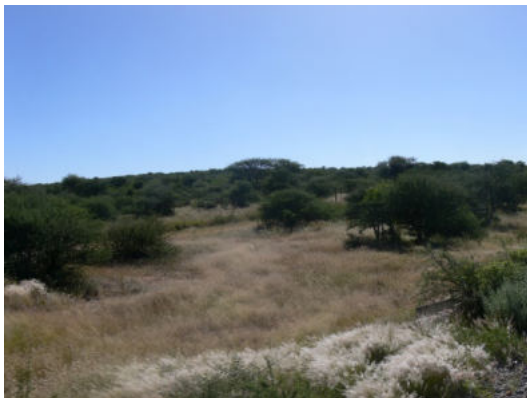
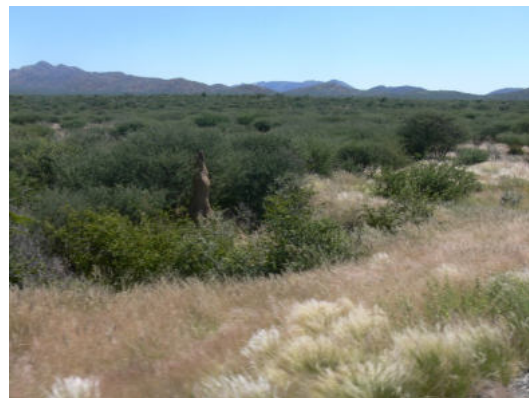
Bush encroachment is visible in areas with dense Acacia thickets in and around the servitude.

Photo 3.6.2 – Bush encroachment in Section 1 and Section 2

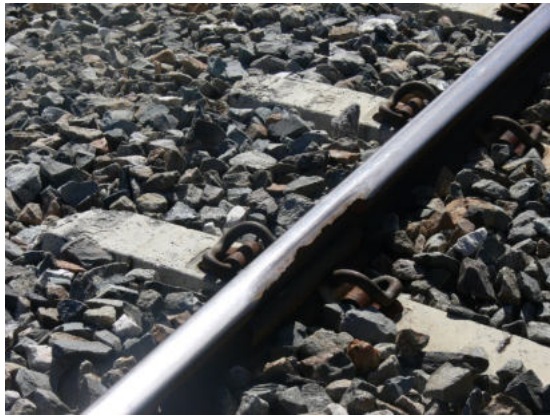
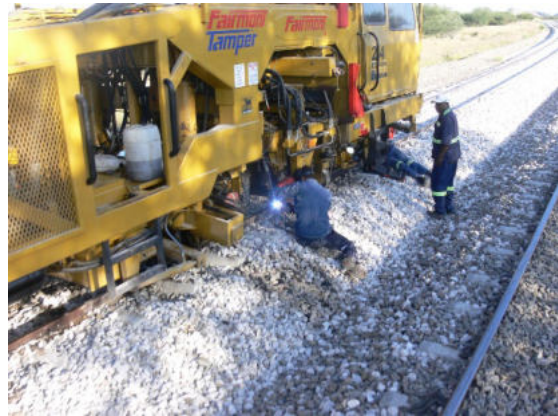
Maintenance and minor construction activities are on-going on the existing railway line. The railroad currently poses a threat to Health and Safety, because of its dilapidated condition in some areas.

Photo 7.8.1 – Broken rail between Erundu and

Replacement of rail near Norman Siding Avond Siding

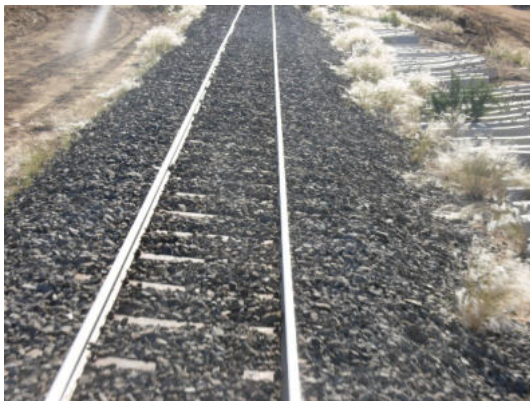
The old steel sleepers have been replaced with concrete sleepers for most of the way from Norman Siding northwards. Sleepers are currently being replaced between Erongo and Norman Siding. From Kranzberg to Erongo Siding the original steel sleepers are still in place and poses a Health and Safety hazard.

According to the engineers this maintenance programme is expensive and not sustainable in the long run.

Photo 3.8.2 – Original steel sleepers

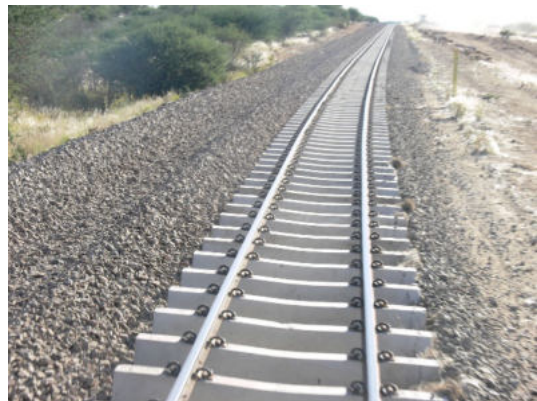
Skeleton tracks without ballast may not be longer than 4 km during maintenance for Health and Safety reasons

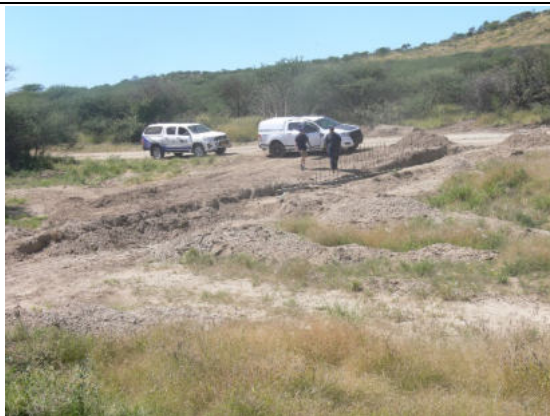
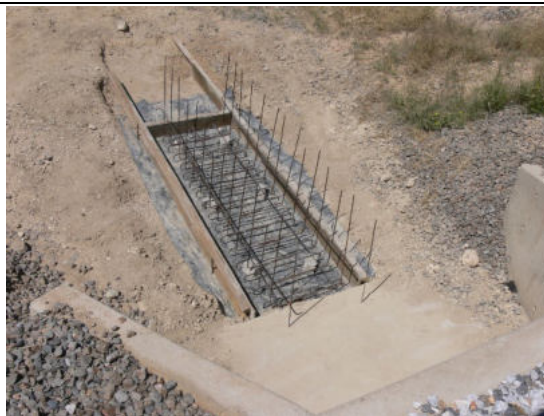
Photo 3.8.3 – Culverts are being reconstructed between Okozongoro and Etuo Siding
