# HARDAP PHOTOVOLTAIC POWER PROJECT

**Annual Operational Monitoring Report**

10 November 2021

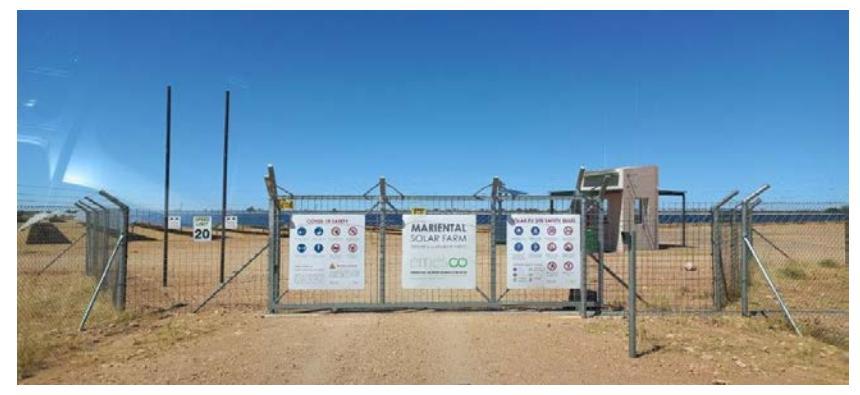
Photo 1 – View of Project site entrance displaying information and warning signs.

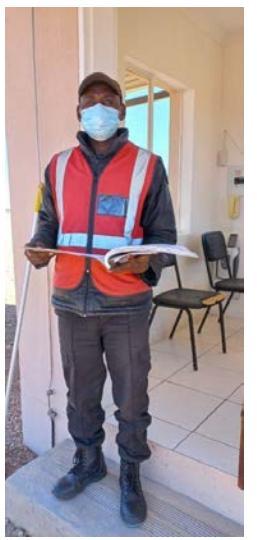
Photo 2 – View of Project site security guard with visitor's register book.

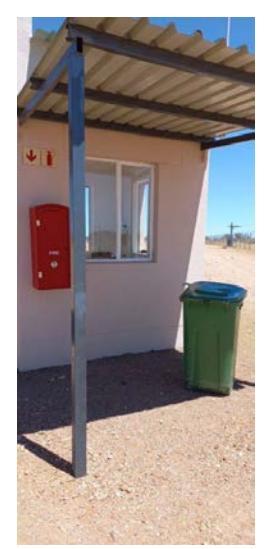
Photo 3 – View of security guard house with fire extinguisher.

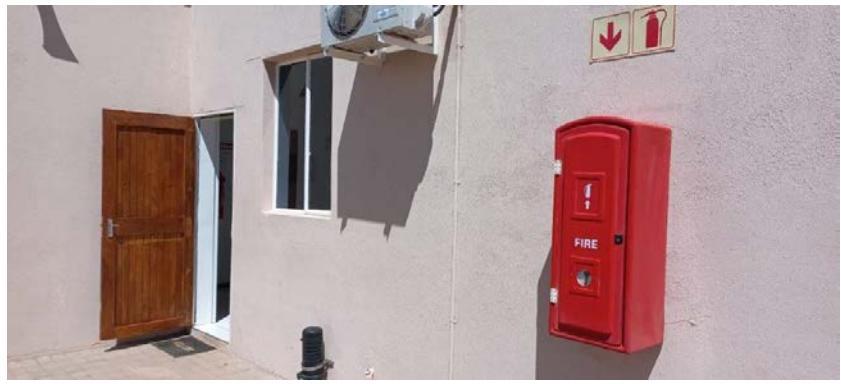
Photo 4 – View of site office with fire extinguisher.

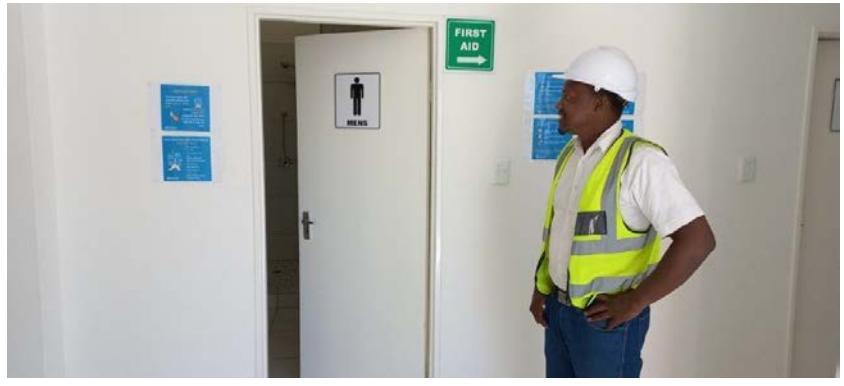
Photo 6 – View of reception area displaying health and safety information and direction to first aid room.

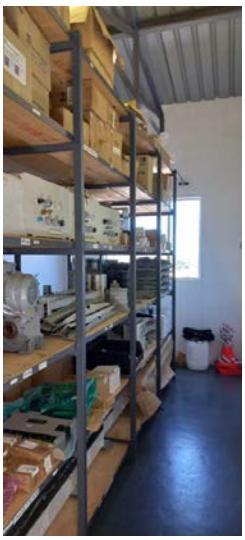
Photo 7 – View of storeroom kept need and tidy.

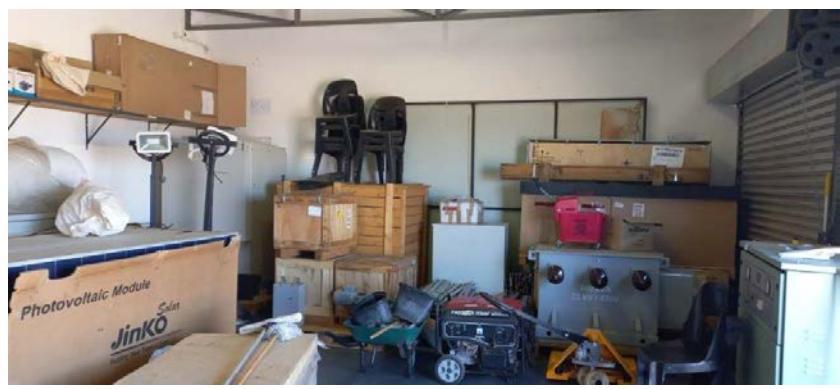
Photo 8 - View of warehouse, kept clean and tidy.

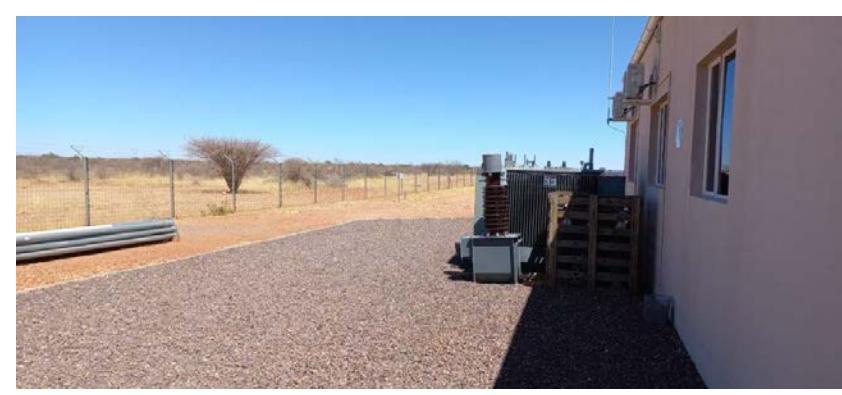
Photo 9 – View of laydown area at site warehouse, kept need and tidy.

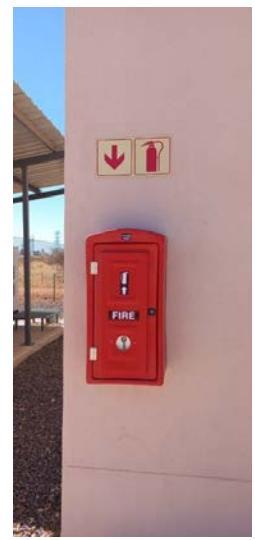
Photo 10 – View of fire extinguisher at site office.

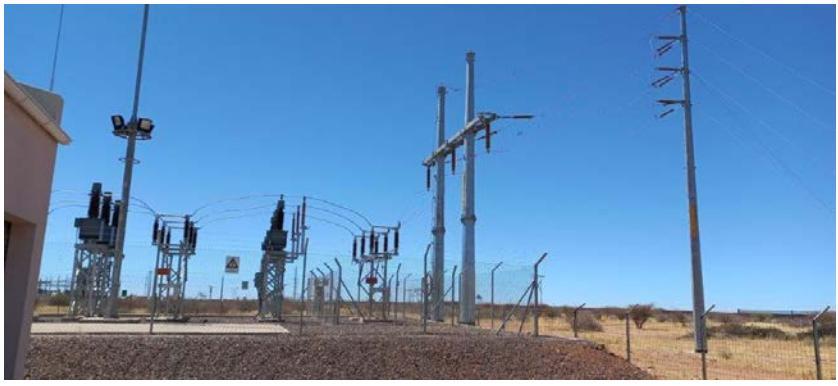
Photo 11 – View of site's substation fenced-in and well maintained.

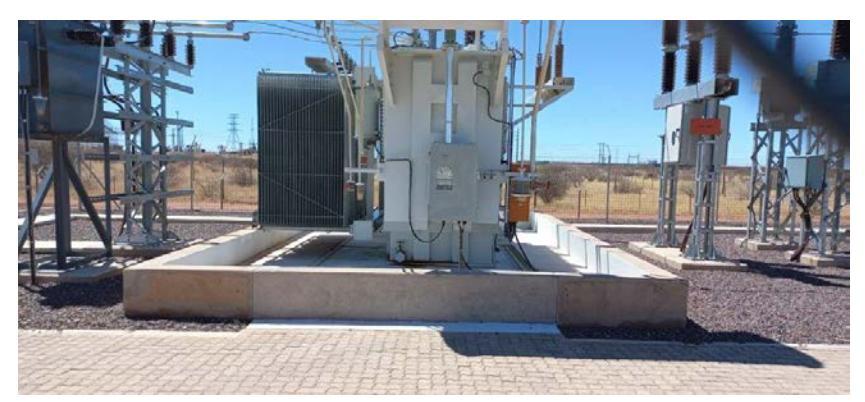
The wastewater septic tank and operational transformers were found in order without any traces of spillage.

Photo 12 – View of transformer located within bunded area.

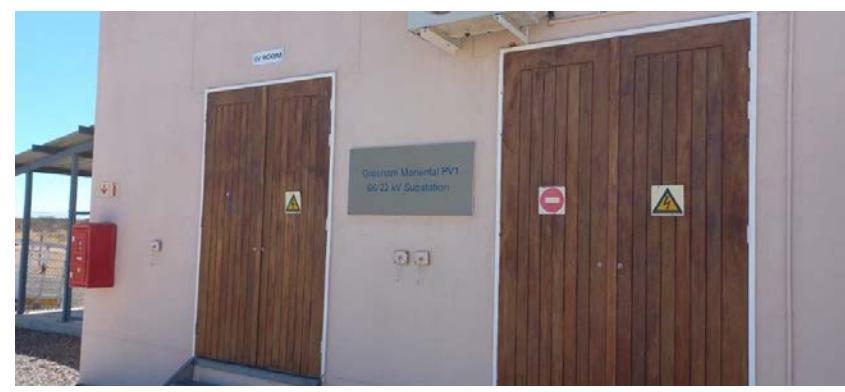
Photo 13 – View of site's substation building with fire extinguisher.

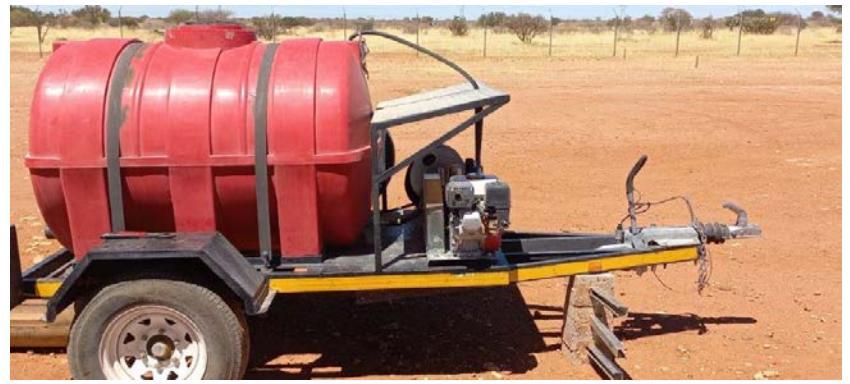
Photo 14 – View of firefighting trailer, operational and in good working condition.

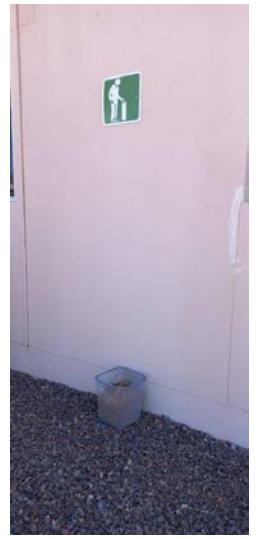
Photo 15 – View of smoking sign indicating dedicated smoking area with sand bucket.

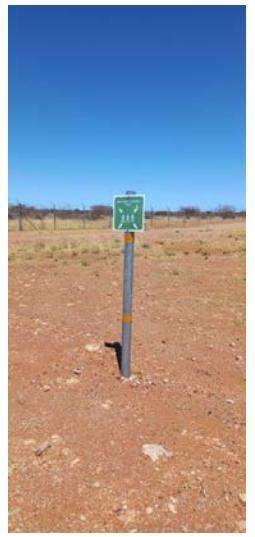
Photo 16 – View of emergency gathering point, close to site office.

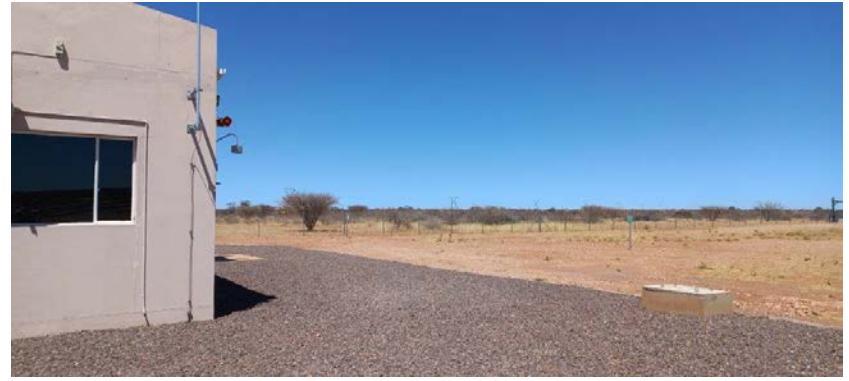
Photo 17 – View of site office with emergency siren.

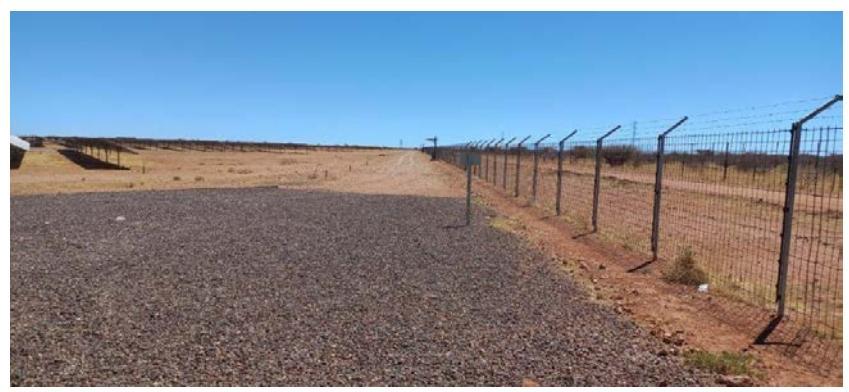
Photo 18 – View of site fence, well maintained and intact.

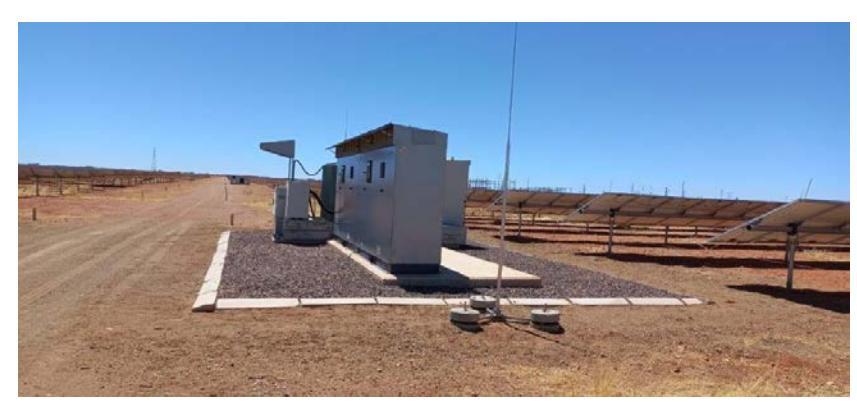
Photo 19 – View of site inverter, well maintained and area surrounding equipment kept clean.

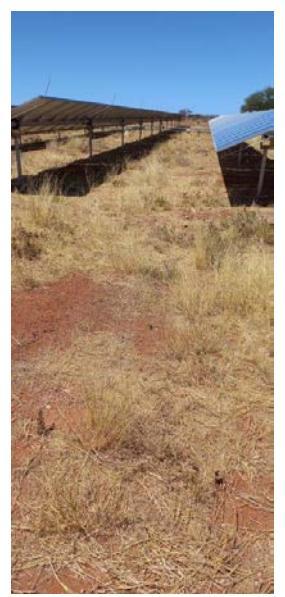
Photo 20 – View of PV panels with are having good ground cover vegetation.

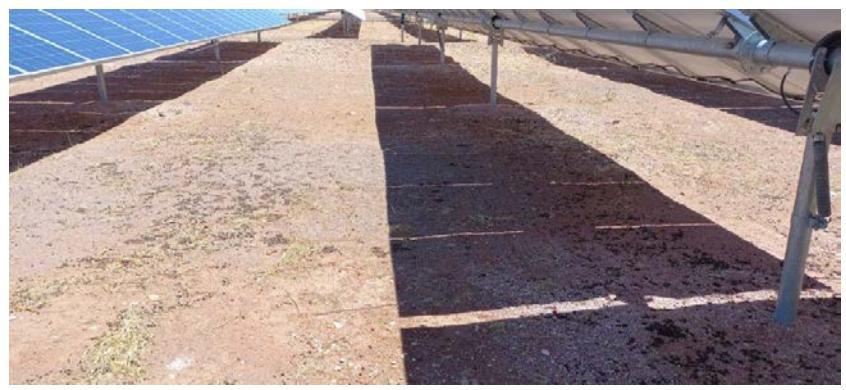
Areas of no ground vegetation cover were observed during the site inspection, which will contribute to unnecessary and larger volumes of dust nuisance during windy days. The greatest impact of this would be on the on-site staff, with very little or no impact to any of the surrounding receptors.

Areas of no ground vegetation cover were observed during the site inspection, which will contribute to unnecessary soil disturbance (i.e. erosion) during the rainy season. This impact will however be limited to the area that has been cleared of vegetation.

Photo 21 – View of lane in between PV sections have sparse vegetation cover.

Total clearance of ground cover should not be done, but rather retained to prevent dust pollution and erosion. It is important that the Site Manager provide proper training and guidance to the responsible personnel on how ground cover should be kept under control as to not have an impact on operations.

Total clearance of ground cover should not be done, but rather retained to prevent soil disturbance (i.e. erosion). It is important that the Site Manager provide proper training and guidance to the responsible personnel on how ground cover should be kept under control as to not have an impact on operations.

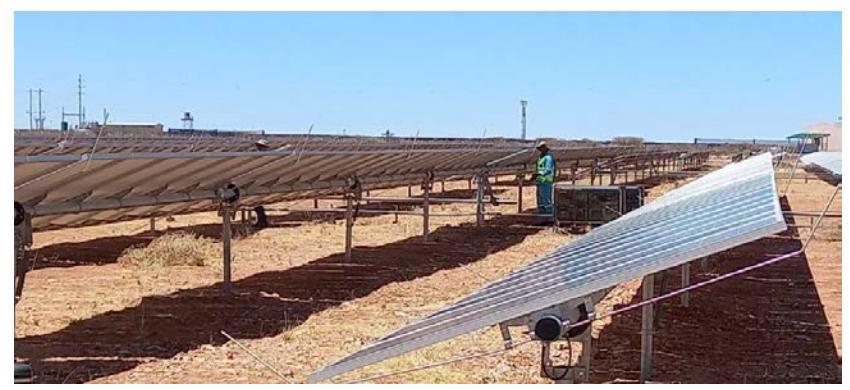
Photo 22 – View of workers doing basic maintenance to PV panels.

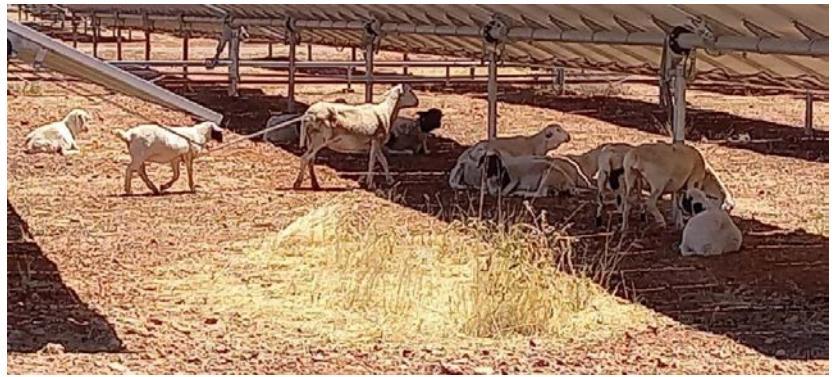
Photo 23 – View of life stock kept on-site as method of natural vegetation management.

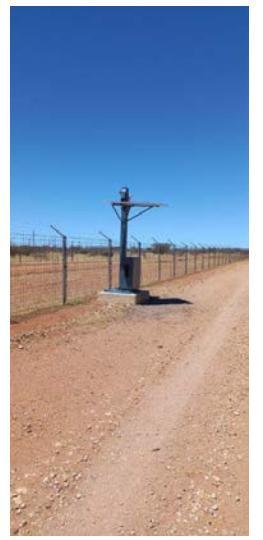
Photo 24 – View of security camera located along boundary fence.
