## Comprehensive Environmental Management & Closure Plan (EMCP) & for the Existing Waste Dumping Site in the Rehoboth Town, Hardap Region

**Document Type: EMP & Closure Plan**

**January 2023**

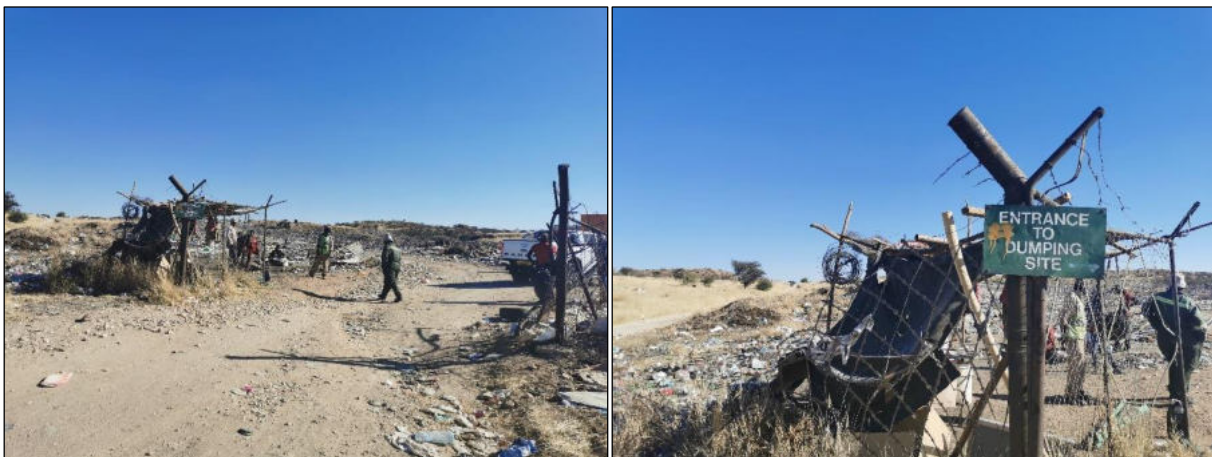
The dumping of solid waste (domestic and building rubbles) is done by the Town Council through the waste removal and disposal contractor (Frontier Multi Industries) who was awarded the contract to manage waste in the Town (including the Dumping Site). The waste is also illegally dumped at the Site by the public. The contractor collects waste from the town, dump/dispose, level /compact, bulldoze, and burn it. The contractor's workers are onsite every day from 08h00 to 17h00. However, the Town Council do not have control of who enters the Site or waste dumping as there is no fence. There were some members of the public onsite, and they scavenge from the Dumping Site. Some of the photos taken on site regarding lack of site access control are shown in Figure 2-1 below.

**Figure 2-1: Photos of the dumping site entrance taken in July 2022**

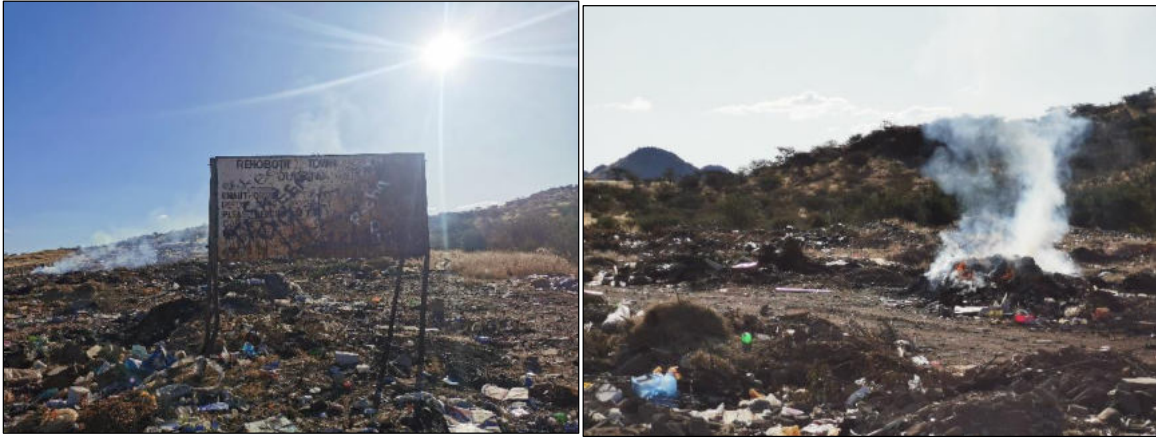
The dumped waste is burnt every 2 days in the week at around 15h00 to 16h00. During site visit there were visible signs of recently burnt waste (Figure 2-2).

Figure 2-2: The waste burning in the afternoon of 13 July 2022 during site visit

There has been an incident of fire outbreak when the waste was burnt in the evenings, and no one was around to monitor the fire. Therefore, improvements will be made going forward.

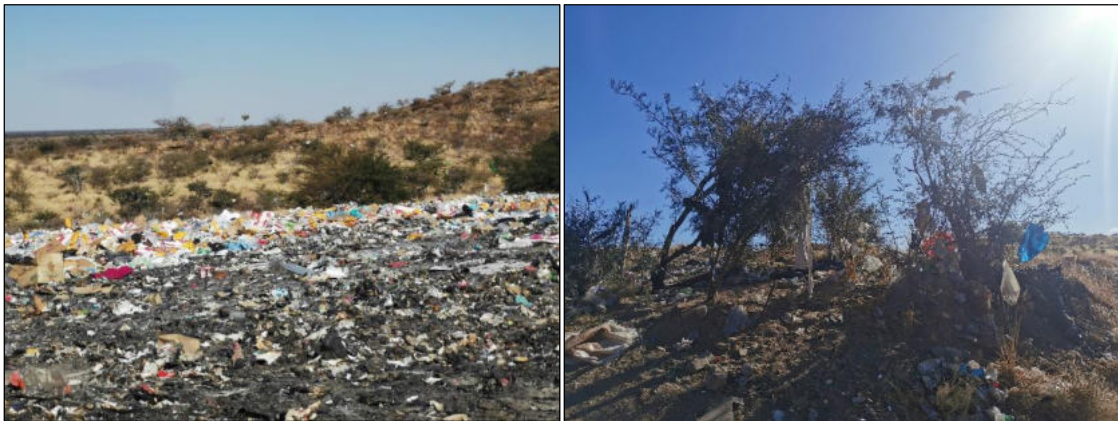
- Littering and illegal refuse (waste) dumping: the light waste such as plastic and papers are blown away by the wind and could be seen trapped on the surrounding vegetation Figure 2-3. There is currently no proper waste storage nor fence to contain the waste inside the dumpsite. This causes a visual nuisance and concern to the surrounding farm animals consuming the plastics. There had been complaints from some neighboring farmers about the wind-blown plastic bags from the Site and these are consumed by farm animals such as sheep, cattle and goats.

**Figure 2-3: The wind-blown waste trapped on the vegetation around the dumping site**

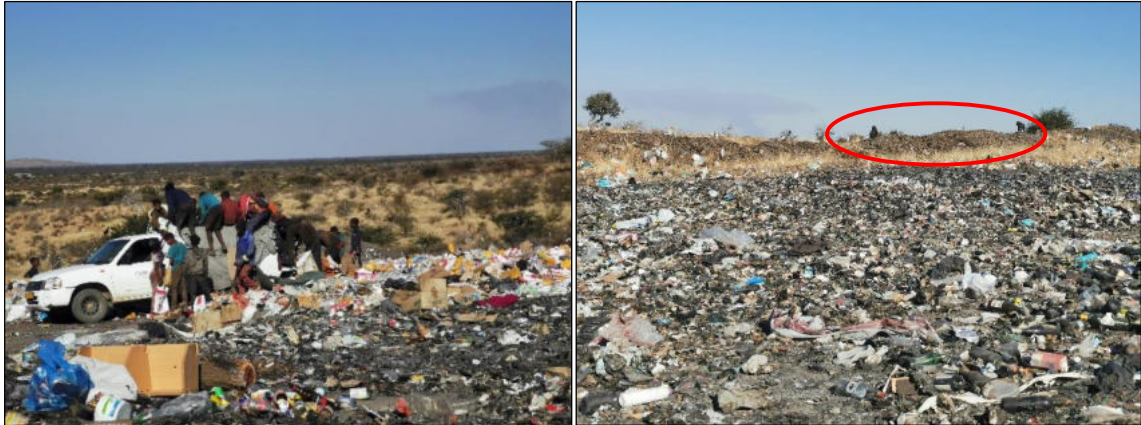
- Vandalism: the site fence has been vandalized over the years and cut by the public to gain access to the Site for waste scavenging. Eventually, there is no fence remaining, and everyone can access the dumpsite anytime. However, there are signs that there was a fence around the Site.

- Waste scavenging: some members of the community gather at the site, wait for the waste disposal vehicles to offload the waste and search for whatever waste items they can use. This was observed during the site visit around 15h00 on the 13<sup>th</sup> of July 2022. Not only people that are scavenging on the waste but also local wild animals such as baboons due to lack of fencing - Figure 2-4.

**Figure 2-4: Local communities and animals (baboons) scavenging on the waste at the Site**

- The dumpsite should be properly fenced off with a high steel pole wall (see Appendix 1) with sufficient warnings (in English, and Afrikaans languages)
- The waste should be properly sorted and disposed accordingly.
- Promote waste recycling such as bottles, garden refuse (garden manure) and plastic.
- The burning of waste should be done between 08h00 and 15h00 only and ensure that there is always someone to monitor the fire until it is completely put out before leaving the Site.
- Prohibit the entrance of children under the age of 18 into the dumpsite. The waste collection for re-use should be controlled and supervised by and done through designated site workers and proper procedures.
- Establish a security control gate to control the entrance into the dumpsite.
- Setting up ablution facilities for the site workers such as the security guards, waste sorters and disposal contractors.

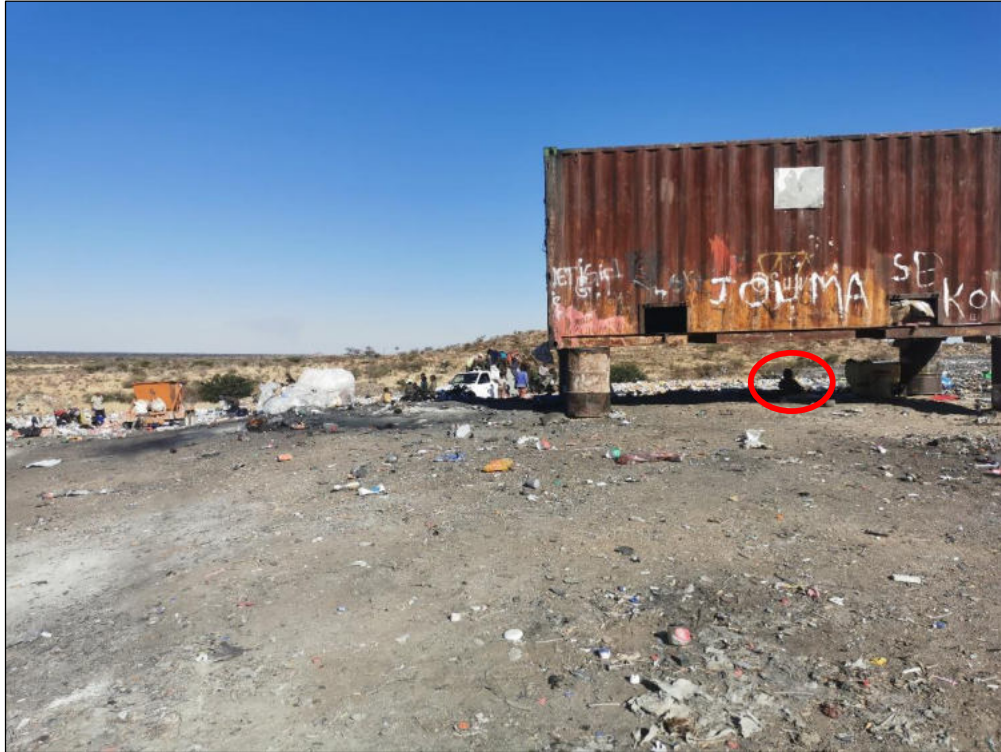
- Health and Safety: the community scavenges for waste items, but this could pose health and safety risks such as stumbling or stepping on unnoticed broken bottles, rotten food items, chemicals and other potential unhealthy items. Another major concern was children running after the slow moving the waste disposal trucks and bakkies to ride / hang on the waste skip bin / containers sides so that they could arrive first when the new waste is dumped so that they can collect (waste) items. There was a young toddler left under a hanging container shade (Figure 2-5) onsite while the parents go to collect items from the newly dumped waste for self-consumption.

**Figure 2-5: A toddler left by his mother under the container shade while she is scavenging at the newly delivered waste by a pickup truck**

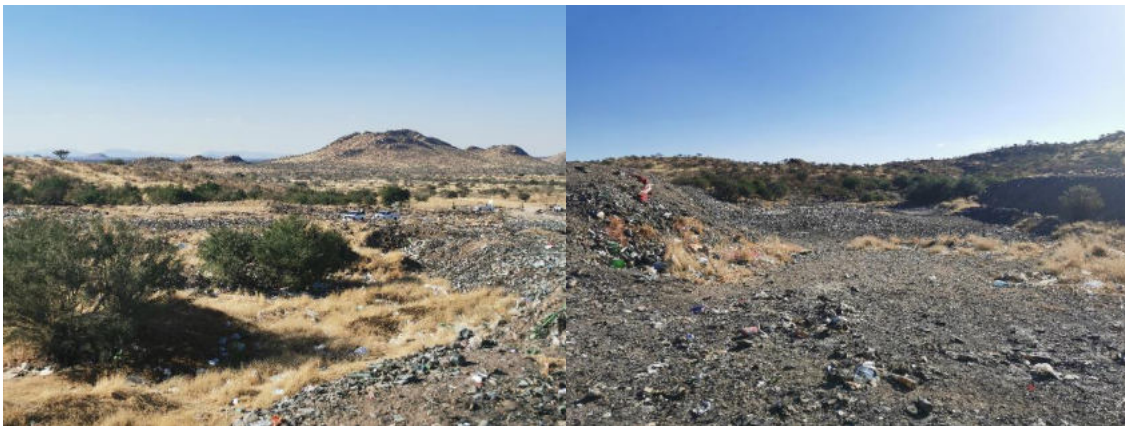
- Groundwater pollution: the dumping site is not lined, therefore leachate seeps into the ground and could have been affecting groundwater over time (negative impact).
- Impact on surface water flow systems. According to the Town Council personnel, there used to be a visible stream on the north-western side of the dumpsite, but it has been since been filled up and potential surface water flow blocked by the piling of waste over the years. This has probably affected the ecological functions around the dumpsite.

**Figure 2-6: The filled-up stream that used to be on the northwestern side of the dumpsite**

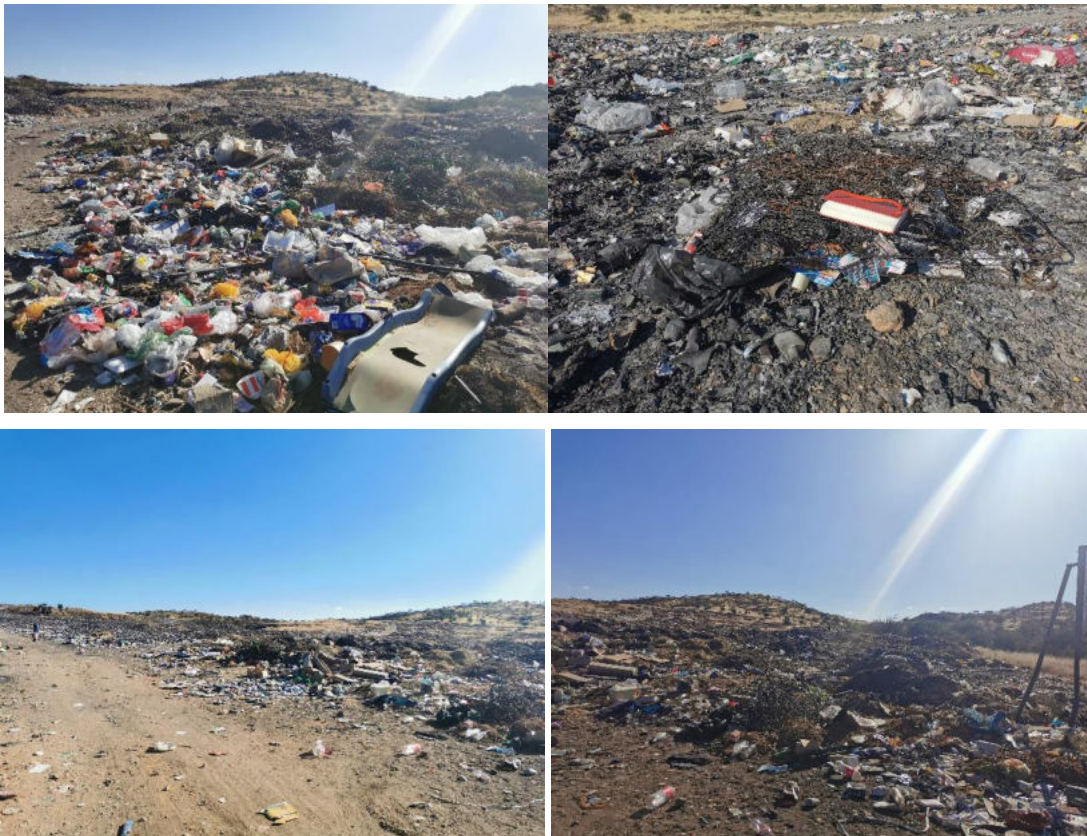
- The population has increased, and therefore, an increase in waste generation, thus exerting pressure at the dumping site. The estimated population is currently at 45,000 (as per the Town Council information).
- There is no proper segregation of waste onsite. There are currently two random segregations that are building rubble and general waste as seen in Figure 2-7 below.

**Figure 2-7: The segregation of waste at the Site**

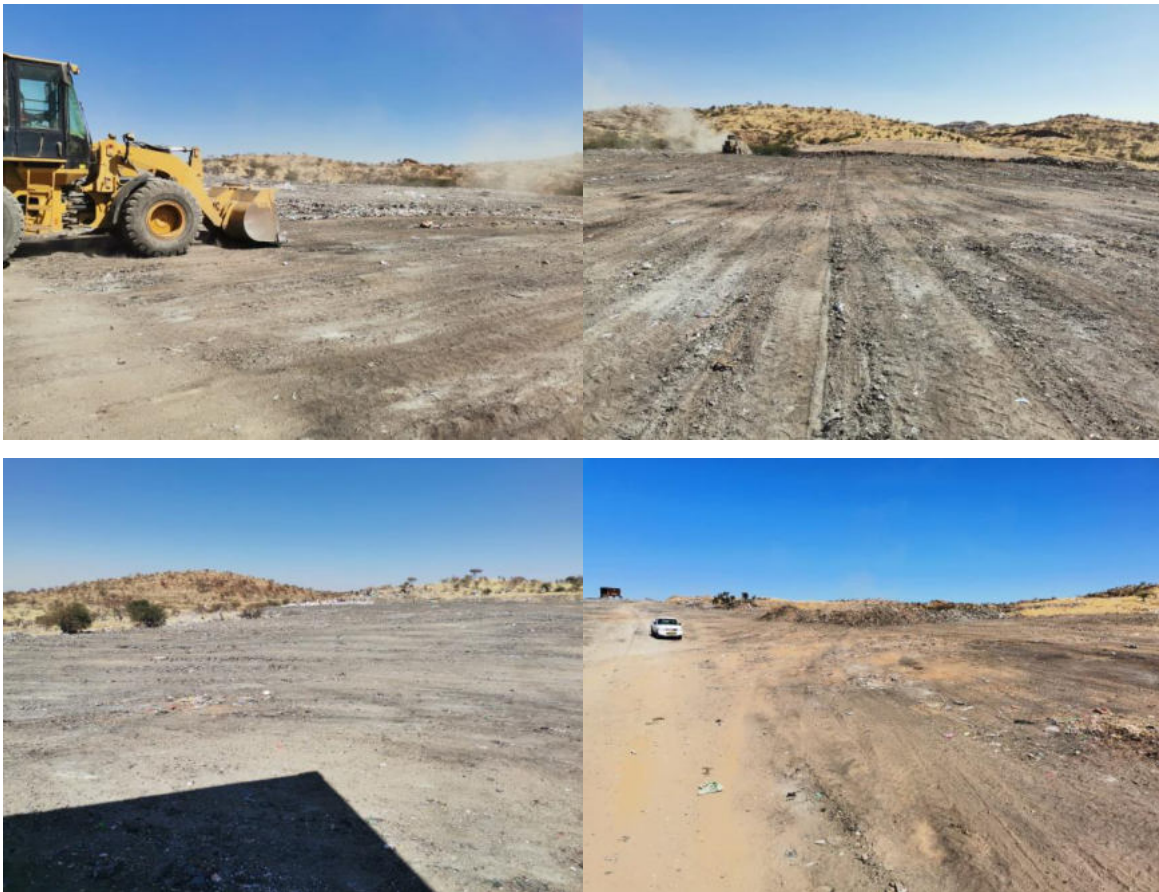
Following the discussions and preliminary recommendations onsite on the 13th of July 2022, the Proponent had commenced with making the necessary changes onsite by compacting the waste and level the Site area. These are shown on the photos in Figure 2-8 and Figure 2-9 below.

Figure 2-8: A - Some of the visual improvements at the dumpsite by the Proponent in August 2022

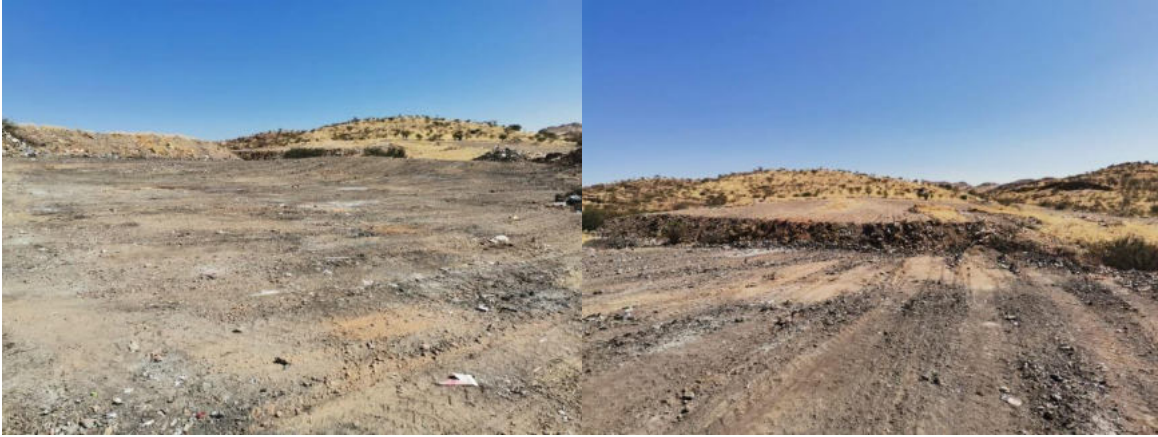
**Figure 2-9: B (Continued) - Visual improvements at the dumpsite by the Proponent in August 2022**

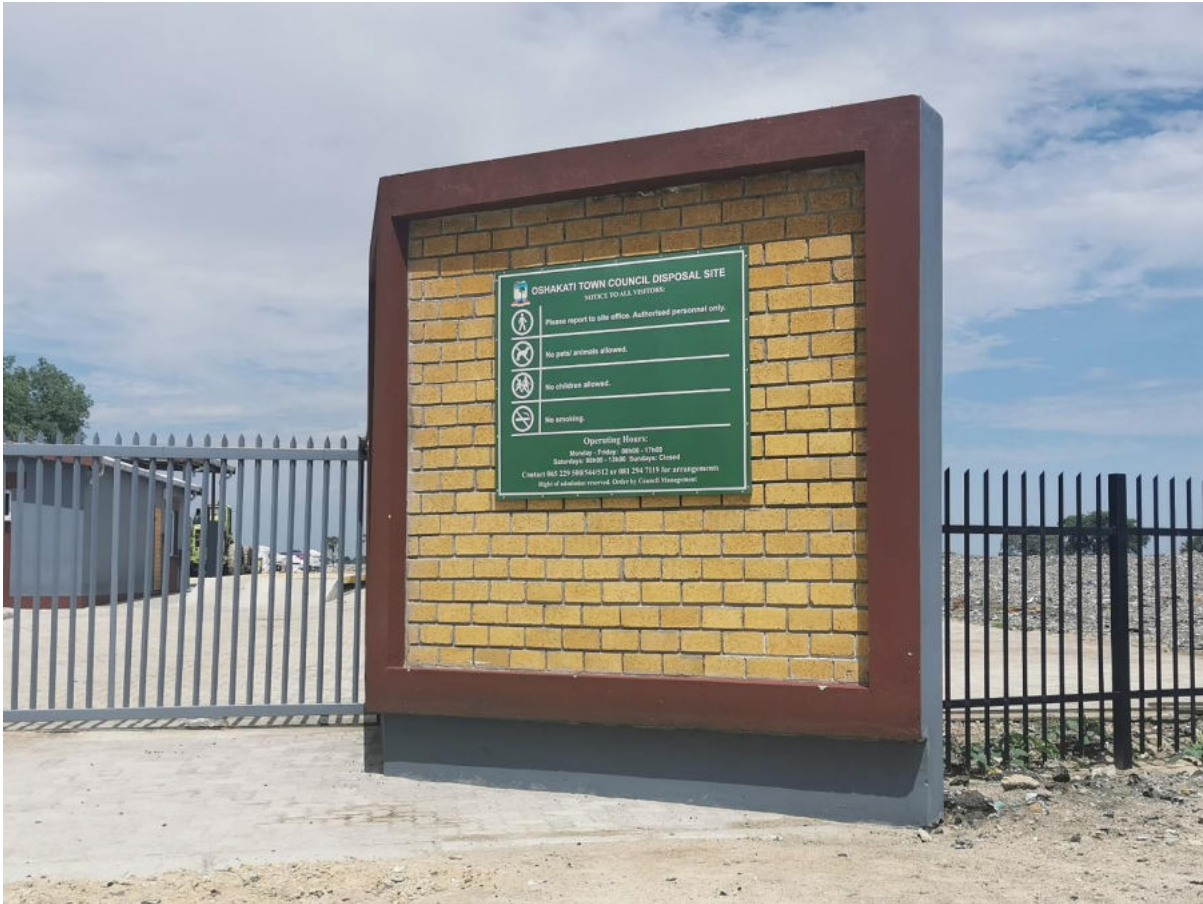
**Oshakati Town Council solid waste dumping site entrance**

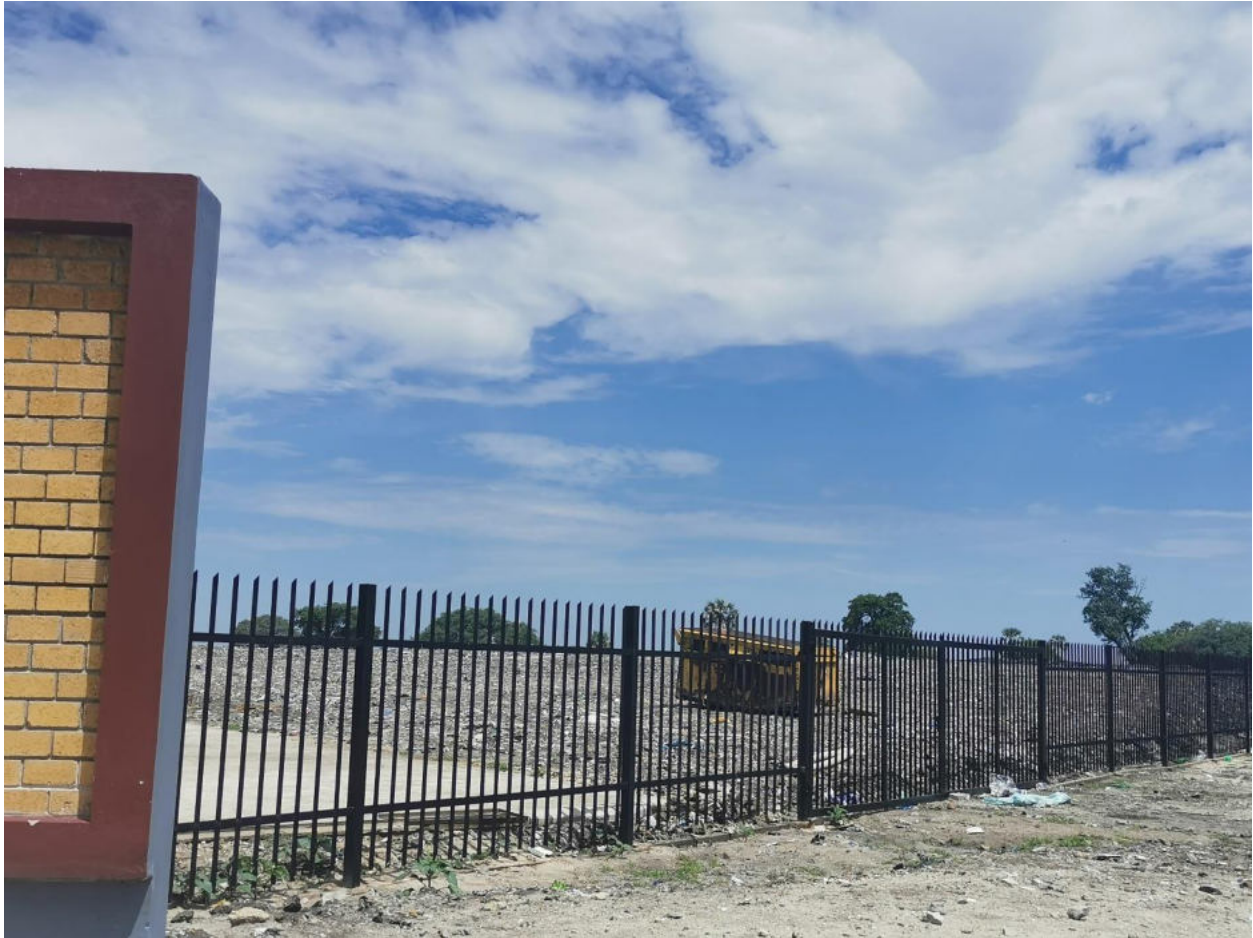
**Oshakati Town Council solid waste dumping site entrance and eastern side wall**
