ENVIRONMENTAL MONITORING REPORT

SHIPWRECK LODGE

SKELETON COAST NATIONAL PARK

PROJECT	Shipwreck Lodge: Renewal of Environmental Clearance
CLIENT	Journeys Namibia (Pty) Ltd for Trip Travel
DOCUMENT NAME	Environmental Monitoring Report
DOCUMENT #	2
DATE	20 March 2020
AUTHOR	Henriette Potgieter Potgieter Consultancy CC PO Box 11867 Klein Windhoek

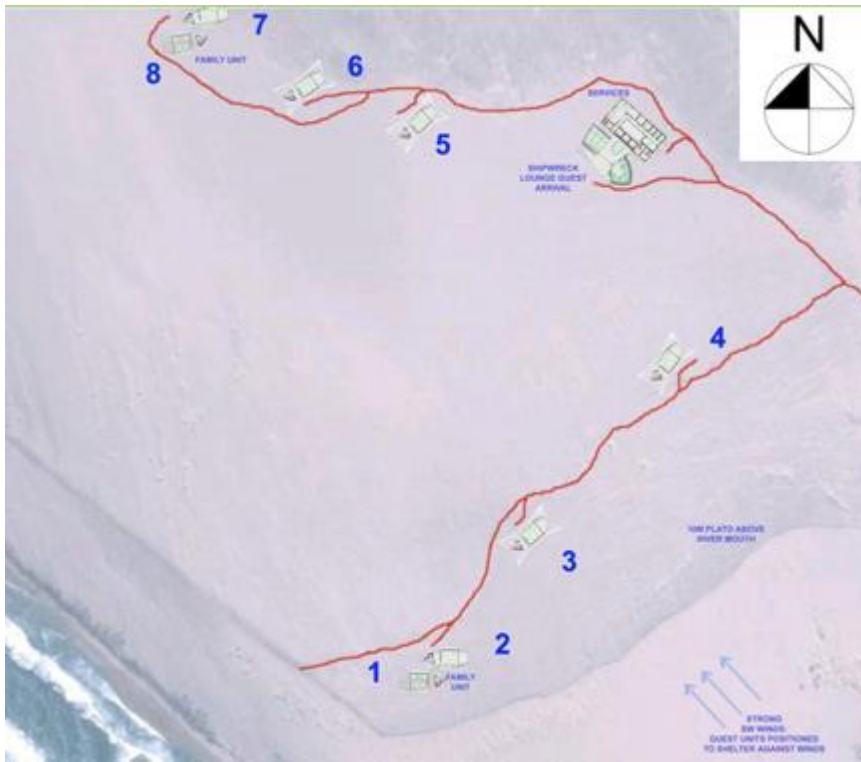
Figure 2. Planned layout of main area and guest rooms as submitted in 2016. (Source: EIA 2016)

The layout of the lodge as submitted in the 2016 EIA is shown in Figure 2, and the current infrastructure layout is given in Figure 3 and Figure 4.

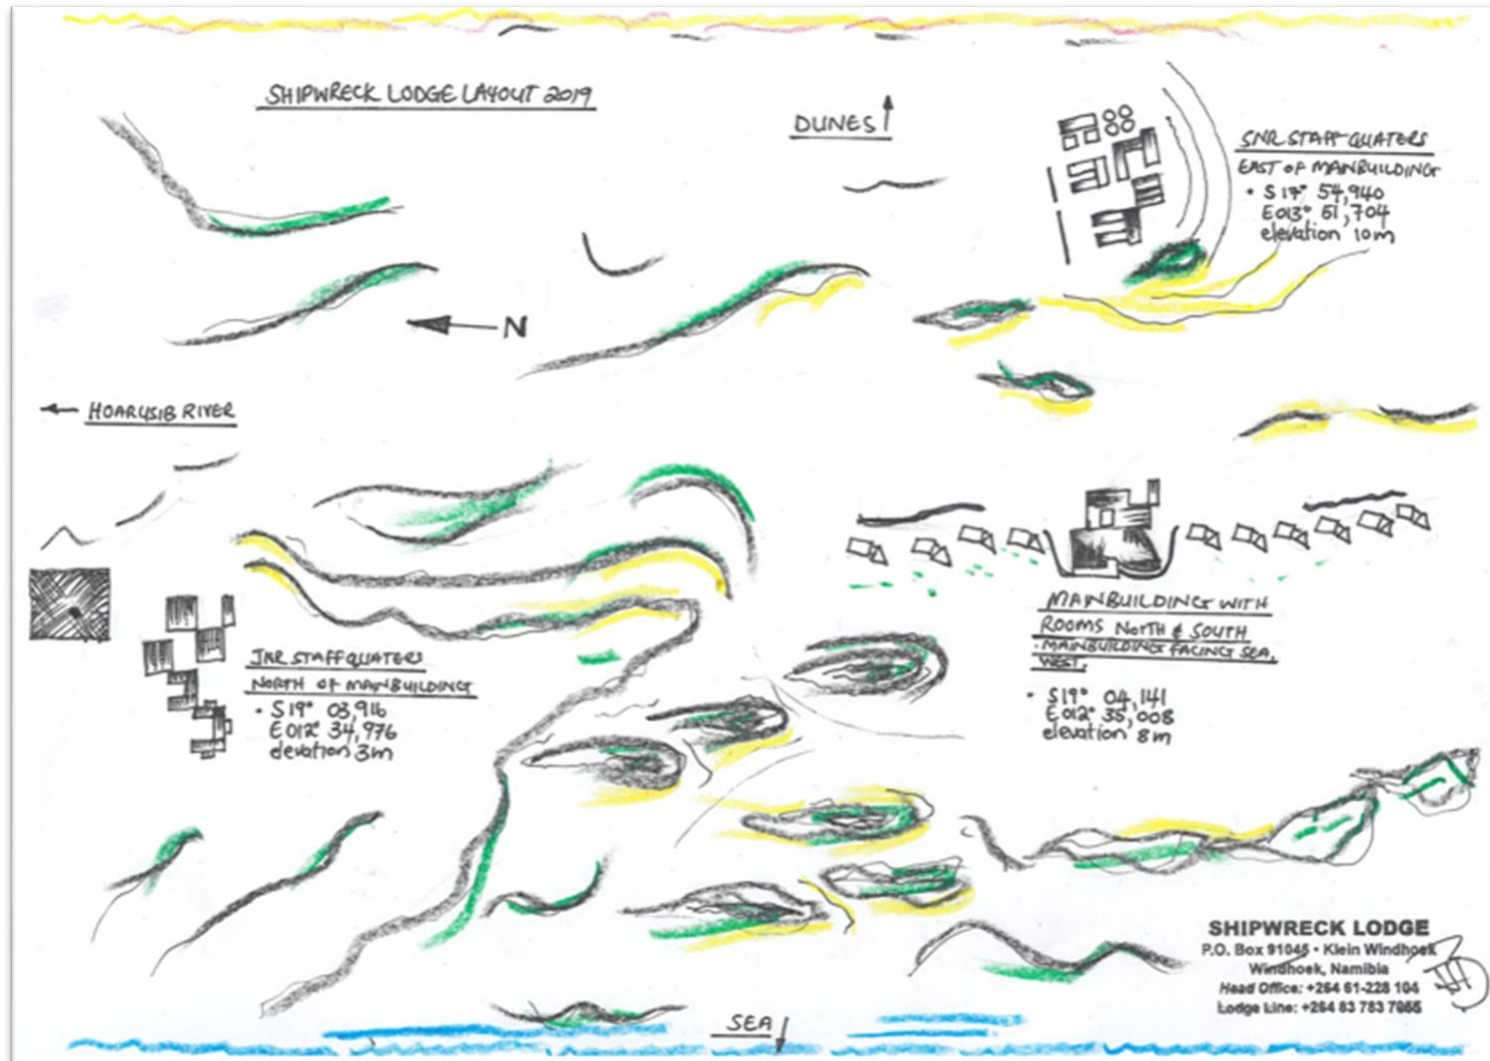
Figure 3. Current layout of the infrastructure of Shipwreck Lodge.

In May 2018, when the lodge was completed, the total infrastructure footprint comprised 874 m². Subsequent changes added 554 m² to bring the total surface coverage to 1,429 m².

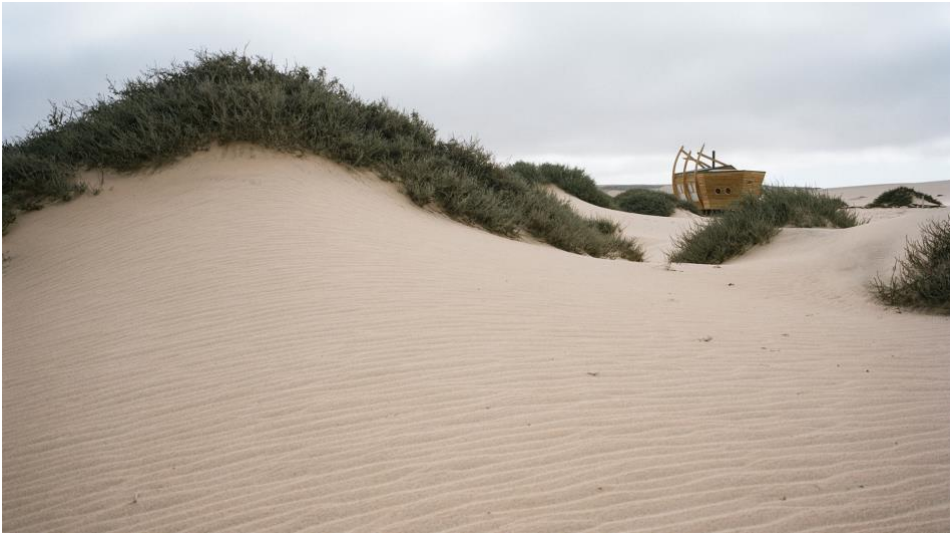
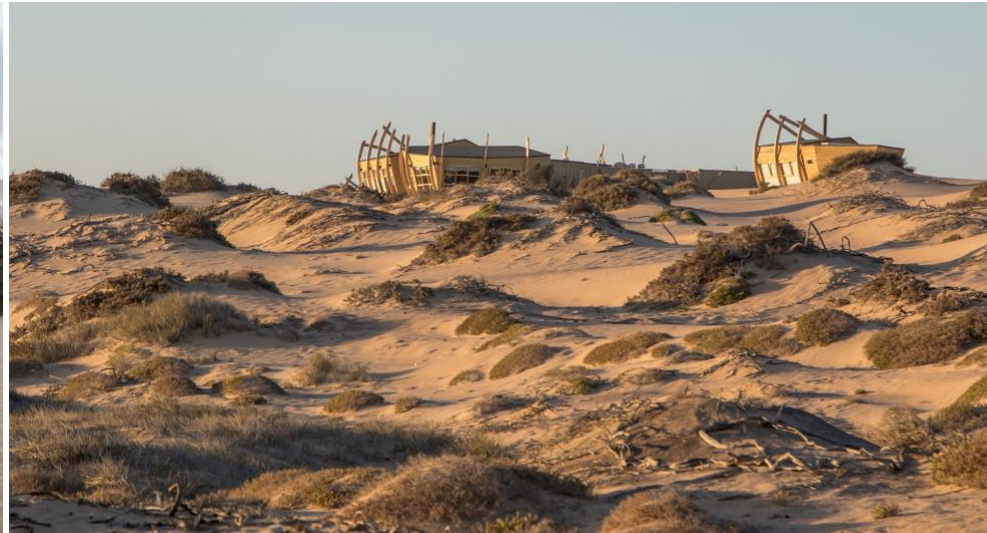
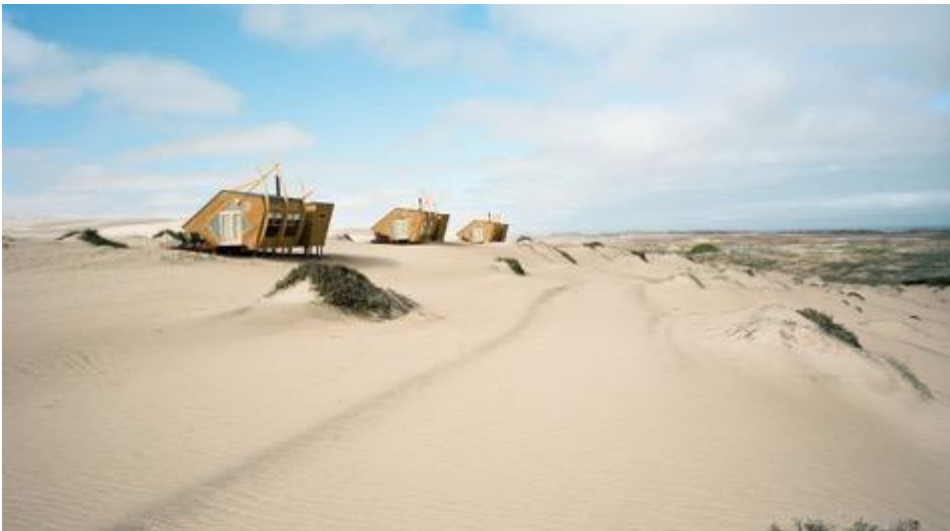
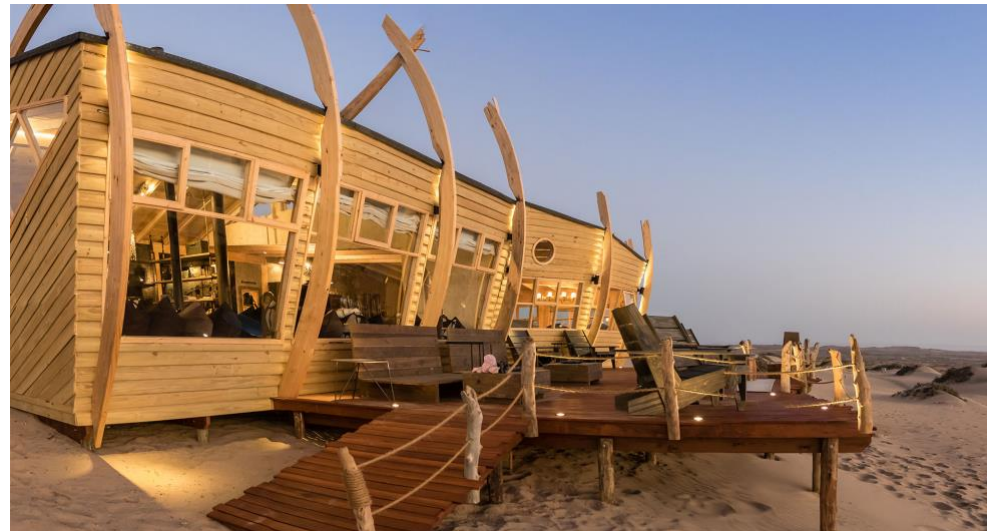
Responsible Person	Measures	Audit 2020
Addressing of Aesthetic and Visual Issues		
The proponent, developer or builder	a. Buildings on the site must be visually pleasing namely it must be in concordance with a certain natural style since the site is in natural surroundings.	Shipwreck Lodge received several international awards for its design aesthetic in the 18 months since opening (Appendix II). All the measures in this section are adhered to. See Figure 5 and Figure 6.

Figure 5. Four pictures showing how the lodge fits into the landscape. The topography and vegetation were incorporated in the design and not disturbed.

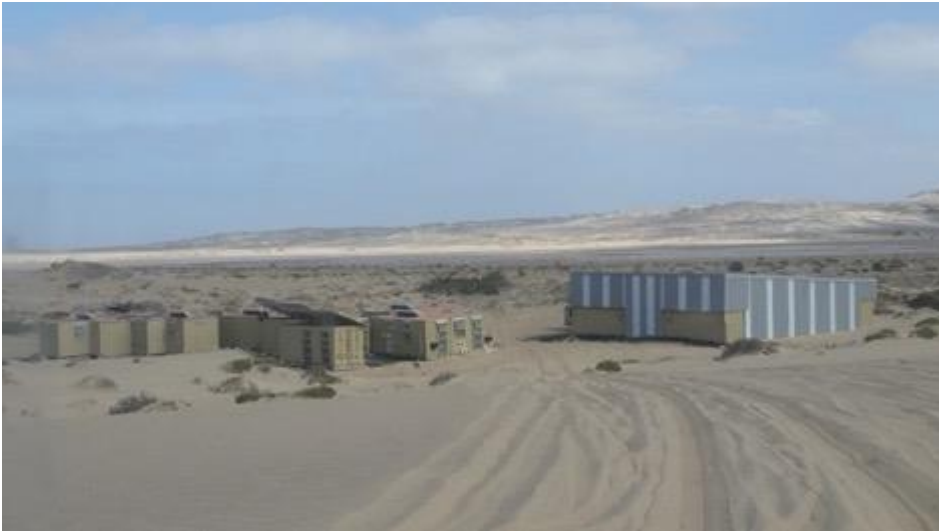
Figure 6. The staff village and workshop area is located and constructed so as to cause no visual disturbance.

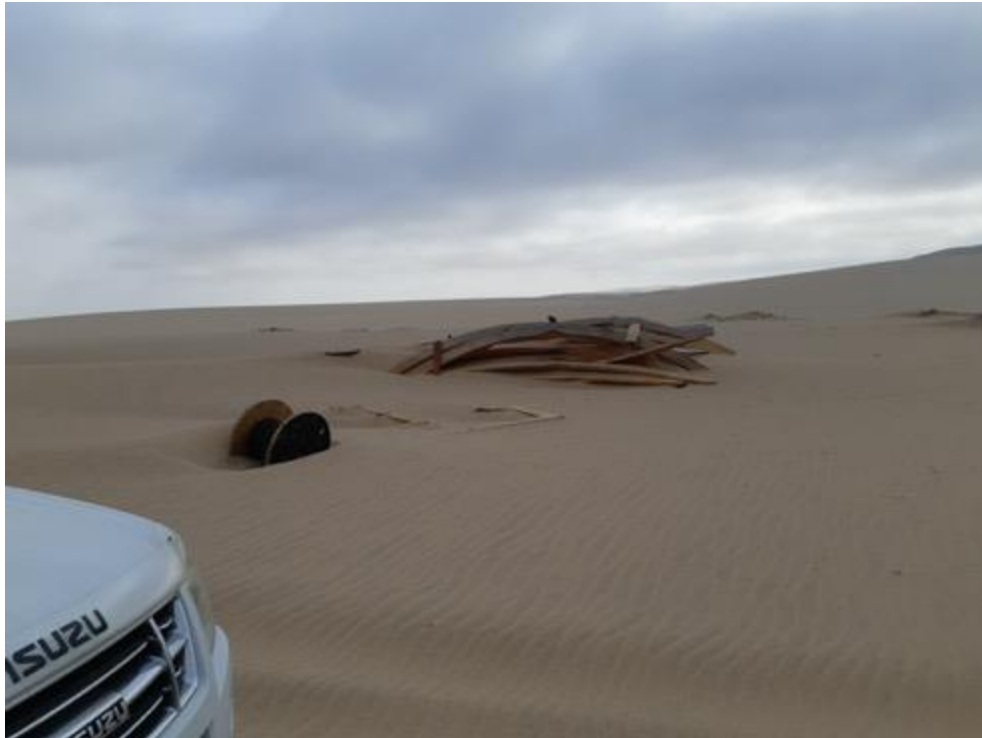
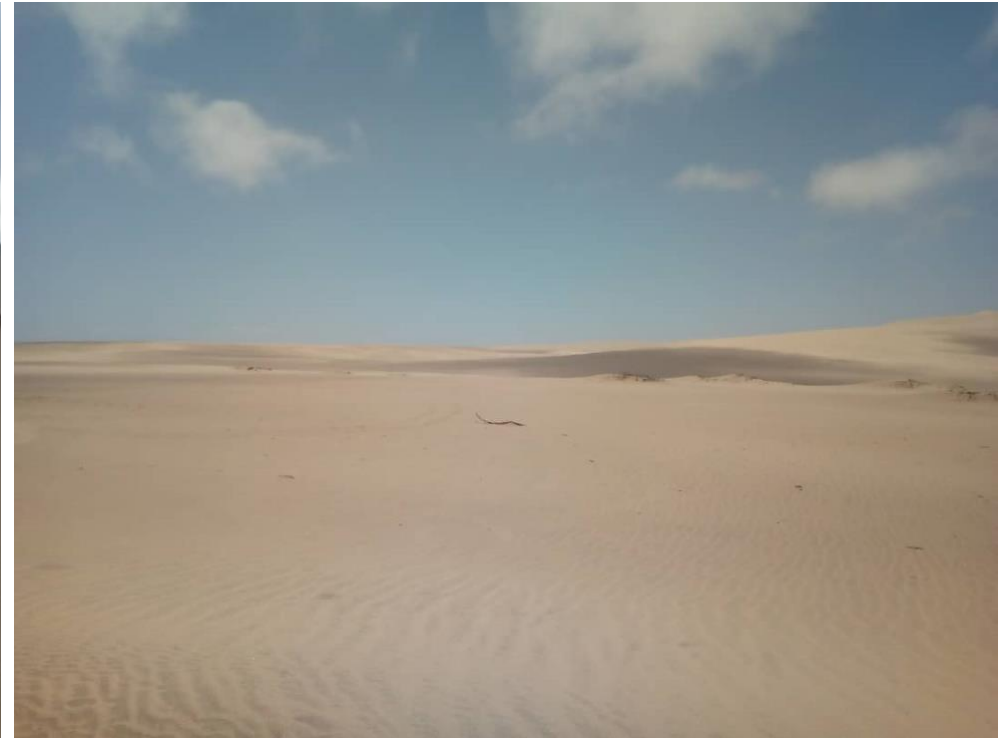
Responsible Person	Measures	Audit 2020
	d. All rehabilitated areas must be monitored over a 4 year time period from the onset of the rehabilitation procedures. (The frequency of monitoring suggested is dependent on satisfactory performance. If however the requirements are not being met, the frequency of the monitoring must be increased).	Minimal disturbance of the topography took place during construction. Substrate of receiving environment consists of sand dunes and is subject to daily strong winds that constantly move the dunes around. No plants were disturbed, damaged or removed. Laydown areas were chosen in unvegetated areas. Figure 7 and Figure 8.

Figure 7. Photographic evidence of rehabilitated laydown area

Photo left: during building, photo right: after construction phase

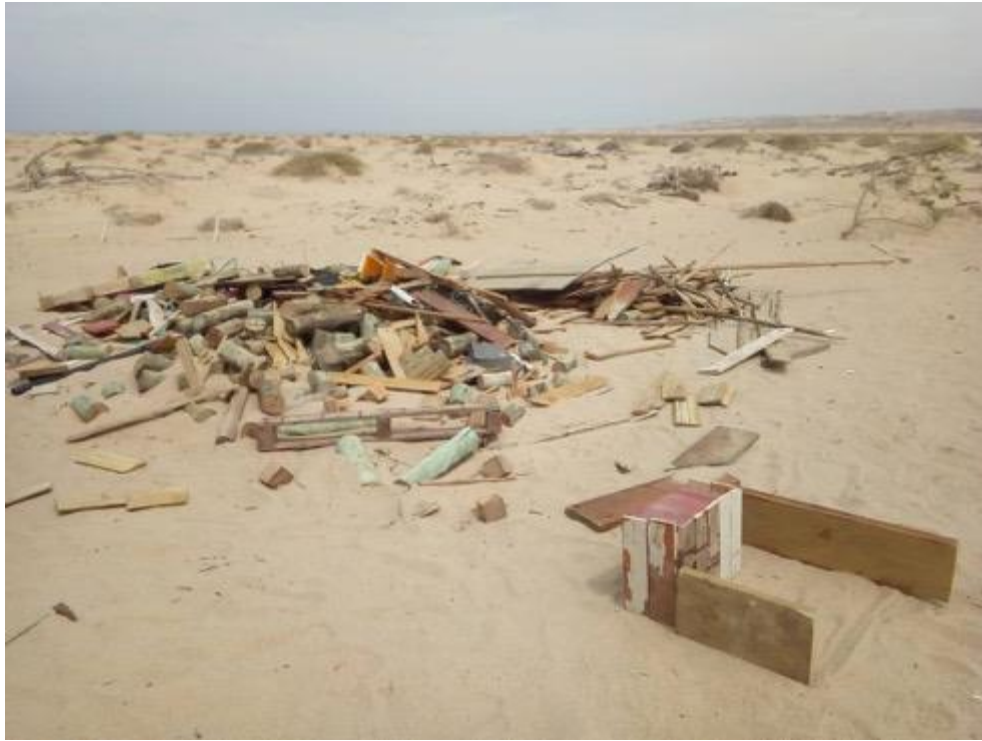
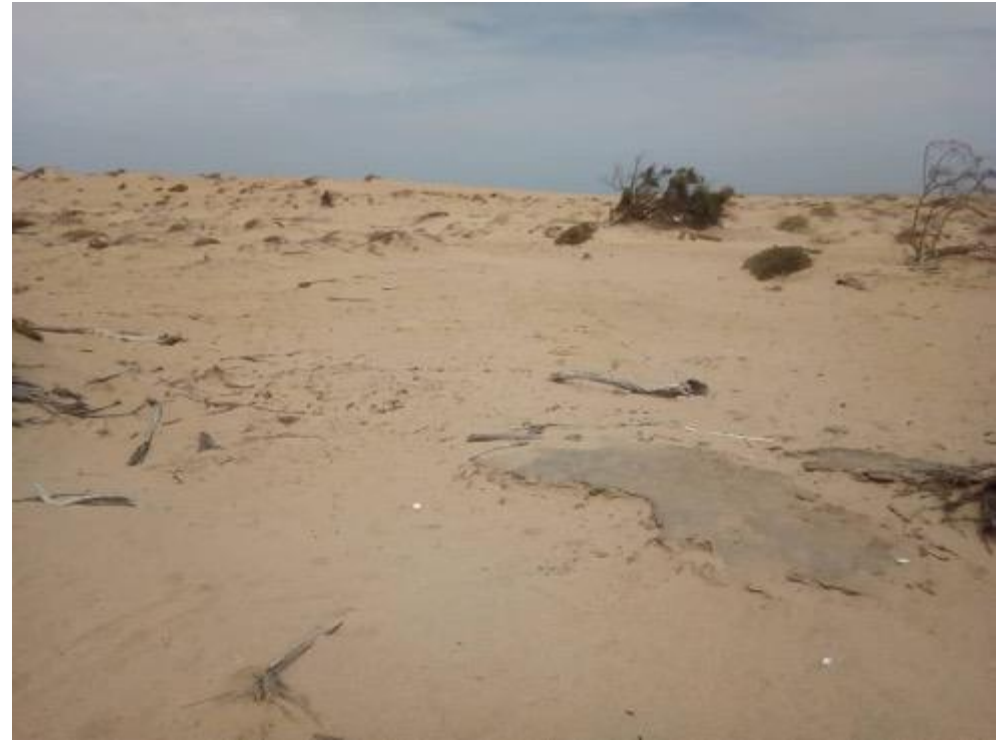
Figure 8. Photographic evidence of rehabilitated rubbish area

Photo left: during building, photo right: after rubble removal after construction

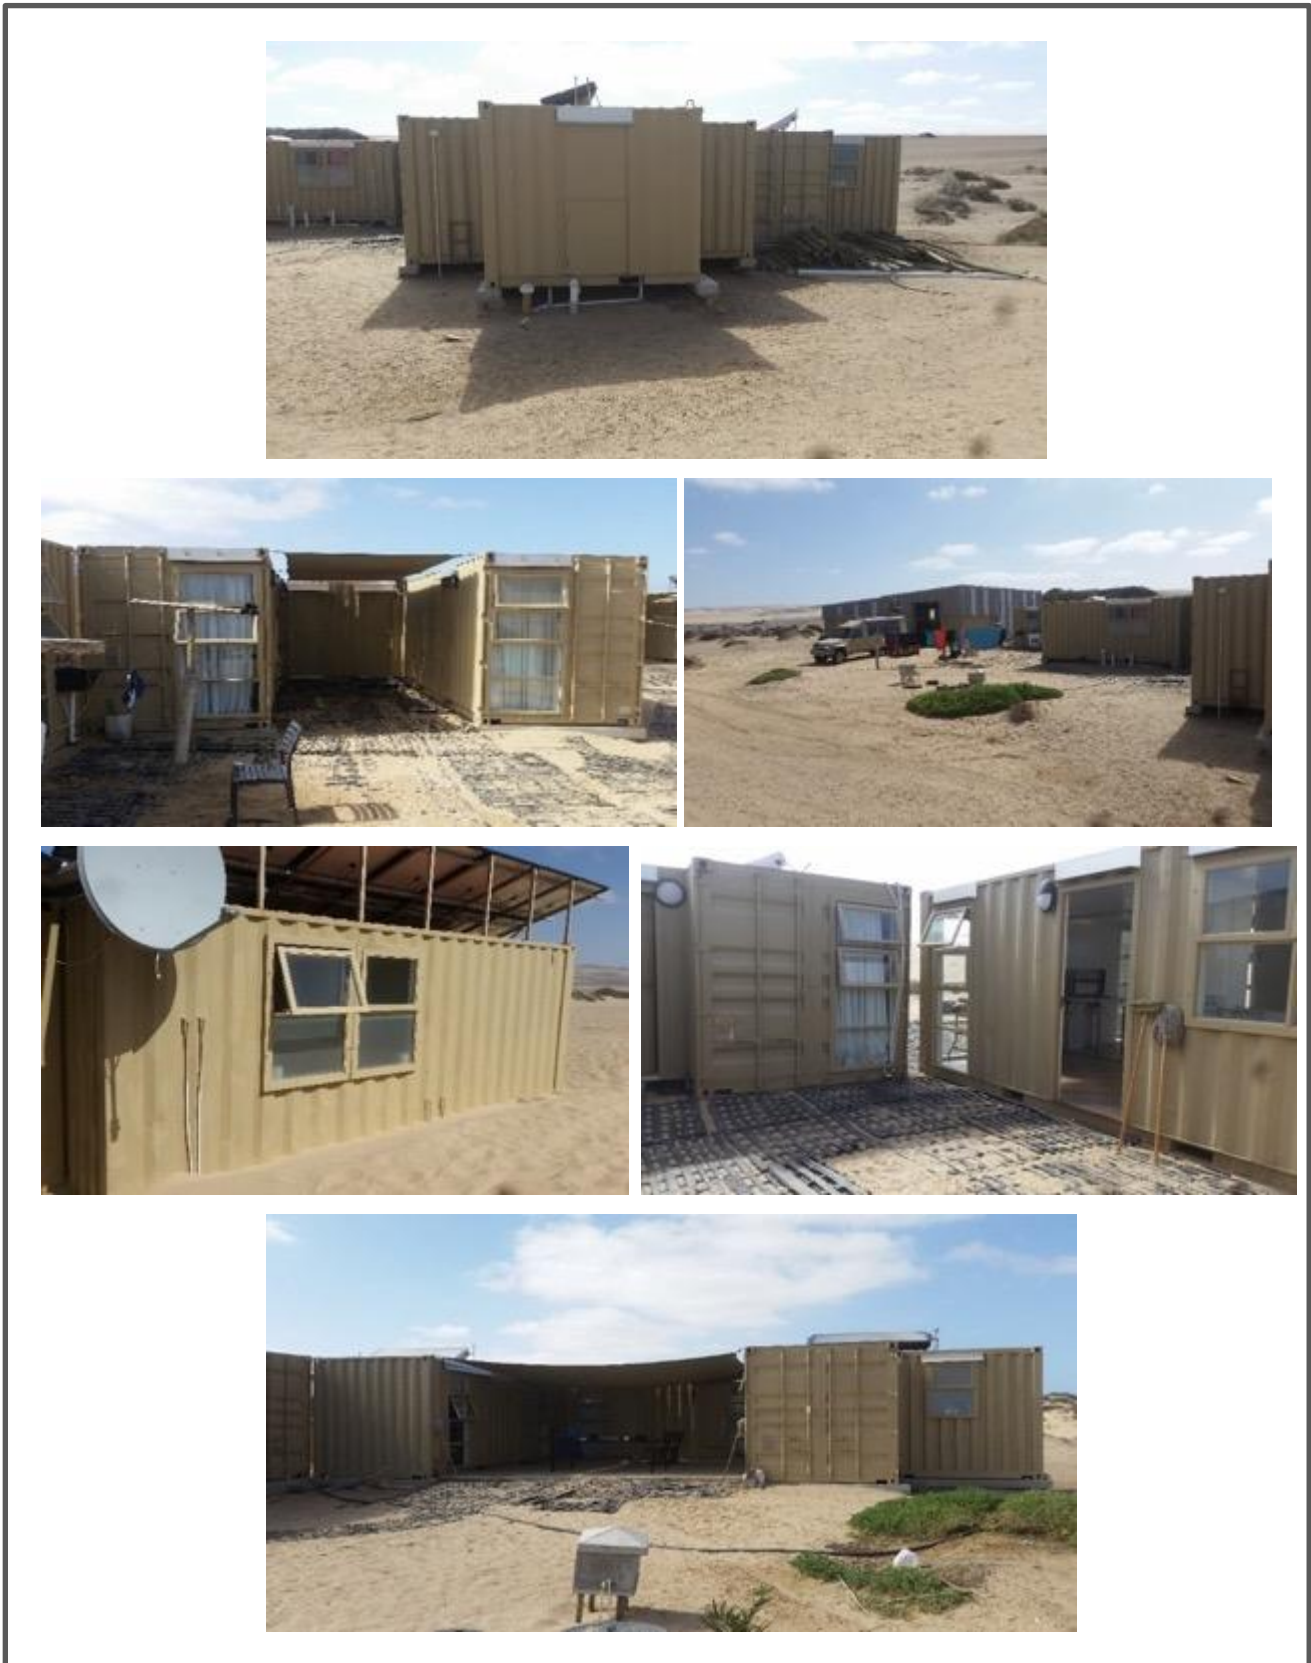
The back-of house, including staff village and workshop, was built entirely from re-purposed shipping containers. This conforms to the MET requirement that no permanent structures be erected.

Figure 9. The staff village and workshop complex is built entirely from shipping containers.

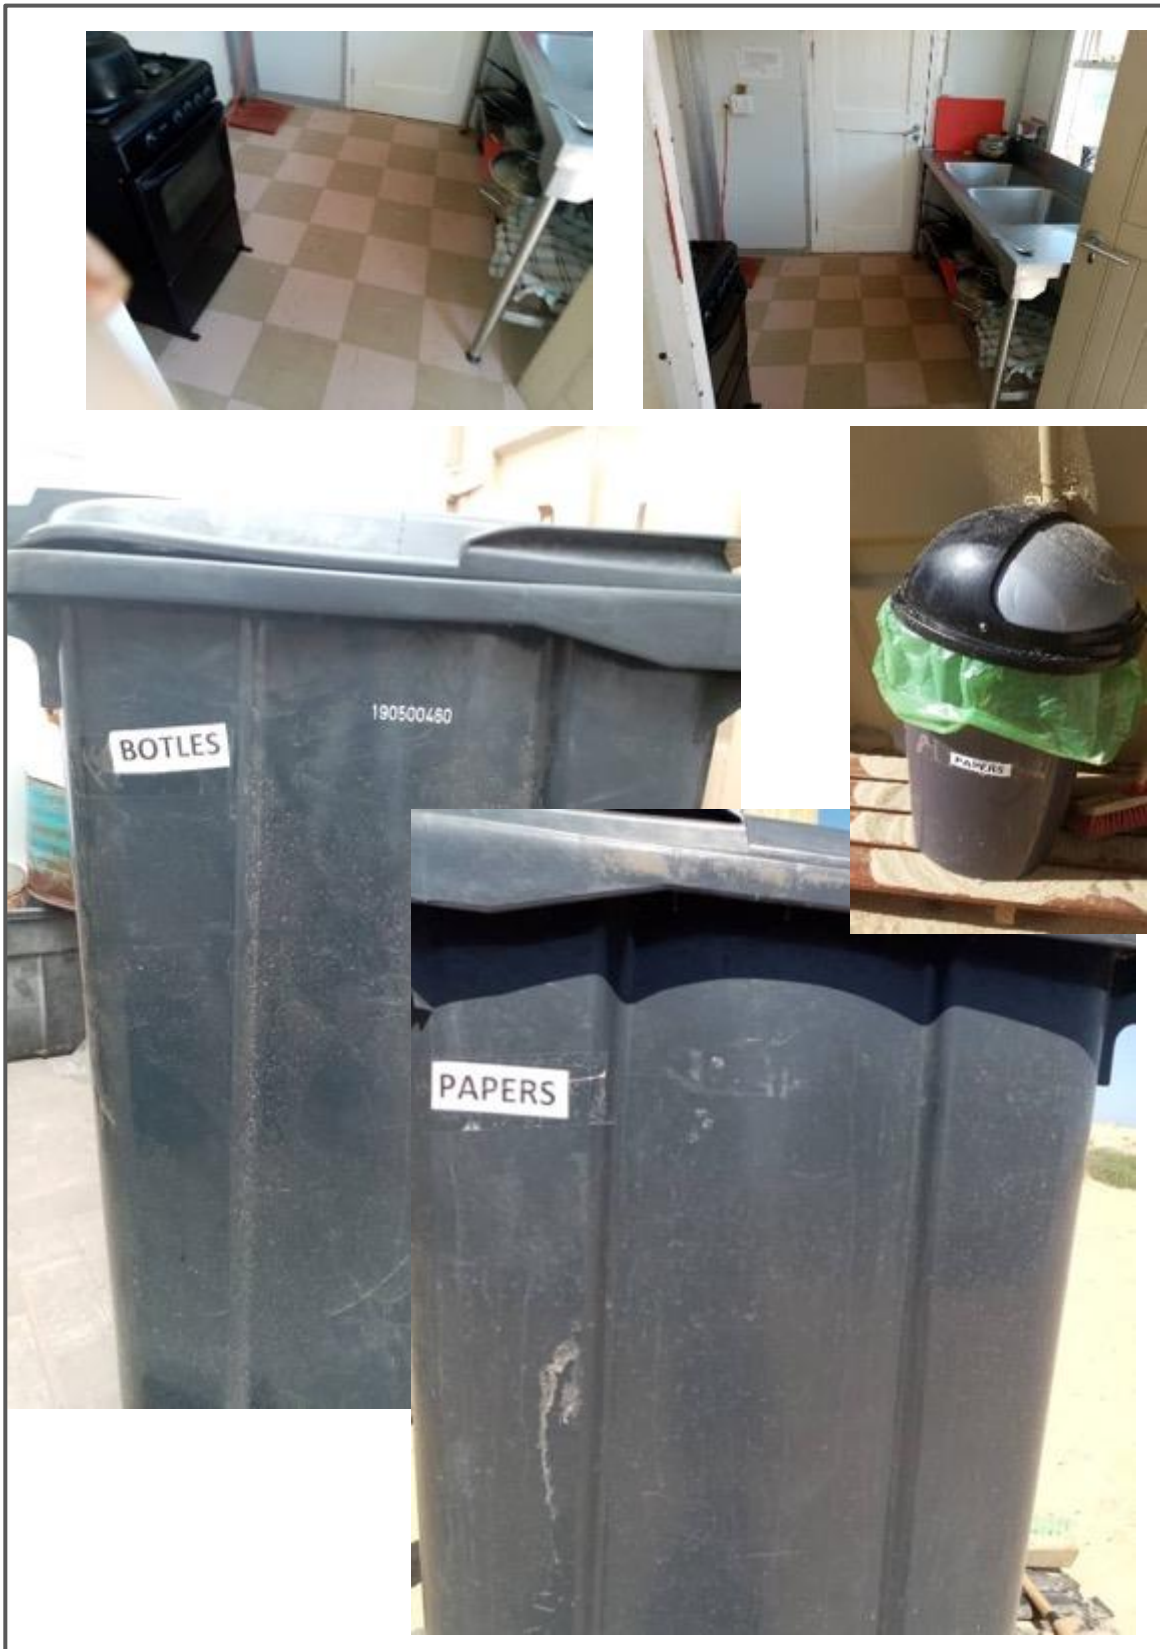
Figure 10. The kitchen and rubbish bins in the staff village.

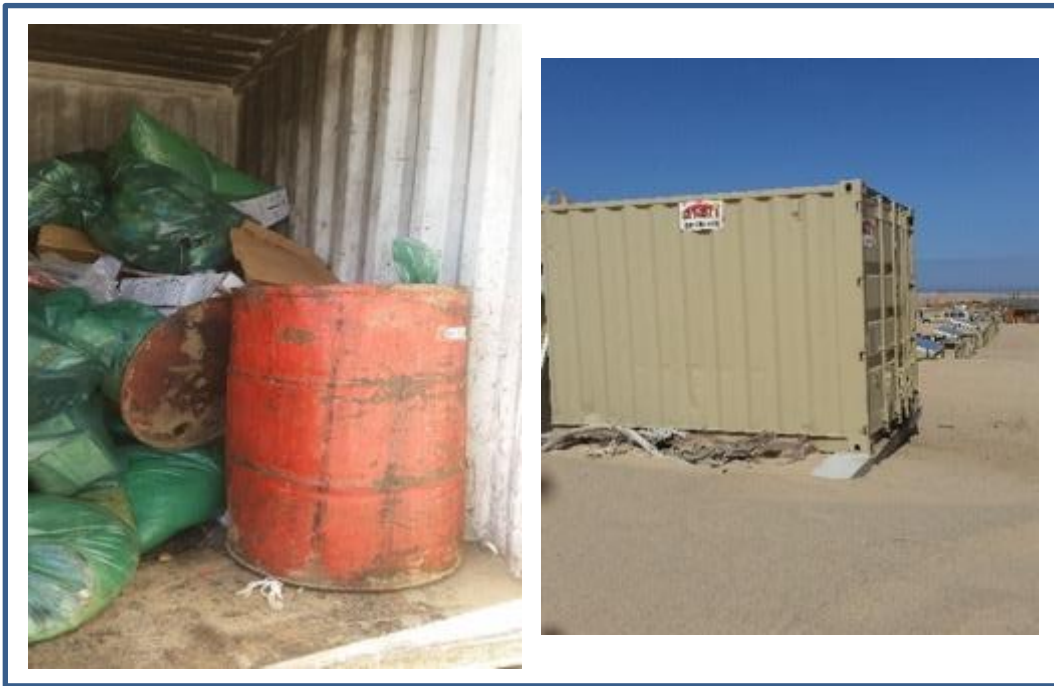
Figure 11. Solid waste is temporarily stored in a sealed shipping container and removed to Walvis Bay with the weekly supply truck.

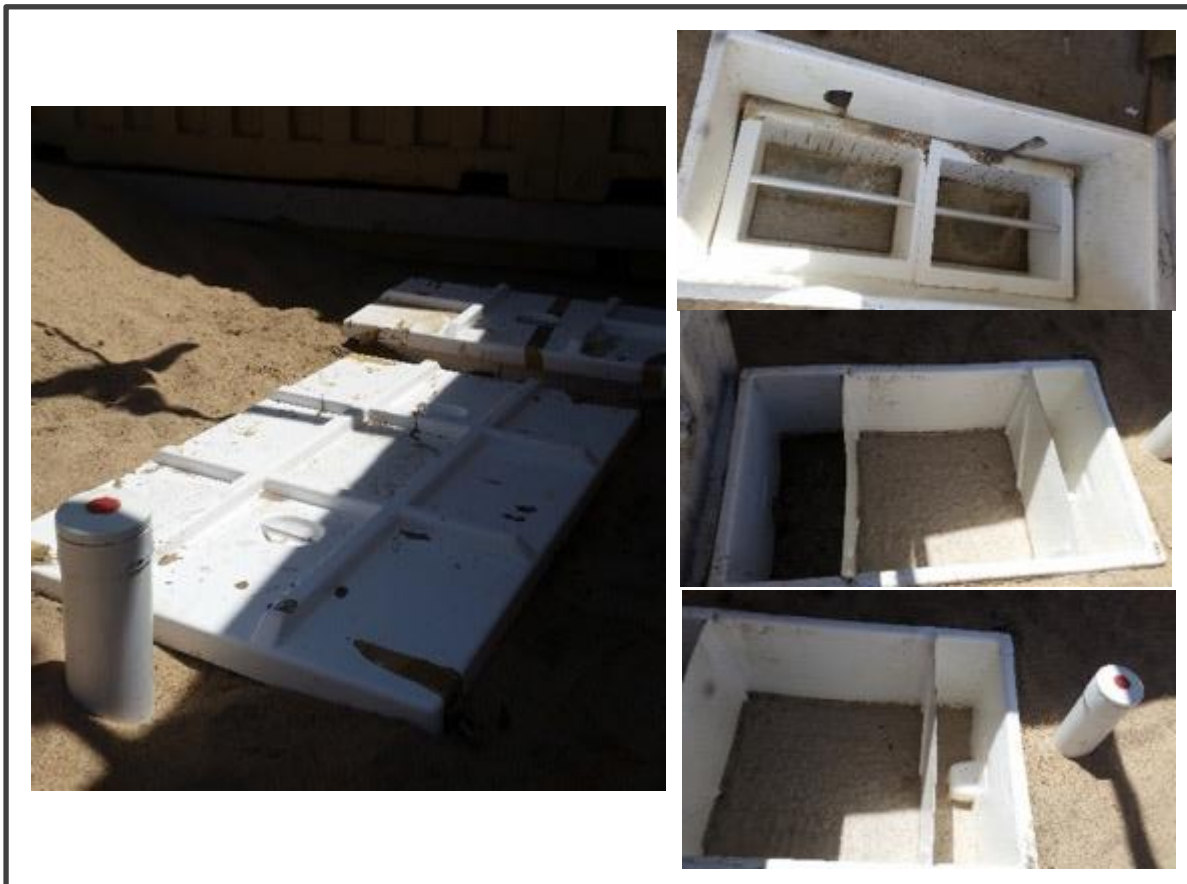
e. Install oil traps in all appropriate places to collect potentially toxic materials.	Fat traps in all kitchen outlets.
	f. When there is made use of diesel generators on site it must be placed on concrete slabs.	Generator is in a sealed shipping container.

Figure 12. Fat traps at both the lodge kitchen and the staff kitchen.

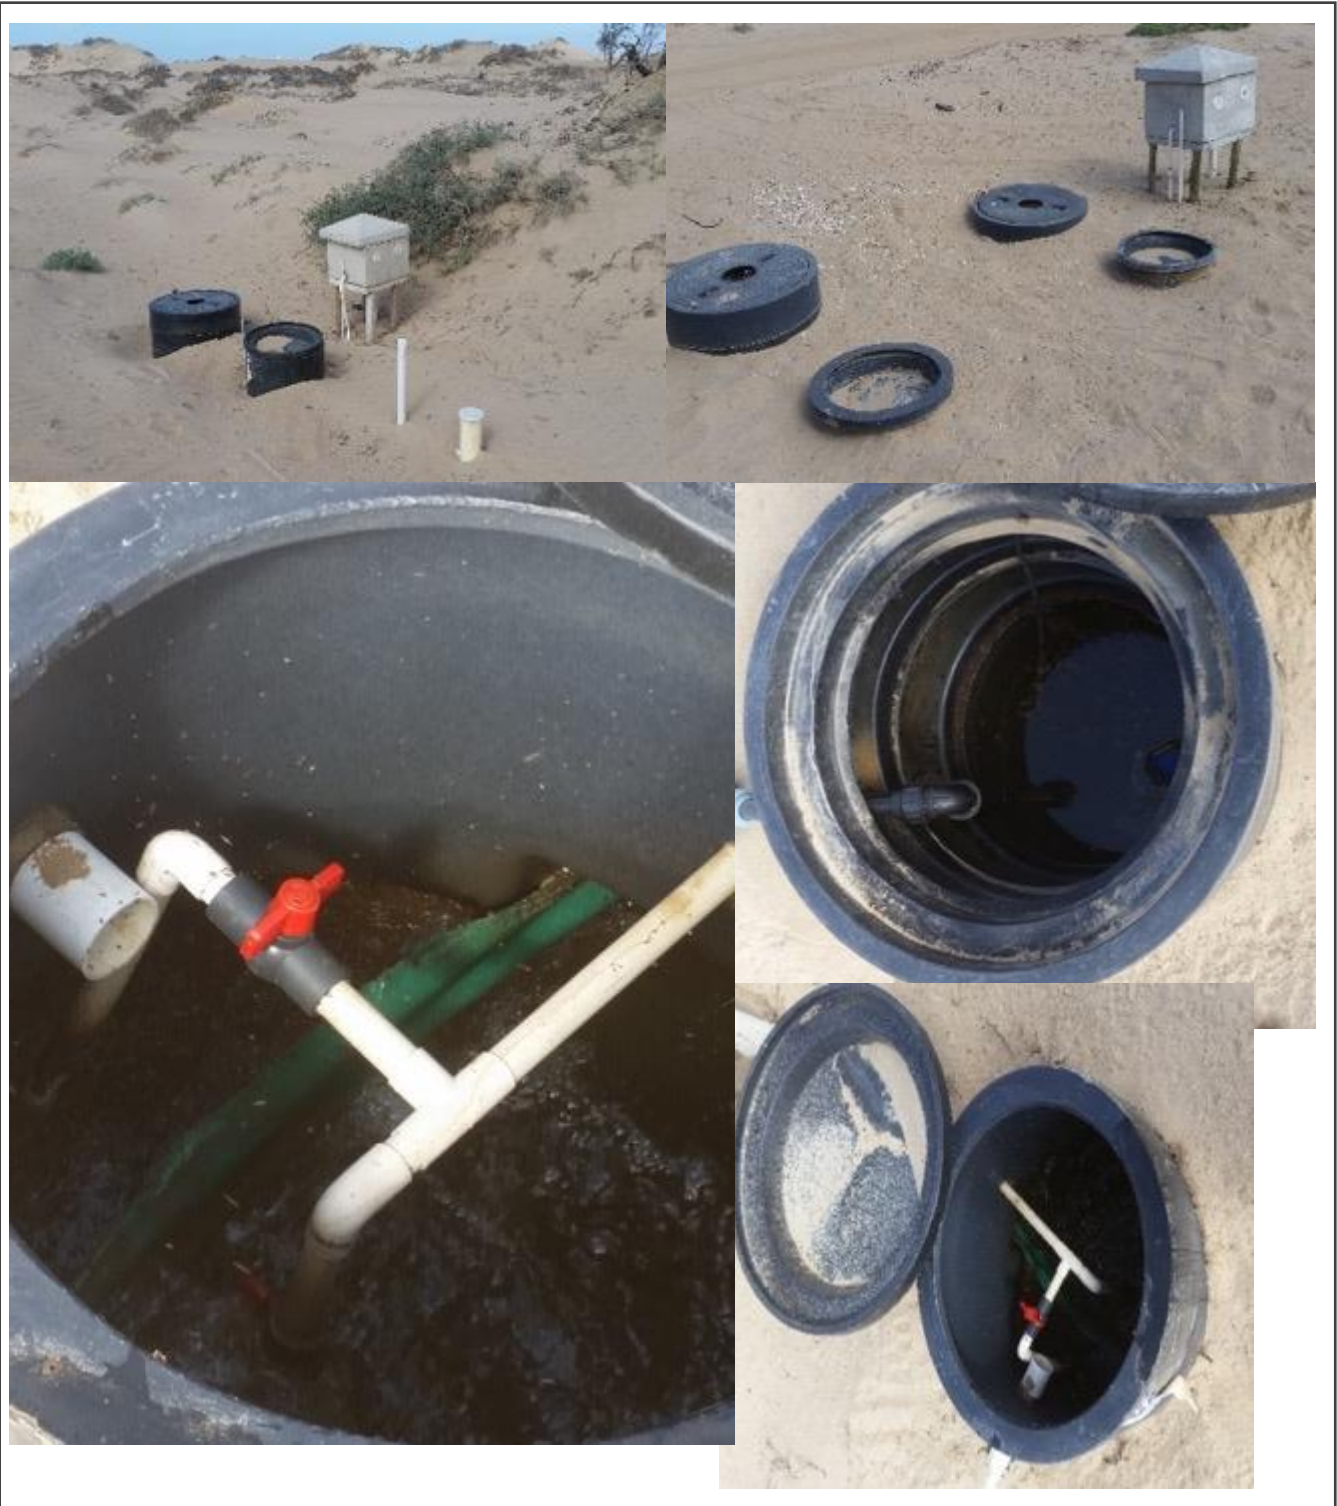
Figure 13. The Bubbler sewage treatment system: aboveground (top two pictures) and the insides of the breakdown and enzyme chambers (bottom three pictures).
