**IMPLEMENTATION OF AND COMPLIANCE WITH THE ENVIRONMENTAL
MANAGEMENT PLAN FOR THE MINING OF SAND BY NAMIBIA
CONSTRUCTION (PTY) LTD ON FARM OSONA NO. 65, OTJOZONDJUPA
REGION, NAMIBIA**

27 March 2023

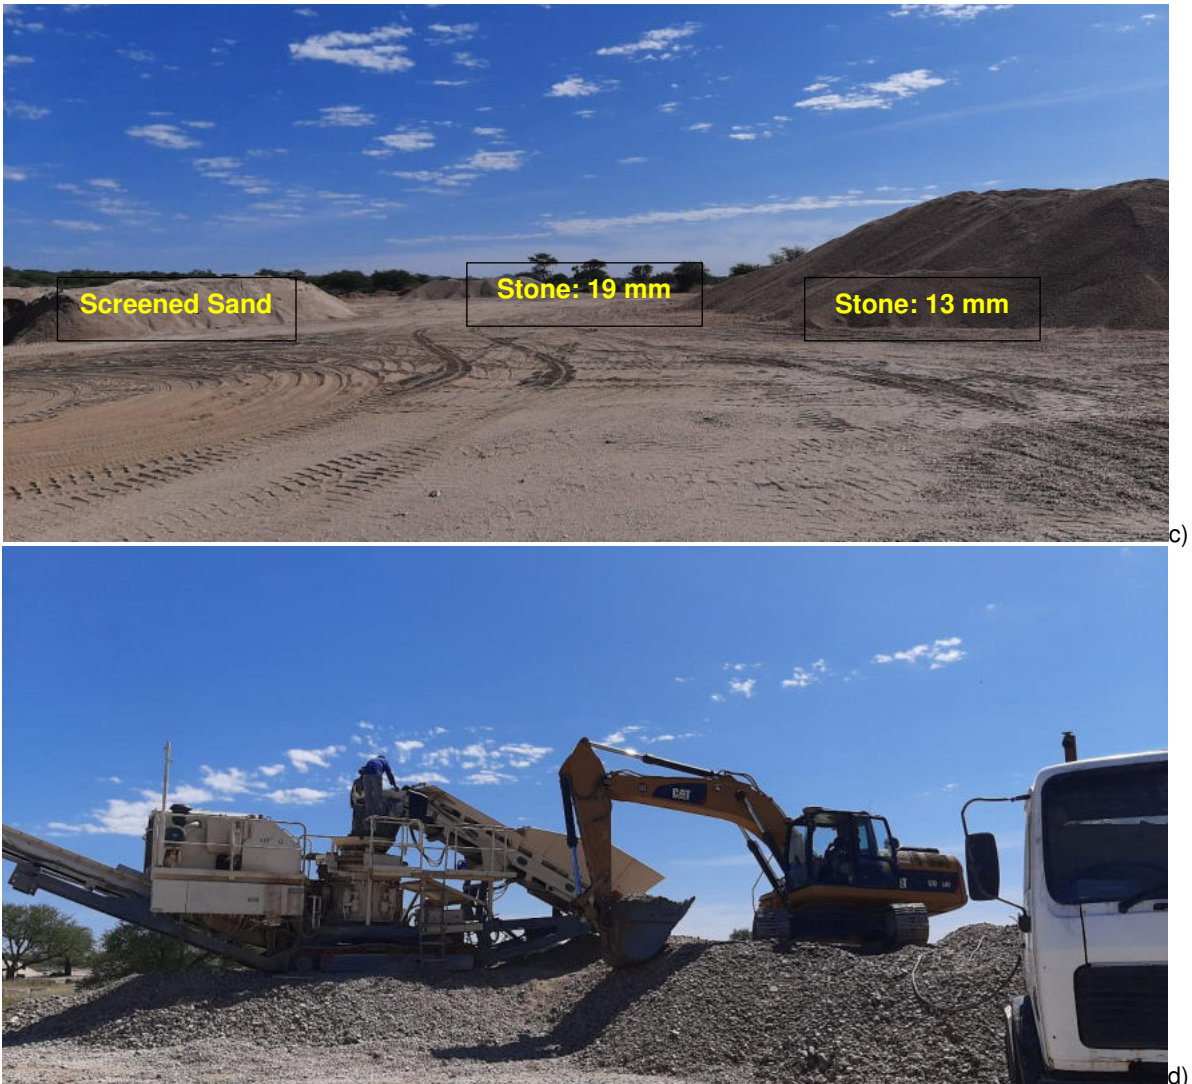
Sand is mined from the riverbed (Figure 3a) and then screened (Figure 3b) into: oversize material; 19 millimetre (mm) stone; 13 mm stone; and sand (Figure 3c). The oversize material (5.0 to 7.5% of all the sand mined) is again crushed (Figure 3d) to obtain mainly 19 and 13 mm stone.

Figure 3: Pictures showing: a) junction of the river coming from Windhoek and flowing into the Swakop River; b) PowerScreen (the river sand can be seen in the background); c) the products: sand, 19 mm stone and 13 mm stone; d) an excavator in the process of loading oversize material onto the crusher (*Source: L. Maartens, 08 March 2023*).

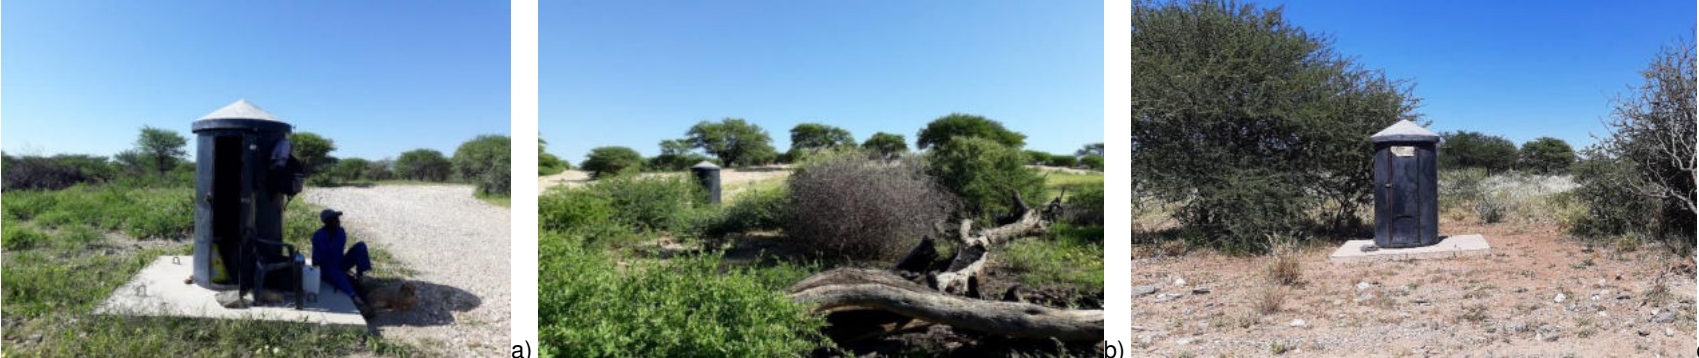
<p data-bbox="183 576 2058 632">Figure 4: Pictures showing the toilets: a) at the entrance gate at the road to the existing stockpile area; b) just south of the existing stockpile area (Source: L. Maartens, 10 March 2020); and c) at the entrance gate at the access road to the Farmhouse (Source: L. Maartens, 08 March 2023).</p>			
Tourism	Ensure the existing access into the river from the plot road is safely maintained.	Compliant and ongoing.	Compliant and ongoing.
Waste management	No litter or waste accumulation will be permitted on site.	Compliant and ongoing.	Compliant and ongoing.
	No burning or burying of waste material will be allowed on site.	Compliant and ongoing.	Compliant and ongoing.
	<p data-bbox="383 833 920 888">Suitable receptacles for waste disposal will be provided at appropriate locations on site.</p> <p data-bbox="383 888 920 975">Employees (NC staff) will be shown the importance of correct waste disposal as well as waste minimisation and recycling through training.</p>	<p data-bbox="952 833 1489 888">Compliant (see Figure 4a – now Figure 5a) and ongoing.</p> <p data-bbox="952 916 1489 971">Additional rubbish bins will have to be provided at the two new stockpile areas.</p> <p data-bbox="952 999 1489 1139">Note that waste is limited (maximum of 10 staff that work in the area and stay in Okahandja). The waste, mainly household, is collected and disposed of at the waste disposal site outside Okahandja.</p>	<p data-bbox="1518 833 2056 860">Compliant and ongoing.</p> <p data-bbox="1518 887 2056 1054">The rubbish bin is currently stored in the container (see Figure 5c); the waste, mainly household, is collected in bags and disposed of at the waste disposal site outside Okahandja (Mr Pieter de Villiers, Foreman, Namibia Construction (Pty) Ltd, pers. comm.).</p>

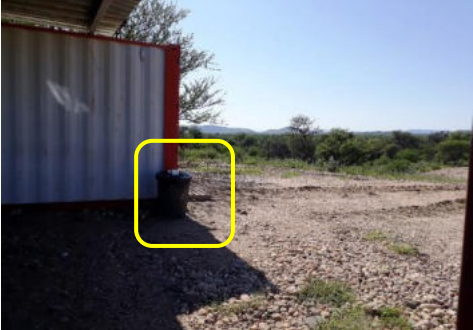
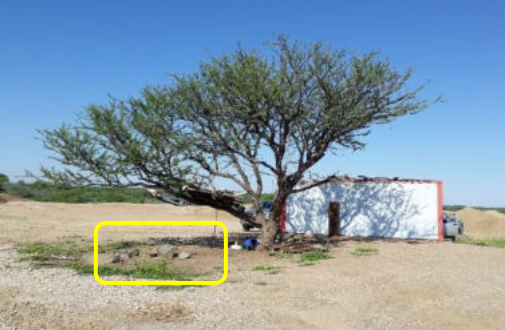
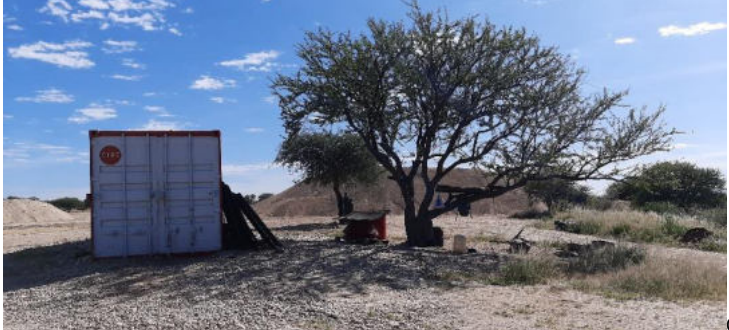
<p>Figure 5: Pictures showing: a) rubbish bin next to the storage container at the existing stockpile area; b) a small, dedicated area was set aside for the making of a fire for the warming of food / water (Source: L. Maartens, 10 March 2020); and c) the area three years later (Source: L. Maartens, 08 March 2023).</p>
<p>Waste management (cont.)</p>	<p>Waste will be removed from site and disposed of at a suitable licensed waste disposal facility.</p> <p>Hazardous (i.e. hydrocarbon contaminated soil) shall be disposed of at the Windhoek Hazardous waste facility.</p> <p>Written evidence of safe disposal of waste will be kept.</p>	<p>It is uncertain as to whether the waste disposal site outside Okahandja is licensed?</p> <p>Hydrocarbon contaminated soil is removed and stored at a dedicated area, until it can be removed and disposed of at the waste disposal site outside Okahandja (Mr Wilfried Schmidt, Contract Manager, Civil Division, Namibia Construction (Pty) Ltd, pers. comm.).</p> <p>It is advised that hazardous waste be disposed of at the licensed, hazardous waste disposal site outside Windhoek.</p> <p>It is advised that records of the amount of hazardous waste to be disposed of at the licensed, hazardous waste disposal site outside Windhoek be kept.</p>	<p>It is advised that hydrocarbon contaminated soil (see Figure 6b) be removed on a regular basis and stored at a dedicated area, until it can be removed and disposed of at the hazardous waste disposal site outside Windhoek.</p> <p>It is advised that records of the amount of hazardous waste disposed of at the licensed, hazardous waste disposal site outside Windhoek be kept.</p>

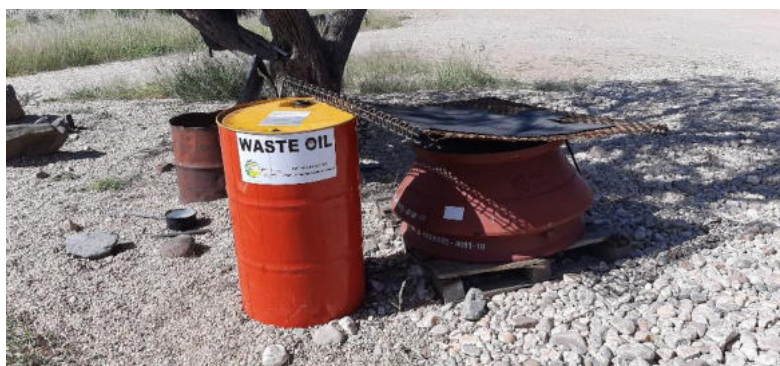
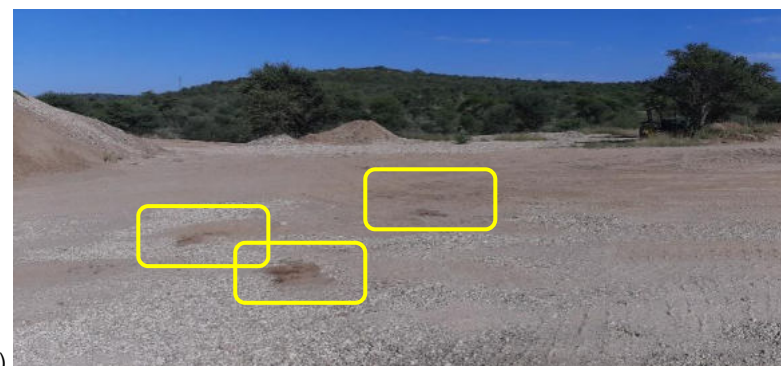
Figure 6: Pictures showing: a) the drum for the collection and storage of the waste oil; and b) areas contaminated with hydrocarbons (Source: L. Maartens, 08 March 2023).

1. That all hazardous waste, including hydrocarbon contaminated soil, be removed and stored at a dedicated area and then be disposed of at the licensed, hazardous waste disposal site outside Windhoek (vs the waste site outside Okahandja); and
2. That absorbent pads and/or spill kits be made available, that personnel are trained in their use, and that any spills are immediately reported and cleaned up.
