COMPLIANCE REPORT 01 FOR THE RENEWAL OF ENVIRONMENTAL CLEARANCES FOR 10 MW Solar (PV) Power Plant at Ohorongo Cement

Prepared by:

Renewal Compliance Report for the 10 MW solar park at Ohorongo Cement SunEQ GmbH

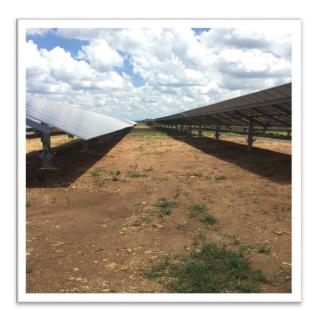
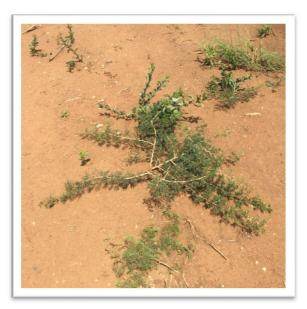
Photo set 1 Sparse grass cover and example of inedible growth

- There is a high occurrence of snakes and therefore likely also of rodents on the terrain.
- The manual management of regrowthn grass is not successful and may lead to increased maintenance. The occurrence of snakes is directly related to this regrowth.

From the photos below it is clear that it is mostly edible grass growing on the terrain.

It is recommended that a limited flock of small livestock be allowed to graze under supervision on the site as a management method. Remaining nonedibles can be remover mechanically once a year.

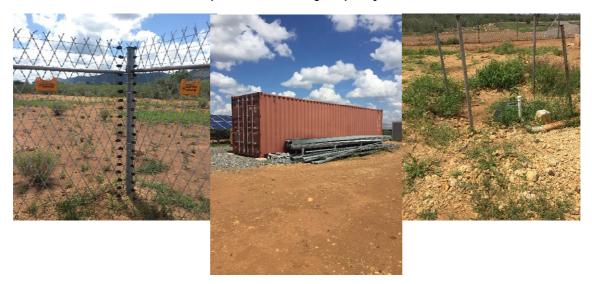
Photo set 2 Warning signs on fence, storage conditions, septic tank soil conditions.

- The warning signs on the perimeter fence is only for the electrical fence. The spacing of the signs are also too far apart.
 - **ü** It is recommended that large enough signs that specifically identify the site as containing electrical danger be added to the perimeter fence every 15m.
- There is not enough container storage space on site. Some sensitive equipment and steel elements are therefore stored in the open. This may cause damage to the equipment and pose a safety threat.
 - **ü** It is recommended that a second storage container eventually be installed to imrove this situation.
- Although the septic tank functions well and is well maintained the soil cover seems to be not sufficient or has sunk down due to natural compaction (se photo below).

- **ü** It is recommended that soil cover be added and raised above the surrounding natural ground level.
- Assure that there are adequate waste storage capacity on site.
