**IMPLEMENTATION OF AND COMPLIANCE WITH THE ENVIRONMENTAL
MANAGEMENT PLAN FOR THE MINING OF SAND BY NAMIBIA
CONSTRUCTION (PTY) LTD ON FARM OSONA NO. 65, OTJOZONDJUPA
REGION, NAMIBIA**

22 February 2020

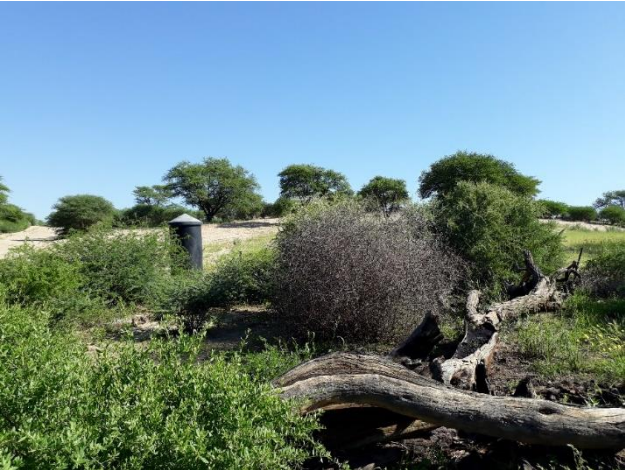
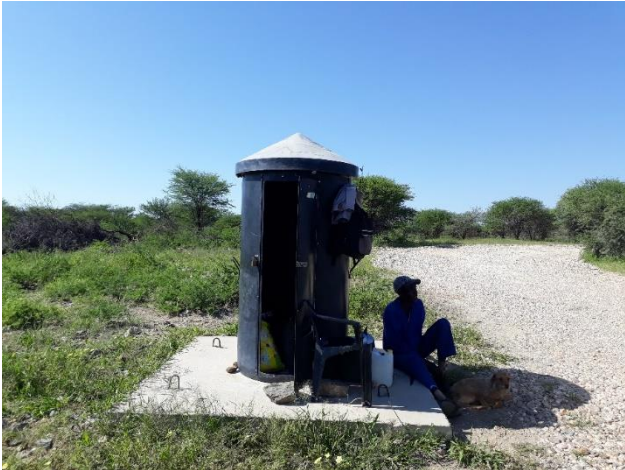
</div> <p>Figure 3: Pictures showing the toilets: a) just south of the existing stockpile area; and b) the entrance to the site / existing stockpile area (Source: L. Maartens, 10 March 2020).</p>

Environmental Issue	Management and Mitigation Measures	Compliance / Comments
	<p>entrance / access road used (see Figure 3). Additional toilets will have to be provided at the two new stockpile areas.</p> <p>Additional monitoring of groundwater quality up-gradient and down-gradient and downstream of the sand mining area is recommended.</p> <p>Emergency situations: - Diesel spillage. An emergency plan should be compiled and kept on site for implementation. Hydrocarbon spill kits stored on site and staff trained in spill kit operations.</p>	<p>N/A.</p> <p>N/A. There are no bulk storage facilities on site. Fuel is brought in daily in two, 210 l drums (Mr Wilfried Schmidt, Contract Manager, Civil Division, Namibia Construction (Pty) Ltd, pers. comm.).</p> <p>It is advised that absorbent pads and/or spill kits be made available, that personnel are trained in their use, and that any spills are immediately reported and cleaned up.</p>

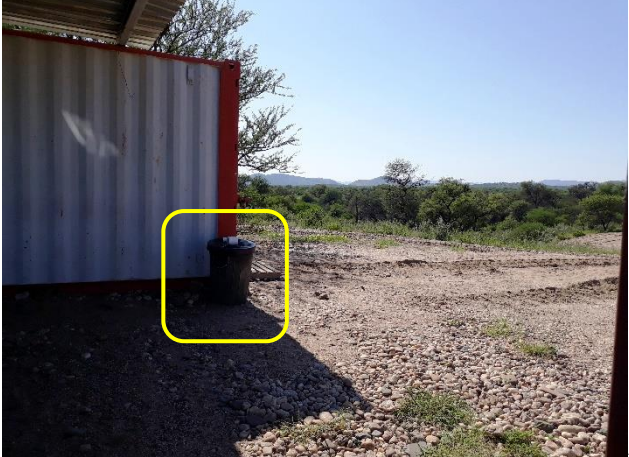
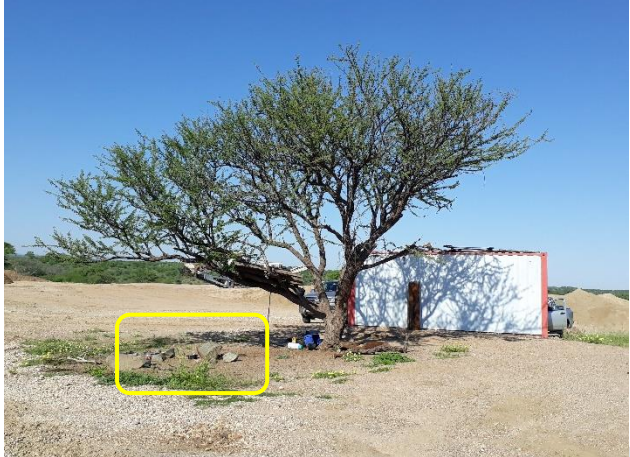
Figure 4: Pictures showing: a) rubbish bin next to the storage container at the existing stockpile area; and b) a small, dedicated area was set aside for the making of a fire for the warming of food / water (Source: L. Maartens, 10 March 2020).

1. That all hazardous waste, including hydrocarbon contaminated soil, be removed and stored at a dedicated area and then be disposed of at the licensed, hazardous waste disposal site outside Windhoek (vs the waste site outside Okahandja); and
2. That absorbent pads and/or spill kits be made available, that personnel are trained in their use, and that any spills are immediately reported and cleaned up.
