**OPERATIONAL PHASE: THE MINING ACTIVITIES ON MINING CLAIMS NO.  
68463 - 68472 NEAR RUACANA IN THE OMUSATI REGION**

**ENVIRONMENTAL MONITORING REPORT (EMR): ENVIRONMENTAL CLEARANCE  
CERTIFICATE (ECC) RENEWAL REPORT**

**MARCH 2020**

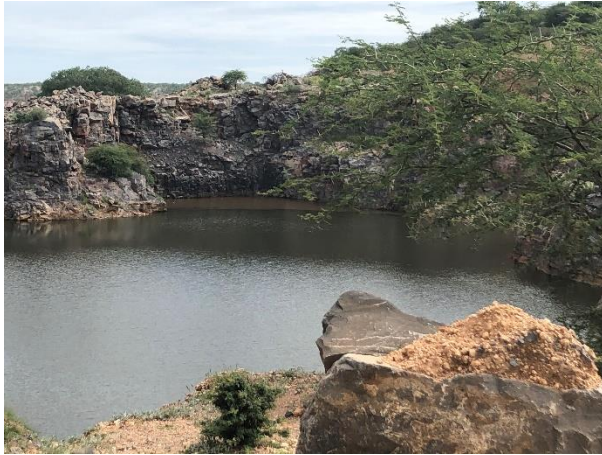
Due to the rain, work was halted at the time of the visit as the pit being mined was flooded. They are estimating up to two weeks for the water to evaporate and subside. The Proponent does not pump the water out of the excavated pit as the community uses it to collect water and animals drink from there.

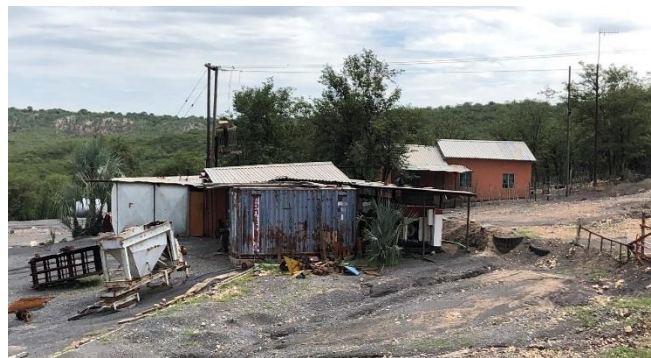
The site has a housing structure for the employees, a workshop storage area structured from containers and steel shade with a sign of oil/ diesel spillage on the ground.

1. Contaminated soils should be removed and stored in designated container until their disposal to the approved waste management facility. The contaminated soils should be replaced with clean soil.
2. Equipment and vehicles may only be washed on the lined surface of the wash bay.
3. Safety signage should be put up at the areas identified during the visit.
4. The exposed mined out areas should be rehabilitated and concurrent rehabilitation undertaken on areas that may pose a visual impact.
5. Other practical uses of the waste rock should be established that the rock can be removed on site. E.g., the waste rock could be packed into small chunks, and covered with seedbank layer (topsoil) he mining areas that may pose a visual impact.
6. Onsite oil tanks should be under the shade and the site should be barricaded as danger area.
7. No animals should be allowed to roam inside the site.

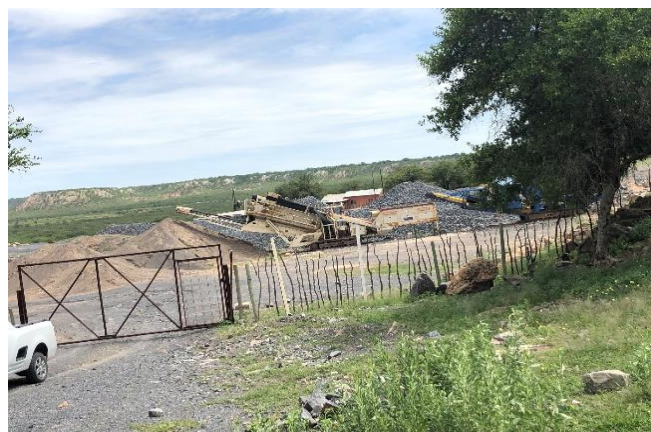
The site is fully fenced off to avoid intruders, animals, children and for the safety of the local community members. The equipment at site is considered dangerous for those that do not have knowledge on how it is operated. Therefore, in order to avoid injuries, the site gates are always kept closed especially during working hours as

animals enter for salt licks and children may get curios about site machinery.

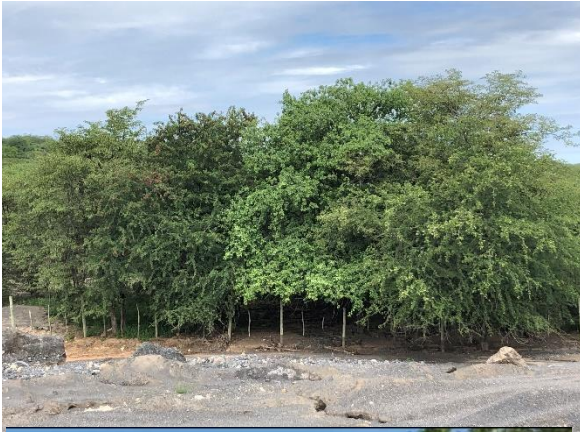
Vegetation, surrounding the site as there's barely any on plant fenced off area, is currently green as it is rainy season with Mopane trees, and minimal thorny (acacia) shrubs. According to the site employee, it is usually not green as the leaves of the Mopane trees dried out (during dry periods). The site is surrounded by mountains, minimizing dust pollution from the crushing to neighboring villages.

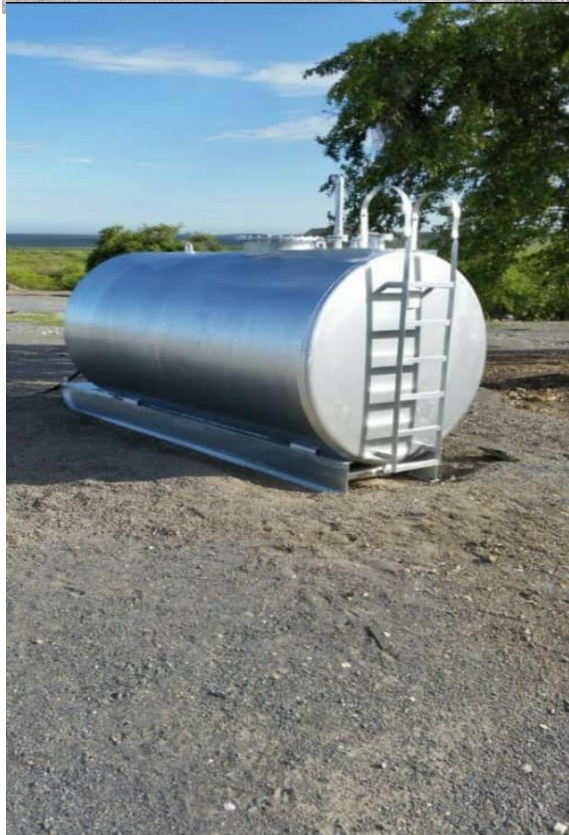
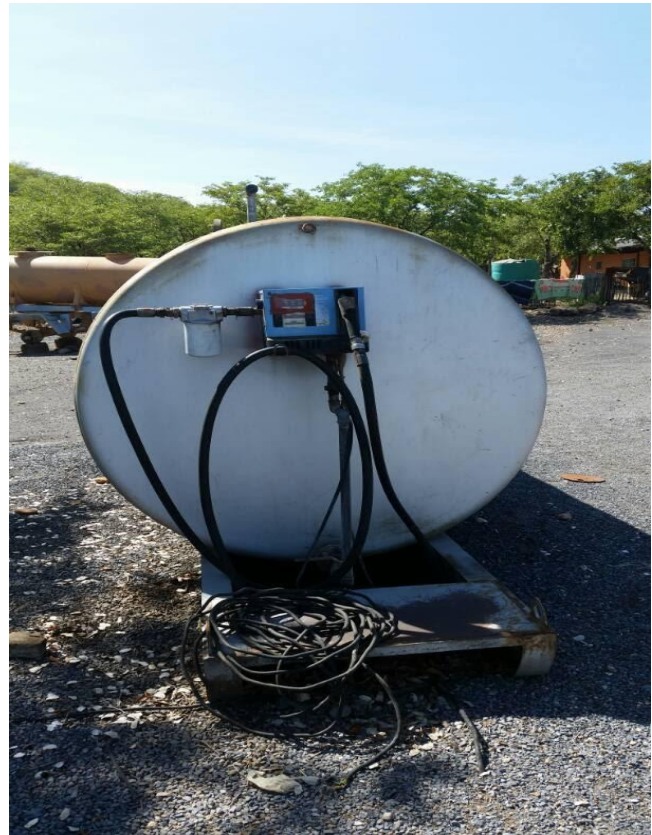
The Proponent uses diesel (see tanks above) as a source of power supply for the mining equipment and equipment, thus no electricity is required for actual mining operations. The diesel is sourced from an above-ground 10 000 liter fuel storage tank installed on site. The fuel is delivered to site by TOTAL Namibia.
