**LANGER HEINRICH URANIUM (PTY) LTD**

**ENVIRONMENTAL AUDIT REPORT FOR THE  
LANGER HEINRICH MINE**

**July 2023**

**Project No: NSP2023LHU1**

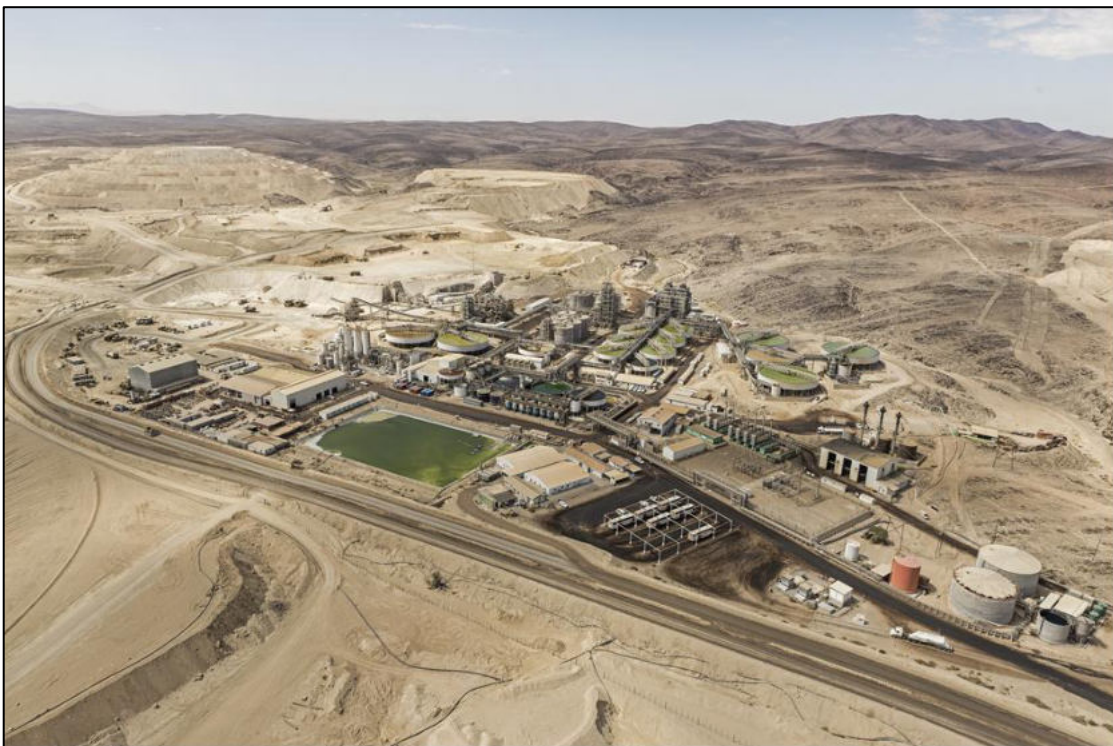
**FIGURE 2: PHOTO OF LHU**

The key infrastructure and activities within ML140 and ML172 implemented before the care and maintenance phase are shown on Figure 2 and are summarised below:

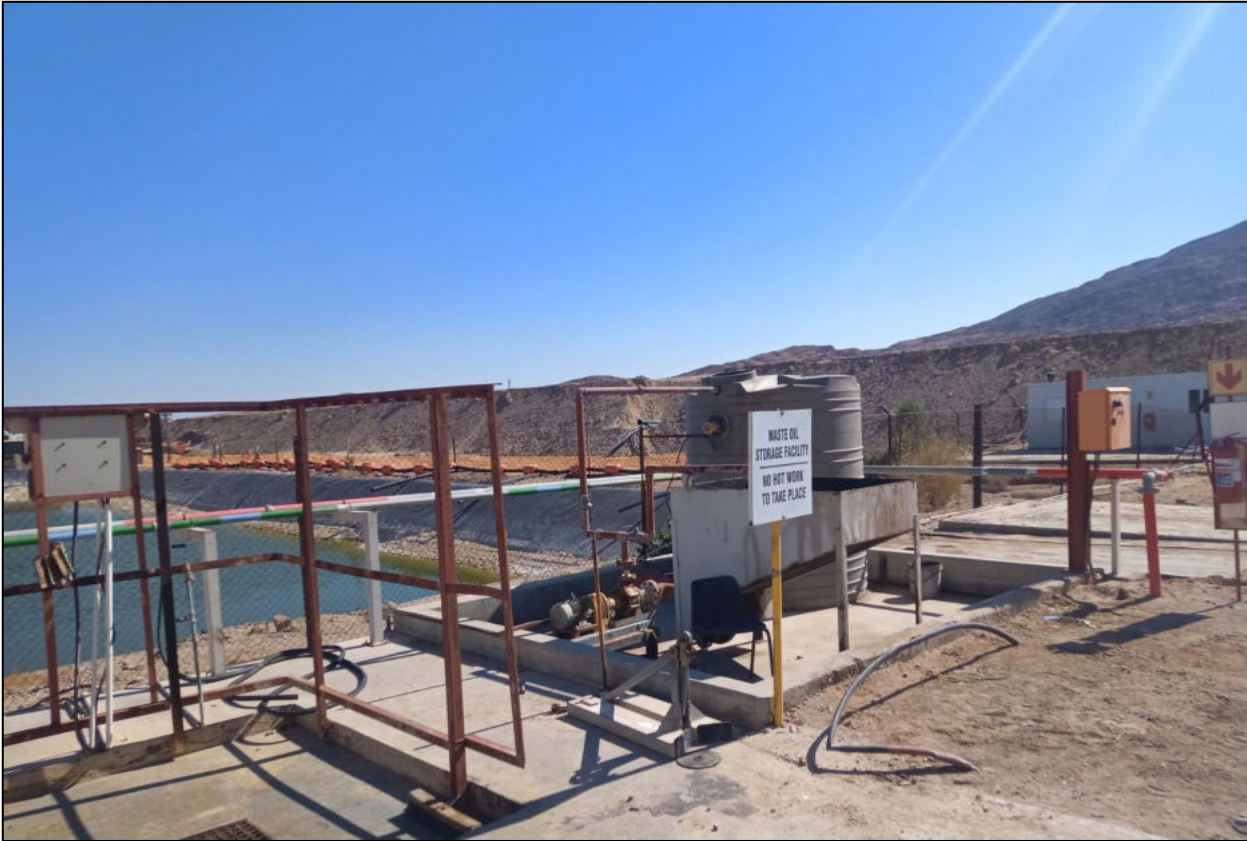
- Various refurbishment activities are currently being undertaken in and around the process plant to improve, amongst others, the clean and dirty water systems. The “process pond”, which was found to be leaking in the past will also be repaired (see photo 1). The effluent still contained in the process pond will first be drenched and disposed of in the TSF.

**Photo 1: Process pond to be repaired**

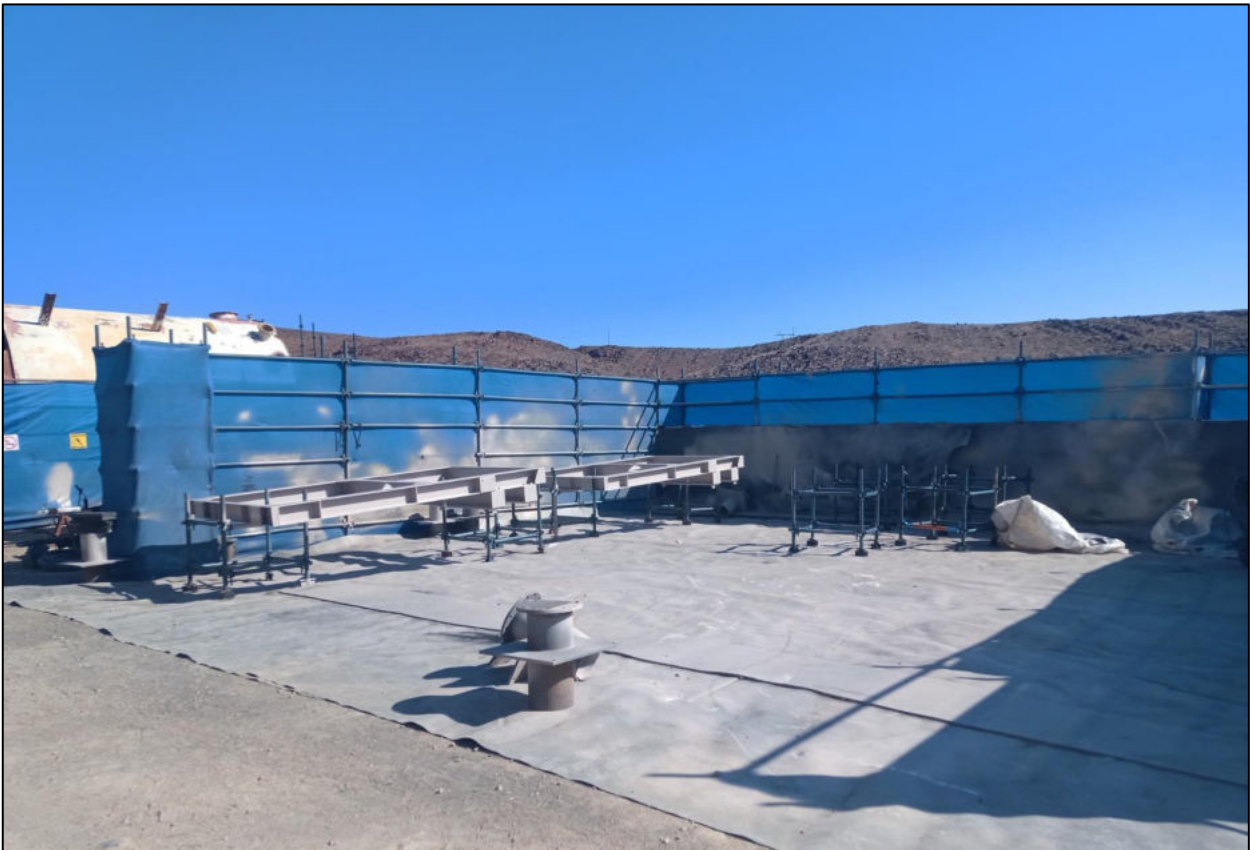
- Painting activities are conducted in dedicated areas - on temporary (plastic) lined areas to prevent spillage (see photo 2).
- Evidence of small hydrocarbon spillage found at the following areas: Diesel refuelling area, Hydrocarbon storage area (see photo 3).
- The 'old' waste oil storage facility will be decommissioned and a new area is being constructed.

**Photo 2: Painting area with lining to prevent spillage**

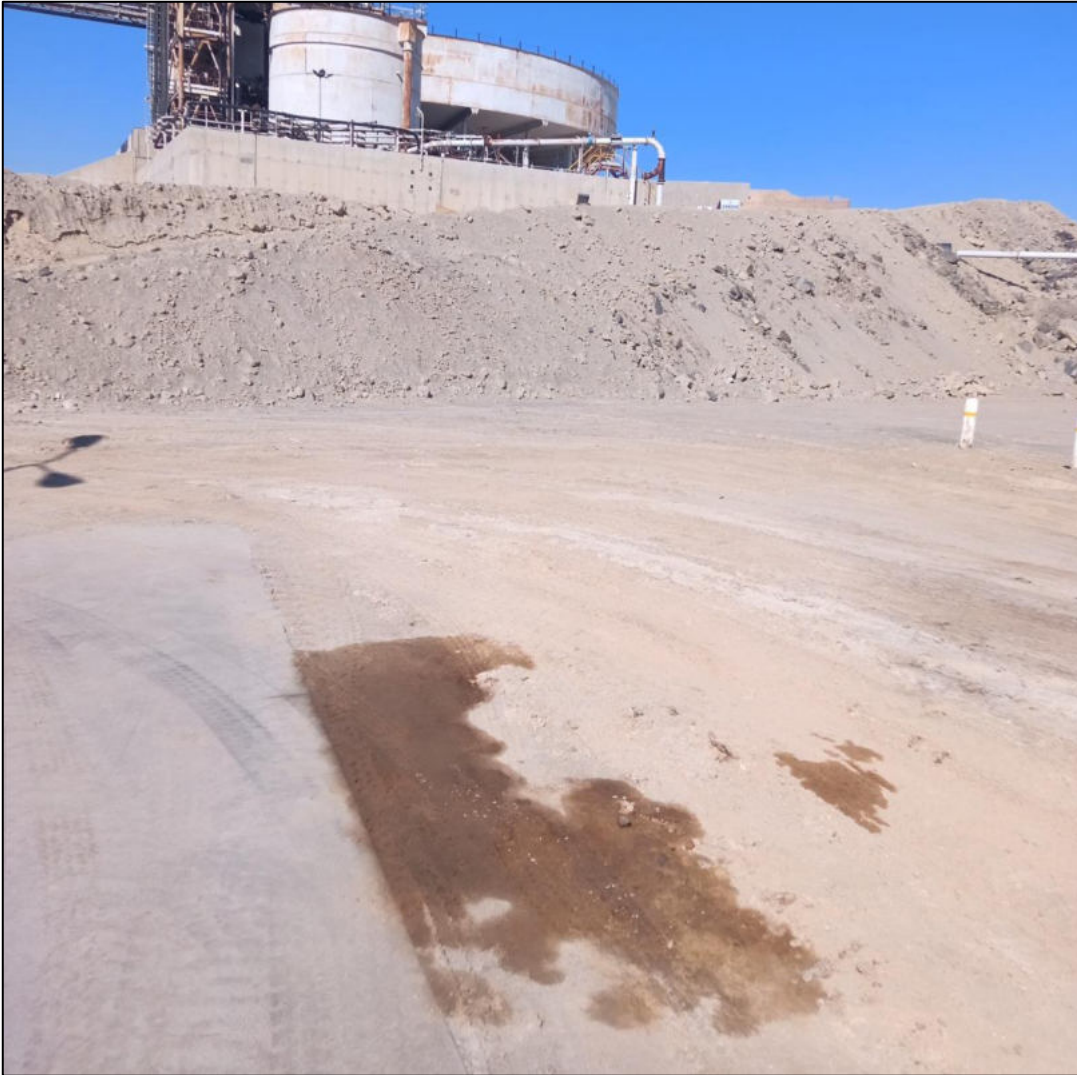
**Photo 3: Hydrocarbon spillage**

- Evidence of small hydrocarbon spillage found on site and uncorrected handling and storage of hydrocarbons, which could lead to further spillages.
  - Signs of spillages of sand-blast material outside the area, posing a contamination risk.

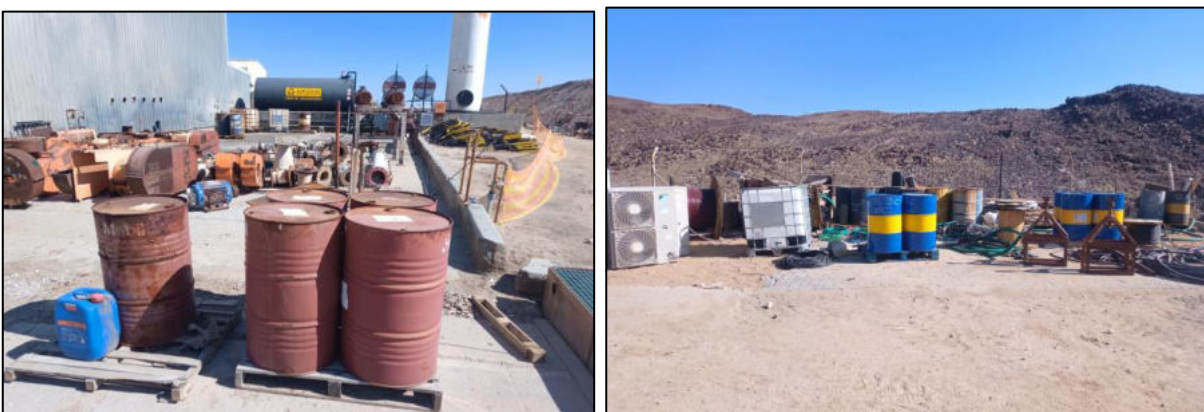
- Even though a temporary dedicated (bunded area) for hydrocarbons are available, various containers with hydrocarbons are stored outside the bunded area posing a risk for more spillages (see photos 4 and 5).
- Sand blasting activities are conducted in a relatively shielded area. However, there are still signs of spillages of sand-blast material outside the area, posing a contamination risk (see photo 6).

**Photos 4 and 5: Hydrocarbon storage – outside bunded areas**

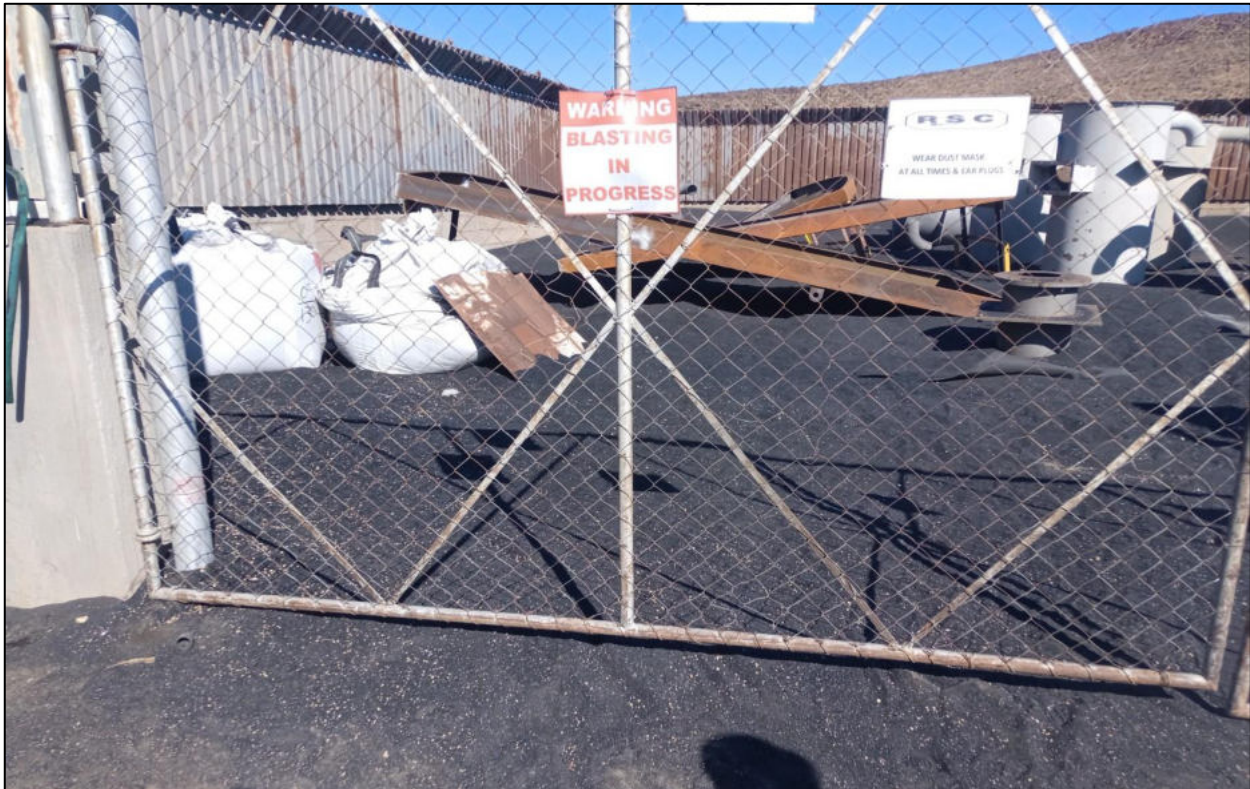
### Photos 6: Sand-blasting area

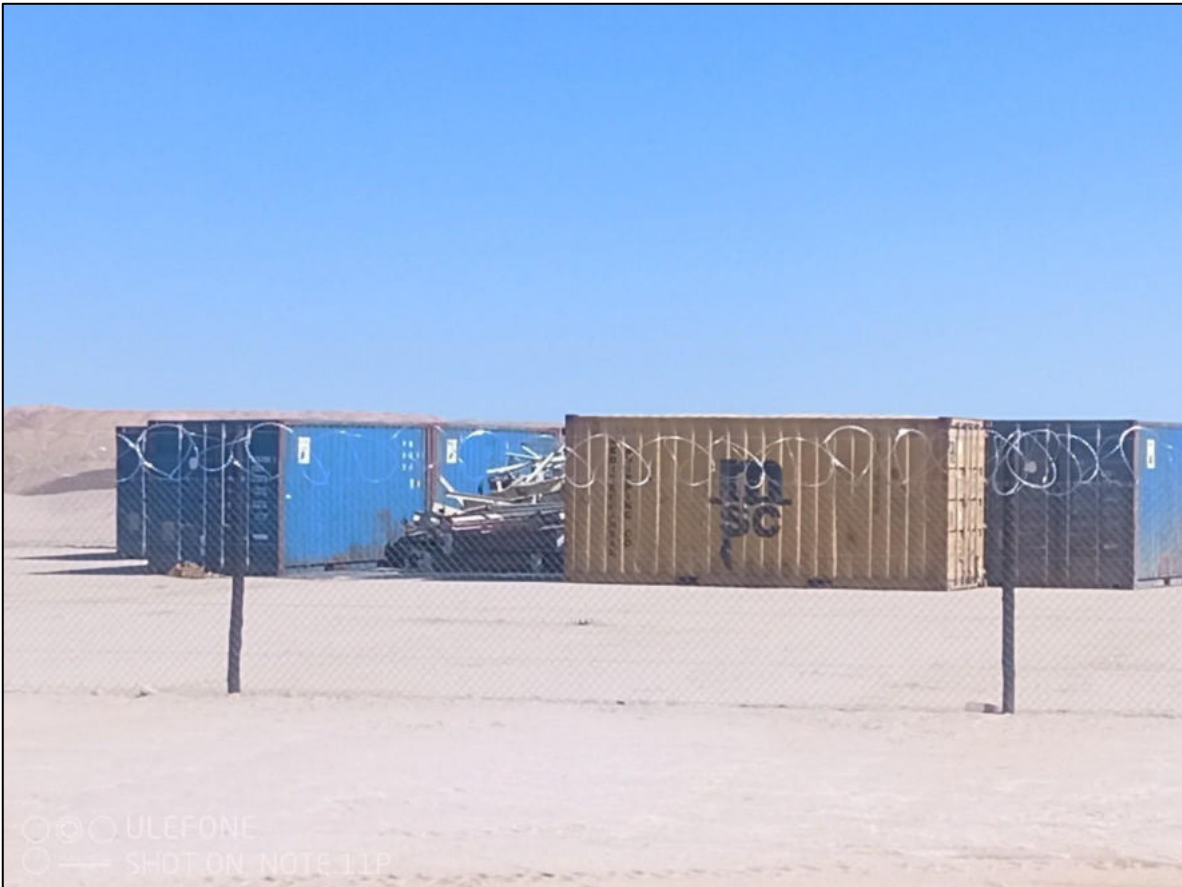
- With reference to section 2.2 the FPR is being dismantled and replaced with upgraded facility. The waste being generated from these activities are largely radio-active contaminated and disposed / 'stored' in dedicated areas on TSF 2.
- In one of the areas, the waste is placed in containers for future safe disposal on site (refer to Photo 7). On another area, the waste appears to be placed in an area which could pose environment risks, on the edge of the TSF (refer to photos 8). Also this areas is not well managed.

**Photo 7: Radio-active contaminated waste stored in container on TSF2**

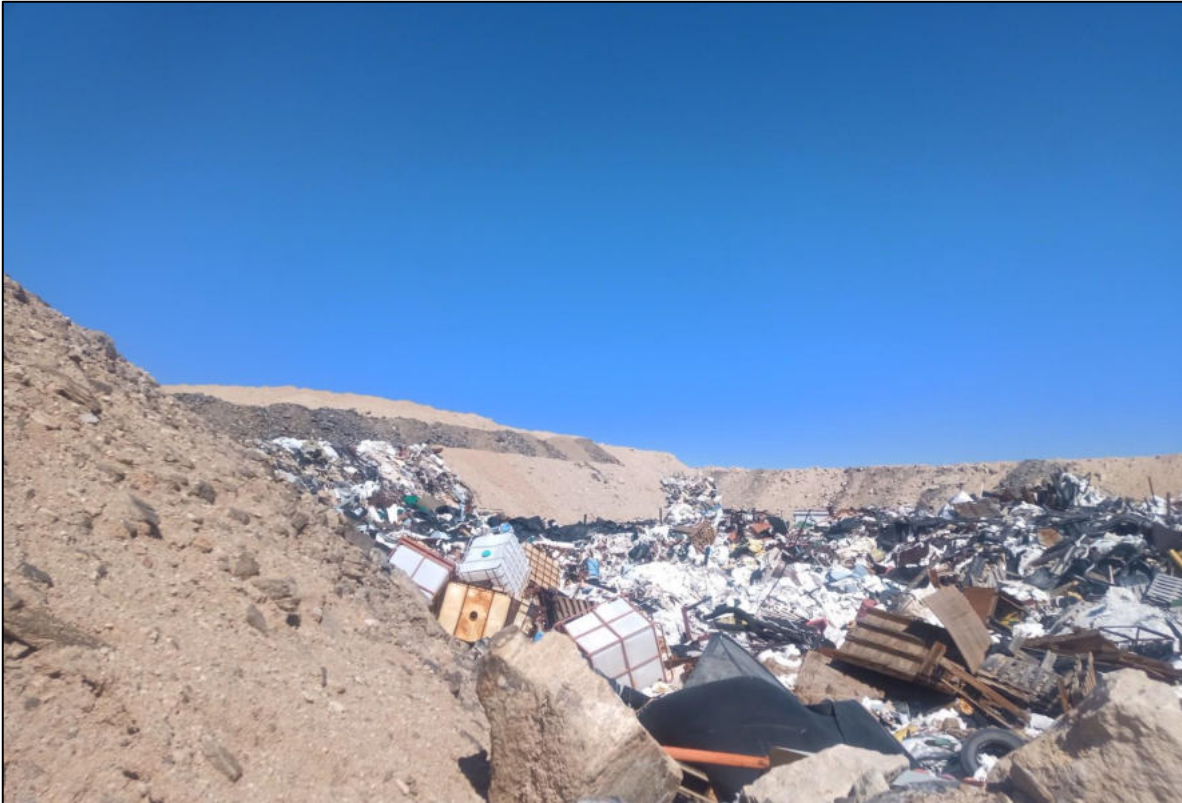
**Photo 8: Radio-active contaminated waste stored in the open on TSF2**
