Scoping Report and EMP for Ichingo Chobe River Lodge

October 2018

Namib Consulting Services cc.

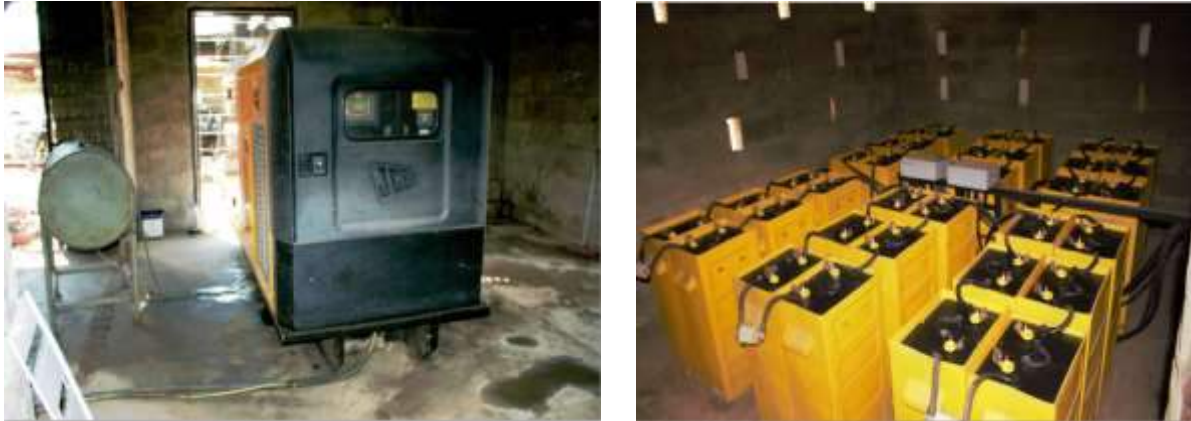
Figure 2 Outlook of the generator room with rechargeable batteries for the solar power system

Power supply to Ichingo Lodge is from two diesel generators (90kw capacity each) operating on at all times. This power supply is supported by backup of a solar voltaic system with its rechargeable batteries with capacity of 15kw to offset the pressure on the generators at times (Fig 2).

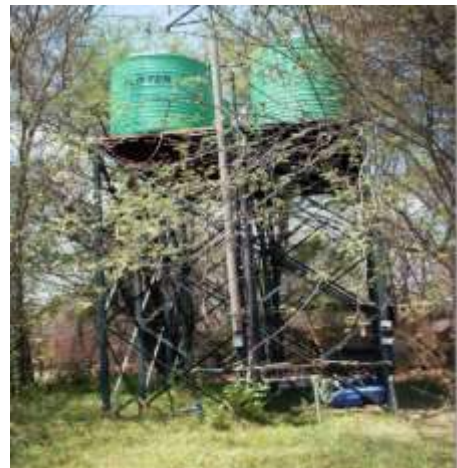
Figure 3 Filtering of the water prior distribution on the lodge

Water supply to the lodge is self-abstracted and treated through filters before distribution to all facilities and used in showers, sinks, kitchen and laundry. Water for drinking purposes is mainly procured bottled water.

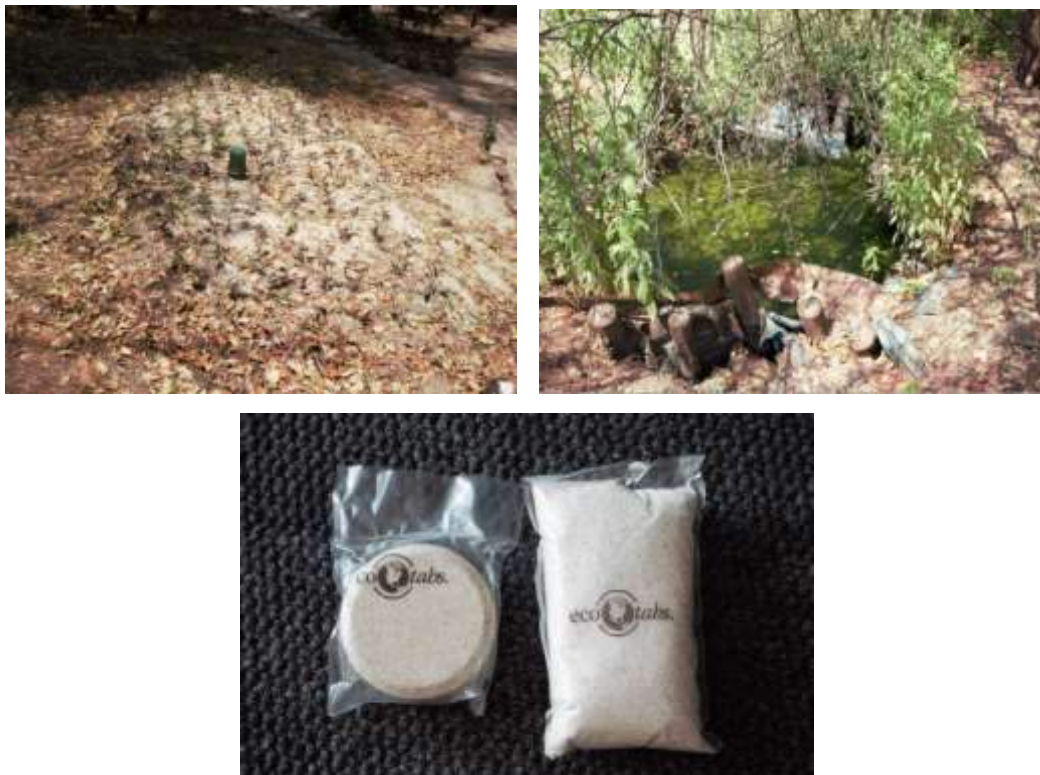
Figure 4 the effluent treatment system on the lodge

⇒ **Blackwater:** all the wastewater from guestrooms, staff accommodation and public toilets inclusive of showers and sinks drains into a septic tank of each building. Comprising of two compartment, ecotabs are applied to the first compartment of the septic tank for biodegradation of the raw sewage, resultantly settling of solids in this tank. Overflow effluent from the first tank flows to the second tank where the liquid is stored and eventually discharges by a French drain. The soak-ways are built +/-200m. away from the river

<p>treatment by solar radiation and evaporation</p> <p>vii. Line the bottom of the ponds with sand and rock material to enable filtration of the final water than plastic lining</p>		
	Solid combustible and non-combustible	<ul style="list-style-type: none"> ○ Waste is separation ○ combustible waste is incinerated ○ Return of recyclables waste and other packaging waste with food supplier 	<ul style="list-style-type: none"> ○ None recyclable waste returned with food supplier may put pressure on landfill at location of disposal in Katima Mulilo. ○ 	<ul style="list-style-type: none"> ○ Lodge collaborates with local community to designate and operate a landfill site on the island 	Low	Senior Manager
Kitchen operations at main and satellite	Greywater	<ul style="list-style-type: none"> ○ Kitchen water discharges into the Chobe river 	<ul style="list-style-type: none"> ○ Direct discharge of satellite kitchen water into the river 	<ul style="list-style-type: none"> ○ Install a fat trap to reduce the oils and fats in water prior discharge into the stream this could include a soak-away to utilize infiltration properties of riverine sand 	Low	Assistant Manager Lodge Operations

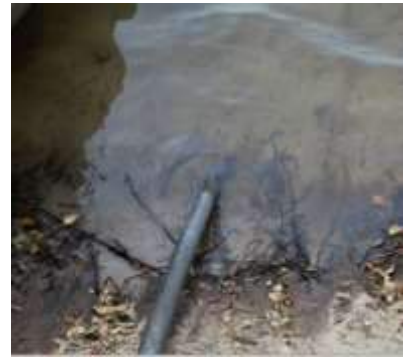
Figure 5 Kitchen greywater discharge point

Greywater: Water used in kitchens is removed of larger diameter solids as it drains from the sinks into an underground pipe. This greywater although still oily eventually discharged directly into the Chobe River (Fig 5).

and other packaging waste to food supplier		disposal in Katima Mulilo.
Kitchen operations at main and satellite	Greywater	Discharge in water and on land	Aquatic life, humans and wildlife	<ul style="list-style-type: none"> ○ Access oils and fats in standing water may reduce oxygen diffusion in the river system, impacting aquatic life ○ Access oils may impair quality of water for direct consumption 	<ul style="list-style-type: none"> ○ Kitchen water discharges into the Chobe river 	Medium	<ul style="list-style-type: none"> ○ Direct discharge of satellite kitchen water into the river
	Solid waste	Discharge on land and water	Aquatic life, humans and wildlife	<ul style="list-style-type: none"> ○ Impair aesthetic value of the area ○ Environmental hazard to both wildlife and humans ○ Degrading waste generate foul smells 	<ul style="list-style-type: none"> ○ Waste is separation ○ combustible waste is incinerated ○ food waste is composted and supplied to local community for keeping worms and pets ○ Return of recyclables waste and other packaging waste 	Medium	<ul style="list-style-type: none"> ○ None recyclable waste returned to food supplier may put pressure on landfill at location of disposal in Katima Mulilo. ○ Establish a tracing system of the beneficiaries of the compost

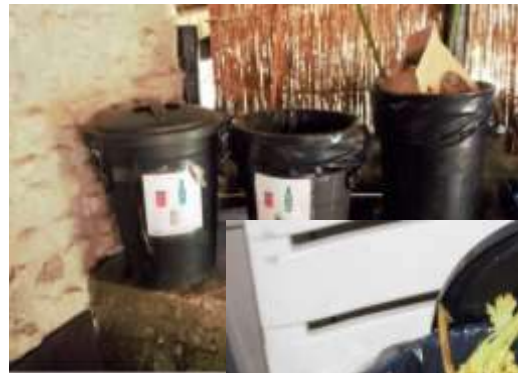
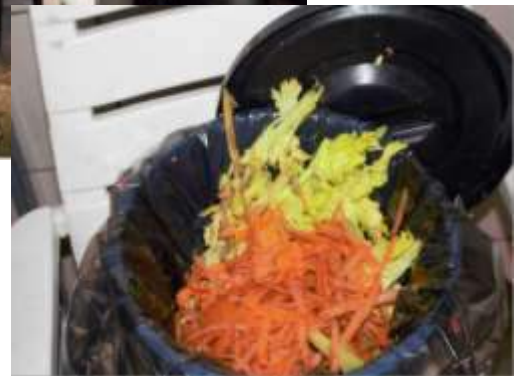
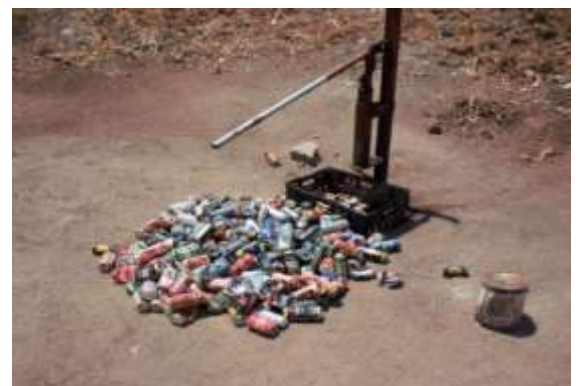
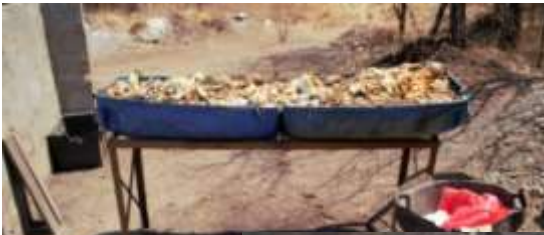
Figure 6 Waste separation practices on the lodge

Handling of solid waste on the lodge involves separation of this waste into combustible, organic waste and recyclables applied across all operations on the lodge. This waste is handled as follows;

- Organic food waste is separated and allowed to drain of leachate before placed in a steel cage for composting (Fig 6, Fig 7). The waste is compost is used for farming of worms and also some provided to communities as manure.
- Combustible waste comprising mainly card boxes and paper is incinerated at a demarcated site on the island within premises of the lodge (Fig 9).
- The recyclables and other plastics, packaging and crushed tins are collected by food supplier Sea-Pride Foods where recyclables are handled further non-recyclables disposed at Katima Mulilo Landfill site (Fig 8).

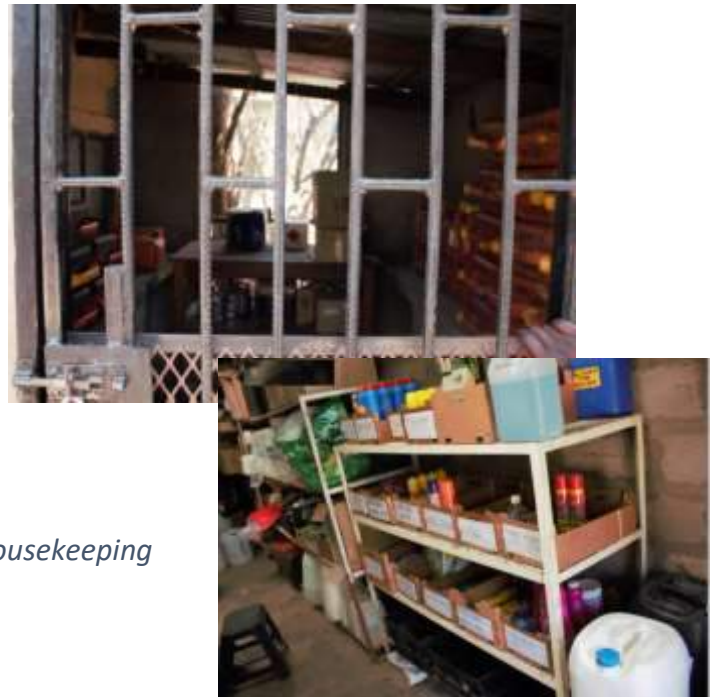
Figure 10 Storerooms for fuels, chemicals and housekeeping detergents

Storages of fuels, detergents and other hazardous substances on the lodge is separated in different storerooms fused together as one building each with own separate access. The chemical shelves are well labeled for identification on entering the stores (MSDS equivalent) (Fig 10).

<p>Storage and use of paints, thickeners, detergents and cants and fuels</p>	<p>Hazardous waste</p>	<ul style="list-style-type: none"> ○ Controlled storage of oils, lubricants and fuels. ○ Regular inspection of storage for leakage ○ Paints and related are securely stored in the storeroom ○ Detergent storeroom well labeled and secure (MSDS) ○ All painting is done on a concrete area before fittings anywhere on the lodge ○ Controlled access to the storerooms 	<ul style="list-style-type: none"> ○ No spillage or soil contaminated handling procedure 	<ul style="list-style-type: none"> ○ Establish formal protocols for handling of hazardous substances inclusive of proper protective wears ○ Oil change on equipment's or machinery to use drip trays ○ Fueling of boats tanks to be done on concretized areas/or nozzle pipes to avoid spills onto the ground or use of drip trays ○ Develop a spill handling procedure for the site. Designate an area for of this contaminated soil (incineration area). Procedure to involve scooping of the soils upon which spill occurred. Application of sawdust to the soils to absorb and reduce the total hydrocarbon content. 	<p>Low</p>	<p>Assistant manager maintenance</p>

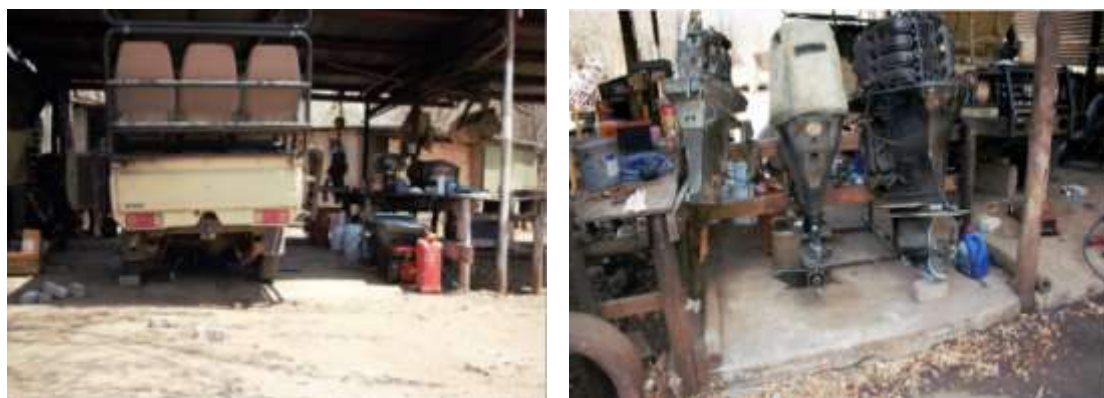
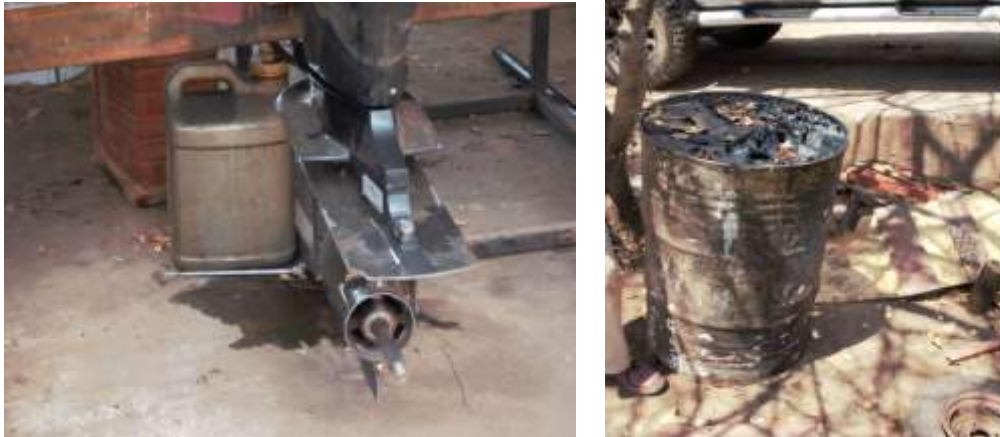
Figure 11 Operations at the workshop area

The workshop area comprises a concrete area where mechanical repair work for vehicles and boat engines is carried out (Fig 11). All painting, thickening and coating or any maintenance work are prepared on the concrete area prior to actual repair or replacement of facilities on the lodge.

Engine oils is stored in a 200 liter drum beside the concrete area of the workshop (Fig 11). Used oil in the drum is provided to some communities members that request it for coating of wood and reeds used in structure to prevent insect attacks.

collected by food supplier		
Maintenance workshop for repairs	Hazardous waste (engine oils etc.)	Deposition on soils to groundwater and surface waters	Aquatic life, wildlife and humans	<ul style="list-style-type: none"> Contamination of land and water sources thus poses as a health hazard Deterioration of the value aquatic system to provide ecosystem services 	<ul style="list-style-type: none"> All repair works carried out on the concrete area of the workshop Waste engine oils stored in a drum. Used oils supplied to local community members for own uses 	Medium	<ul style="list-style-type: none"> Waste oil drum placed on bare soils No tracing system of the local community members that collect oil and specific uses No spill handling procedure
Storeroom and use of paints, thickeners, detergents, lubricants and fuels	Hazardous waste	Spills on soils, surface and to groundwater	<ul style="list-style-type: none"> Aquatic life, wildlife and humans 	<ul style="list-style-type: none"> Contamination of the soils and water resources Compromise health of the workers Render aquatic system cease its ecosystem functioning 	<ul style="list-style-type: none"> Controlled storage of oils, lubricants and fuels. Regular inspection of storage for leakage Paints and related are securely stored in the storeroom Detergent storeroom well labeled and secure (MSDS) All painting is done on a concrete area before fittings 	Medium	<ul style="list-style-type: none"> No spillage handling procedure

<ul style="list-style-type: none"> ○ Lack of a tracing system of the beneficiaries of the compost 	<p>awaiting collection by supplier to avoid disturbance by wild animals</p> <ul style="list-style-type: none"> ○ Establish a system of recording the collectors of compost and uses 		
Maintenance workshop for repairs	Hazardous waste	<ul style="list-style-type: none"> ○ All repair works carried out on the concrete area of the workshop ○ Waste engine oils stored in a drum placed on bare soils. ○ Used oils supplied to local community members for own uses 	<ul style="list-style-type: none"> ○ Waste oil drum placed on bare soils ○ No tracing system of the local community members that collect oil and specific uses ○ No spill handling procedure 	<ul style="list-style-type: none"> ○ Develop a spill handling procedure for the site. Designate an area for bioremediation of this contaminated soil. Procedure to involve scooping of the soils upon which spill occurred. Application of sawdust to the soils to absorb and reduce the total hydrocarbon content. ○ Waste oil drum to be placed on an area bounded with concrete slab and its opening always closed. ○ Develop a recording system of community members that collect oil and uses ○ Oil change on equipment's away from the concrete area to use drip trays 	Low	Assistant manager maintenance

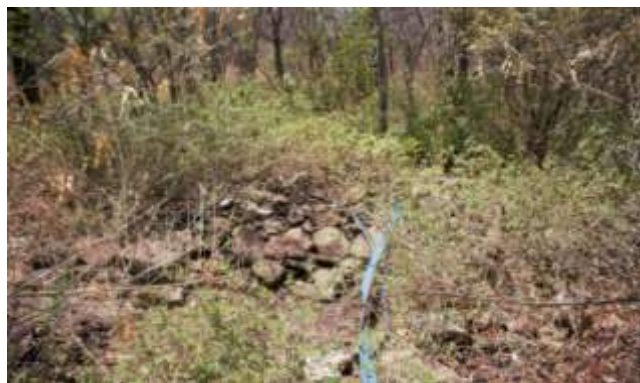
Figure 12 Discharging of Laundry water

Laundry operations supply housekeeping personnel with clean linen daily thus these operations are critical on the lodge. Laundry water drains into a 500 liters tank upon which when full outflows discharges approximately 300m in the northern direction away from the river although still within the lodge premises. The water discharges on an artificial pile of rocks away with patchy vegetation.

<p>order well stored in the secure storeroom.</p> <ul style="list-style-type: none"> ○ Redundant equipment's stored behind the storeroom 	<ul style="list-style-type: none"> ○ Solid waste placed behind the staff not secure attracting wild animals to disturb this waste 	<ul style="list-style-type: none"> ○ Waste behind the staff kitchen to be secured at all time to avoid animal disturbance. ○ Improve hygienic conditions of the staff kitchen area 		
Laundry operations	Greywater	<ul style="list-style-type: none"> ○ Laundry water drains into a plastic tank prior to ○ outflow when full discharges onto a nearby vegetated area away from the riverine area 	<ul style="list-style-type: none"> ○ The holding tank seems to be a temporal measure as it keeps being shifted 	<ul style="list-style-type: none"> ○ Construct levees to control dispersion around the discharge area ○ Designate a permanent placement of the holding tank of laundry water away from active areas of the lodge 	Low	Assistant manager maintenance

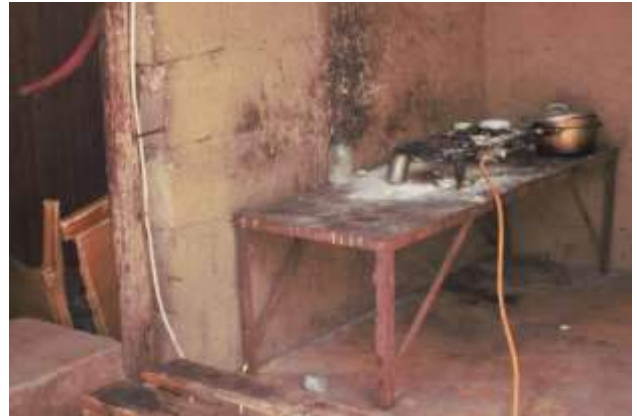
Figure 13 Staff kitchen fused to Parts Storeroom

A number of redundant equipment's are kept behind this storeroom while the secure inside is used to store parts still in working condition. Fused with the storeroom is a kitchen used by the staff for preparation of meals and dining area.

<p>Parts Storeroom and staff kitchen</p>	<p>Hazardous waste</p>	<ul style="list-style-type: none"> ○ Regular inspection of the storeroom for spillages and leakages ○ All parts and equipment's in working 	<ul style="list-style-type: none"> ○ Redundant equipment's are kept on bare soils ○ Hygienic conditions of the staff kitchen not in good order 	<ul style="list-style-type: none"> ○ Place a plastic lining under all redundant equipment's kept outside the storeroom ○ Develop a decommission strategy for all the redundant equipment's 	<p>Low</p>	<p>Assistant manager maintenance</p>
