Scoping Report and EMP for Zambezi Queen Houseboat

October 2018

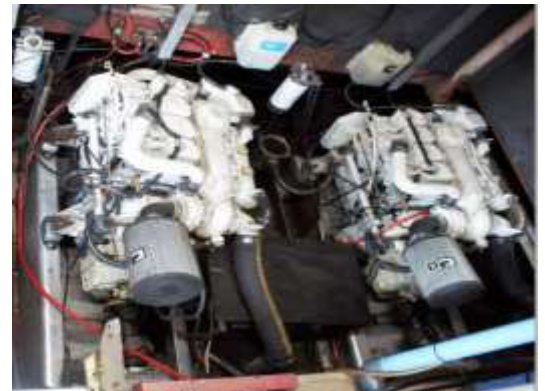
Figure 2 Outlook of the engine and power supply for the houseboat

Power supply for the boat is from two diesel generators aboard, supplying all the power requirements on a 24 hours basis. The boat comprises a tank that stores diesel fuel that can serve for seven (7) days before another refueling is required. A fuel bowser designed tanker collects fuels from Kasane and refuels the boat.

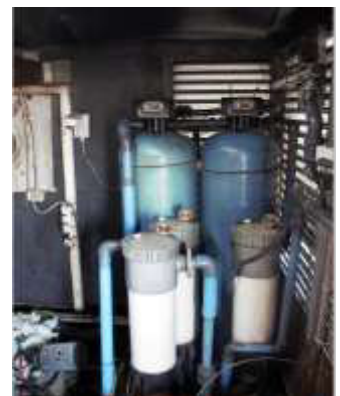
Figure 3 Treatment of water for facilities and ice making machine

Water used onboard the houseboat is abstracted directly from the Chobe River and treated through a process that involves filtration and disinfection by using UV light. This treated water is used in kitchens, sinks and lavatories aboard. Water for drinking is mostly procured bottled, while that used for ice cubes is separately treated onboard through a reverse osmosis process.

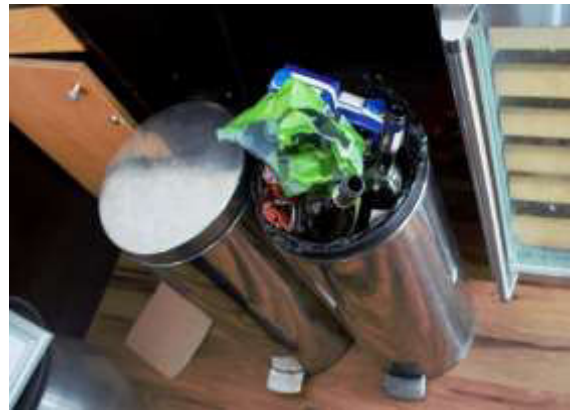
Figure 4 Waste separation practices onboard

Solid waste from the houseboat is separated in accordance to final disposal measures in place. Such waste includes recyclables such as plastic bottles, glass bottles and cans, but also combustible such as packaging card boxes and papers as well as organic waste.

- Organic food waste is separated from other solid waste onboard and transferred to land for further handling.

- Combustible waste including packaging card boxes, some plastic and papers are also separated from other waste and transferred onshore for further handling.
- The recyclables and other plastics, packaging are separated and collected by the food supplier Sea-Pride Foods for recycling and others for disposal at Katima Mulilo landfill site.

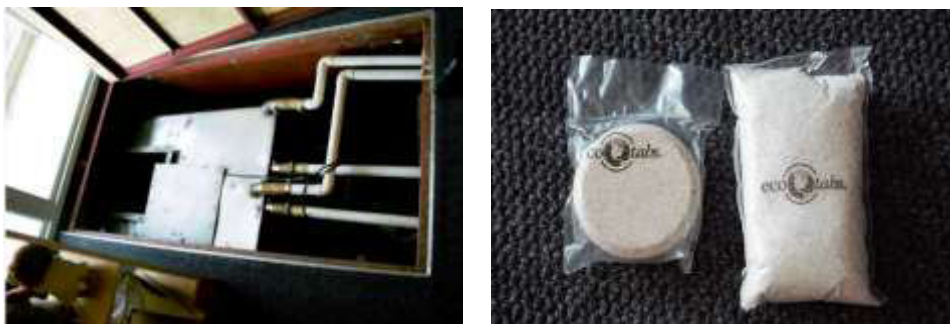
Figure 5 First sewer tank onboard the houseboat where eco-tabs are applied

- A first holding tank (1000 liters) receives all the wastewater from sinks, showers and toilets of guestrooms inclusive of public lavatories for the workers aboard. Biological breakdown of the sewerage is initiated by addition of eco-tabs (Fig 4). These eco-tabs are applied to the tank every Tuesday of the week.

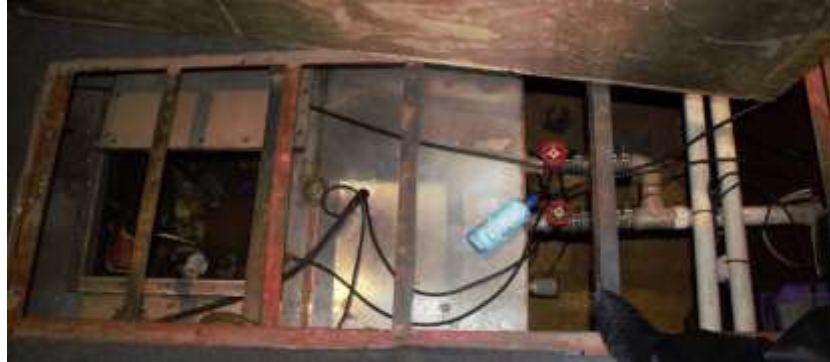
- A rising level of wastewater in the first tank triggers outflows into the second tank (1000ltrs), where biological breakdown of the constituents of the sewage water continues. The tank

comprises of a macerator pump that reduces solids to small pieces in order to deal with rags and other solid waste. It has a rotating arm that stirs the effluent both clockwise and anticlockwise to avoid clogging thus mixing and aerating the effluent received from the first tank as it further undergoes degradation by microorganisms.

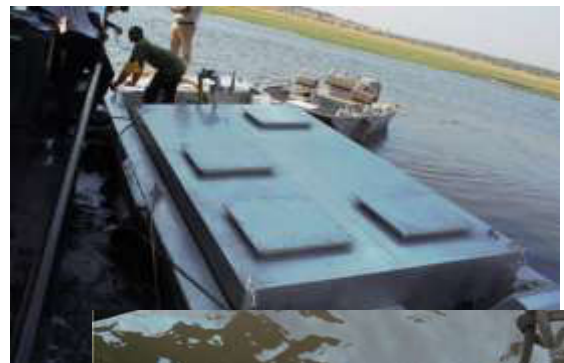
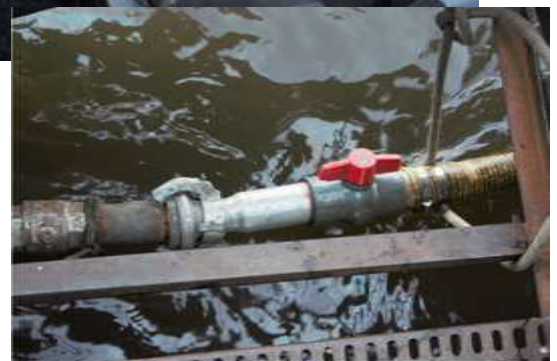
Figure 6 Pumping out of effluent from the houseboat

- This stirred effluent flows into a third (head tank) tank with 4 compartments. Three of the compartment are utilized for thorough biological breakdown of the constituents of the sewage by microorganisms. The final compartment of the tank is used to store the effluent prior its collection from the boat.
- Final step aboard the houseboat is the removal of the effluent from the boat. The effluent is pumped into a tanker designed small boat (honey sucker tanker). This tanker has capacity of 5000 liters and frequents the houseboats three times a day to collect this effluent. Figure 6 shows the honey sucker tanker and with connection of couplings to pump out the effluent to the tanker

Transfer of pre-treated effluent to a tanker (honey sucker) and transfer to land-based treatment system	Pre-treated Blackwater	<ul style="list-style-type: none"> ○ Pumping system involves coupling of that locks to prevent leaks during pumping into the honey sucker tanker 	<ul style="list-style-type: none"> ○ At completion of pumping and disconnection, some residual effluent left in the pipes drains into the water. 	<ul style="list-style-type: none"> ○ Design and implement a bucket system to collect the residual effluent in the pumping pipes and add it to pumped effluent for onshore treatment ○ No leaks /Spills into river 	Low	Captain
Transfer of fuels onto the boat and their storage	Hazardous waste	<ul style="list-style-type: none"> ○ Fueling point involves nozzle insertion into the tank to avoid any spills ○ All portable fuels stored in a secure storage 	<ul style="list-style-type: none"> ○ Although fueling nozzles involves insertion into the tank, overflow of the tank and possible spills could still occur and need to be managed ○ Refueling of small boats may result in spills. 	<ul style="list-style-type: none"> ○ Use of a funnel to fill the fuel tanks of the boat with drip or spillage tray under ○ Filling up of the tanks should be conducted with full alertness and under supervision. ○ Develop standard operating procedure (SOP) for fuel handling. ○ All small boats fuel tanks to be fueled with placement of drip trays underneath or on areas if the boat where any spillages may not leak or spill into the river e.g. the engine room 	Low	Captain

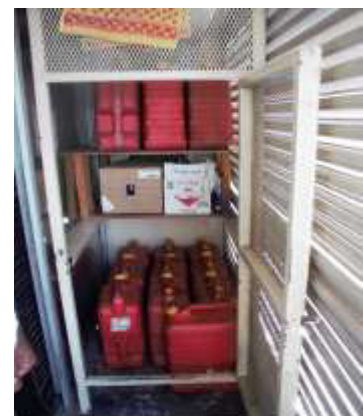
Figure 7 Storerooms for fuels

At the back of the boat is a secure storage compartment of fuels and other chemicals. All stored chemicals and fuels are well identifiable.

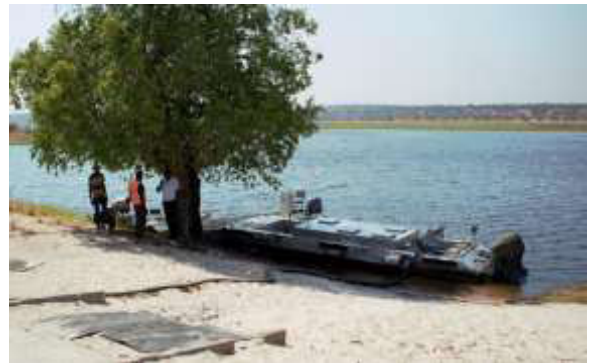
Figure 8 Effluent transfer to a land based treatment system

The tanker transfers the resultant pre-treated effluent to a land based treatment system at Ncheku Warehouse offshore of the Kasika area.

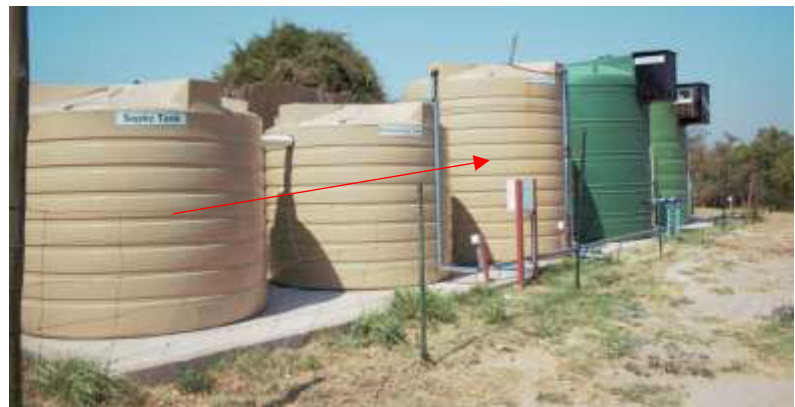
Figure 9 Effluent treatment system at Ncheku-Kasika

- Pre-treated effluent delivered to the land-based treatment system is collected into a **first septic tank**. The septic tank consists mostly of liquid, and is level controlled and outflows into the second tank called the **conservancy tank**. The conservancy tank is utilized mainly for temporal storage of the sewerage. This tank is also level controlled and outflows outflow into the third tank called the **balancing tank**. The purpose of the balancing tank is ensure control of the outflow into the **bio-tower tank** also called the trickling filters.

- In the bio-tower tank, pre-treated wastewater is spread over the surface of a media, and as it trickles downward through the bed of filters, microbes feeds on the nutrients in the water forming a slime of microbes on the filters. As water continues to trickle down the filters, air

circulates upward through the media, as treated water is removed by an underdrain system. The biological slime of microbes formed on the media as water drains may need removal. However, bio-towers are advantageously known for generating very little sludge.

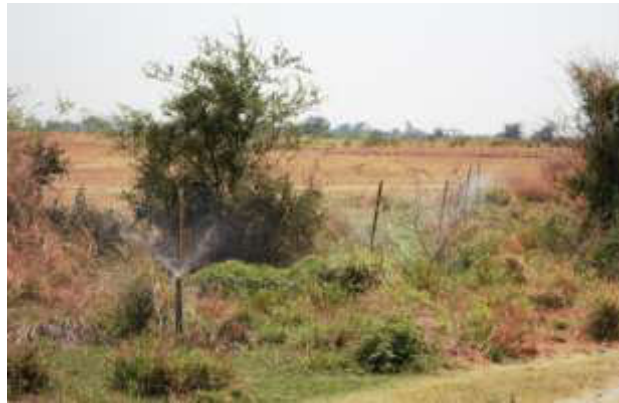
Figure 10 Final treated effluent sprinkled on nearby vegetation

- The fifth tank of the system is the disinfection tank, where the treated effluent from the bio-towers is disinfected by ozonation as final step. The final tank is referred as irrigation tank as it temporally stores treated effluent. Fitted with a level trigger, releases the final effluent through a sprinkler system as it fills up.

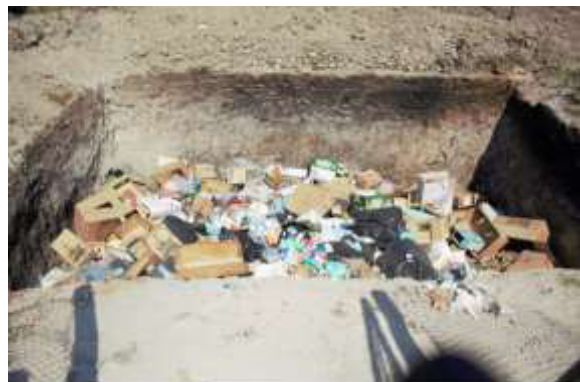
Figure 11 Solid waste disposal onshore

On land although organic waste and combustible waste is separated from the Zambezi Queen houseboat, the two are together disposed into a landfill (Fig 11). The landfill is well fenced although the gate appears uncontrolled. Incineration appears not regularly scheduled and implemented. The landfill was constructed on land given by community of Kasika.

Secondly, lack of a designated landfill site on the island and Kasika seems to be a major cause of inconsistent handling of waste both for lodge operations and local community. As per suggestions of the community at the consultation meeting to endeavor in seeking a portion of land from the people of the island to designate as landfill site, the lodge to support these efforts as it may potentially be beneficial and minimize environmental costs for own handling of waste.

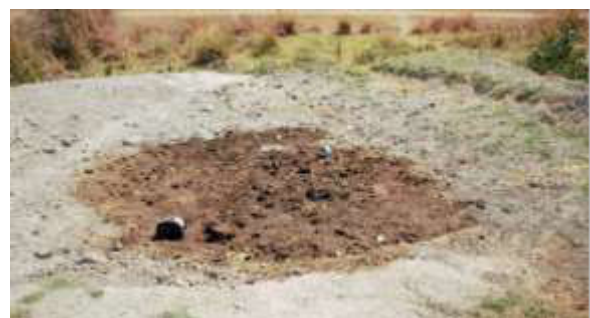
Figure 12 Waste oil disposal onshore

Waste oil from the maintenance works on the boat is transferred onshore for disposal in a shallow landfill beside the fenced solid waste landfill site.

Maintenance aboard the boat	Hazardous waste mainly waste oil	<ul style="list-style-type: none"> ○ Spillages are handled with engine cleaner and resultant liquid waste pumped for disposal onshore 	<ul style="list-style-type: none"> ○ Improvement needed on handling of the oil or chemical contaminated water on land 	<ul style="list-style-type: none"> ○ Contaminated oil water potentially used as ignitor for combustible waste incineration 	Low	Maintenance Manager

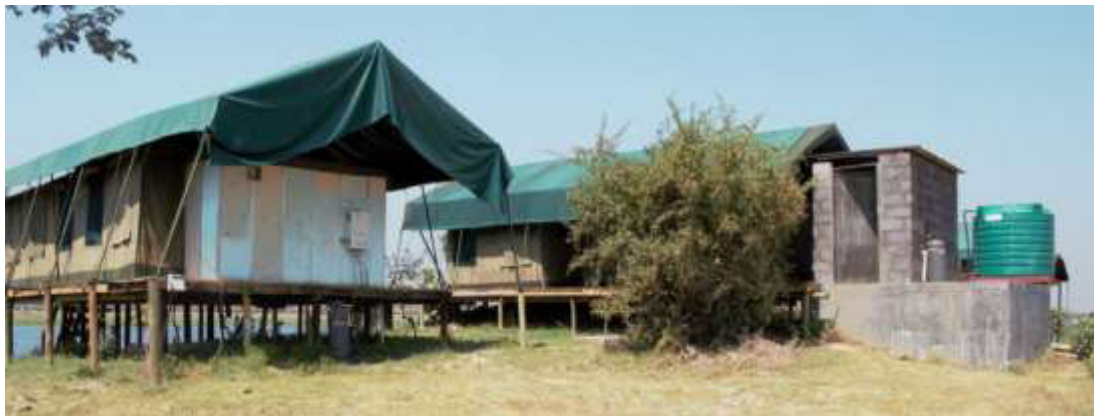
Figure 13 Staff accommodation with own utility facilities

Much of the houseboat employees of Zambezi Queen are day workers, shuttled onto the board every morning and leaving for onshore accommodation by end of the day. The accommodation comprises three blocks of tents on decks each with septic tank to receive water from lavatories, sinks and showers. Another block is utilized as kitchen for the staff, while water supply to the accommodation and laundry room located 50m away is from two tanks (Fig 13). All solid waste from accommodation and laundry are disposed at the existing landfill.

accommodation for on-shift staff only	<ul style="list-style-type: none"> ○ No response plan if any septic tanks may overflow ○ Lack of timely maintenance of pipes and other aging infrastructure 	<ul style="list-style-type: none"> ○ Develop a response plan for overflowing septic tank ○ reporting of incidents of infrastructure dilapidation, urgent repair and closeout of incidents 		
Power generation onshore operations and during night time for Zambezi Queen	Hazardous waste	<ul style="list-style-type: none"> ○ Generator stationed on concrete area to contain spills and leakages 	<ul style="list-style-type: none"> ○ Generator area not kept well tidy ○ Observable spillages beside the beyond the bounded area ○ Bund/concrete in some areas appears breaking not maintained ○ Empty cans left around the area ○ Generator exhaust pointed on the ground 	<ul style="list-style-type: none"> ○ A spill procedure involving the scooping of all the contaminated soils and disposed at incineration area to apply to this area with urgency ○ Repair the concrete bounding the generator area avoid spillage to the ground ○ No empty cans or other materials used in the generator area to be placed on the ground except where with a plastic lining under it ○ The exhaust pipe of the generator need be pointed away from the soils into the air to avoid accumulation of fumes on specific spot on the ground 	Low	Maintenance Manager

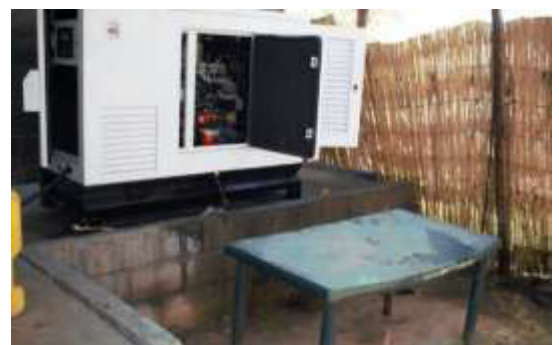
Figure 14 Diesel generators for power supply for onshore operations and overnight to Zambezi Queen houseboat

The land based operations of laundry, staff accommodation, and effluent treatment system rely on power generated from two diesel generators located beside the Laundry. Also served from these generators is the Zambezi Queen houseboat during night time through a cable extending over the water to the boat.
