# Scoping Report and EMP for Chobe Princess 3 Houseboat

October 2018

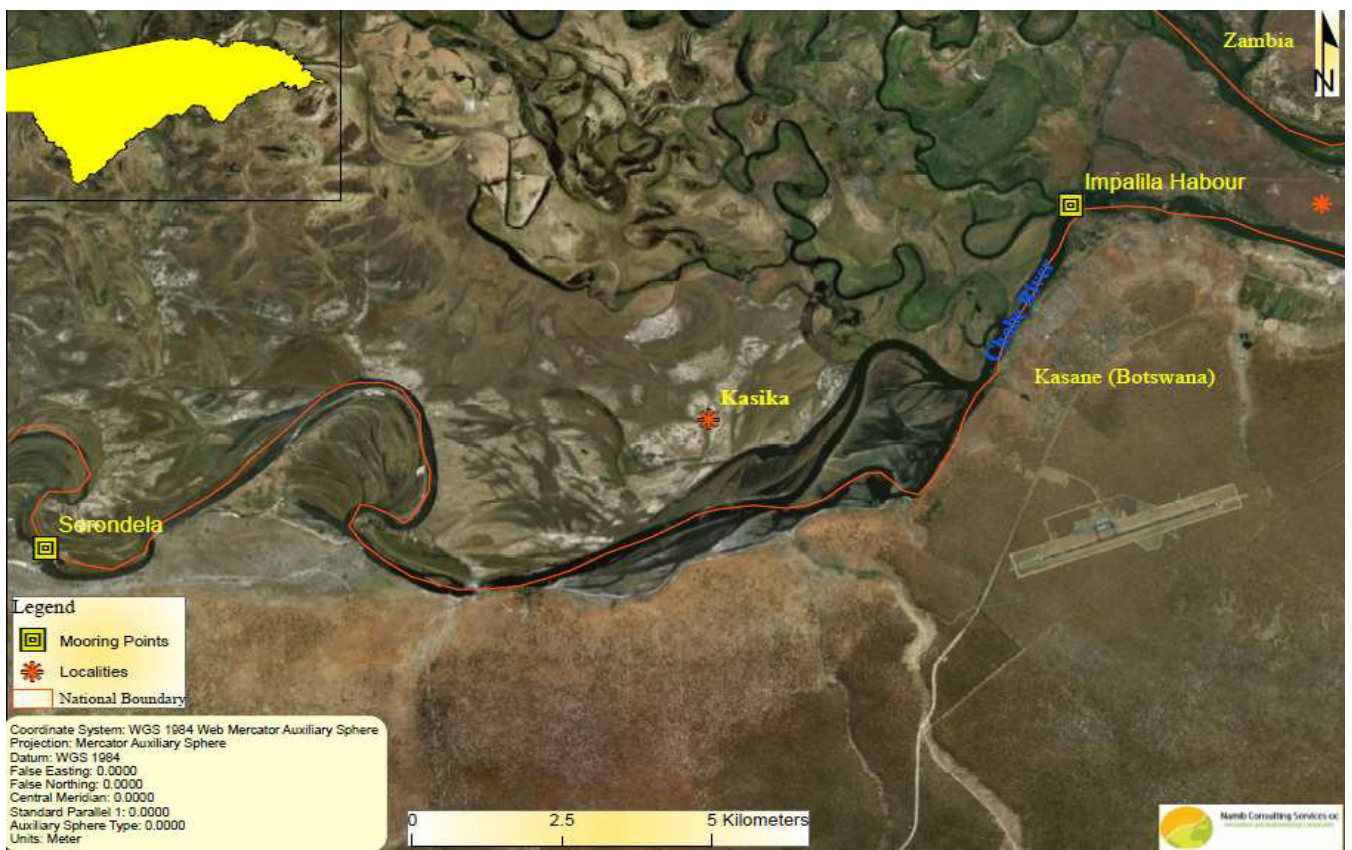
Figure 1 Mooring points of Chobe Princess 3

Chobe Princess 3 is the one of the smallest capacity of the houseboats under Zambezi Houseboats. Having begun its operations in 2004, offering tourists accommodation and leisure activities on its cruise in the Chobe River. The houseboat embarks on a three day cruise of the Chobe River to its furthest point of mooring at Serondela. Two nights are spent at Serondela before embarking on a return trip to Impalila mooring harbour for re-stocking where another night is spent. The map below provides a view of the mooring points of Chobe Princess 3 houseboat.

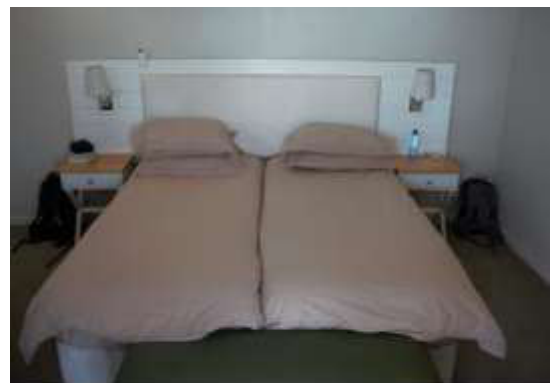
The top deck of the boat are dining area, bar and an open deck with swimming pool and a room. On the middle deck is the kitchen and ground deck mainly rooms. A typical room will comprise a double bed, toilet with sink and shower.

*Figure 2 Accommodation on Chobe Princess 3 Houseboat*

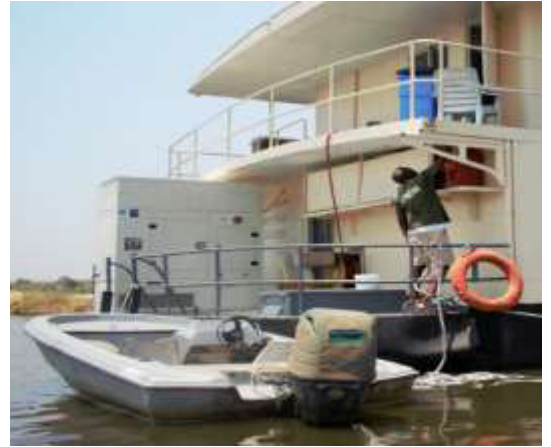
Power requirements for the boat is supplied from a diesel generator aboard. The boat comprises a 500 liters tank that stores diesel fuel that can serve for 7 days both for its cruises and generators. A fuel bowser designed tanker collects fuels from Kasane and refills the boat.

*Figure 3 Location of generator at back of the houseboat*

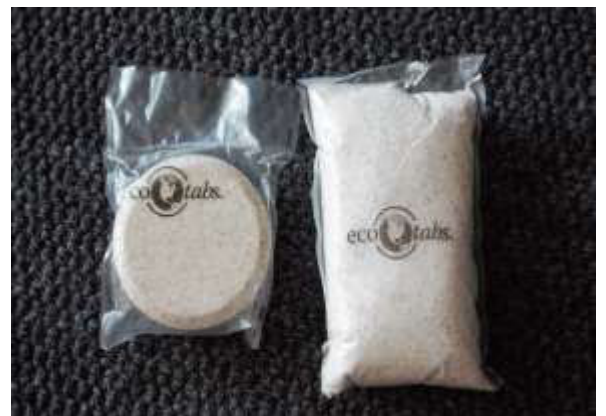
- A first holding tank receives all the wastewater from sinks, showers and toilets on the upper deck of the boat. Eco-tablets are applied to this tank for microbial degradation of the sewage (Fig 4). The rise in level of sewer water in the tanks triggers effluent outflow into the second tank.

*Figure 4 Eco-tabs applied to sewer tanks aboard*

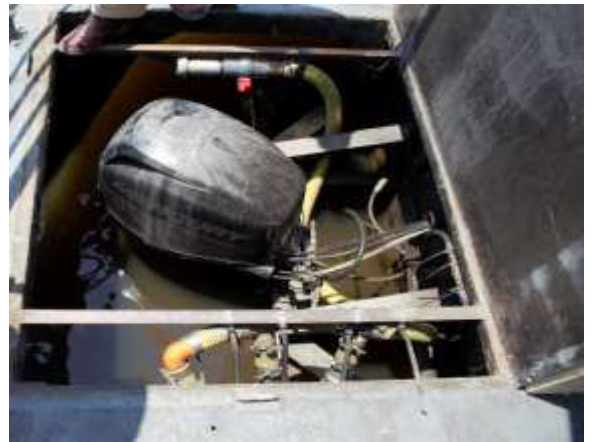
- The second tank is the holding tank receiving effluent from the first tank. The tank comprises a macerator pump that reduces solids to small pieces in order to deal with rags and other solid waste before it is pumped to sewerage boat (honey sucker tanker).

- Final step in handling effluent on the boat is pumping out by a honey sucker (tanker) for further onshore treatment and disposal at Ncheku-Kasika. This tanker has capacity of 5000 liters and collects from the houseboat once in a day to collect this effluent.

*Figure 5 Piping for pumping effluent off the houseboat's tanks*

degradation of the organic matter	further handling at Ichingo Lodge <ul style="list-style-type: none"> <li>○ Regular inspection of application of separation of waste</li> </ul>		
	Greywater	Water	Aquatic life, humans and wildlife	<ul style="list-style-type: none"> <li>○ Access fats and oils may interfere with air-water interface processes reducing oxygen diffusion process</li> </ul>	<ul style="list-style-type: none"> <li>○ Greywater is discharged directly into the river</li> <li>○ Sink drain strainer to remove solids in draining water</li> </ul>	Medium	<ul style="list-style-type: none"> <li>○ No fat traps aboard the boat</li> </ul>
<b>Transfer of pre-treated effluent to a tanker (honey sucker) and transfer to land-based treatment system</b>	Pre-treated Blackwater	Water or land	Aquatic life, humans and wildlife	<ul style="list-style-type: none"> <li>○ Degrade the quality of water in the area spreading outwards affecting aquatic life and make water unusable</li> <li>○ Environmental health hazard to humans and wildlife</li> </ul>	<ul style="list-style-type: none"> <li>○ The Pumping system involves couplings that locks together to avoid any leaks during the process</li> </ul>	Medium	<ul style="list-style-type: none"> <li>○ At completion of pumping and disconnection, some residual effluent left in the pipes drains into the river.</li> </ul>

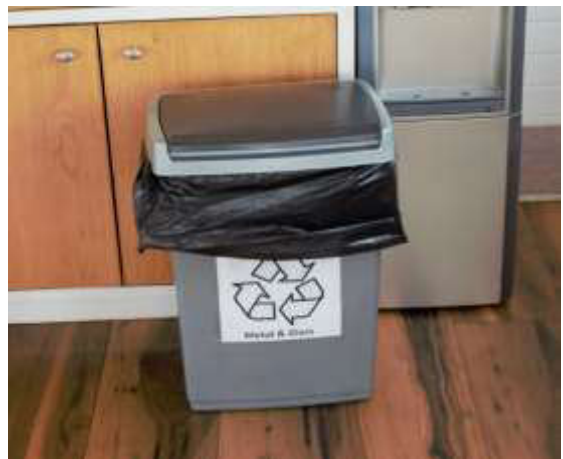
- Food waste is separated from other solid waste onboard and transferred to Ichingo Lodge
- Combustible waste is also separated from other waste for further handling at Ichingo lodge
- The recyclables and other plastics, packaging and bottles are collected by food supplier Sea-Pride Foods for further handling and some disposed at Katima Mulilo town landfill site.

*Figure 6 Garbage bins for waste separation*

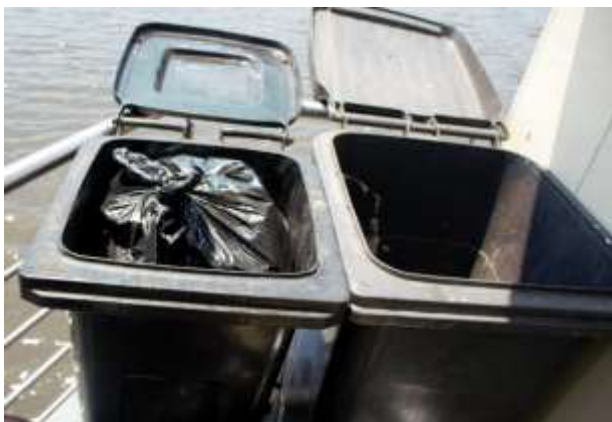
*Figure 7 Solid waste awaiting transfer from the boat to Ichingo Lodge*

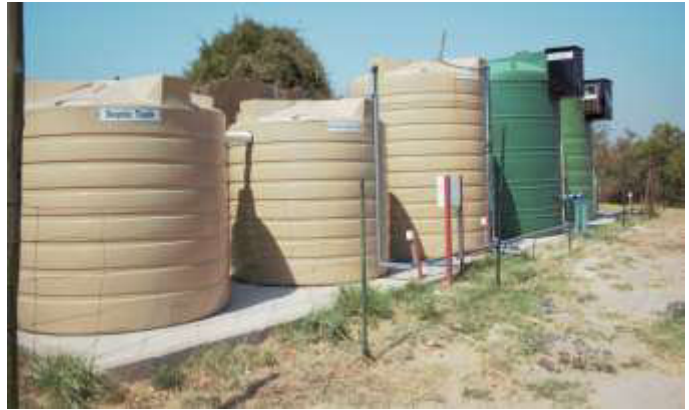
- Pre-treated effluent delivered to the land-based treatment system is collected into a first tank septic tank. The septic tank consists is mostly liquid which is level controlled and outflows into the second tank called the conservancy tank. The conservancy tank is utilized mainly for temporal storage of the sewerage whilst also level controlled and outflows outflow are into the third tank called the balancing tank. The purpose of the

balancing tank is ensure control of the outflow into the bio-tower tanks also called the trickling filters.

*Figure 8 Effluent treatment system at Ncheku-Kasika*

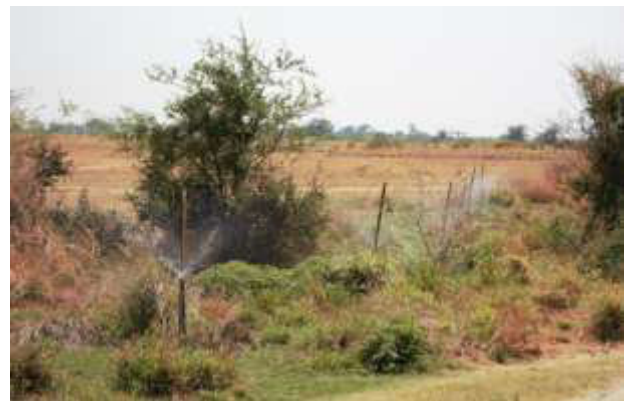
- In the bio-tower tank, pretreated wastewater is spread over the surface of a media, and as it trickles downward through the bed of filters the microbes feeds on the nutrients in water to forming a slime of microbes on the filters. As water continues to trickle down the filters, air circulates upward through the media as treated water is removed by an underdrain system. The biological slime of microbes on formed on the media as water drains may need removal. However, bio-towers are advantageously know for generating very little sludge.
- The fifth tank of the system is the disinfection tank, where treated effluent from the bio-towers is disinfected by ozonation as final effluent. The final tank is refereed as irrigation tank as it temporal stores treated effluent using a level trigger to release final effluent through a sprinkler system just beside the treatment plant.

*Figure 9 Final effluent release through sprinklers*
