ZEST INVESTMENTS CC

An Update Environmental Management Plan for the
Renewal of an Environmental Clearance Certificate for
the Operation of Ongoba Quarry, Omakange

Omusati Region

Application No. APP-001877

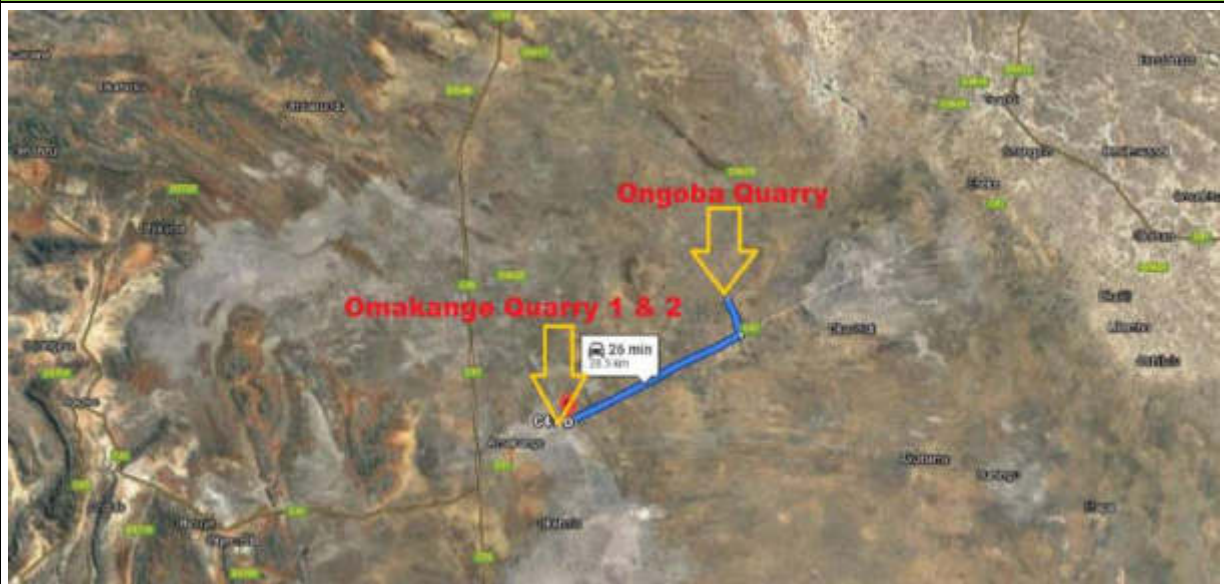
Figure 2: Distance Between the Satellite Quarry and Main Quarry

The third location where ZI conducted quarrying activities is about 30 km, northwest of Omakange Quarry 1 & 2 and accessed as indicated in **Figure 2**. This satellite operation was established by ZI for the exclusive production of G3 base course materials only. The dolomitic rock quarried at the main operation had too much free lime fines which made the production of G3 a cumbersome process hence more costly.

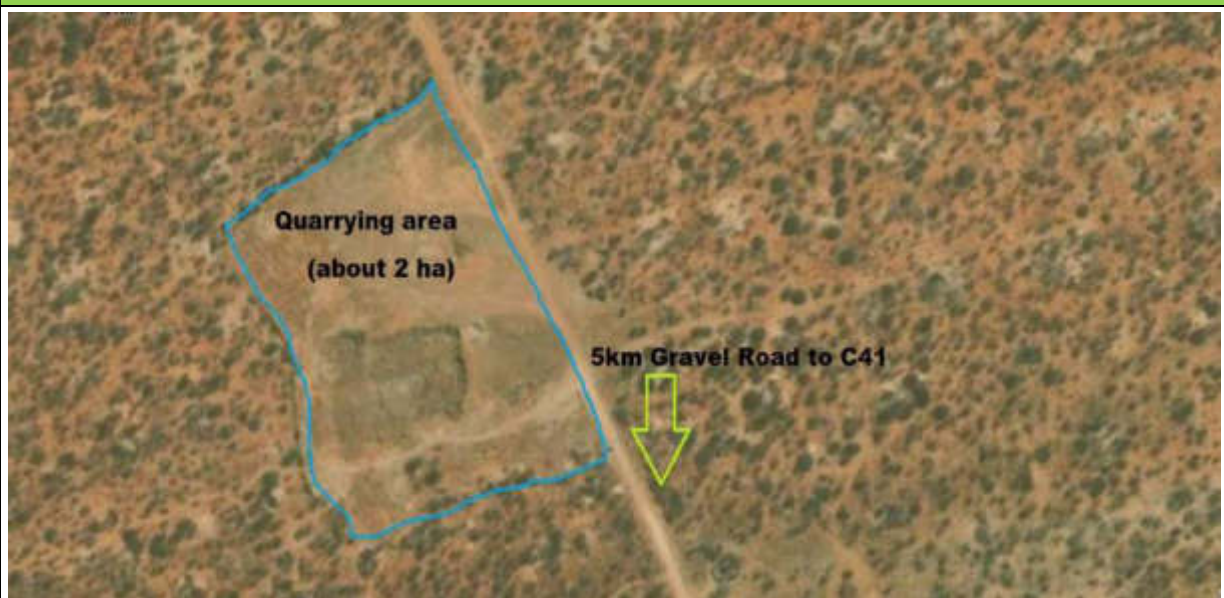
Figure 3: Quarry Layout and Access Road

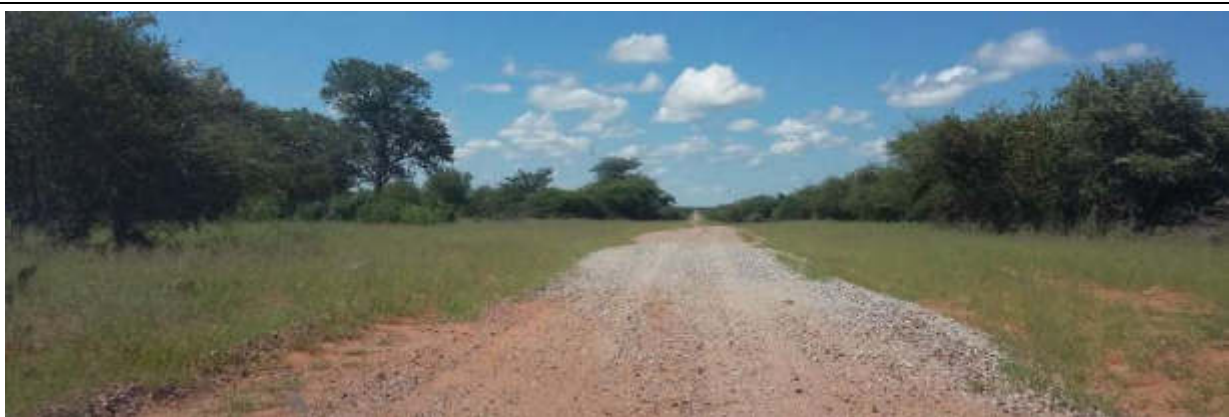
Figure 4: Access Road to the Satellite Quarry (5km from C41 – Road is also used by communal farmers in the area)

From the main quarry, the satellite quarry at Ongoba is approximately 30 km and reached by driving 25 km on C41 in the direction of litananga/Okahao, followed by driving another 5 km on the gravel road (**Figure 4**).

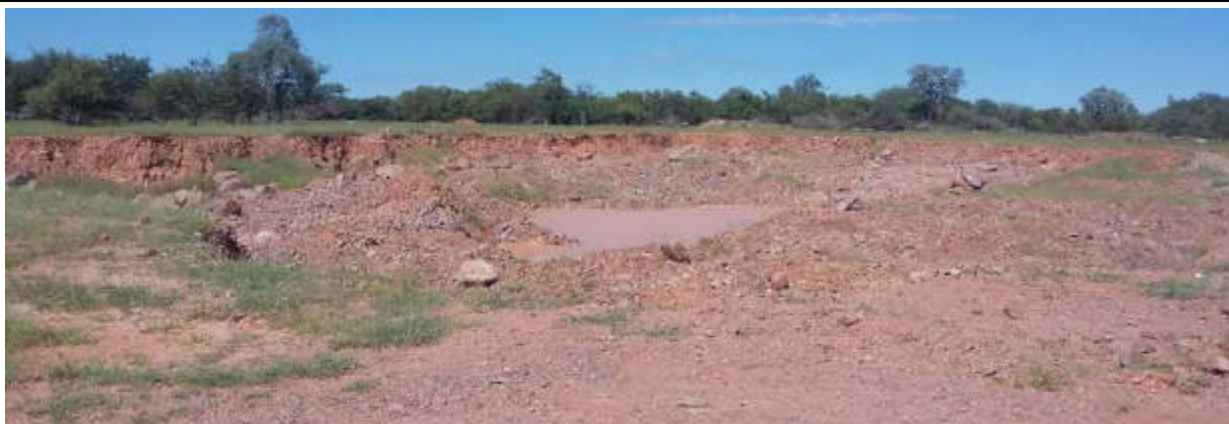
Figure 5: Shallow Excavated Trenches – photo taken March 2017. Note pooling of rainfall water in the trench

The quarry is confined to an area of about 2 ha (20 000 m²). This whole area has been cleared of vegetation (**Figure 5**). Within this cleared land, quarrying activities, i.e. the land area where excavations have been made is about 2 000 m². Here shallow trenches have been excavated exposing the dolerite rock which is quite shallow.

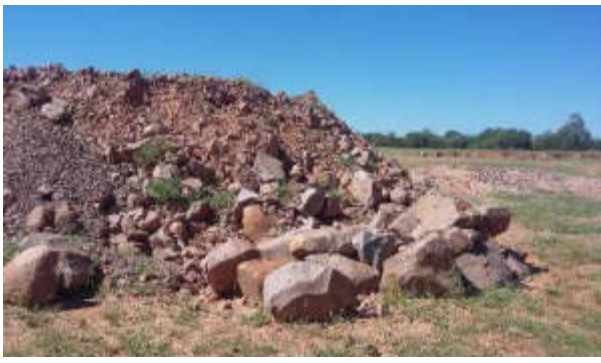
Figure 6: Waste rock Stockpile (March 2017)

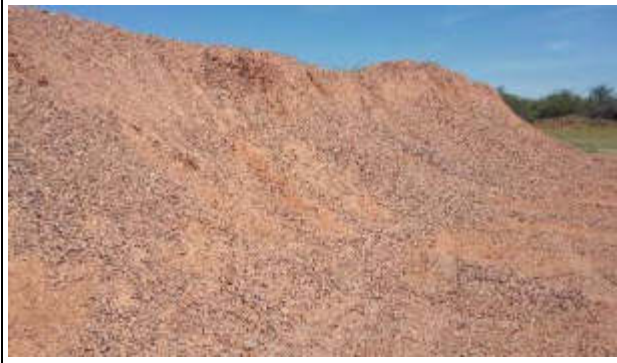
Figure 7: Typical G3 Base Course Materials (Mar 2017)

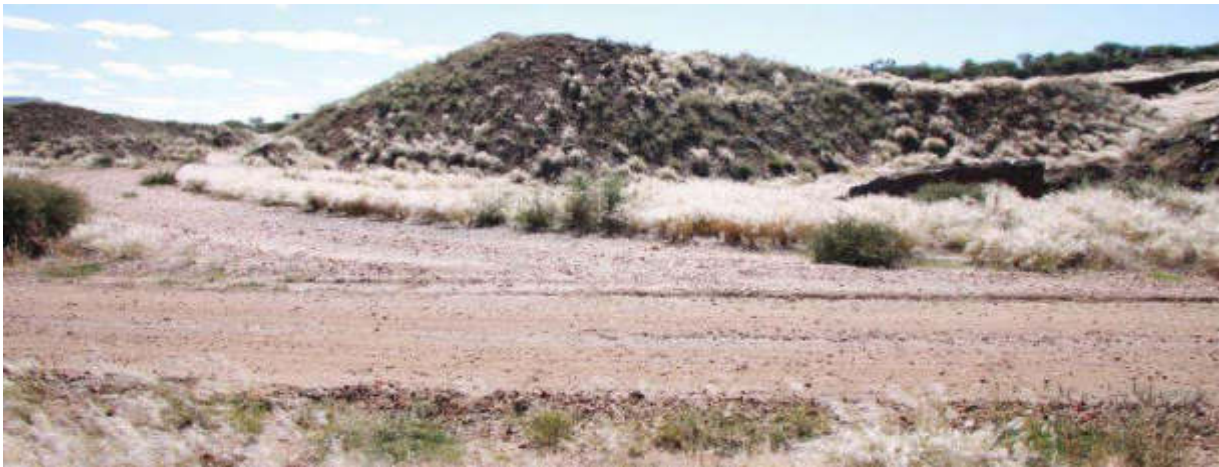
- The current conditions of the quarry as of July 2021 is as depicted in photographs taken on 18 July 2021 (**Figures: 8-10**). Natural grass cover and vegetation have re-established fairly well after more than three years of non-activities. Stockpiles of G3 base course materials and another one of waste rock observed in March 2017 (**Figures: 6 & 7**) were still intact. Again, natural grass cover and vegetation have re-established well after several years of inactivity (**Figure : 8**). The excavated shallow pit was also covered with grass (**Figure: 5 and Figure : 9**).

Figure 8: G3 Stockpile (Jul 2021). Note natural grass and vegetation re-growth

- Judging from the current quarry conditions, it evident that pre-quarry conditions can be attained with a well-executed rehabilitation plan. This plan should involve backfilling of the trenches and profiling of stockpiles, thereby allowing natural vegetation to grow.

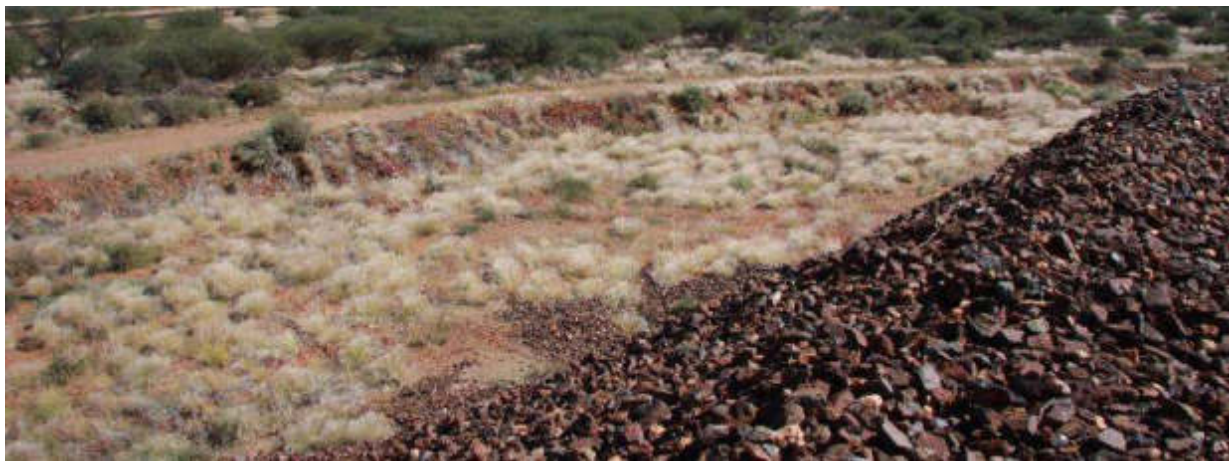
Figure 9: An earth berm below the excavated area and stockpiles made to contain the rainfall runoff on the site

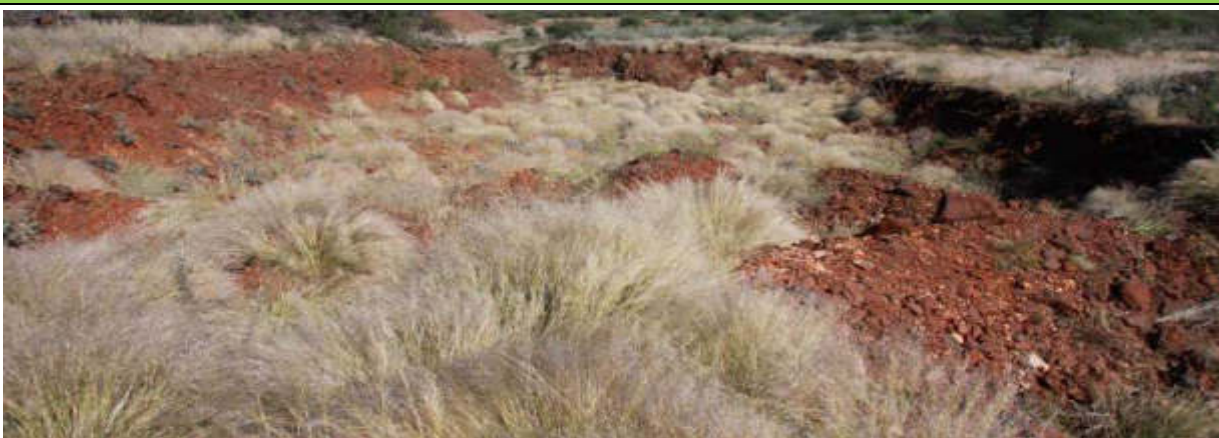
Figure 10: The shallow excavated area showing cut off edges that are susceptible to erosion – July 2021. Note how natural vegetation has re-established itself spontaneously
