# ENVIRONMENTAL MANAGEMENT PLAN

## SAND MINING FROM AN EXISTING BORROW PIT FOR CONSTRUCTION MATERIALS, LÜDERITZ TOWN COUNCIL

**LÜDERITZ TOWN COUNCIL**

September 2016

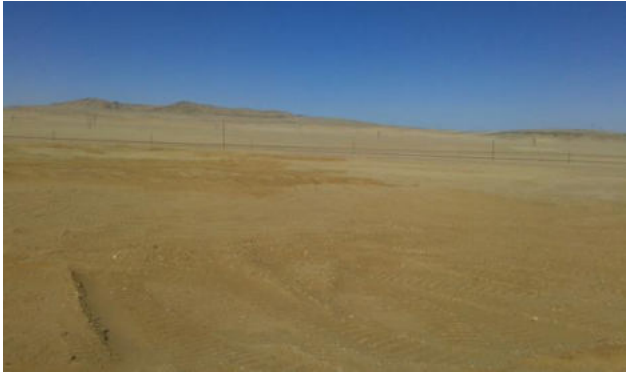
<p>The general setting of the existing borrow pit site (<i>no vegetation</i>)</p>

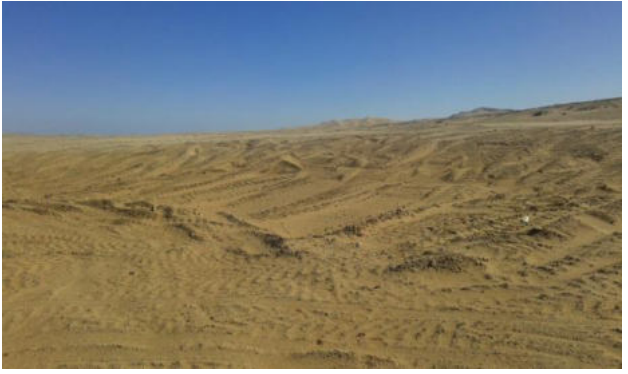
<p>Vehicle tracks as a sign of previous activities</p>

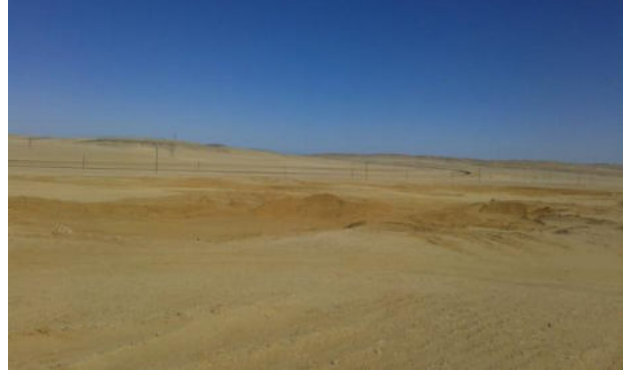
<p>The existing borrow pit, note the shallowness of the excavations to facilitate rehabilitation</p>

The approach and recommendation of sand mining is to maintain a maximum depth of less than 2 meters across the borrow pit, as opposed to deeper excavations (beyond 2 meters). Keeping the borrow pit shallower is a measure to ensure that the site is able to reshape itself as a result of sand movement by the wind over time. In other words, to shallowness can aid natural rehabilitation, relatively.

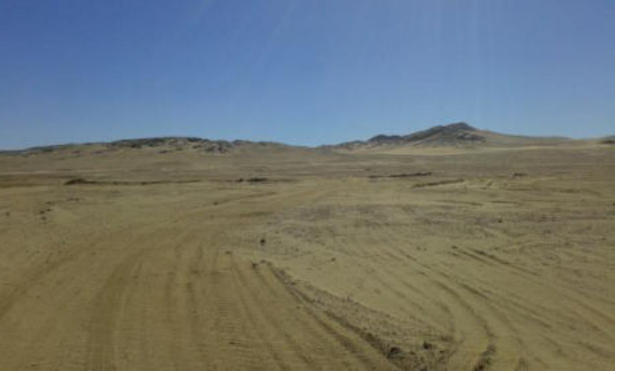
<p>Road track to the existing borrow pit</p>

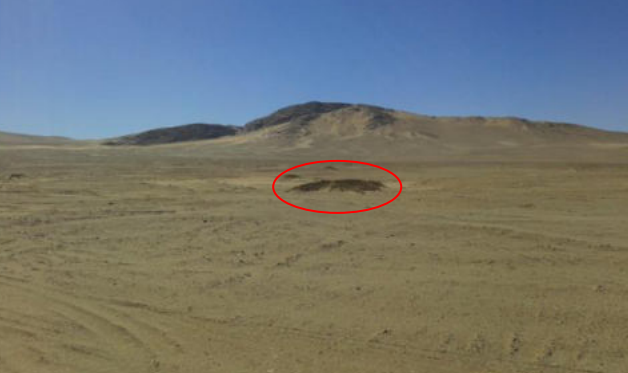
<p>Stockpiles from previous excavations (red circle).</p>

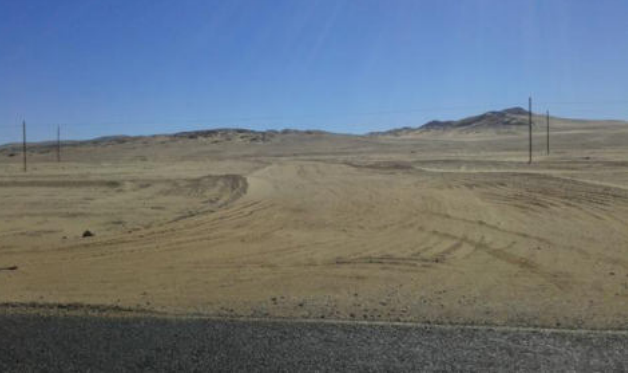
<p>Entry to the borrow pit requiring signage to warn motorists on the B4 Road about the presence of earthmoving vehicles.</p>

Aspect	Management Objective	Management Action	Action Frequency	Indicator / Source	Data	Party responsible for implementation
		The road leading to the borrow site must be marked with a "NO ENTRY for public vehicles" sign.				
<b>Vehicle Emissions</b>	Reduce unnecessary greenhouse gas (GHG) emissions from poorly maintained or malfunctioning equipment	All vehicles and equipment shall be kept in good working order and serviced as required. Ensure that vehicles do not leak oil etc	Project term	Physical verification and routine monitoring, record of non-compliance		LTC_TE
<b>Visual quality</b>	Namib Naukluft National Park is frequented for its scenery.	Demarcate the borrow site working area and contain all activities within the demarcated working area.	Project term	Physical verification and routine monitoring		LTC_TE
		Appropriate signage and information posters to be prominently displayed and maintained to warn motorists about the presence of earthmoving vehicles.

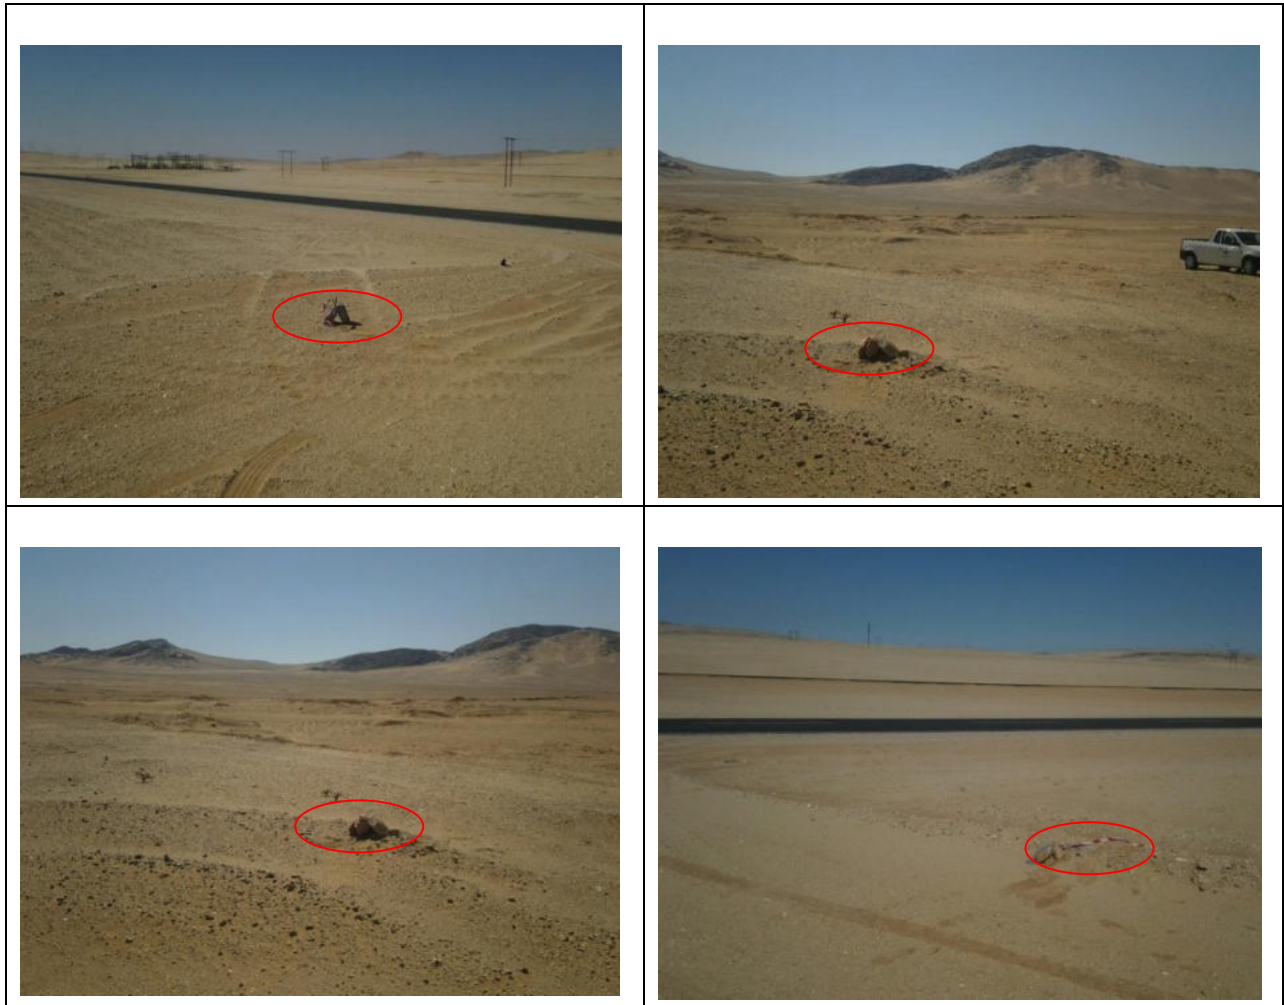
**Table 2-3: Shows the pegs (circled in red) demarcating the borrow pit boundaries**

The pegs comprise of a Pin (steel rod) embended into the ground and a pile of rocks for visibility (because the pin can easily be buried by the sand).
