Mushara LODGE

ENVIRONMENTAL MANAGEMENT PLAN

Application for Environmental Clearance

Application for Environmental Clearance: Mushara Lodge

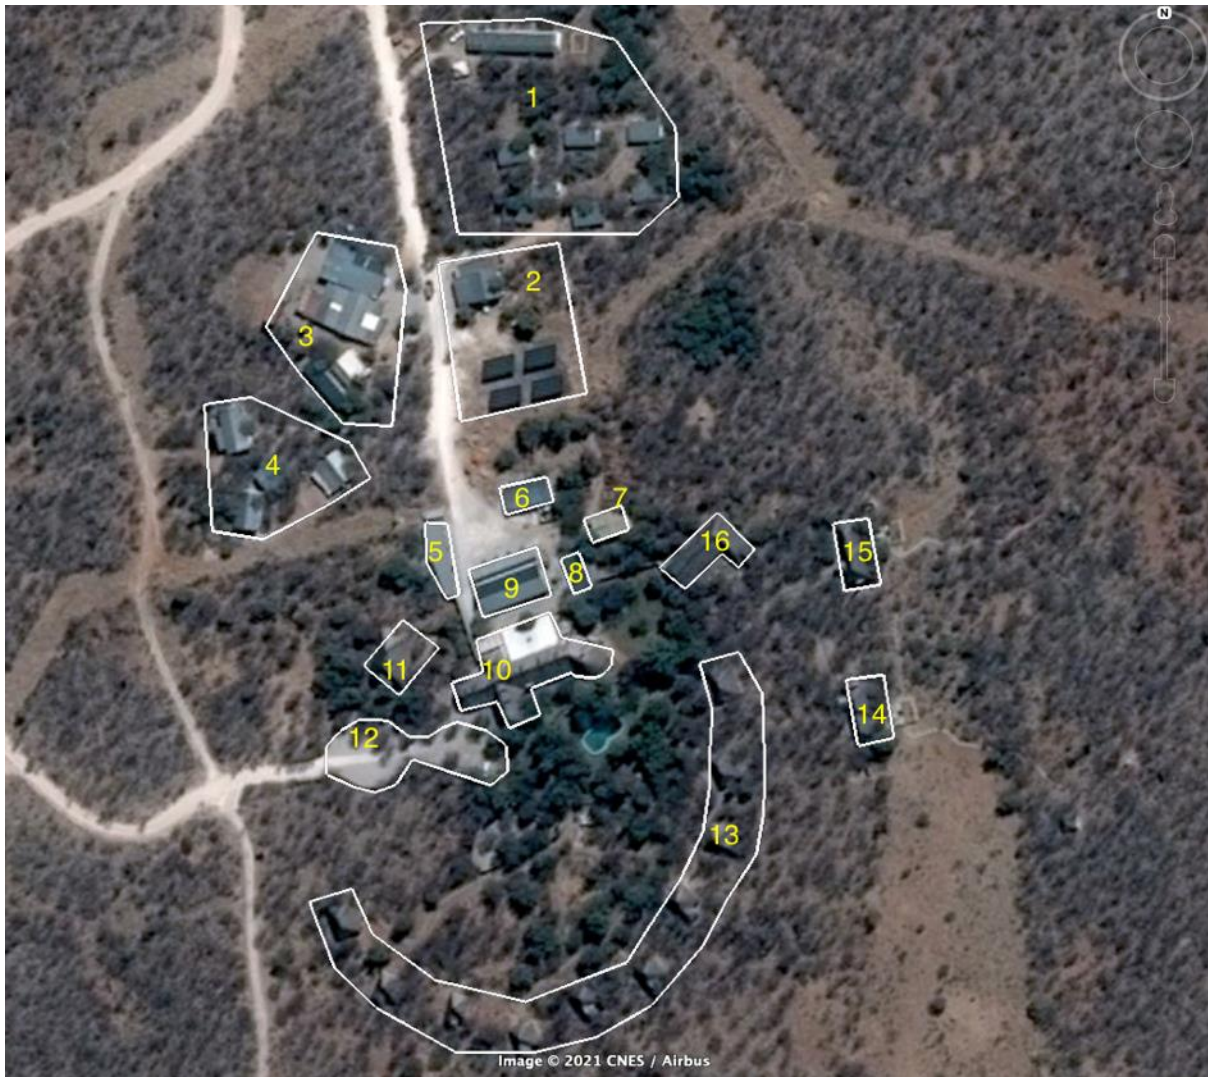
Figure 2. Layout of Mushara Lodge.

Total footprint of the lodge and its support structures is approximately 5 ha. The layout of infrastructure is given on a Google Earth map in Figure 2.

- 1 Staff village
- 2 Workshop and 4 solar panels
- 3 Game drive complex (rented out)
- 4 Management accommodation
- 5 Parking x8
- 6 Parking x6
- 7 Water tanks
- 8 Laundry and canteen
- 9 Storage shed
- 10 Main building
- 11 Family house (2 bedrooms)
- 12 Guest parking
- 13 Guest rooms (ten separate, free-standing units)
- 14, 15 Villa 1 and 2
- 16 Guest room complex (six rooms under one roof)

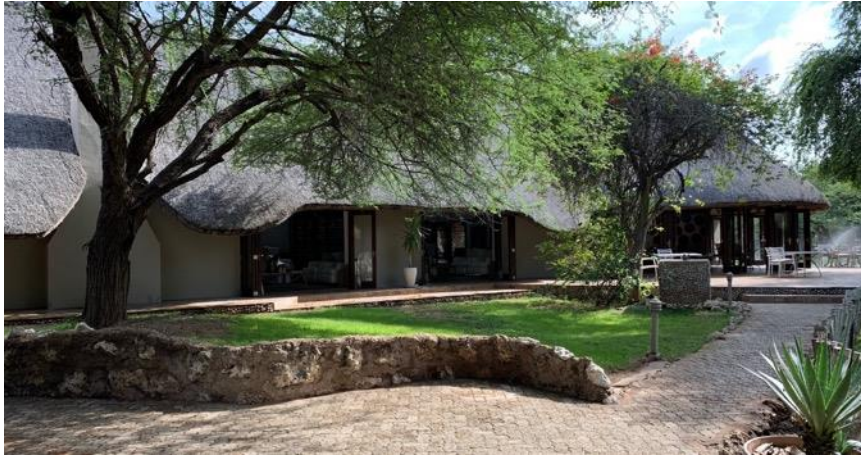
The 950 m² main area (#10 in Figure 2) is a thatched, plastered brick structure with a concrete floor and contains all the guest common areas as well as the kitchen and its storerooms (Figure 3).

Figure 3. The thatched main area.

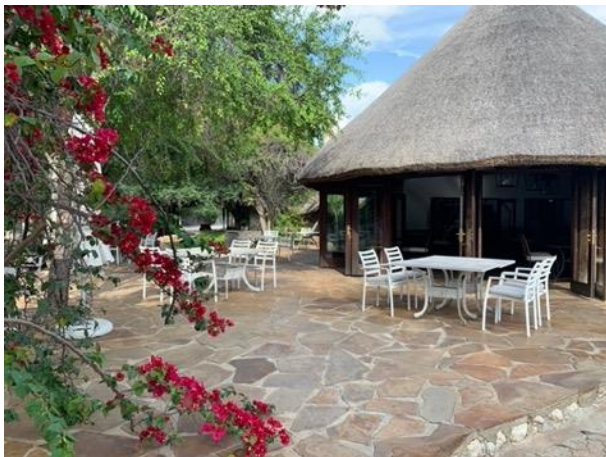
Figure 4. Paved terrace.

The guest areas comprise a lounge, bar, library, curio shop, dining area, two restrooms and two sets of offices (Figure 5 and Figure 6). There is also an open-air dining terrace with a slasto paved floor (Figure 4), and a swimming pool surrounded by lawn (Figure 7).

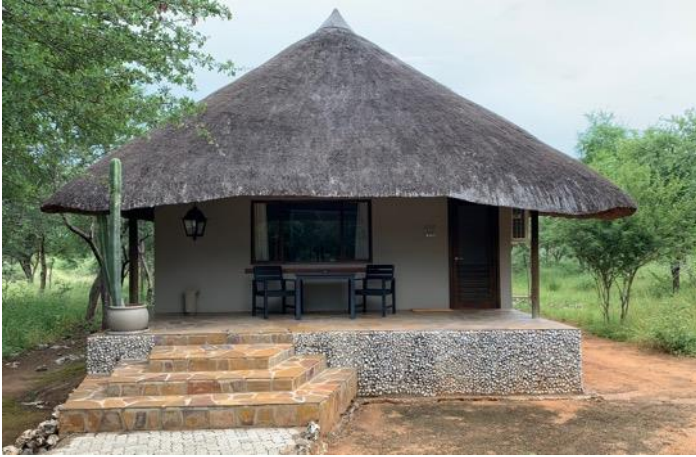
Figure 8. A free-standing guest room.

- Ten free-standing rooms with thatched roofs, each consisting of a double bedroom, bathroom and veranda (Figure 8 and #13 in Figure 2).
- One self-contained family house of 228 m² with two en suite bedrooms, a dining room, kitchen and lounge (Figure 9 and #11 in Figure 2).
- Two luxurious villas of 148 m² each. Each villa consists of a lounge/dining area, bedroom, bathroom, patio, outside shower and plunge pool (Figure 10 and #11 in Figure 2).
- A 222 m² guest room complex with one triple and two single rooms, plus three single rooms for paying guides. All these rooms are en suite (Figure 11 and #16 in Figure 2).

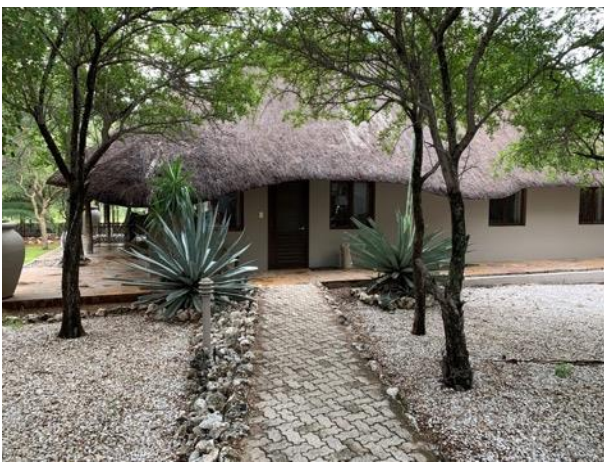
Figure 9. The two-bedroom family house.

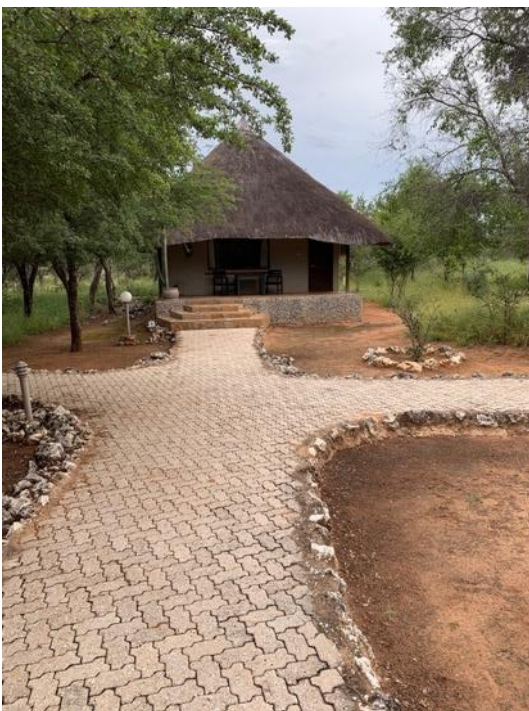
Figure 12. Paved pathways to carry foot traffic.

Pathways are paved with interlock bricks and clearly demarcated. All foot traffic at the lodge, both staff and guests, is confined to these raised pathways (Figure 12).

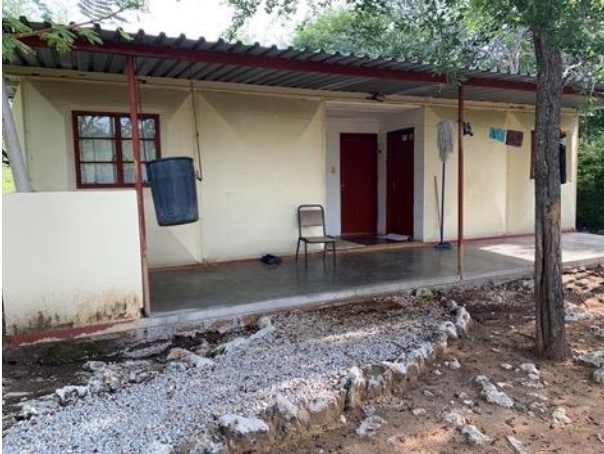
Figure 13. A staff village block with two bedrooms, a bathroom and veranda.

The staff village is approximately 100 m from the lodge and accommodates 35 staff members in separate blocks (#1 in Figure 2). Each block consists of a veranda, laundry basin, two bedrooms and a bathroom with shower, toilet and basin (Figure 13).

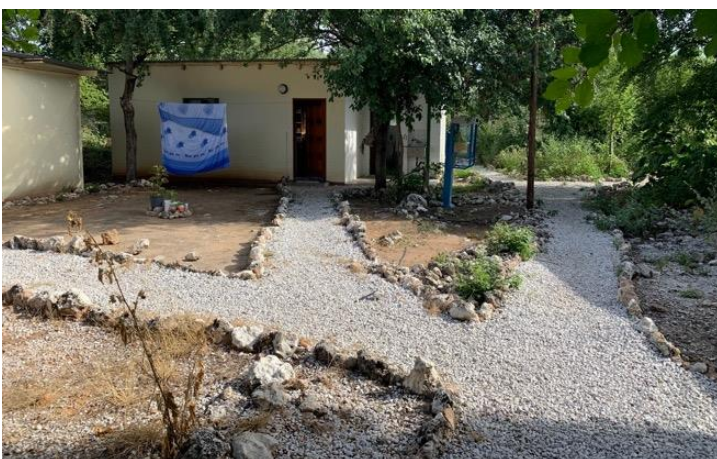
Figure 15. Gravel pathways in the staff village.

Pathways to and inside the staff village are clearly demarcated, bordered by stones and covered in gravel (Figure 15).

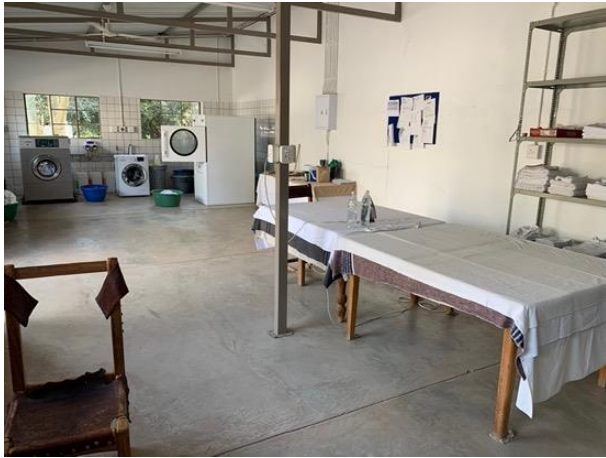
Figure 16. Laundry.

Next to the kitchen is a 180 m² plastered brick building with concrete floor housing the laundry (Figure 16) and staff canteen (Figure 17 and #8 in Figure 2).

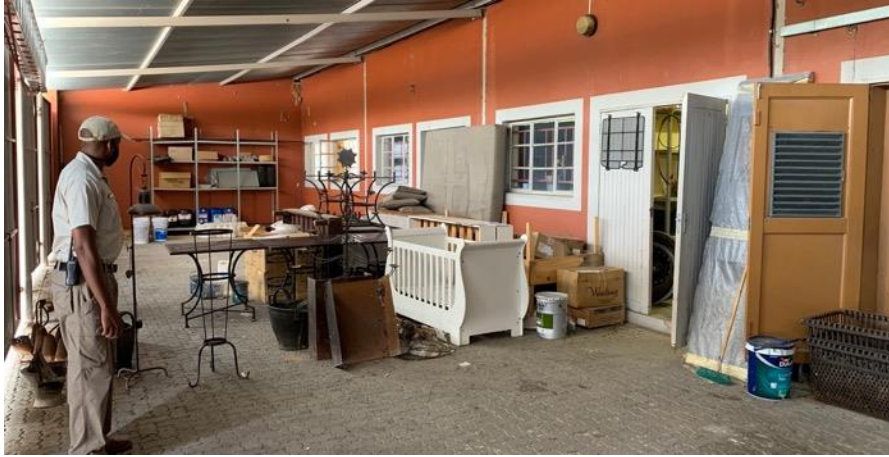
Figure 18. Paved floor in the storage shed.

A 326 m² building of plastered brick with a concrete floor and IBR roof (#9 in Figure 2). The shed is divided into separate storage areas:

- Housekeeping (Figure 21)
- Pool cleaning materials
- Fuel. 2 x 5,000 litre tanks mounted on steel frames on a sealed concrete floor. Mushara Bushcamp and Outpost also bring their vehicles here to be refuelled (Figure 19).
- Basic maintenance equipment (Figure 20)
- Workshop for general lodge maintenance
- Generator (discussed in Section 2.4.4)
- 5 parking bays (Figure 18)

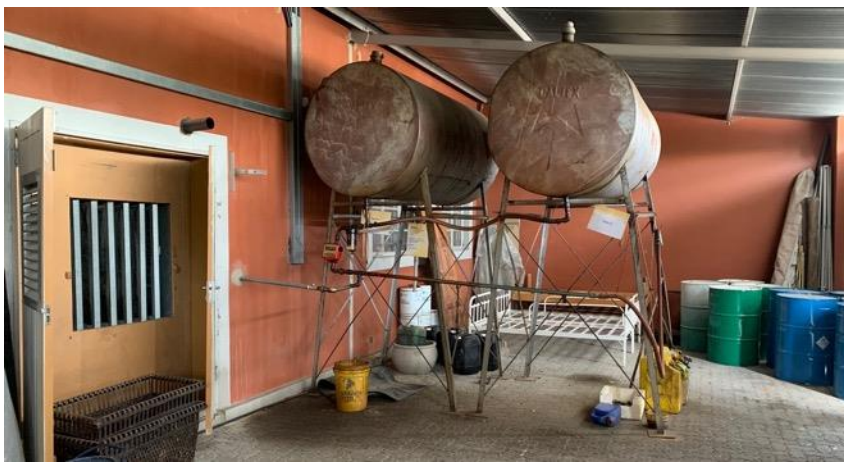
Figure 19. Fuel tanks and the door to the generator room.

NATURE OF IMPACT	MITIGATION	RESPONSIBILITY
Fuel storage and refuelling procedures cause soil and groundwater contamination	Fuel is stored in mounted, sealed tanks on an impervious surface in storage shed.	Mgr, Guides, Maint
	Fuel is dispensed over impervious surface in storage shed.	Mgr, Guides, Maint
Machinery use disturbs the natural quiet	Graders, tractors and power tools are used during daylight only.	Owner, Mgr
Contamination of soil by herbicides and pesticides	Used according to manufacturer's specifications. Care is taken to avoid spills and unnecessary contact with soil, water, vegetation and animals. Decanting is done over a drip tray to prevent spillage and further than 40 m of any natural water source.	Mgr, Maint
Contamination of soil by paint, thinners, varnish, turpentine, detergents, etc.	These substances are stored in sealed, clearly marked containers and only in designated store rooms. Care is taken to avoid spills and unnecessary contact with soil, water, vegetation and animals. Decanting is done over a drip tray to prevent spillage and further than 40 m of any natural water source.	Mgr, Maint

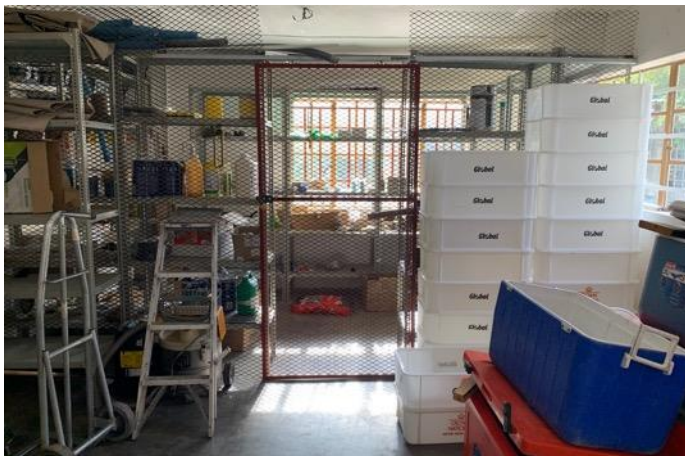
Figure 20. Well-lit and ventilated maintenance storeroom in the shed.

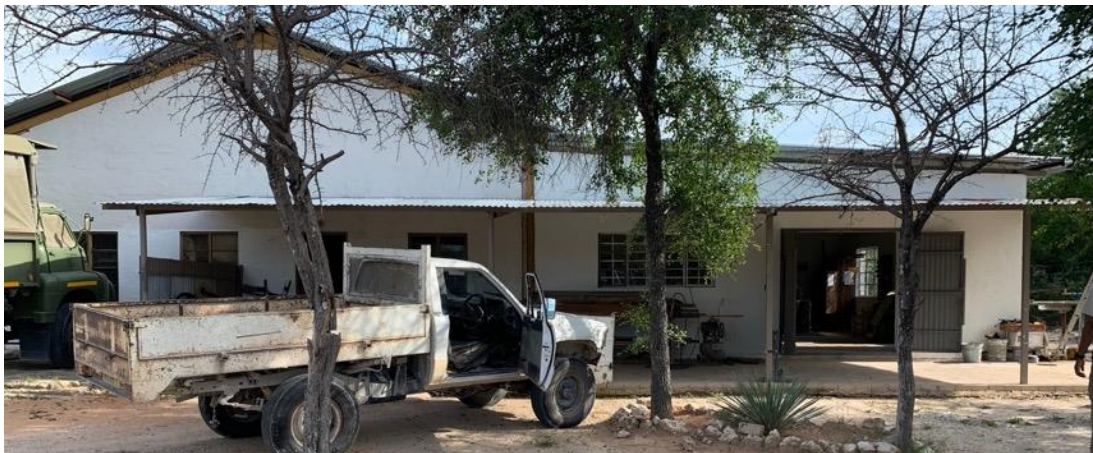
The workshop shed comprises 81 m² and has plastered brick walls, a concrete floor and corrugated iron roof (Figure 22 and Figure 23).

Figure 22. Workshop for basic vehicle maintenance.

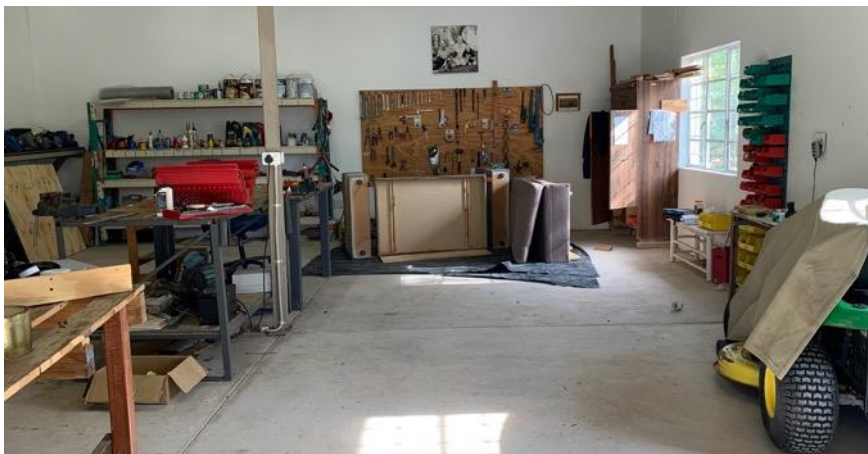
Figure 23. Inside the workshop.

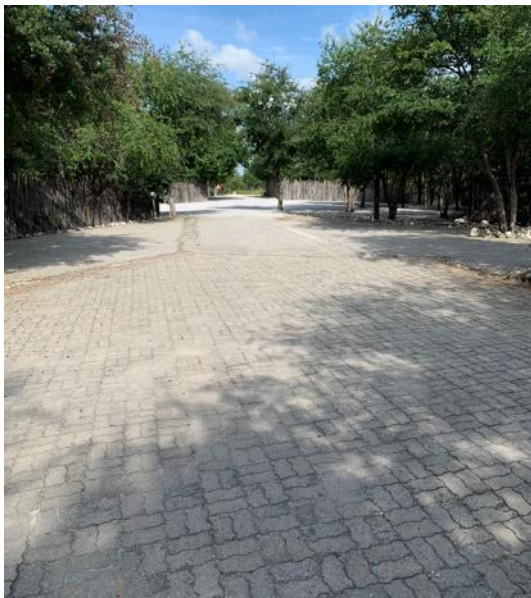
Figure 24. Paved entrance road with gravel parking bays on both sides for guest cars.

- Guest vehicles are parked on gravel at the lodge entrance (Figure 24).
- Lodge vehicles are parked on a gravel surface in a 175 m² carport consisting of a steel frame covered with IBR sheeting. There are 12 parking bays in the carport and it is located at the back of house next to the storage shed (Figure 25).
- Lodge game drive vehicles are parked in a steel and concrete structure covered with IBR sheeting. This structure has 6 parking bays (Figure 26).

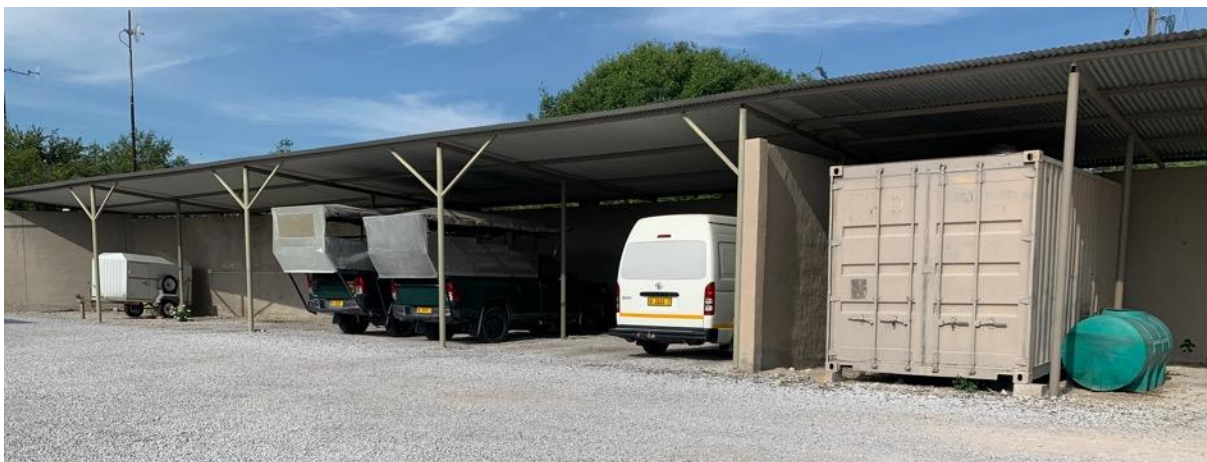
Figure 25. Carport with 12 parking bays.

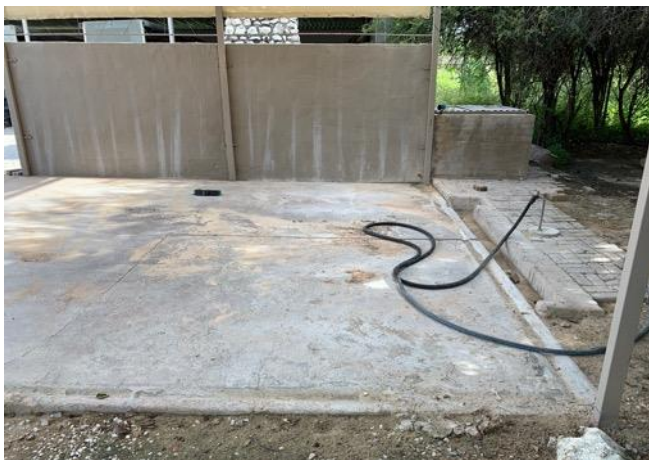
The car wash is under shadecloth on a concrete surface (Figure 27).

Figure 27. The car wash area with sloping floor and drainage ditch.

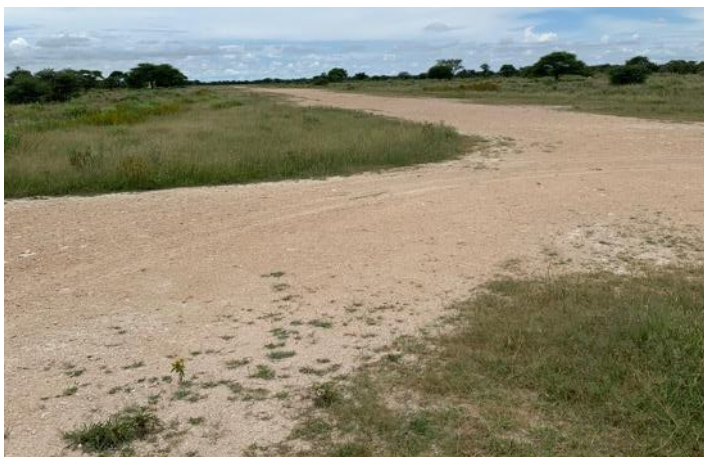
Approximately 2 km from the lodge is an airstrip that services Mushara Lodge, Bushcamp and Outpost. It is 1.3 km long, 30 m wide and has a turnaround and run-up pad at both ends (Figure 28).

Figure 28. The airstrip.

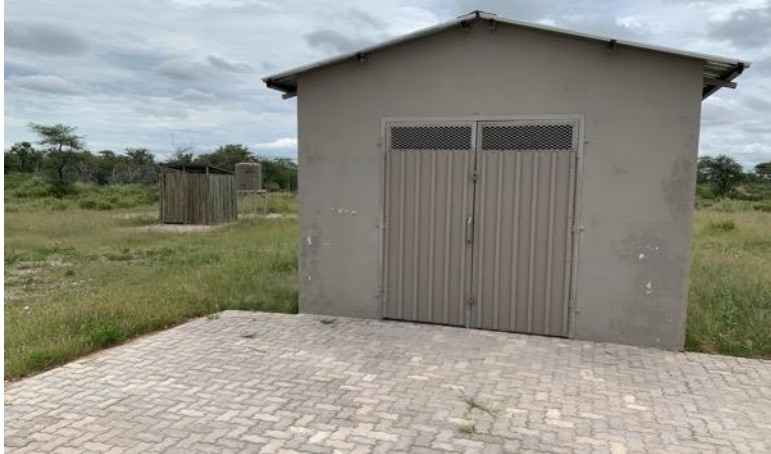
Figure 29. Afgas shed. Toilet and water tank are visible on the left.

There is an Afgas storage shed that is kept locked, a toilet, water tank and shaded waiting area (Figure 29 and Figure 30).

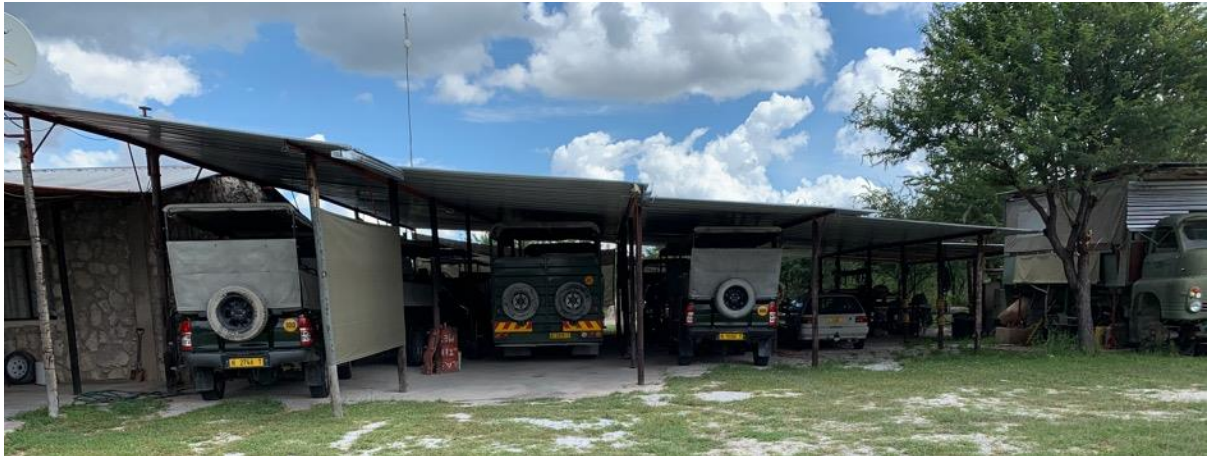
Figure 31. Shed for 20 converted vehicles in the game drive complex.

An open-sided steel frame, covered with IBR sheeting and with a gravel surface, houses a variety of vehicles converted for game drives (Figure 31), as well as a workshop for vehicle maintenance (Figure 32).

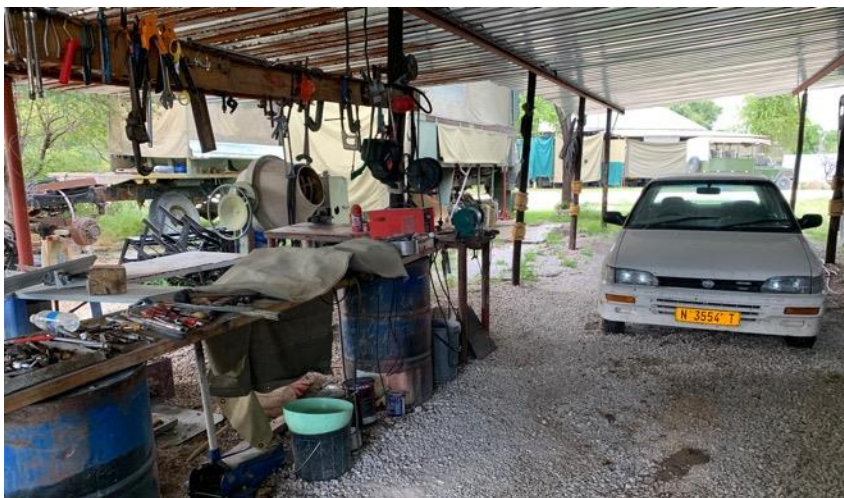
Figure 32. The shed also contains a space with tools for vehicle maintenance.

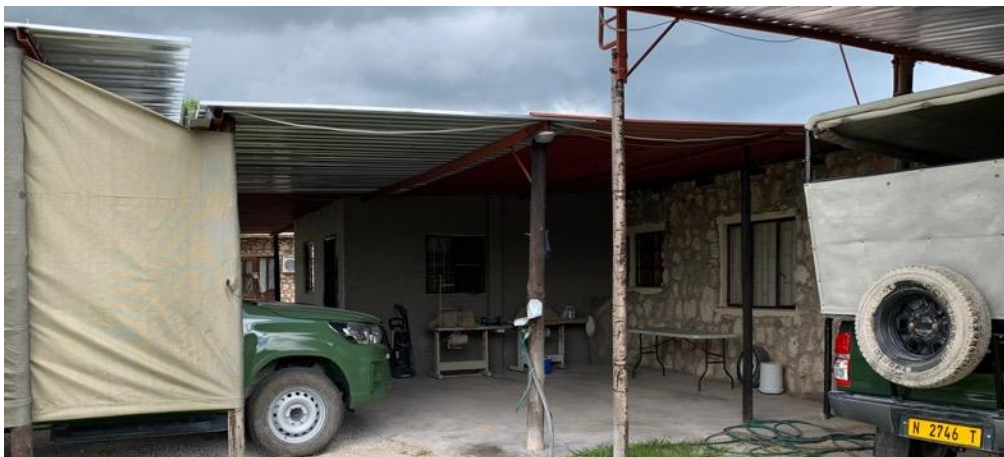
Figure 33. Vehicle shed and a stone house in the game drive complex.

Three accommodation units, built of stone and plastered brick with concrete floors and IBR roof sheets, house 8 people (Figure 33):

- 3 bedrooms, 2 bathrooms, kitchen, lounge/dining, covered veranda, 2 storerooms.
- 1 bedroom, bathroom, kitchen/lounge.
- 3 bedrooms, 1 bathroom.

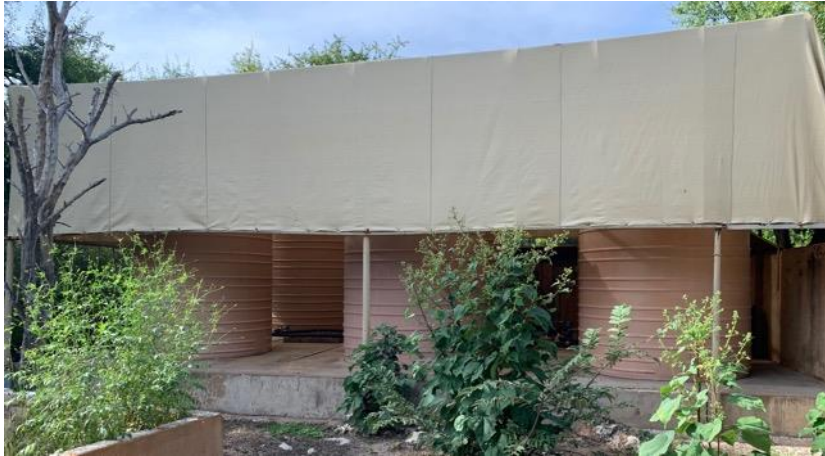
The water table on the farm is shallow at 12 m and boreholes reach to a depth of 30 m. From 2 boreholes located at the lodge, water is pumped 50 m to 6 storage tanks of 10,000 litres each on a concrete surface (Figure 34). Booster pumps take the water from the tanks to points of use. All water pumps are electric.

A large-scale descaling system removes excess lime from the water before it enters the reticulation system.

Figure 34. Six water tanks.

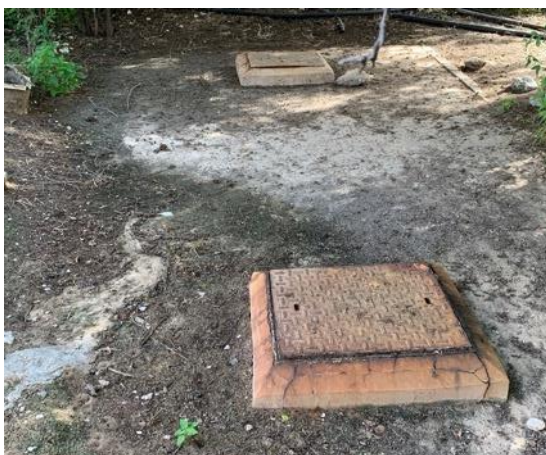
- Guest rooms - 8 (Figure 38)
- Laundry and kitchen - 1 (Figure 35)
- Staff village - 6 (Figure 36 and Figure 37)
- Game drive complex - 2

Figure 35. French drain for kitchen, laundry and car wash.

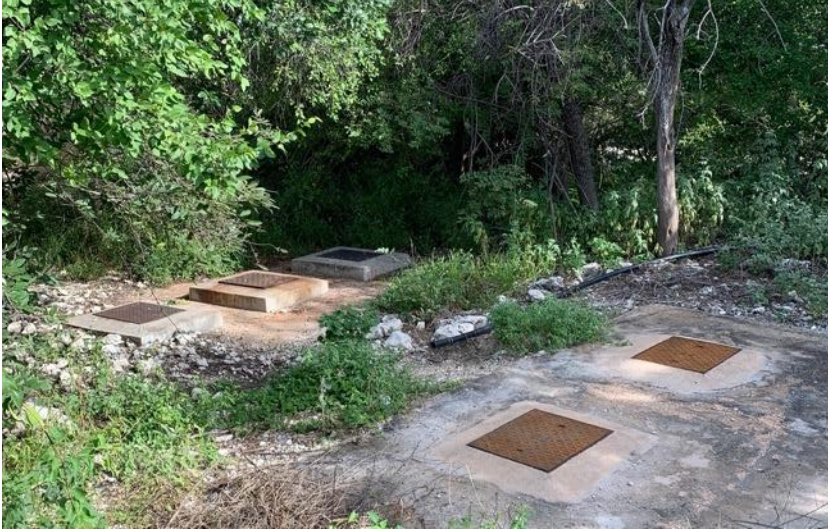
Figure 36. The staff village sewage drains into two systems.

Considering the shallow water table (12 metres), it is essential to prevent groundwater contamination through percolation by ensuring that septic tanks are sealed and leak-free.

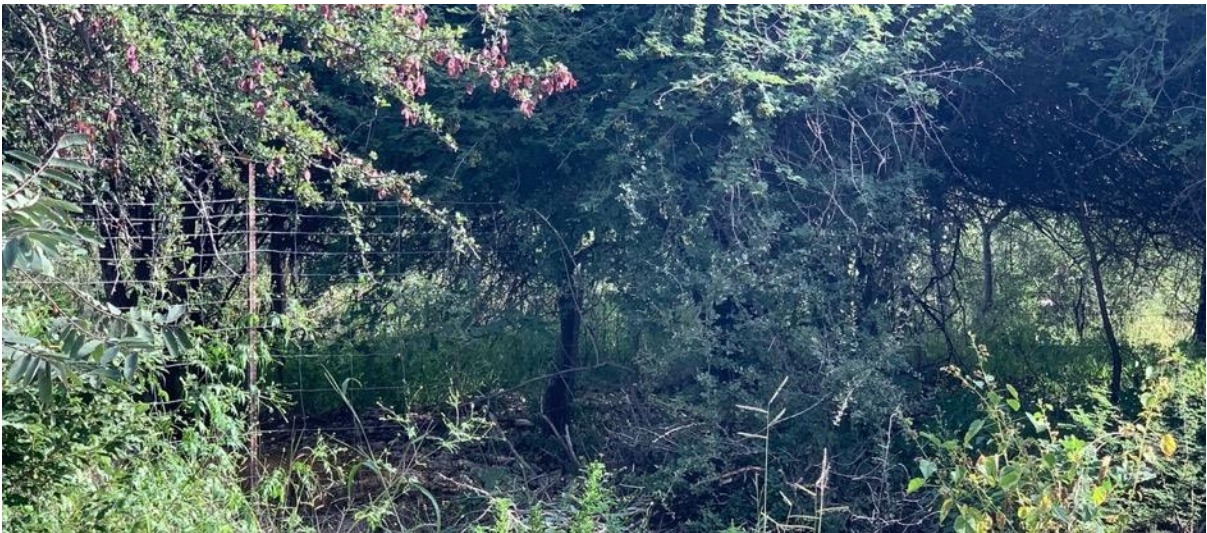
Figure 37. The staff village sewerage systems drain to a fenced in soak-away.

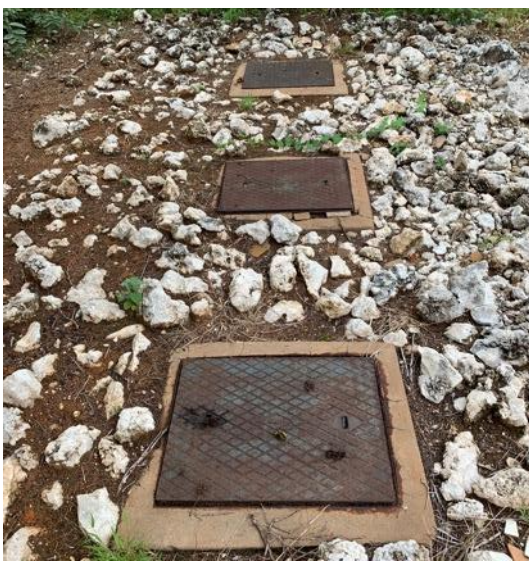
Figure 38. One of eight French drains servicing the guest rooms.

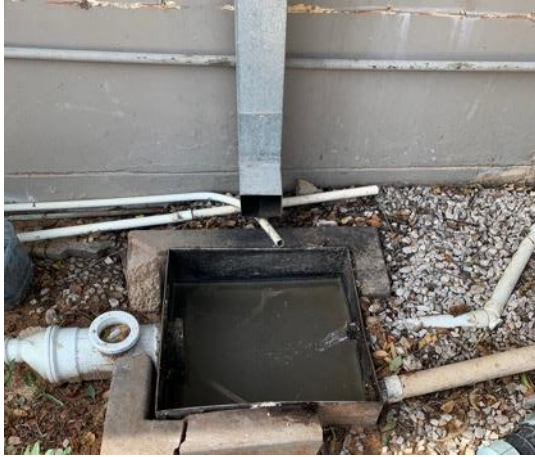
A fat trap is installed at the kitchen drain to prevent fatty substances from entering the sewerage system (Figure 39).

Figure 39. Fat trap at the kitchen drain outlet.

NATURE OF IMPACT	MITIGATION	RESPONSIBILITY
	Bio-degradable cleaning chemicals are used to preserve bacteria in the septic system	Mgr
Ecological impacts	Fat traps at kitchen outlets are maintained.	Mgr, Maint
	Septic tanks and soak-aways are maintained.	Mgr, Maint
Unpleasant odours	Qualitative monitoring of odours.	All
	The source of unpleasant odours are identified and remedied within 1 week of identification.	Mgr, Maint
VEHICLE USAGE		
Erosion of roads and tracks	Regular maintenance of roads and tracks.	Owner, Maint
	Culverts are made to disperse concentrated water flow.	Owner, Maint
Damage to roads and tracks	Low tyre pressure on all operational vehicles.	Mgr, Guides
	Operational vehicles are 4-wheel drive and of standard width.	Owner
Off-road driving causes compaction of and damage to soil	No off-road driving is allowed. Only permitted access roads and paths are used by employees, guests and vehicles.	All

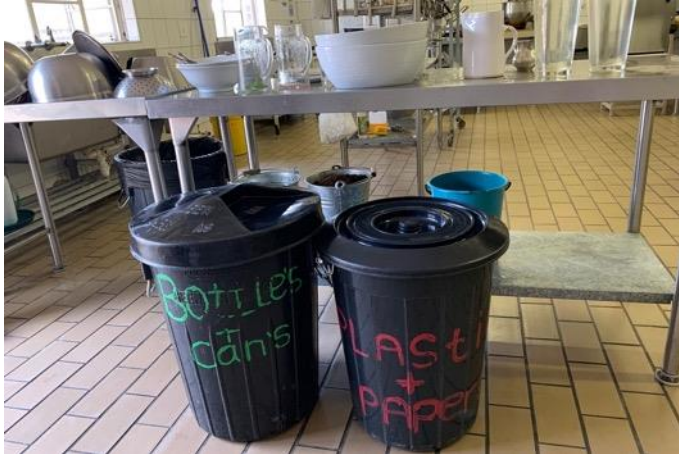
Figure 40. Rubbish bins in the kitchen have lids and are clearly marked.

Refuse is separated into bins at source (Figure 40 and Figure 41). From the bins, rubbish goes directly to one of three disposal sites: the incinerator, the farm landfill or the “animal restaurant”.

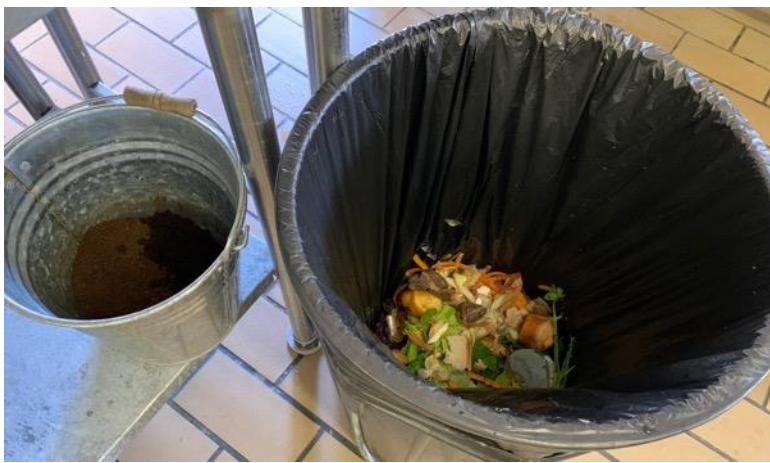
Figure 41. Bins marked for organic waste: coffee grounds and vegetable refuse.

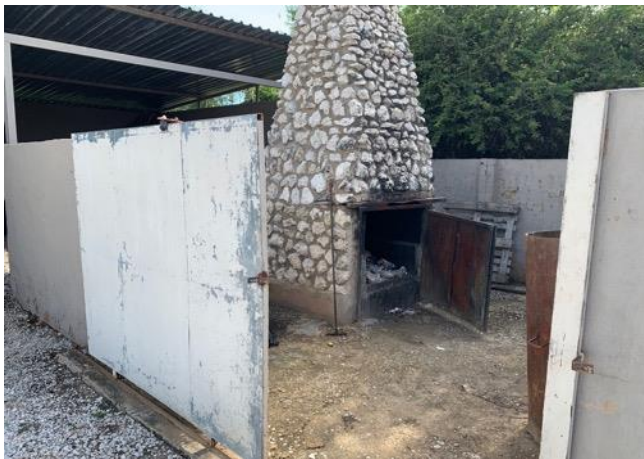
The incinerator (next to #6 in Figure 2) is enclosed by a 1.8 m high wall with a secure sliding door and is inaccessible to mammals (Figure 42). The risk of fly-blown rubbish is eliminated by standard operating procedure: flammable waste is brought to the incinerator in closed bins; from the bins it goes directly into the incinerator and the door is then shut. The fire is never left unsupervised. No waste is stored in the incinerator enclosure: whatever is brought here, is burnt immediately. The ash is taken to the farm landfill every day.

Figure 42. The incinerator, secured by high walls and a sliding gate.

Damage to plants	Only permitted access roads and paths are used by employees, guest and vehicles at all times.	All
	No off-road driving is allowed.	All
Spread of invasive vegetation	The area is kept free of invasive vegetation.	All
SOLID WASTE		
Large volumes of rubbish are generated	Minimise waste by buying supplies in bulk and using re-usable packaging.	Owner, mgr
	Minimise water bottle waste by promoting local tap water and providing re-usable water bottles to guests.	Owner, mgr
Waste management	Appropriate waste bins are provided at the point of source. All waste bins are covered and secured to be wind and animal proof.	Mgr
	No waste is buried in depressions, drainage lines or omurambas.	Mgr, Maint
	Burnable waste goes from the bins directly to the incinerator twice daily. Metal, glass and rubber is taken from the bins to the farm landfill at least once a day.	Mgr, Maint
	Incinerator enclosure is kept free of materials that can be wind-blown. Incinerator is maintained. Burning is always supervised.	Mgr, Maint

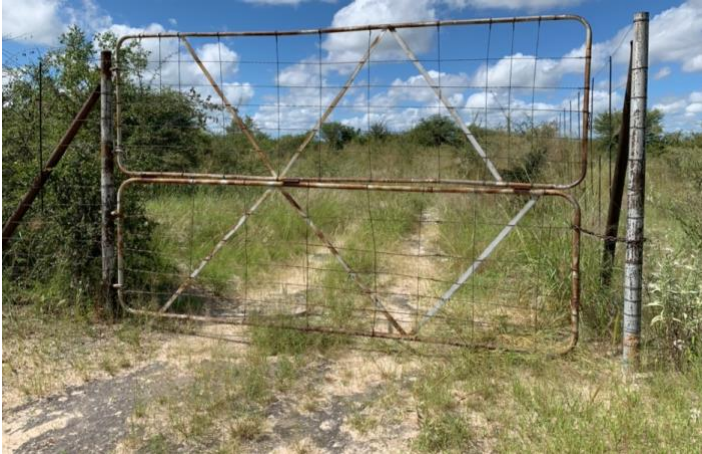
The farm landfill is surrounded by a 2.2 m high fence (Figure 43). One a year when road maintenance is done, the rubbish is bulldozed into a compact heap on one side of the landfill. There are no fly-away items or rubbish being blown by the wind because only heavy materials are dumped here (metal, glass and rubber) (Figure 44).

Figure 43. Gate to the fenced in farm landfill.

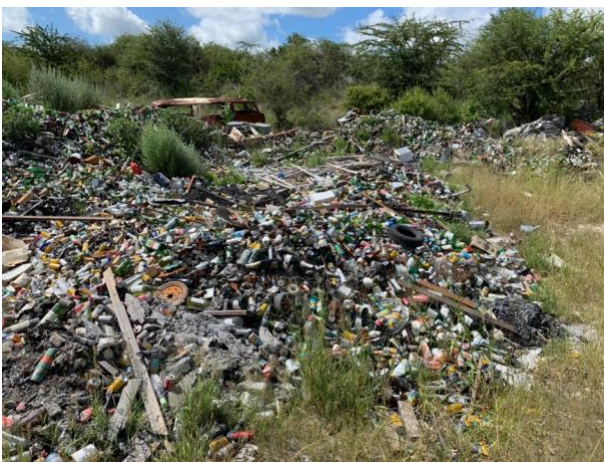
Figure 44. The landfill for solid materials such as glass, rubber and metal.

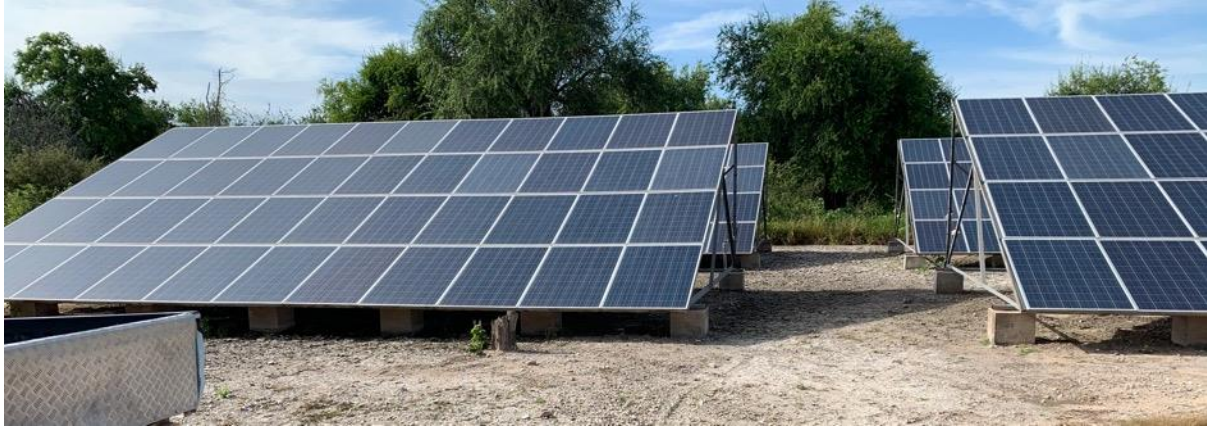
Figure 45. Four solar panels feed into the grid.

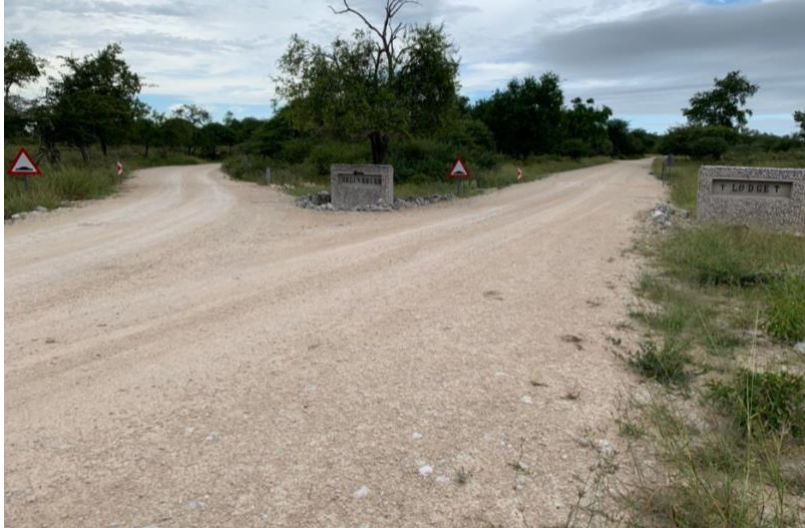
There is a limited track network on the farm, since 99% of activities consist of drives into Etosha National Park. Access to the lodge is on a 1.3 km constructed limestone gravel road with camber and drainage ditches (Figure 47). Once a year a professional road maintenance contractor is hired to grade the road, and repair and maintain speed bumps and culverts.

Water seeps away relatively quickly in this flat landscape with its lime soils, and there is seldom standing water in the roads. In the rainy season when the ground is wet, only the main access roads are used. No sundowner drives on the farm are offered in the wet season either. These protocols limit erosion and damage to roads and tracks.

Figure 47. The access roads are gravelled and professionally maintained by contractors.
