Mushara

BUSH CAMP

ENVIRONMENTAL MANAGEMENT PLAN

Application for Environmental Clearance

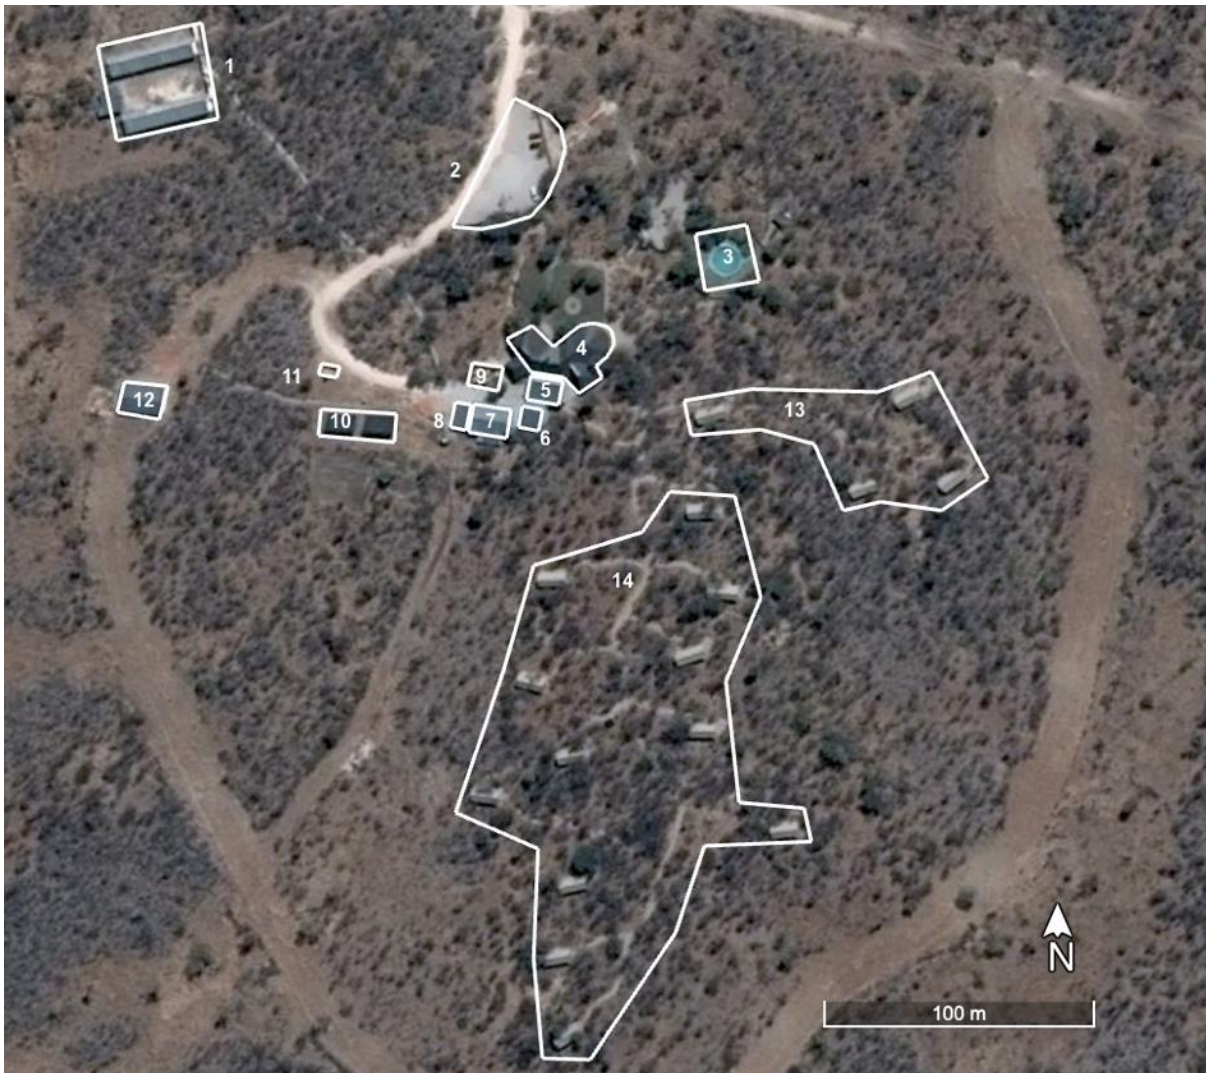
Figure 2. Layout of Mushara Bush Camp.

Total footprint of Bush camp lodge and its support structures is approximately 3 ha. The layout of infrastructure is given on a Google Earth map in Figure 2.

- 1 Staff village
- 2 Guest parking
- 3 Swimming pool
- 4 Main area
- 5 Kitchen
- 6 Canteen
- 7 Storage shed
- 8 Parking for lodge vehicles
- 9 Water tanks
- 10 Solar
- 11 Incinerator
- 12 Managers' accommodation
- 13 Family rooms x 4
- 14 Double rooms x 12

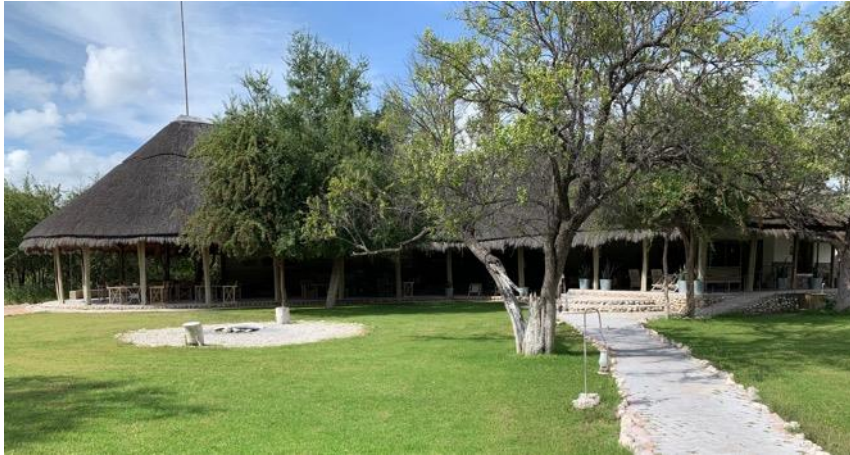
Figure 3. Main area.

The 827 m² main area (#4 in Figure 2) is open on three sides and has a thatched roof (Figure 3). There is a concrete floor in the lounge, and the dining area floor is compacted earth covered with white gravel.

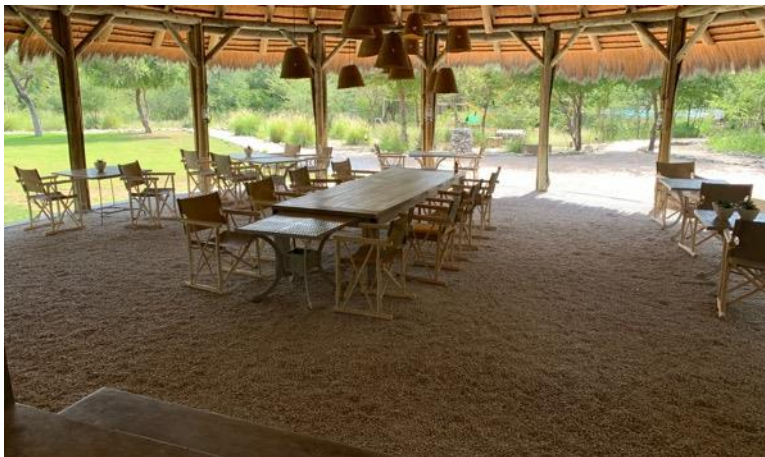
Figure 4. Dining area with gravel floor.

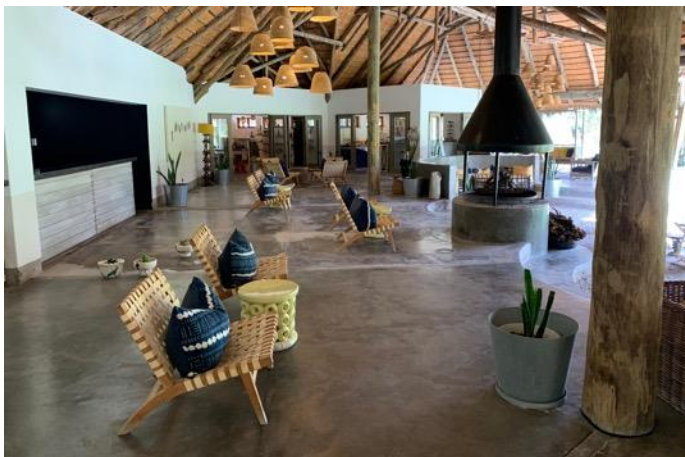
Figure 5. Concrete floor in main area.

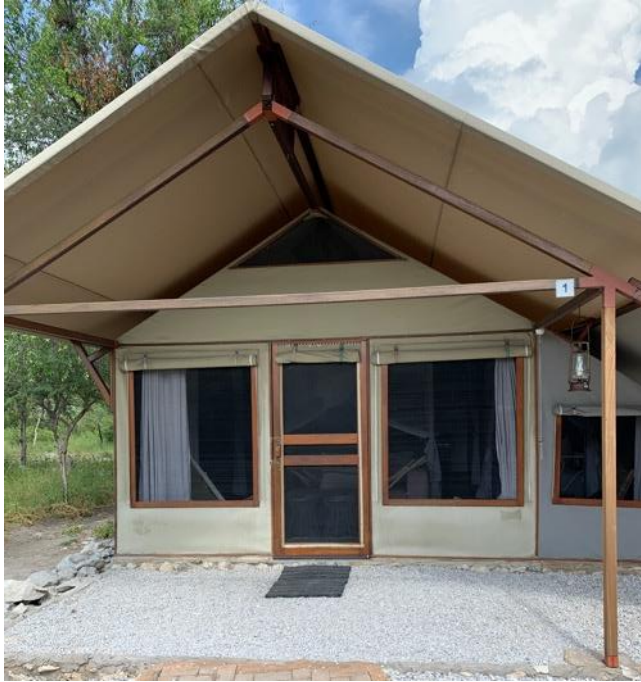
Mushara Bush Camp can accommodate a total of 40 guests in free-standing tent structures, consisting of canvas wrapped around a meranti wood frame, and set on a concrete slab. The roofs are canvas with shade netting stretched over. All the tents are air conditioned.

Figure 8. Guest rooms consist of canvas over wood frames.

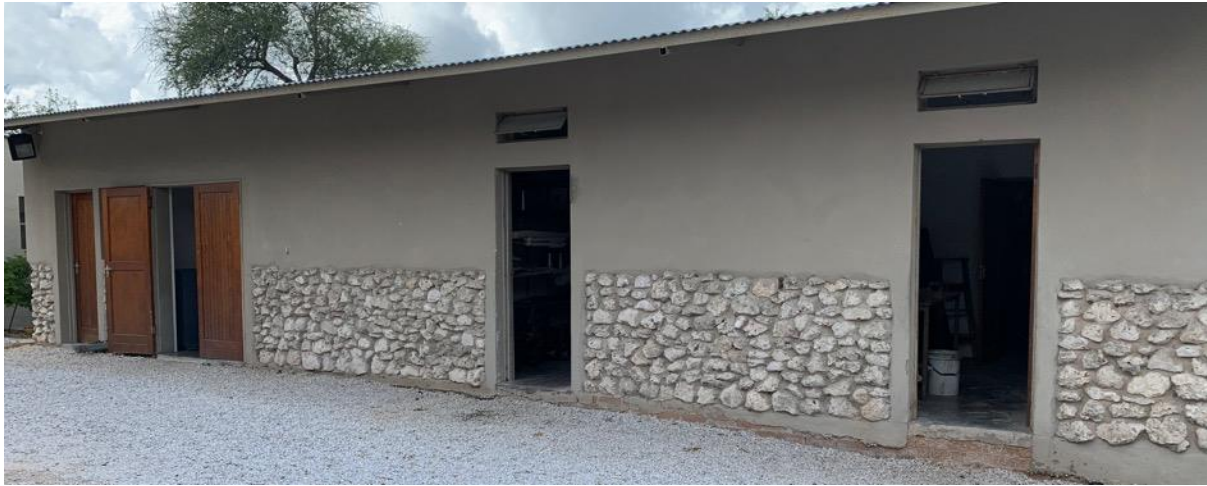
A 140 m² building of plastered brick walls with a concrete floor and IBR roof (#9 in Figure 2).

The shed contains six separate rooms:

Figure 15. Storage shed with doors to a staff toilet, the laundry, housekeeping store and bar store.

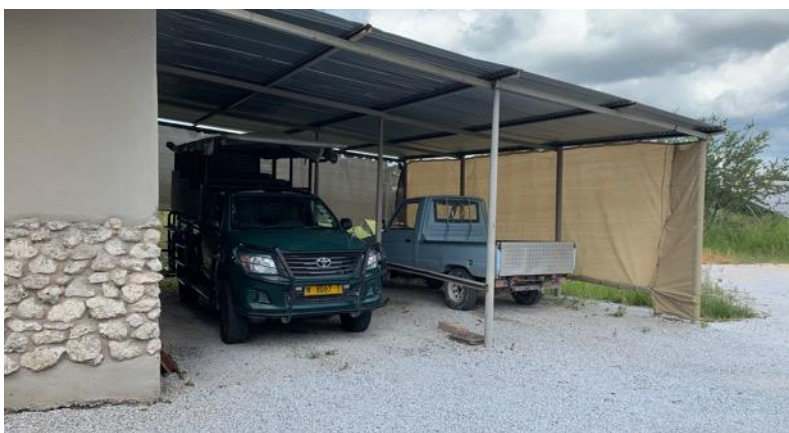
- Guest vehicles are parked on gravel at the lodge entrance (#2 in Figure 2).
- Lodge vehicles are parked on a gravel surface in a 32 m² carport consisting of a steel frame covered with IBR sheeting (#8 in Figure 2).

Figure 17. Parking for lodge vehicles .

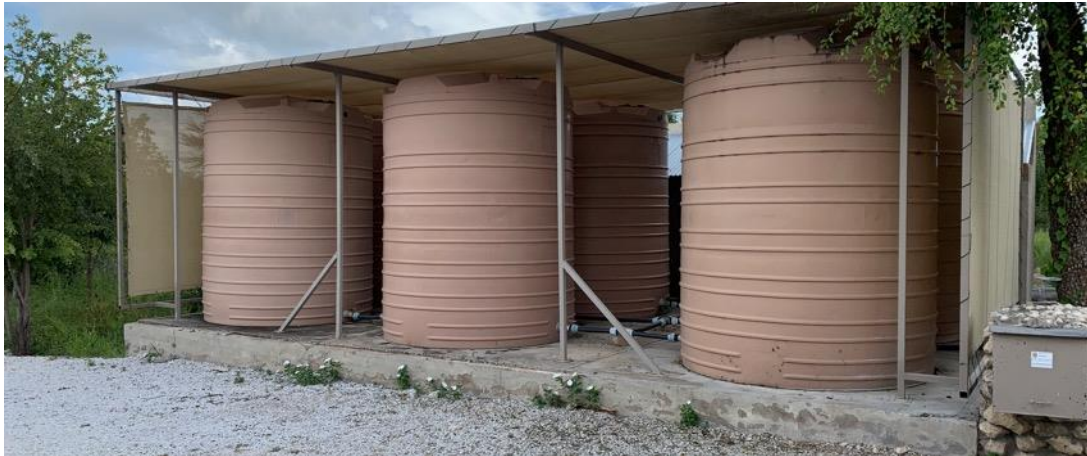
The water table on the farm is shallow at 12 m and boreholes reach to a depth of 30 m. From 2 boreholes located at the lodge, water is pumped 50 m to 6 storage tanks of 10,000 litres each on a concrete surface. Booster pumps take the water from the tanks to points of use. There is also a fire hydrant with its own booster pump. The water pumps are electric.

Figure 20. Six water tanks on a concrete slab.

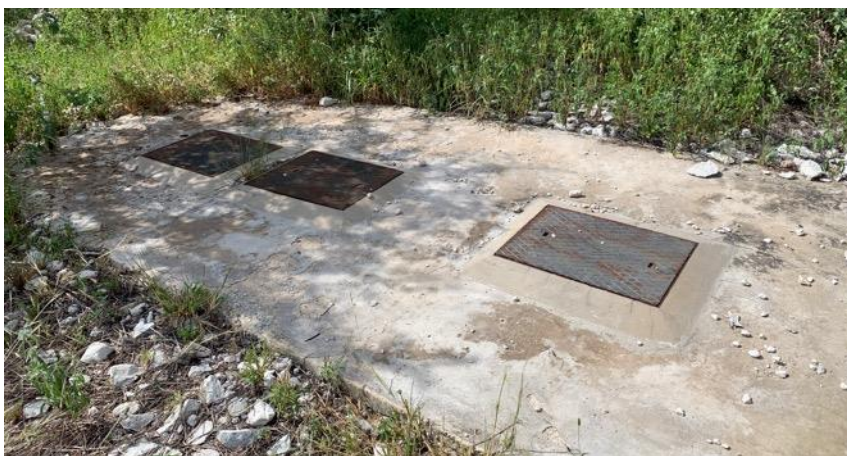
There are 11 independent sewerage systems for treating sewage and wastewater at Bush Camp. Each system consists of sealed and impermeable, concrete 3-chamber French drains with a capacity of 40 m³. The contents of the last chamber are pumped out regularly to drain into the ground near the drains.

The wastewater from showers, basins, kitchen and laundry goes into the sewerage system. Swimming pool backwash water drains into the soil.

Figure 21. Example of a 3-chamber French drain system servicing the guest rooms.

Considering the shallow water table (12 metres), it is essential to prevent groundwater contamination through percolation by ensuring that septic tanks are sealed and leak-free.

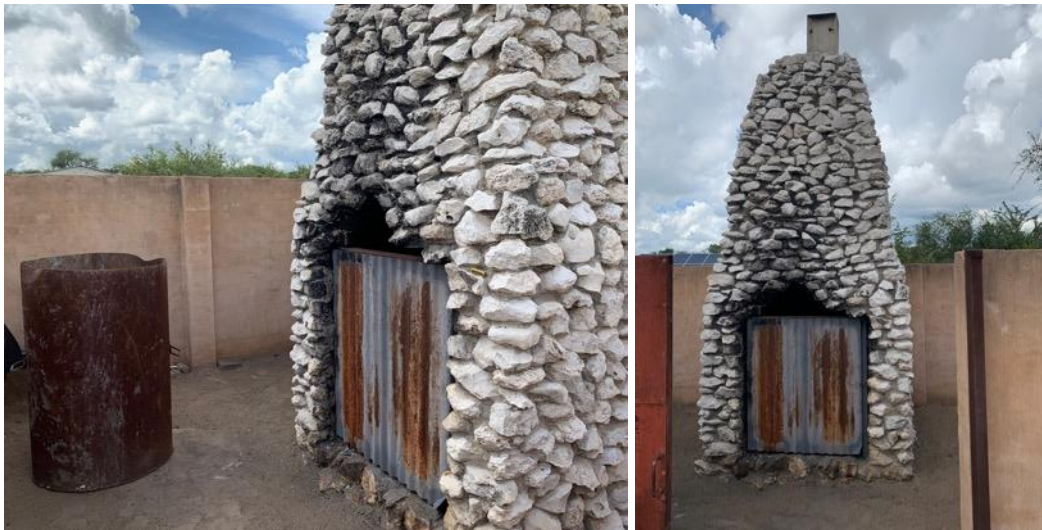
The incinerator (#11 in Figure 2) is enclosed by a 1.8 m high wall with a secure sliding door and is inaccessible to mammals. The risk of fly-blown rubbish is eliminated by standard operating procedure: flammable waste is brought to the incinerator in closed bins; from the bins it goes directly into the incinerator and the door is then shut. The fire is never left unsupervised. No waste is stored in the incinerator enclosure: whatever is brought here, is burnt immediately. The ash is taken to the farm landfill every day.

Figure 22. The incinerator inside a walled enclosure.

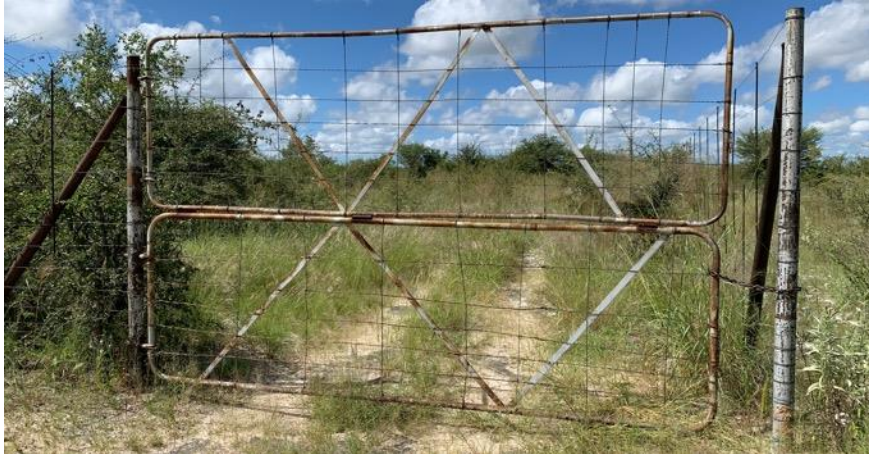
The farm landfill services the three lodges on the farm and is surrounded by a 2.2 m high fence. Once a year when road maintenance is done, the rubbish is bulldozed into a compact heap on one side of the landfill. There are no fly-away items or rubbish being blown by the wind because only heavy materials are dumped here (metal, glass and rubber).

Figure 23. Gate and 2.2 m high fence around the landfill.

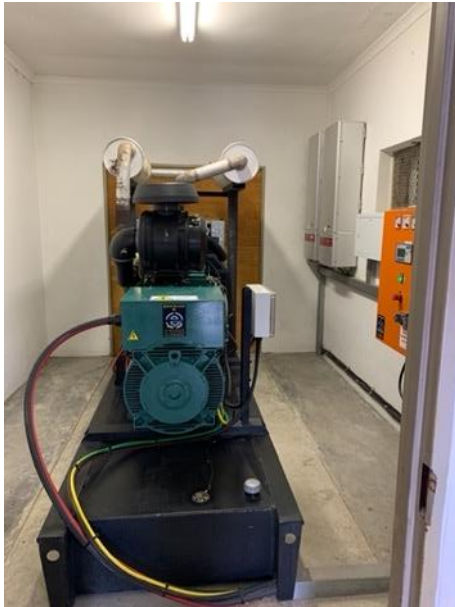
Figure 25. Generator room.

A back-up generator of 140 KVA is used when the grid power is out. The generator is mounted on an impermeable concrete floor in a plastered brick room in the storage shed. The room has sealing to make it sound-proof, and air ducts for ventilation and cooling.

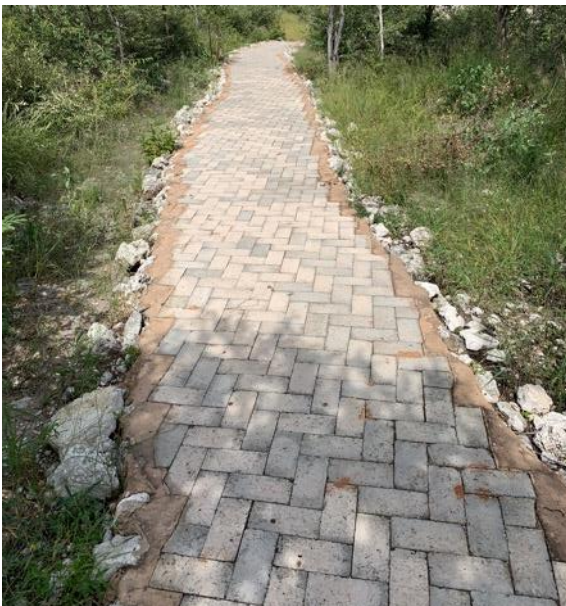
Pathways help conserve the indigenous vegetation by ensuring that staff and guests have an easy walk. The main area, swimming pool and guest rooms are connected by a network of demarcated and well-lit pathways of bricks. In the back-of-house area and the staff village, well-maintained and demarcated gravel pathways lined with stones perform the same function.

Figure 28. Paved pathways in guest areas prevent damage to soil and plants.

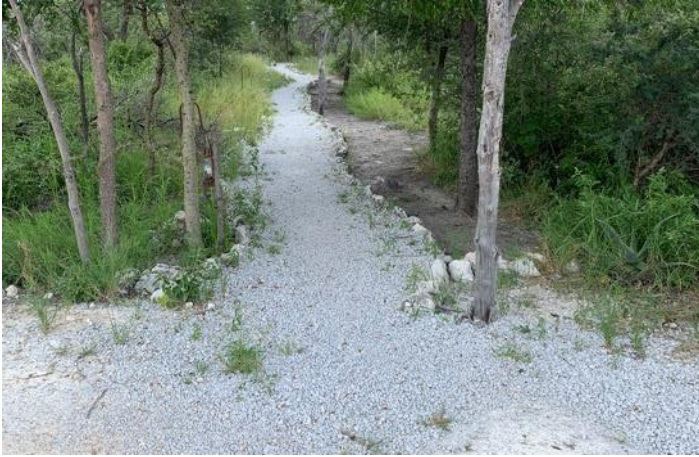
Pathways to and inside the staff village are clearly demarcated, bordered by stones and covered in gravel.

Figure 29. Pathway to the staff village is lined with gravel.

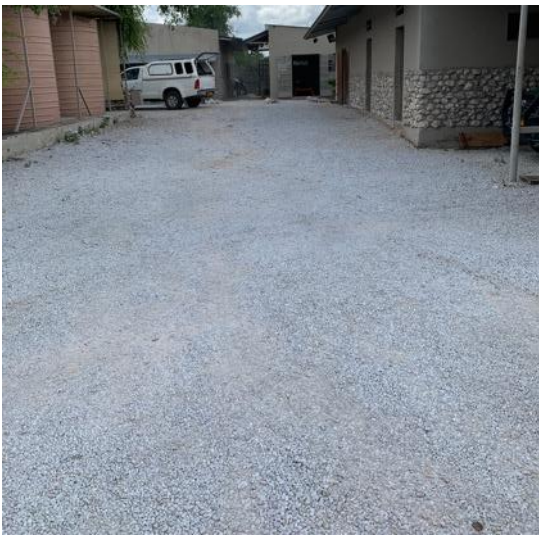
All large ground surfaces in the back-of-house are compacted soil covered with gravel.

Figure 30. Gravel surface in the back-of-house.
