Mushara OUTPOST

ENVIRONMENTAL MANAGEMENT PLAN

Application for Environmental Clearance

for Mushara Outpost

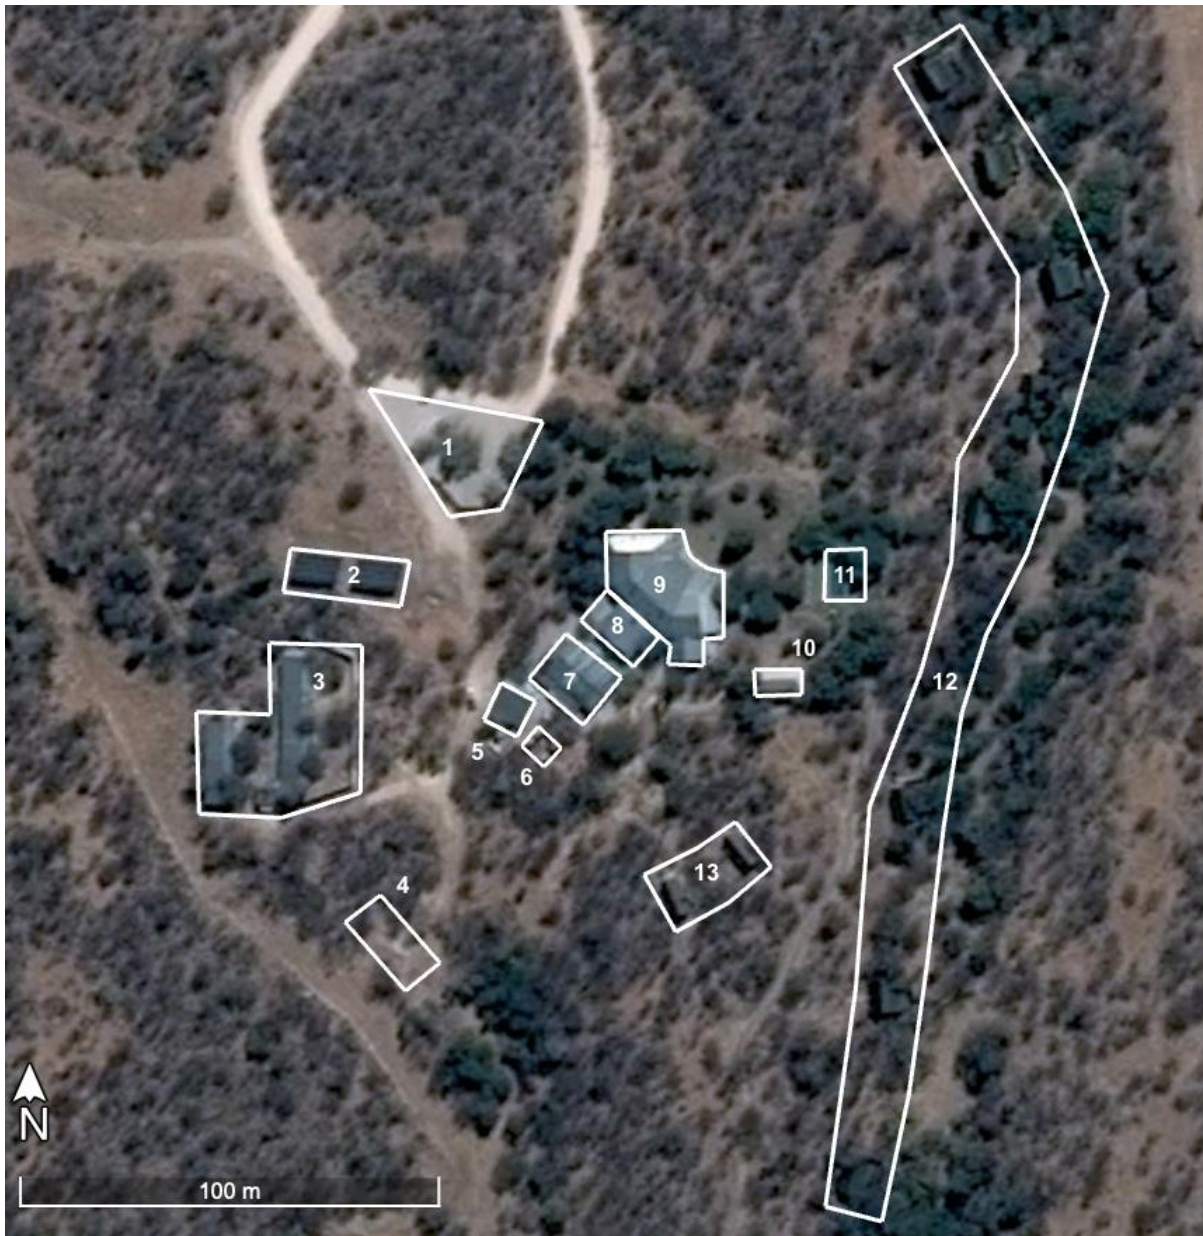
Figure 2. Layout of Mushara Outpost.

Total footprint of Outpost lodge and its support structures is approximately 2.6 ha. The layout of infrastructure is given on a Google Earth map in Figure 2.

- 1 Parking for guests
- 2 Solar panels
- 3 Staff village
- 4 Management accommodation
- 5 Canteen
- 6 Water tanks
- 7 Storage shed
- 8 Kitchen
- 9 Main area
- 10 Curio shop
- 11 Swimming pool
- 12 Guest rooms x 8 double
- 13 Guide rooms x 2 single

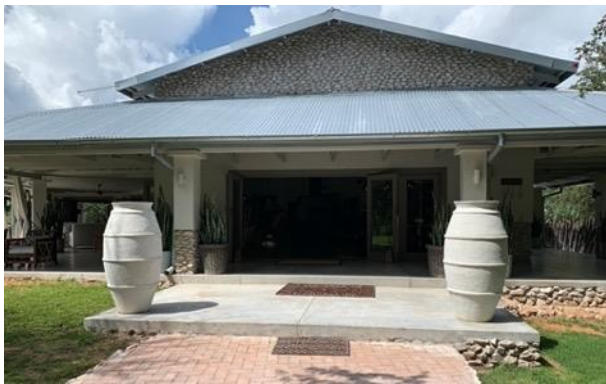
The 570 m² main area (#9 in Figure 2) is a plastered brick and cement building with a corrugated iron roof and concrete floors (Figure 3). It is surrounded on three sides by a wide veranda (Figure 4).

Figure 3. The main area in the style of an old farmhouse.

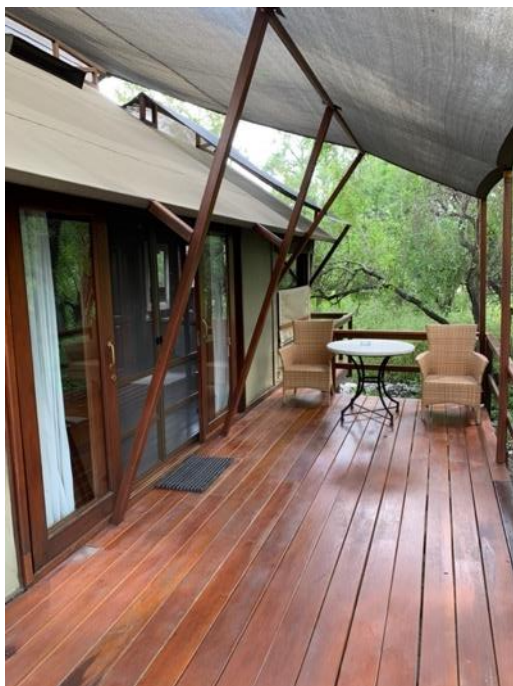
Mushara Outpost can accommodate a total of 16 guests in free-standing tent structures, consisting of canvas wrapped around a meranti wood frame that is set on a raised wooden platform (#12 in Figure 2). The roofs are canvas with shade netting stretched over (Figure 7). All the tents are air conditioned.

Figure 7. Guest tents are set on raised wooden platforms.

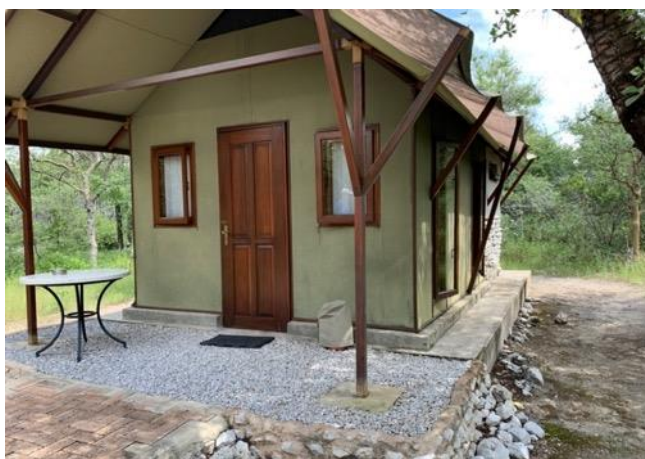
There are also two single tents for visiting tour guides, each comprising a bedroom, bathroom and veranda (#13 in Figure 2). The guide tents are set on concrete slabs (Figure 8).

Figure 8. One of two tents for visiting tour guides.

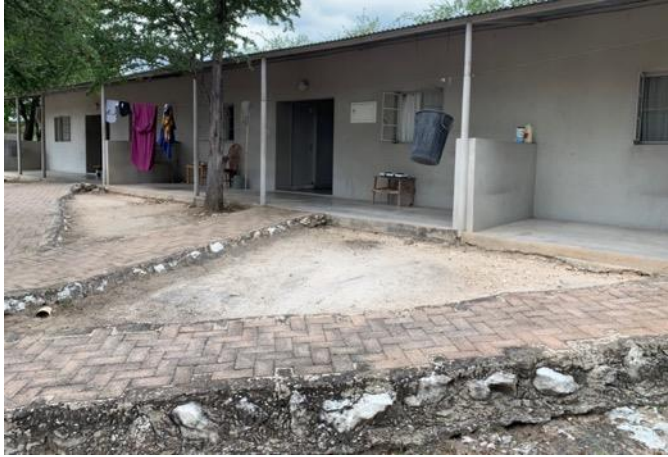
The staff village is approximately 80 m from the main building and accommodates 22 staff members in two long blocks (#3 in Figure 2). There are 11 rooms in total and every two rooms share a bathroom and veranda with laundry basin and rubbish bin. The buildings in the staff village are made of plastered brick and cement, with corrugated iron roofs and concrete floors (Figure 9).

Figure 9. The staff village with raised, paved pathways.

Pathways in the staff village are raised and paved. No cooking is done in the staff village. Staff meals are prepared in the lodge kitchen and served in a canteen.

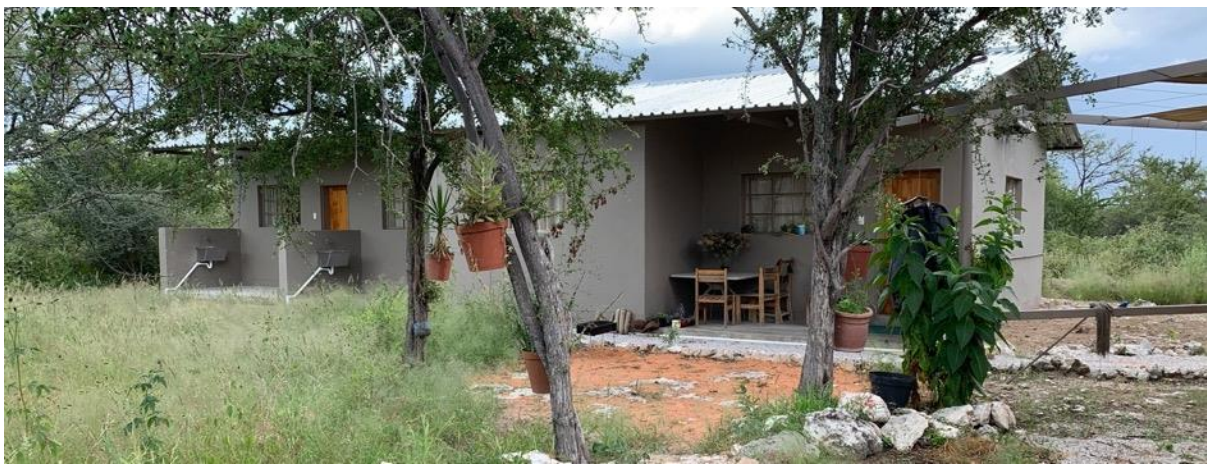
Management staff are accommodated in a plastered brick and cement building with corrugated iron roof and concrete floor (#4 in Figure 2). The building contains three flats, each with a bedroom, bathroom, kitchenette and veranda (Figure 10).

Figure 10. House for management staff.

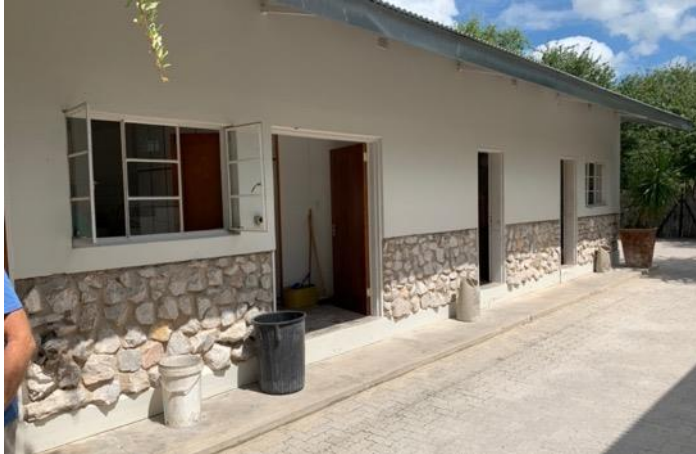
A 140 m² building of plastered brick walls with a concrete floor and IBR roof (Figure 11 and #7 in Figure 2) contains six separate rooms:

Figure 11. Storage shed with doors to laundry, store room and workshop.

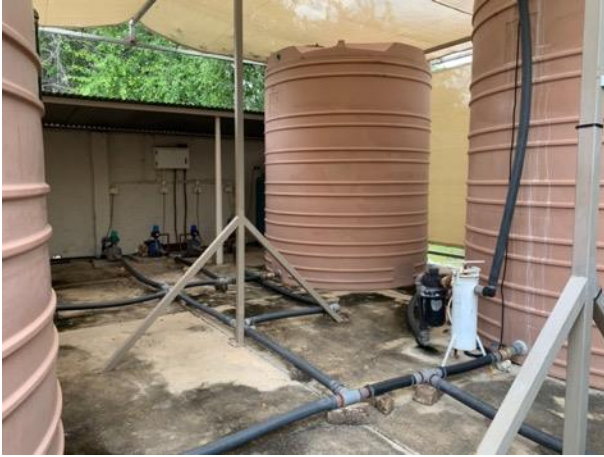
The water table on the farm is shallow at 12 m and boreholes reach to a depth of 30 m. From 2 boreholes located at the lodge, water is pumped approximately 20 m far, to 4 storage tanks of 10,000 litres each (# 6 in Figure 2). The tanks are set on a concrete surface (Figure 16). Booster pumps take the water from the tanks to points of use. There is also a fire hydrant with its own booster pump. All water pumps are electric.

Figure 16. Water tanks on a concrete slab.

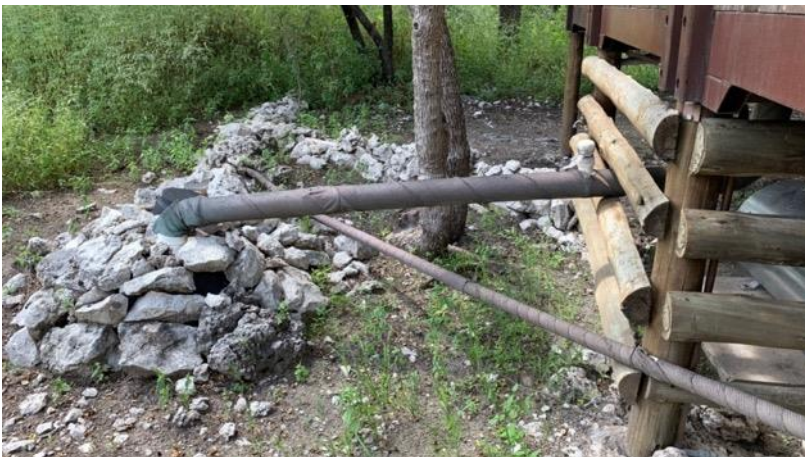
Outpost uses single-tank digester systems for the treatment of sewage. Sewage goes into sealed, impermeable plastic tanks (called digester tanks) for breakdown, and the overflow drains into the bush. Grey water from the showers and basins in the guest tents drain to an evaporation area next to each tent. Each guest tent has its own digester system (Figure 17).

Figure 17. Pipes leading to the digester tank from a guest room.

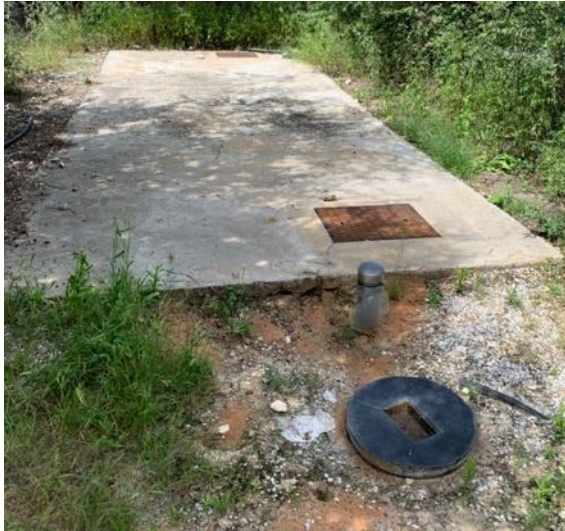
The main area, kitchen, laundry and two guide rooms share a 3-chambered French drain system for grey water, and a digester tank for sewage from the toilets (Figure 18). The staff village is serviced by one 3-chambered French drain for the grey water and two digester tanks for sewage from the toilets.

Figure 18. French drain and digester tank for the main area and guide rooms.

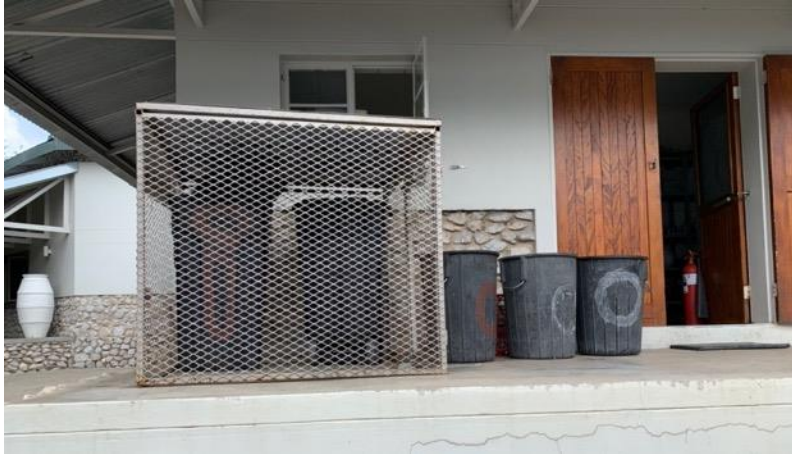
Refuse is separated into bins at source (Figure 19). From the bins, rubbish goes directly to one of three disposal sites: the incinerator, the farm landfill or the “animal restaurant”.

Figure 19. Rubbish bins and cage at the kitchen back door.

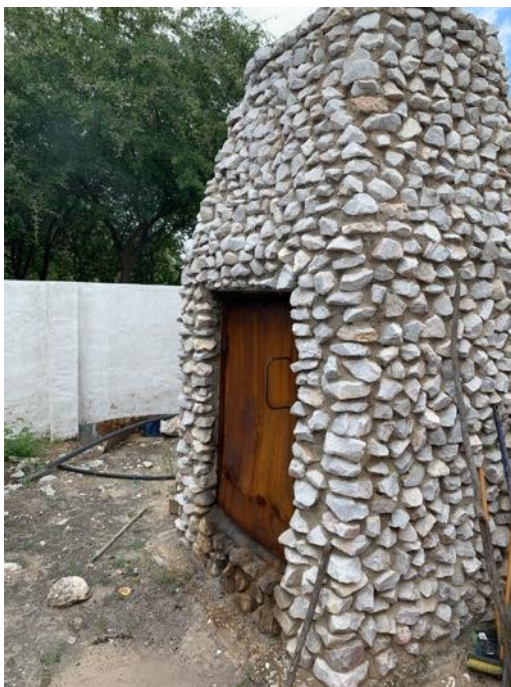
The incinerator is enclosed by a 1.8 m high wall with a secure sliding door and is inaccessible to mammals (Figure 20). The risk of fly-blown rubbish is eliminated by standard operating procedure: flammable waste is brought to the incinerator in closed bins; from the bins it goes directly into the incinerator and the door is then shut. The fire is never left unsupervised. No waste is stored in the incinerator enclosure: whatever is brought here, is burnt immediately. The ash is taken to the farm landfill every day.

Figure 20. The incinerator enclosure is inaccessible to mammals.

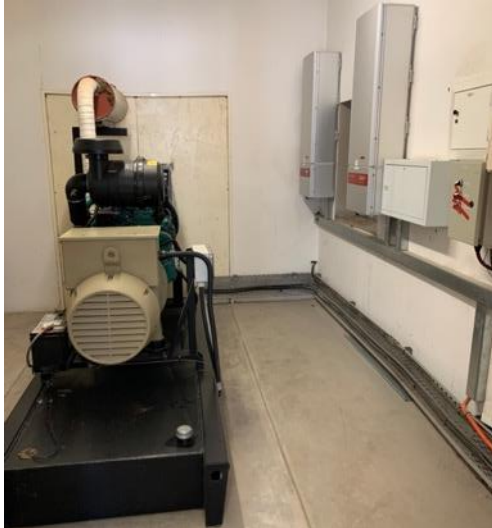
A back-up generator of 140 KVA is used when the grid power is out. The generator is mounted on an impermeable concrete floor in a plastered brick room in the storage shed. The room has sealing to make it sound-proof, and air ducts for ventilation and cooling (Figure 21).

Figure 21. The generator room is sealed for noise.

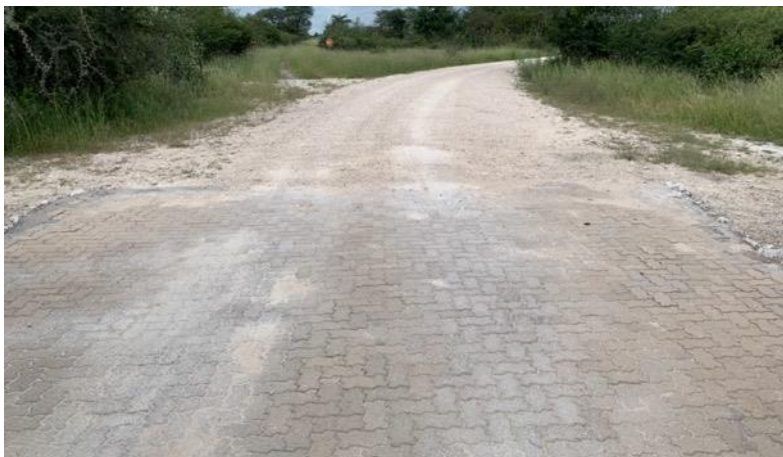
There is a limited track network on the farm, since 99% of activities consist of drives into Etosha National Park. Access to Outpost from the C38 is on a 1.5 km constructed limestone gravel road with camber and drainage ditches (Figure 22). Once a year a professional road maintenance contractor is hired to grade the road, and repair and maintain speed bumps and culverts.

Figure 22. Road surface at the entrance gate to Outpost.

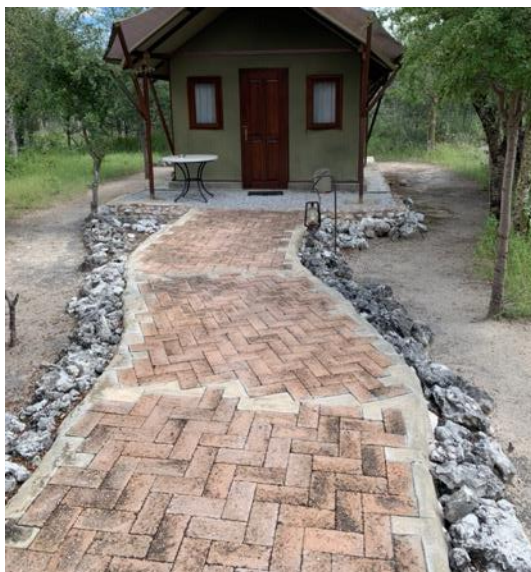
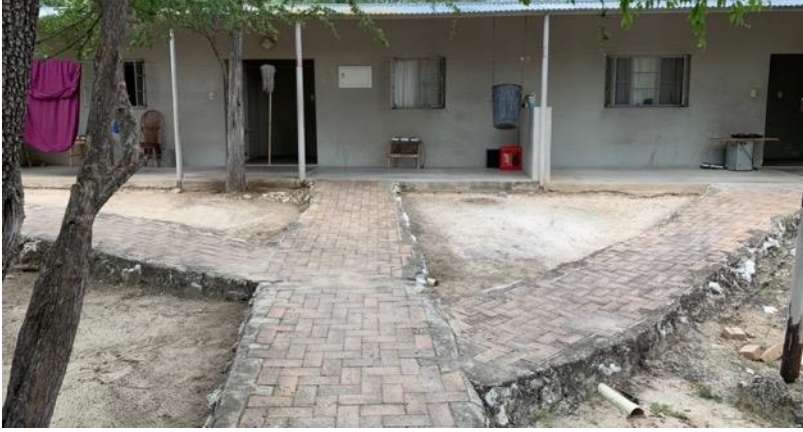
Pathways help conserve the indigenous vegetation by ensuring that staff and guests have an easy walk, thereby preventing erosion. The main area, swimming pool and guest rooms are connected by a network of demarcated and well-lit pathways paved with bricks, as are the back-of-house area and staff village (Figure 25 and Figure 26).

Figure 25. Raised, paved pathways connect the guest areas and back of house.

Figure 26. Paved pathways in the staff village.
