WARMQUELLE GREEN SCHEME IRRIGATION PROJECT

ENVIRONMENTAL MANAGEMENT PLAN

FEBRUARY 2021

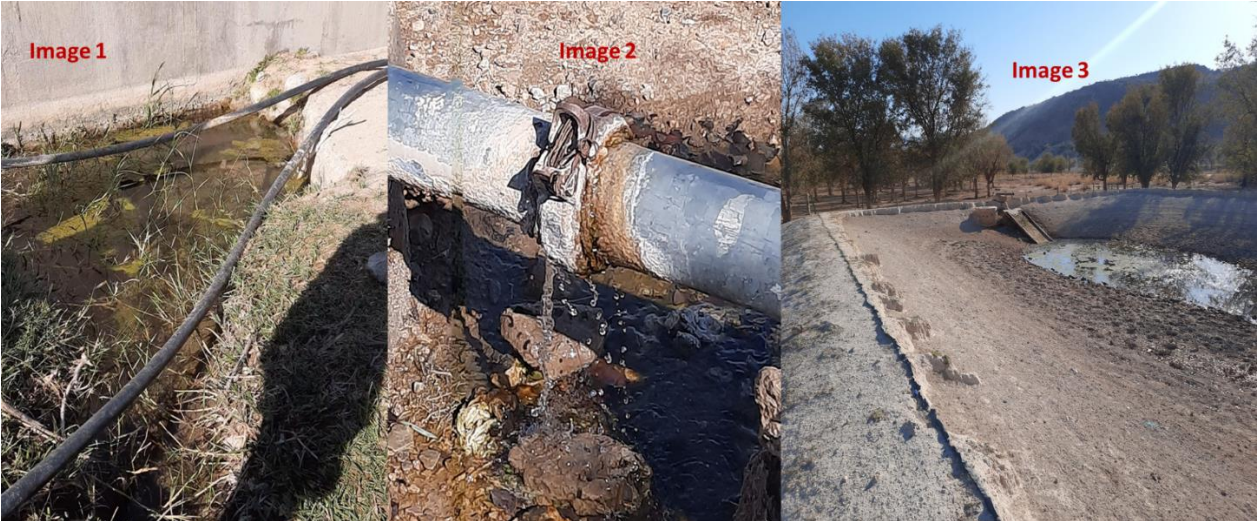
Figure 1: Image 1 - Silted water abstraction weir at the source, Image 2 - Water leakages along the pipeline, Image 3 - Heavily silted water storage earth dam at Warmquelle. The pond is poorly

secured, is a hazard to children from the community and deaths from drowning have been witnessed in the past Source: Own images taken during field visit.

Aspect / Infrastructure	Status	Planned Activity
Water Source	Ongongo Fountain is the main water source	Rehabilitation of the pipeline: cleaning the pipeline and sealing leaks
Abstraction	The abstraction point comprises of the pipeline connected to a heavily silted weir at the fountain	Desiltation of the weir
Water conveyance / transportation	Water is transported by a 6 km galvanized steel pipeline which has several leaks and suspected silt points along the length.	Replacing of conduits to prevent leaks, clearing sand from the pipes, building of concrete footings supporting the conduits.
Storage dam	Silted and broken boundary fence	Desiltation and fencing
Crop production area	Existing field area is clean and free of vegetation	Land clearing on the additional 5Ha

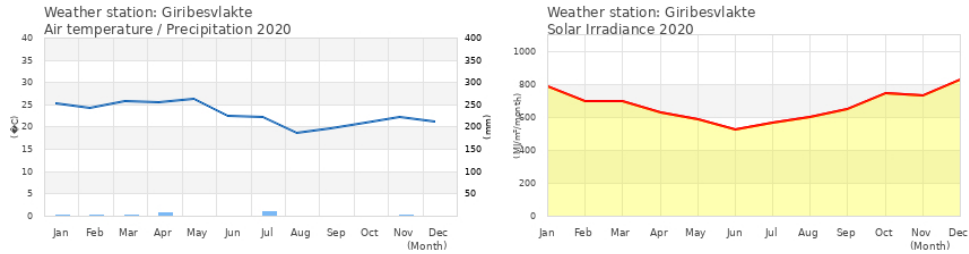
Figure 4: Average monthly temperature, precipitation and solar irradiance for the Warmquelle area. Source: SASSCAL Weathernet: http://www.sasscalweathernet.org/weatherstat_monthly_we.php.

The median annual rainfall ranges from less than 50 mm to 250 mm in Namibia's hyper-arid southwest and coastline, and peak at 350 to 550 mm in the sub-humid northeast. Overall, about 22% of the country is classified as hyper-arid, 70% as arid, and less than 8% as dry sub-humid, (Mendelsohn, 2003). The potential evaporation is more than five times greater than average rainfall in the greater part of the country and lack of rainfall is regarded a key limitation to the country's development. This makes Namibia one of the world's most vulnerable countries with regard to climate change due to its extreme aridity and dependence on primary industry, combined with a limited adaptive capacity, (Brown, 2009). Approximately 70% of Namibia's population lives in rural areas. Farming is the dominant land use in Namibia, but it is characterized by low production and high risk due to arid conditions, infertile soils and generally poor land use practices. The project area is very arid and water is critical resource for both human beings and wildlife. It is very critical to embrace a combination of various technologies for water harvesting, efficient conveyance (zero losses) and efficient utilization on the agricultural enterprise to be established.

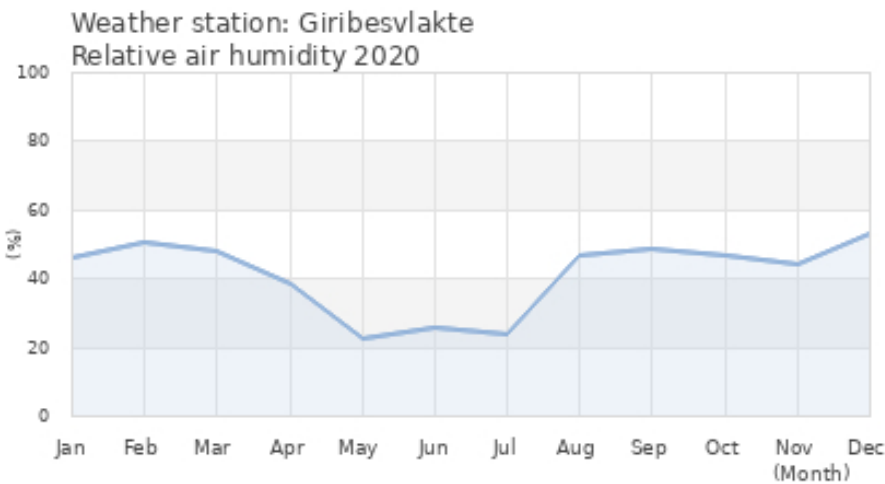
Figure 5: The project area's monthly average humidity. Source: SASSCAL Weathernet: http://www.sasscalweathernet.org/weatherstat_monthly_we.php.

The air in the proposed project area is generally dry throughout the year with an average humidity of about 20%. This is too low than the tolerable humidity of 70 -80 % for fresh vegetable production. Optimum growing humidity is achievable under controlled cultivation systems using fogging systems which will be installed in both net houses and green houses.

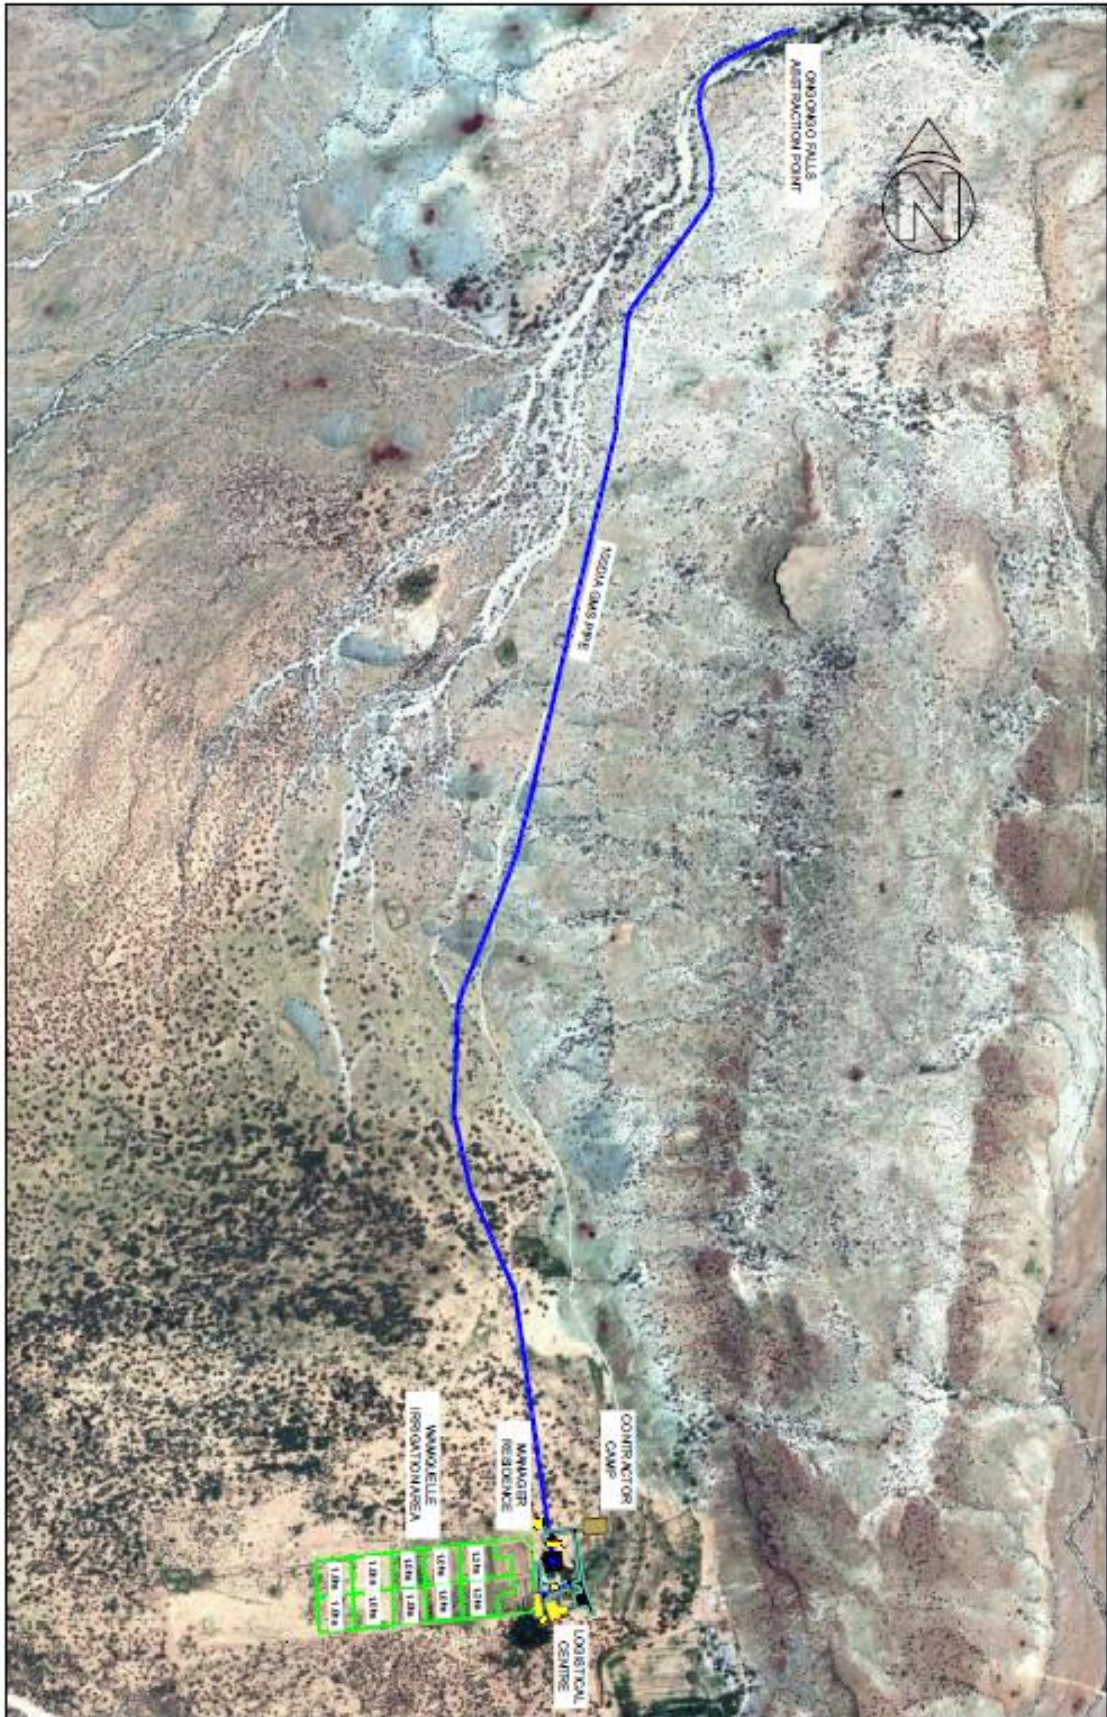
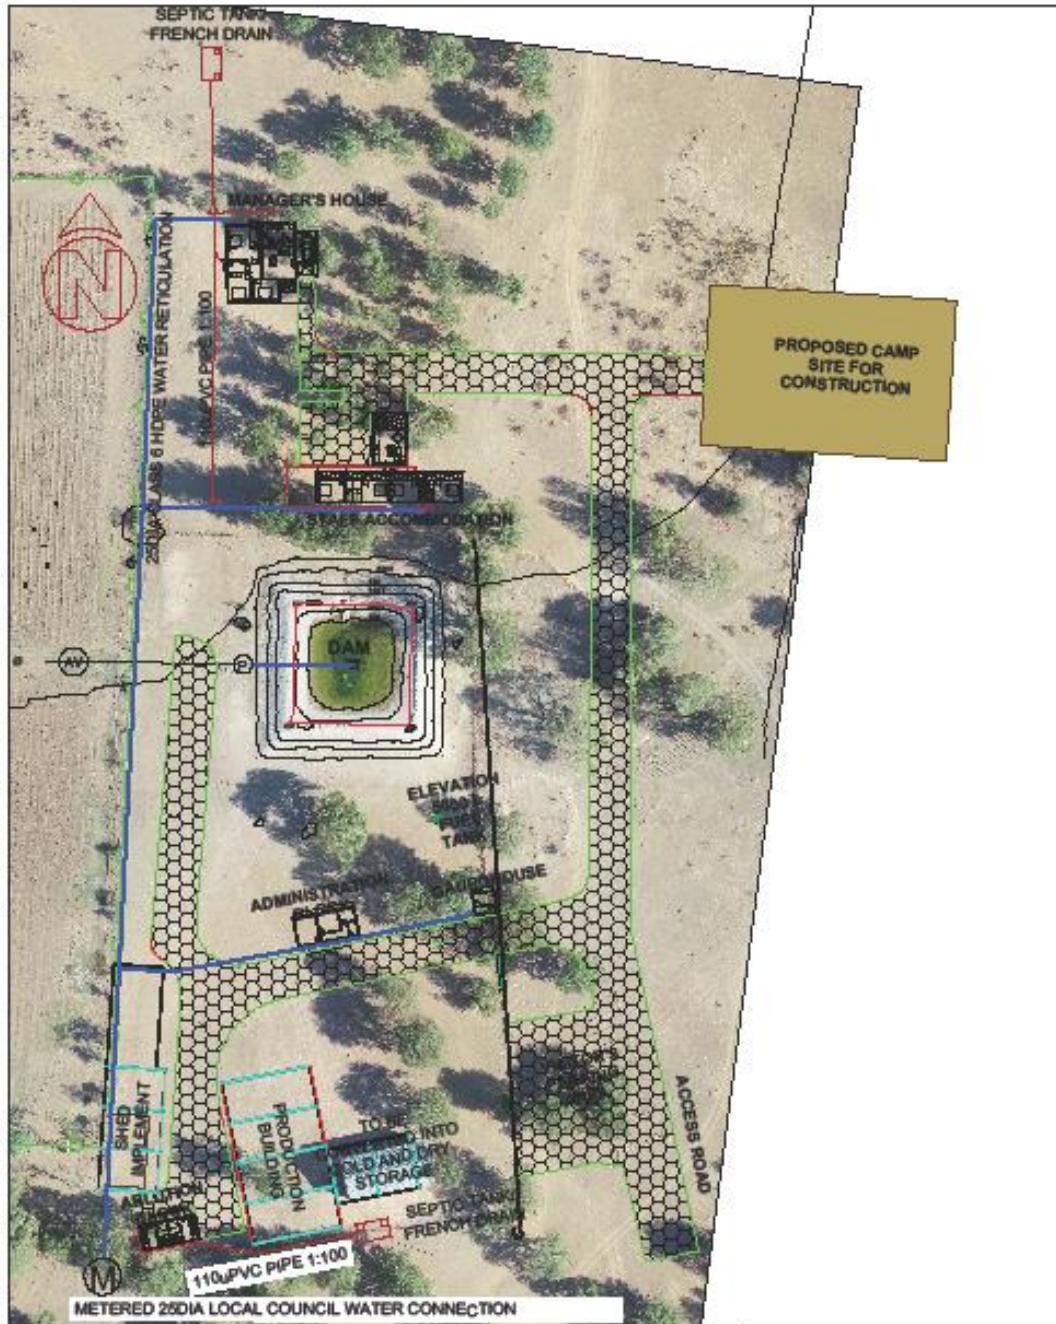
ANNEXURE C1

- 110 DIA uPVC PIPE
- 25 DIA HDPE CLASS 4 DOMESTIC WATER LINE
- M 25 DIA DIAMETER KENT WATERMETER

Project WARMQUELLE/KHOWARIB IRRIGATION		Drawing Name WARMQUELLE SEWER LAYOUT		Date 15/01/2021
Client ENVIRONMENT INVESTMENT FUND OF NAMIBIA P. O. BOX 38157, AUAS VALLEY, WINDHOEK, NAMIBIA Phone: +264 61 431 7780 Email address: Contact person:	Project Managers DUNAMS CONSULTING ENGINEERS 8065 SCHWEITZER STREET, WINDHOEK WEST, WINDHOEK, NAMIBIA Phone: +264 61 238 911 Email: Contact person: A. Ushona	Contractor FIVE STAR INVESTMENT CC. ERF NO. 474, LONDON STREET WINDHOEK, NAMIBIA Phone: +264 811 622 042 Email: fivestar.invest@yahoo.com Contact person: L. Makutana	Agricultural Consultant ALOE AGRICULTURE TECHNOLOGIES (PTY) LTD. ERF NO. 919 NANCHAB ST, GIBESHA, BOX 20143, WINDHOEK, NAMIBIA Phone: 264 813 230 188 Email: info@aloesagritech.com Contact person: K. Shilolo	Consultants OUTRUN CONSULTANTS CC. NO. 10 WOERMANNBROCK BLDG, INDEPENDENCE AVENUE BOX 7622, KHOMASDAL WINDHOEK, NAMIBIA Phone: 264 61 2883 57 Email: Contact person: J. T. Makutifi
