# ENVIRONMENTAL ASSESSMENT OF THE PROPOSED TANNERY ESTATE WINDHOEK

PROJECT NAME	Environmental Assessment of the proposed Tannery Estate on Portion 1 of Elisenheim No 68.
STAGE OF REPORT	Draft Scoping Report
CLIENT	Tannery Estate (Pty) Ltd. Attention: Dirk Mudge
CONSULTANT	Enviro Dynamics cc Enquiries: Stephanie van Zyl Tel: +264 (0) 61 223 336 E-Mail: <a href="mailto:Stephanie@envirod.com">Stephanie@envirod.com</a>
DATE OF RELEASE	November 2016
AUTHOR MAPPING	Stephanie van Zyl Eddy Kuliwoye

# STONE PROJECTS IN WINDHOEK ENVIRONMENTAL CONDITIONS ASSESSMENT

<b>Project:</b>	<b>ENVIRONMENTAL CONDITIONS ASSESSMENT FOR THE STONE PROJECTS IN WINDHOEK AS ON 29 MARCH 2015</b>	
<b>Report Version/Date</b>	Final 05 August 2015	
<b>Prepared for:</b>	<b>Stone Projects Namibia (Pty) Ltd</b> P.O. Box 22605 Windhoek Namibia	
<b>Lead Consultant</b>	Geo Pollution Technologies (Pty) Ltd PO Box 11073 Windhoek Namibia	TEL.: (+264-61) 257411 FAX.: (+264) 88626368
<b>Main Project Team</b>	<b>Pierre Botha (Leader)</b> (B.Sc. Geology/Geography); (B.Sc. (Hons) Hydrology/Hydrogeology)	
<b>Cite this document as:</b>	<b>Botha P, 2015 March; Environmental Conditions Assessment for Old Tannery - Stone Projects

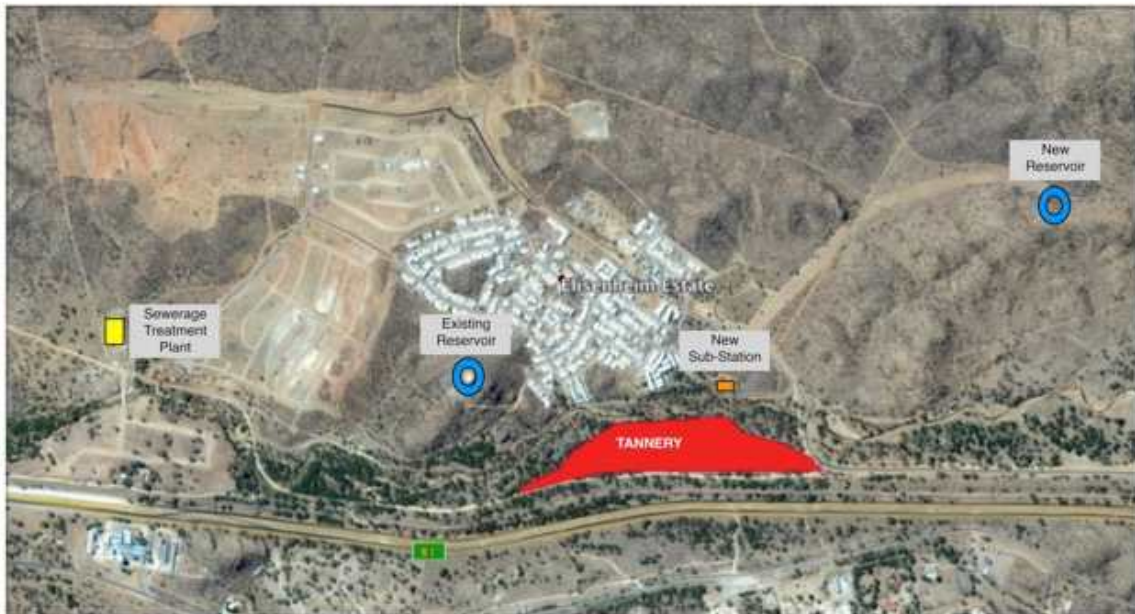
Figure 4: Bulk water, power and sewerage supply to the estate.

A NamPower 11kV overhead powerline supplies power to existing structures on the development. As the development falls within the extended City boundaries, a power supply from the City of Windhoek is proposed. The NamPower supply will need to be disconnected and overhead structures will need to be decommissioned and removed. Further investigation is required to determine the extent of the existing internal electrical infrastructure.

The infrastructure as explained is shown in Figures 3 and 4.

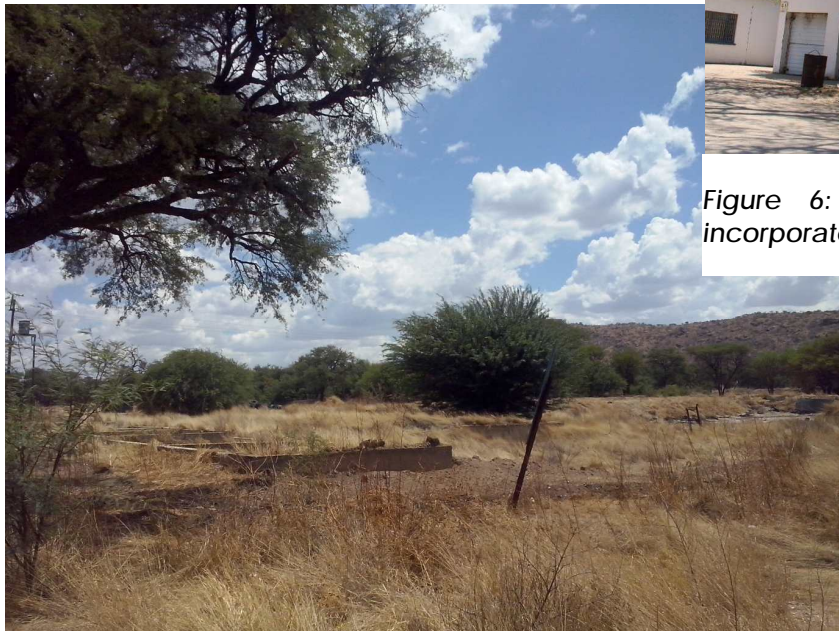
Figure 7: Large area dominated by grass cover; tree cover associated with alluvial plains in the background

Besides this natural habitat, an area of the site has been influenced by sheet flow originating from a tributary shaped by a culvert in the B1 to the west (Appendix B). On this portion, vegetation growth is limited and dominated largely by grass cover (Figure 7).

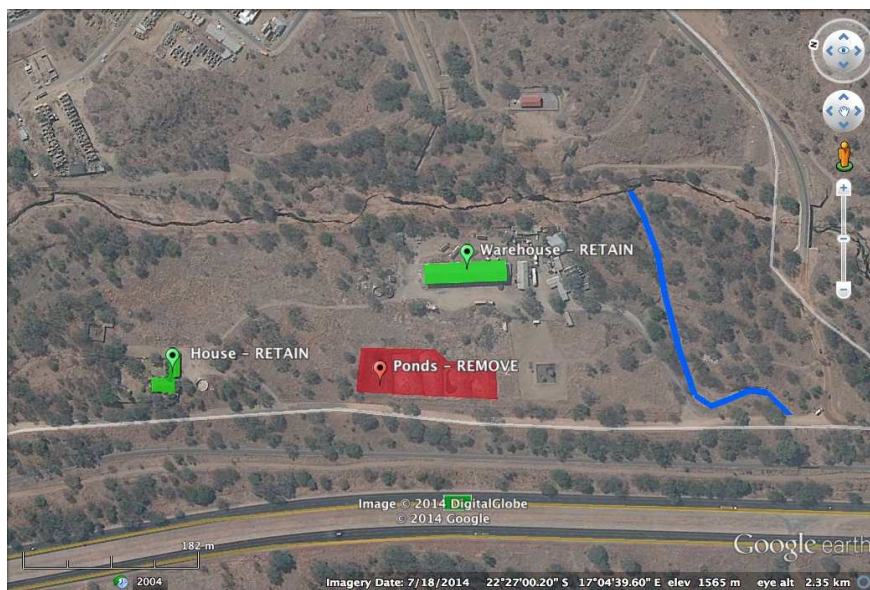
Figure 9: Existing structures and activities on the site, indicating which are to be retained and which removed.

The buildings on the site are currently being leased mainly for residential purposes and light industrial purposes, e.g. oil salvaging and processing, storage, etc. (Figure 9 - Figure 10).

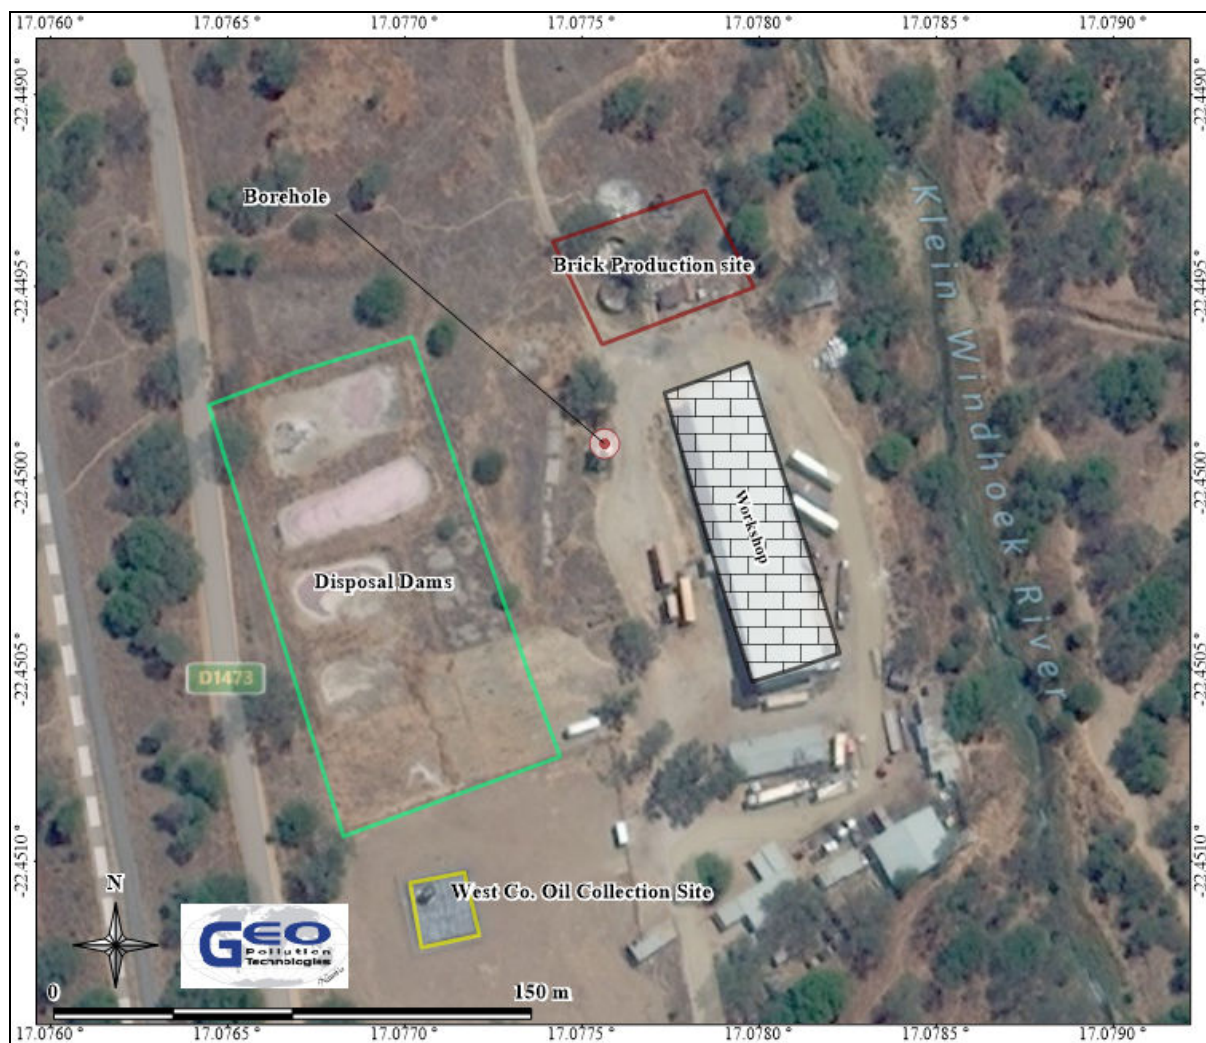
Figure 2. Site Overview

The study site is located 20 km north of Windhoek near the Elisenheim Township. Next to the Trans- Kalahari B1 highway. The Klein Windhoek River is located to the east of the workshop area (see Figure 2). A workshop is located on the site where the tannery operation used to operate. A borehole is located near the workshop towards the left in a westerly direction where the water sample was collected. An oil waste collection point is located south of the disposal dams, located over some of the old dams.

About 77 metres from the workshop building towards the west are four visible dams where waste from the tannery operation was pumped to. Evaluation of historic images indicated that in 2004, 7 disposal dams were visible on site. Over time some of the dams were covered with soil as can be seen in the images from the period 2004 – 2015, see Figure 3.

All the dams were found to be lined with a thin plastic liner to reduce infiltration into the subsurface. Muddy material containing hair and salt deposit is present in the dams.

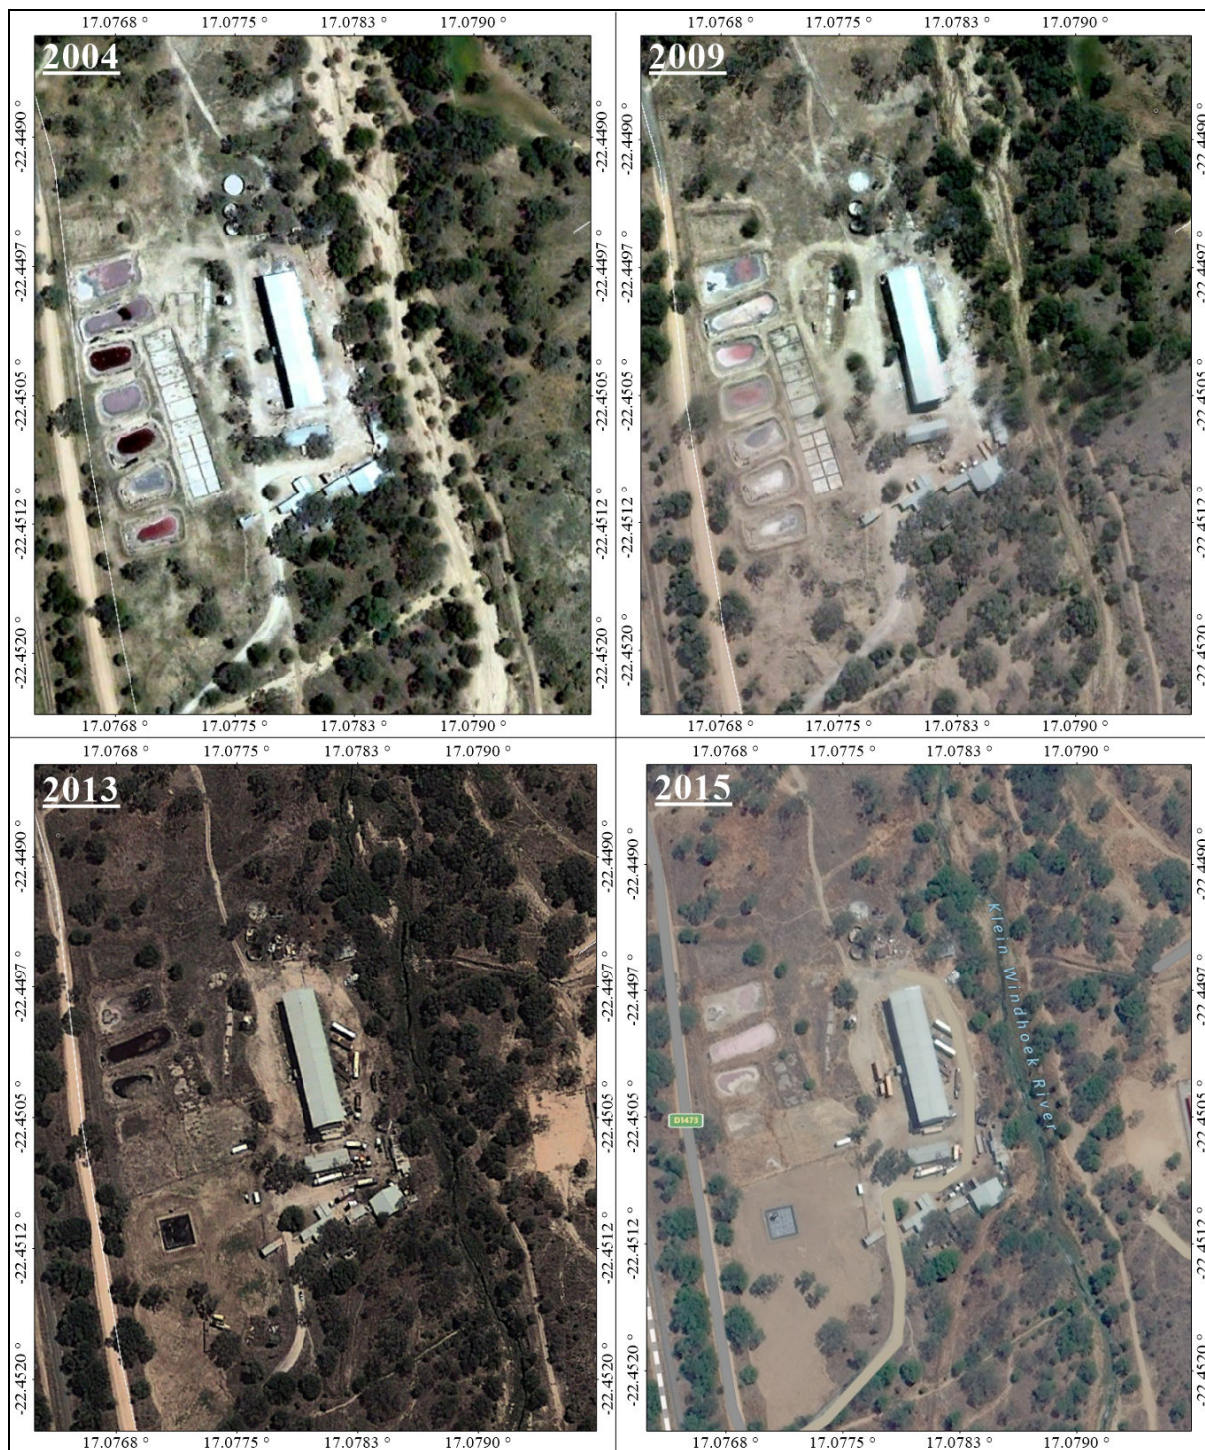
**Figure 3. Historic to recent images of project site**

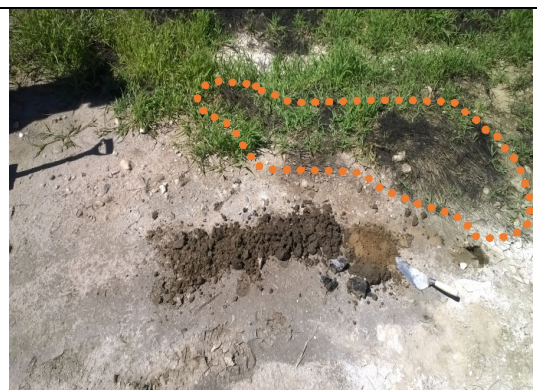
**Photo 1. Staining at Sample Point A1**

The site surrounding is generally clean. Oil stains from the nearby waste oil collection operation has contaminated the top surface of the dam directly to the north of their operation. One such oil stain can be seen in Photo 1 where sample A1 (8551539) was collected.

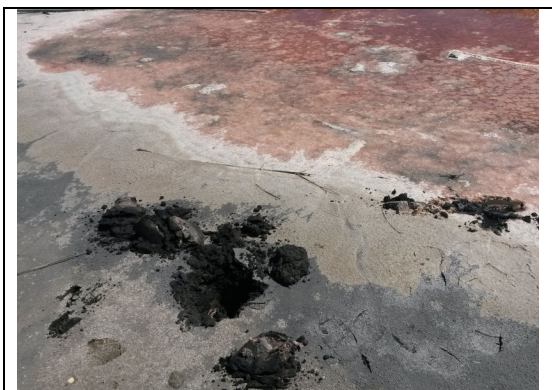
**Photo 2. Salt surface layer and sludge**

Some of the dams has a salt layer (Photo 2) with water present in part of the dam surfaces (Photo 3). The pinkish salt colour is similar to that of Cr(VI) salts.

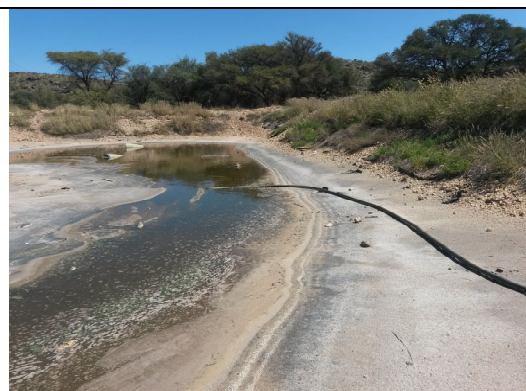
**Photo 3. Water in dams**

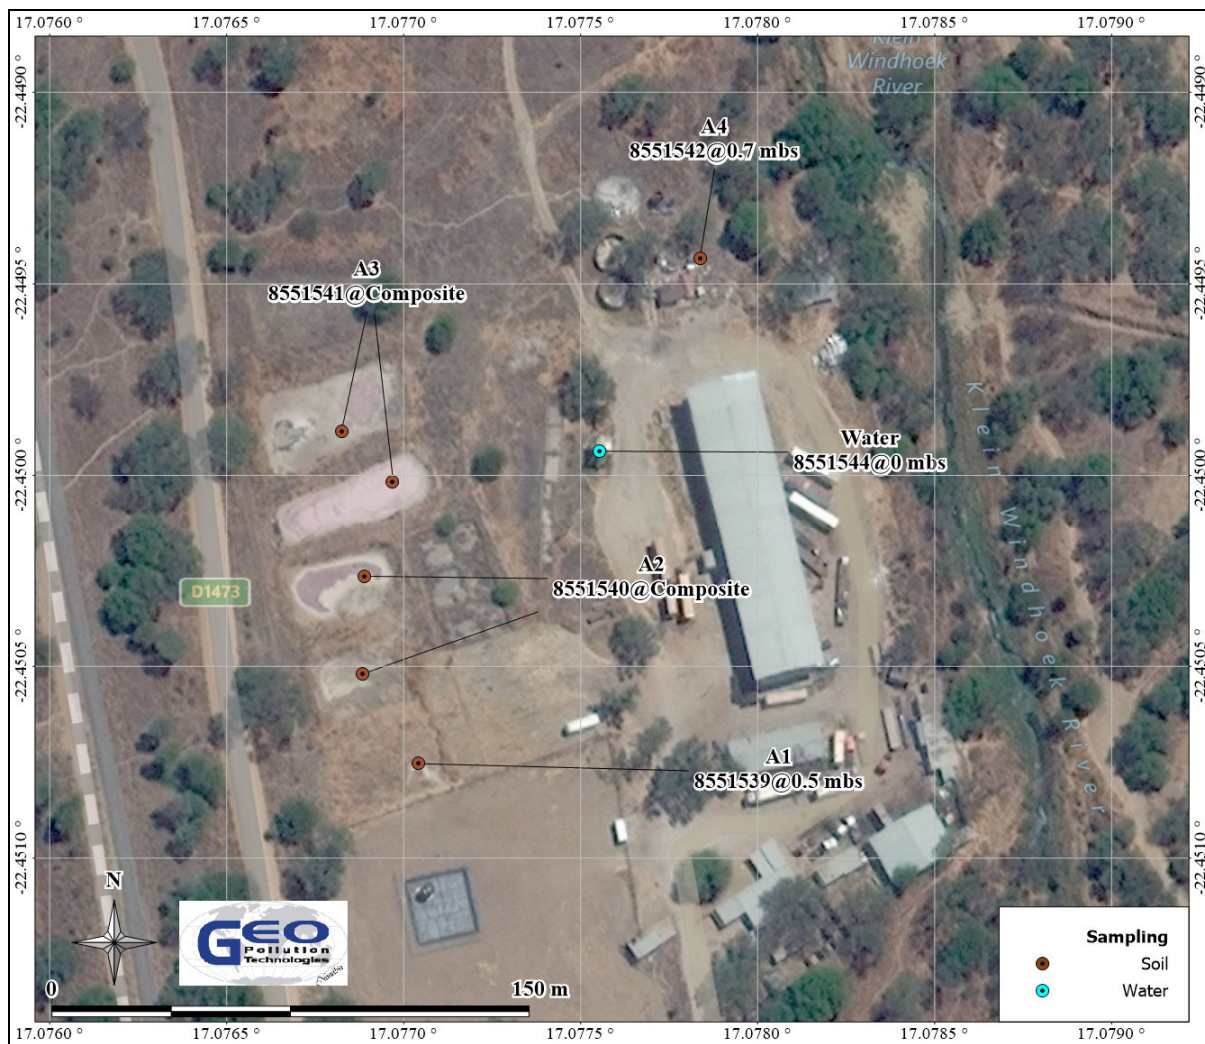
**Figure 4. Sample Locations**

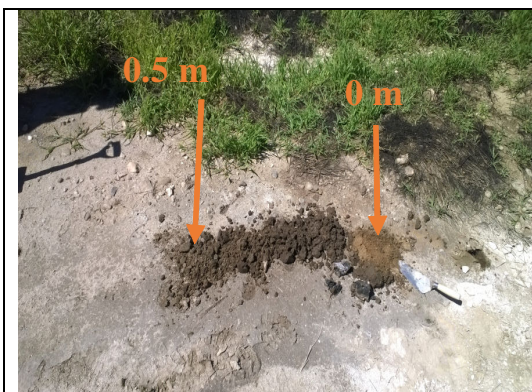
**Photo 4. Sample Point A1**

**Sample Point A1** was made through augering into a partially covered dam. The surface was hard and drilling difficult to penetrate. The hole was drilled up to 0.5 m when a plastic liner was intersected. Soil was dry at 0 m but clayey deeper down the hole. Oil stains are visible on surface in Photo 4. Auger hole A1 was used to take sample number 8551539 at 0.5 m.

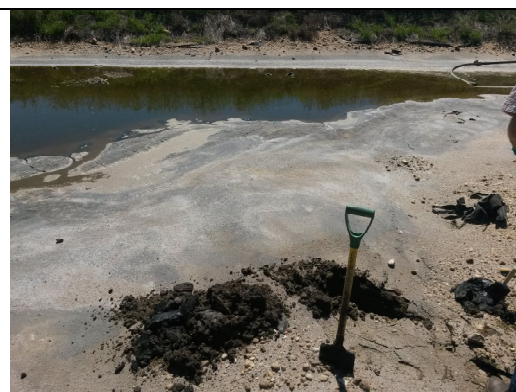
**Photo 5. Sample Point A2**

**Sample Point A2** consisted of two soil samples combined as indicated in Figure 4. The soil was sludgy and had a strong odour. Soil was collected at surface. Composite soil from the two locations was used to take sample number 8551540.

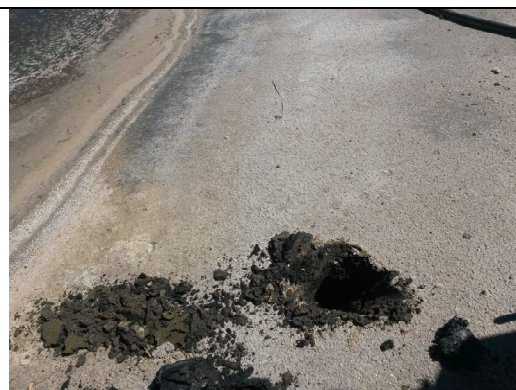
**Photo 6. Sample Point A3**

**Sample Point A3** consisted of two soil samples combined as indicated in Figure 4. The soil was sludgy and had a strong odour. Soil was collected at surface. Composite soil from the two locations was used to take sample number 8551541.
