ONGAVA TENTED CAMP

ENVIRONMENTAL MANAGEMENT PLAN

2021

Prepared for the renewal of Environmental Clearance by Ongava Game Reserve (Pty)
Ltd

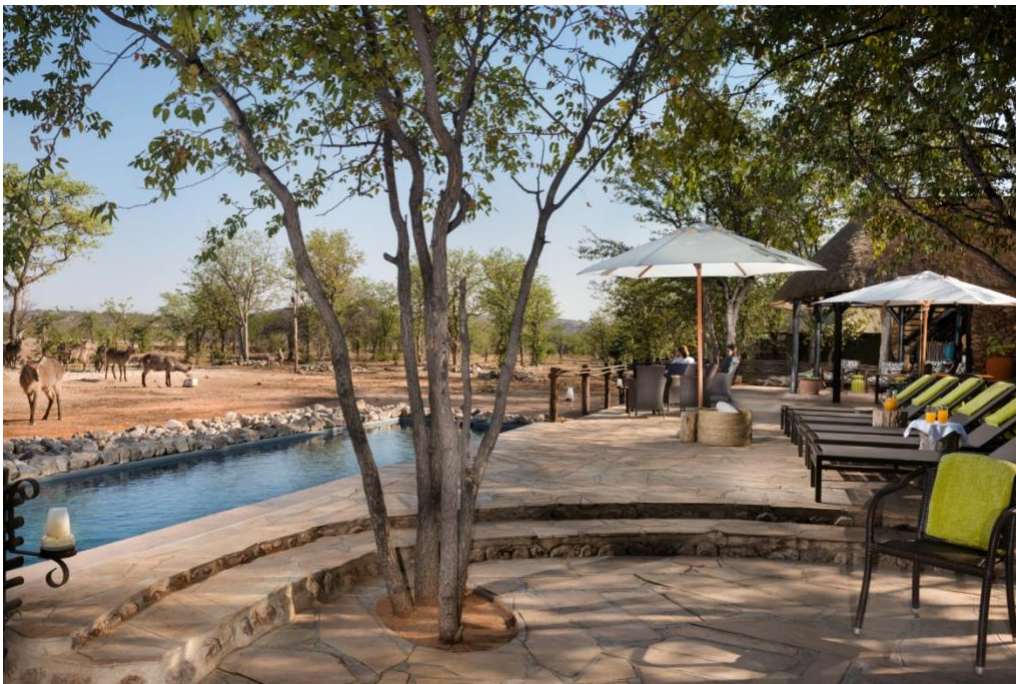
Figure 2. Swimming pool and main area.

The main area is built of stone and thatch with stone paving and a wooden deck. It contains a bar, curio shop, dining room, lounge and outdoor lounge/eating area (C in Figure 3). The swimming pool is surrounded by stone paving (Figure 2). Vehicles park in a compacted dirt area (A in Figure 3).

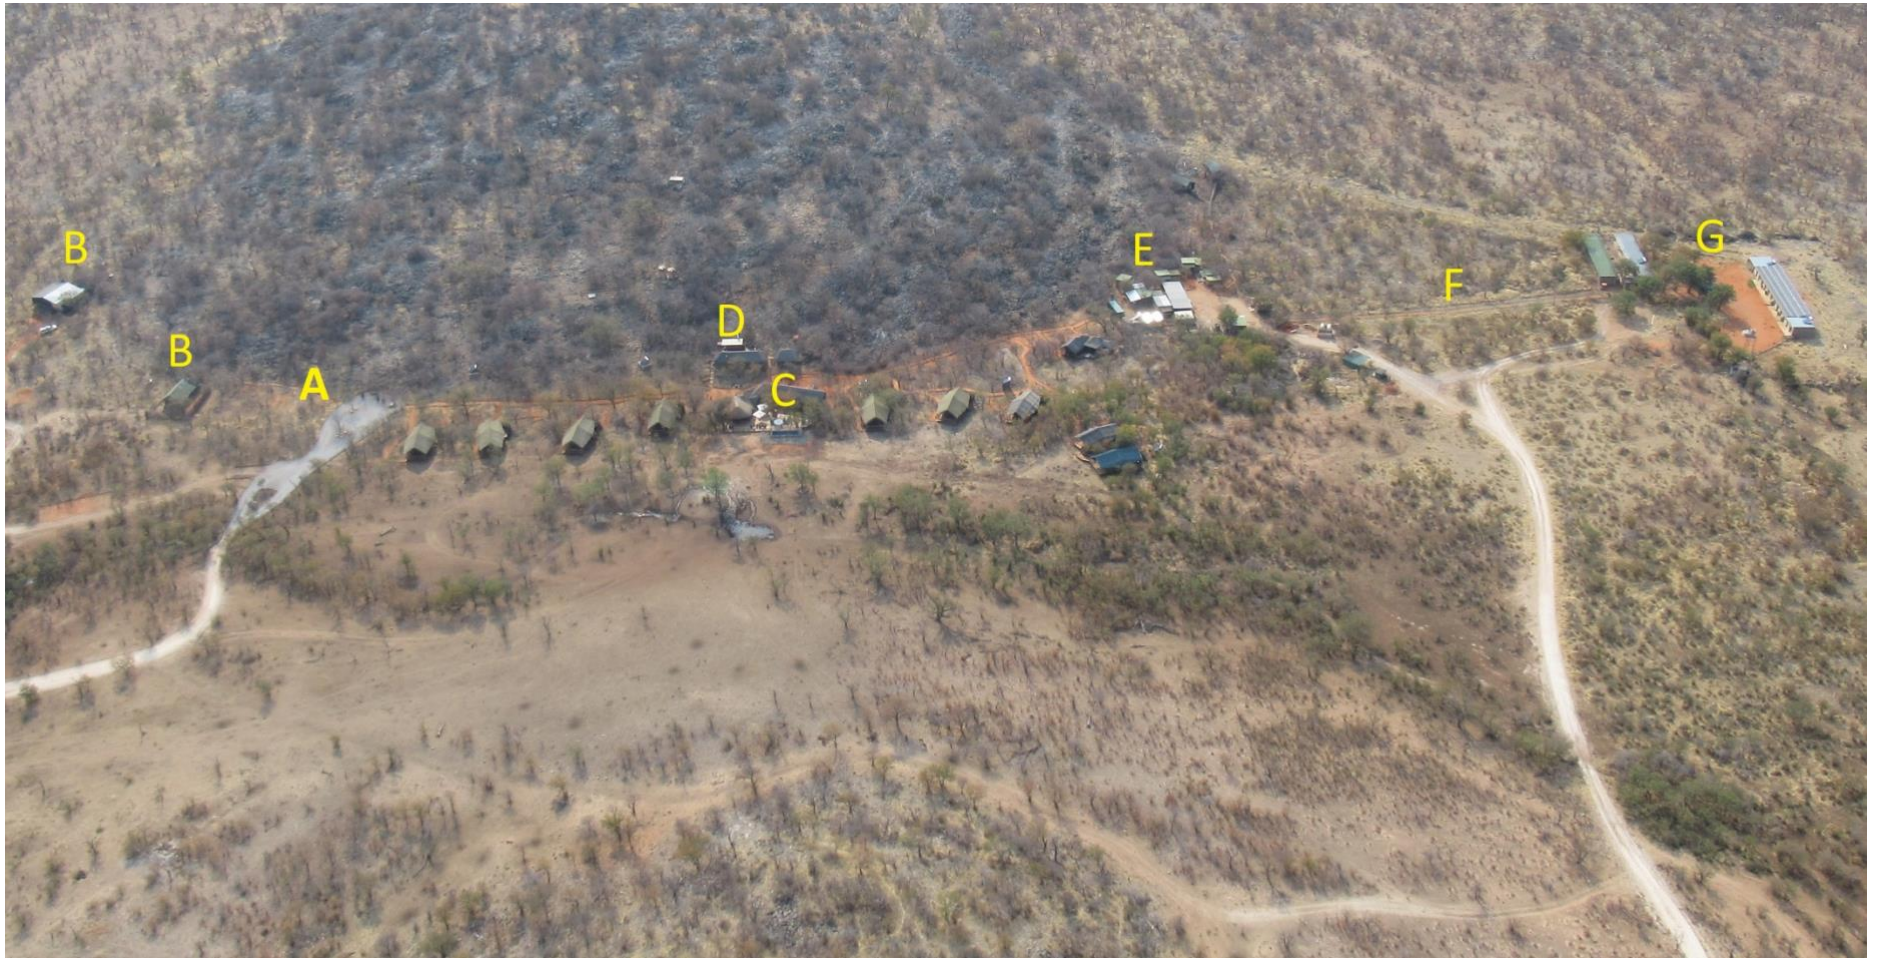
Figure 3. Aerial photo showing layout of Ongava Tented Camp.

A: Parking, B: 2x management houses, C: main area, D: kitchen, E: laundry and senior staff accommodation, F: fenced path to staff village, G: staff village

Ongava Tented Camp nestles in Mopani woodland at the foot of a dolomite hill (Figure 3). The buildings are positioned on ground level for a close-up, intimate bush experience. A waterhole directly in front of the lounge ensures frequent wildlife encounters in the camp.

The kitchen, a stone building with corrugated iron roof and concrete floors, is detached from the main area (D in Figure 3). It includes food and drinks storage, an office and staff toilet.

The laundry and housekeeping store rooms are housed in a brick building with corrugated iron roof (E in Figure 3).

The lodge has 26 staff members. The staff village (G in Figure 3) is surrounded by a 2.3 m high fence with two electrified strands, necessitated by the regular presence of lions in the camp. The pathway to the staff village is also fenced (F in Figure 3). Each staff member has a single room and ablutions are shared. Other staff facilities include a kitchen and lounge with DSTv provided by Ongava.

The laundry and senior staff accommodation compound (E in Figure 3) contains five en-suite guide rooms, and three en suite management rooms.

Management accommodation (B in Figure 3) consists of two canvas, deck and thatch houses; one with two bedrooms and the other with one bedroom.

There is no workshop at Ongava Tented Camp, since all vehicle maintenance is done at the Reserve headquarters. Maintenance and housekeeping store rooms are indicated by E in Figure 3. Diesel tanks (two 2,200 litre) are mounted on a bunded cement floor to contain spillage. The entire back of house complex (E in Figure 3) is surrounded by a 2.3 m high electrified fence.

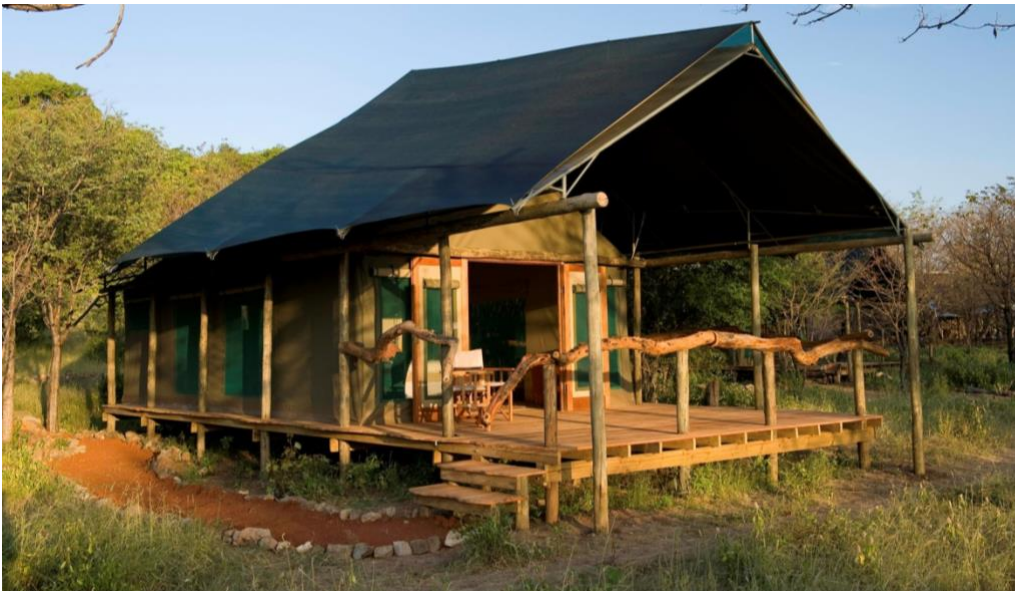
Figure 4. Guest tent.

There are eight guest units sleeping a total of 18 guests, plus two twin tents for paying pilot/guides. The tents are mounted on wooden platforms, connected to the main area by sand pathways (Figure 4). All the tents are en-suite.
