# ENVIRONMENTAL MANAGEMENT PLAN

**For Solar Salt Mining Operations on Mining Licence  
ML147 - Cape Cross within the Dorob National Park,  
Erongo region.**

#### ENVIRONMENTAL REPORT FOR MINING LICENCE: ML-147

**JULY TO DECEMBER 2018**

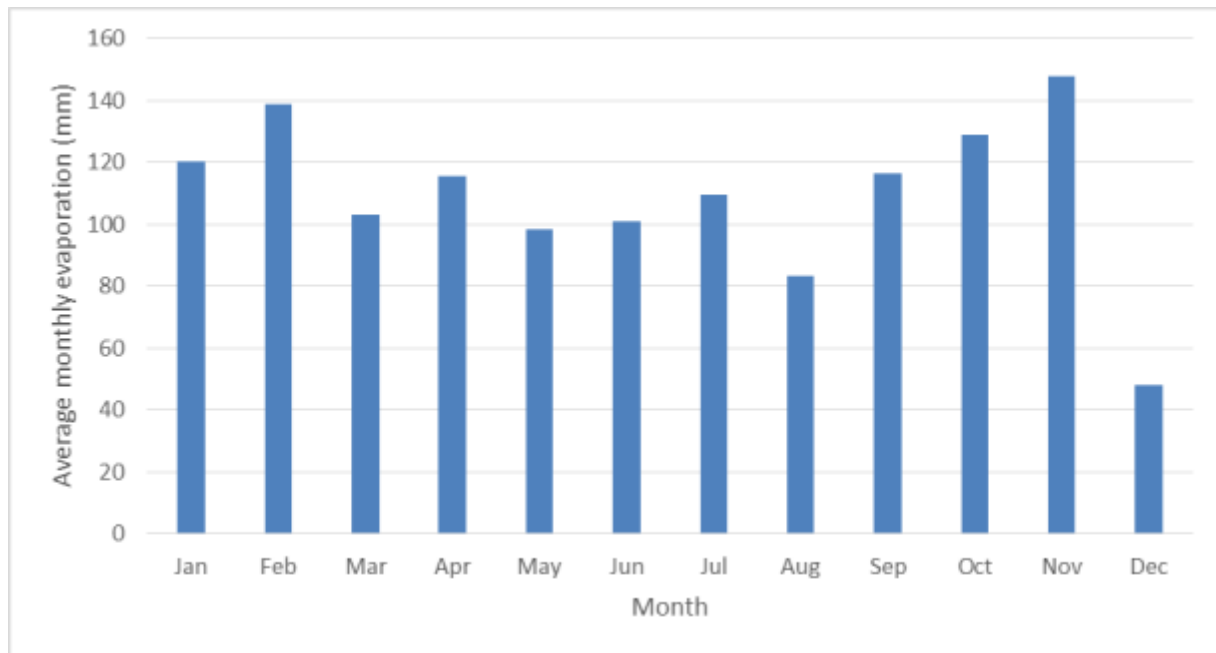
At Cape Cross, Gecko Salt, which operates a centralised salt wash plant within its Accessory Works area, regularly conducts continuous measurement of the evaporation rate using an A-pan. This information indicates the rate at which salt crystallises in the ponds. The evaporation A-pan data up to July 2018 is summarised in the following graph. Data collection started in April 2009. The average annual evaporation for the period was 1.3m/m<sup>2</sup> for a previous period for a full year of data. During the warmer and windy months evaporation rates are higher.

Figure 1. Monthly average evaporation from the A-pan at Cape Cross from 2009 to 2018

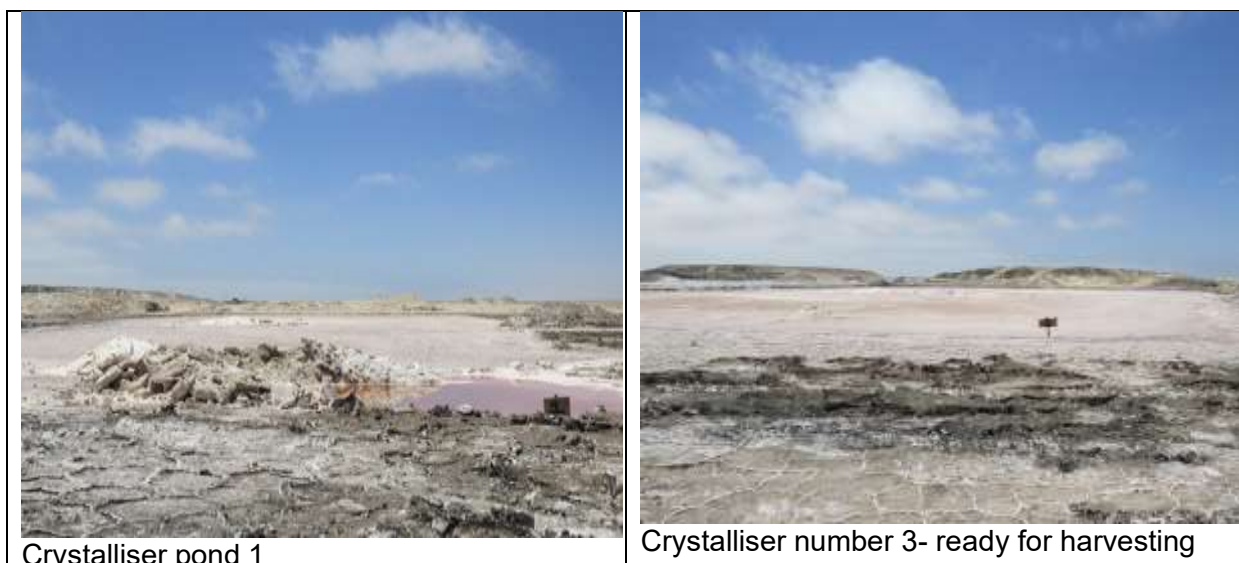
Figure 3. Images of the crystallisers 1 and 3

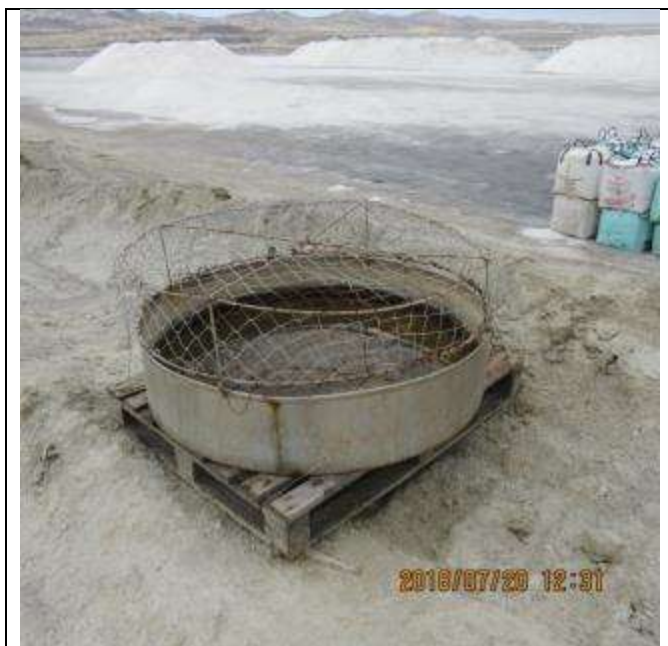
No dedicated weather station was commissioned for providing weather data for the mine. Only an A-pan which measures evaporation has been commissioned.

Figure 4. Image of A-Pan evaporation pan at Cape Cross salt pan

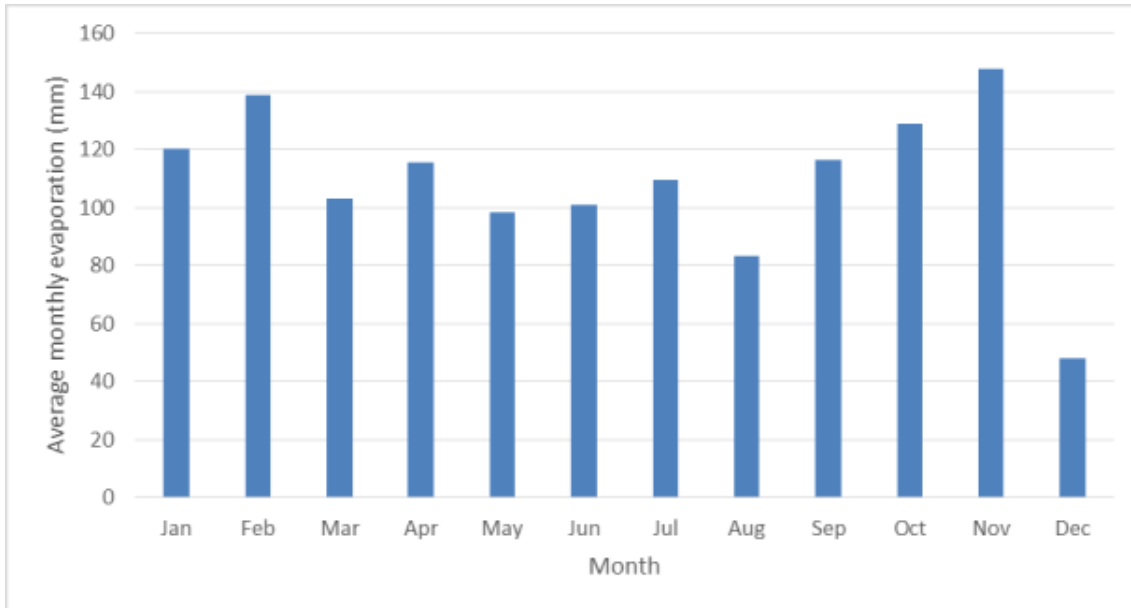
At Cape Cross, Gecko Salt, which operates a centralised salt wash plant within its Accessory Works area, regularly conducts continuous measurement of the evaporation rate using an A-pan. This information indicates the rate at which salt crystallises in the ponds. The evaporation A-pan data up to July 2018 is summarised in the following graph. Data collection started in April 2009. The average annual evaporation for the period was 1.3m/m<sup>2</sup> for a previous period for a full year of data. During the warmer and windy months evaporation rates are higher.

Figure 1. Monthly average evaporation from the A-pan at Cape Cross from 2009 to 2018

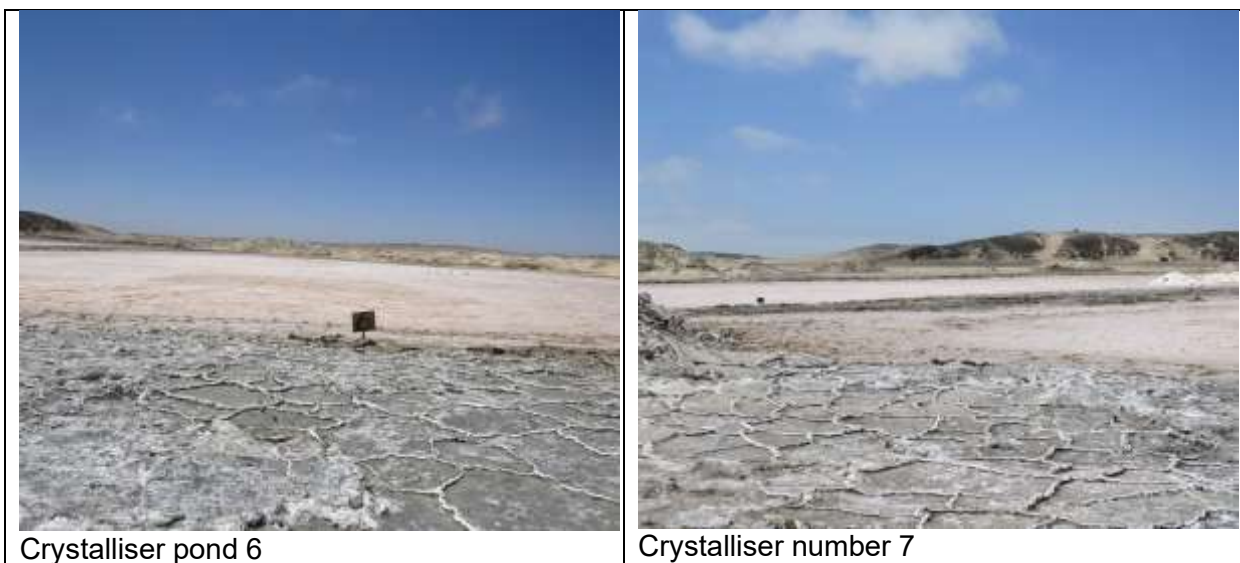
Figure 3. Images of the crystallisers 6 and 7 ready for harvesting

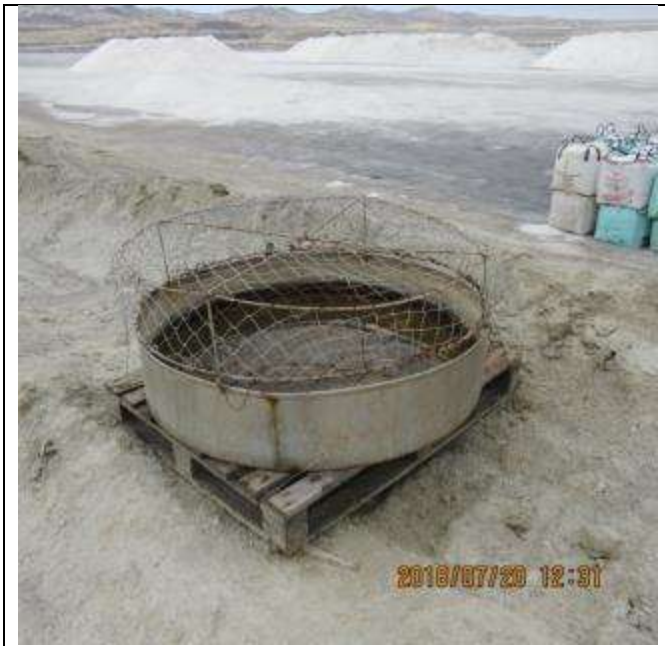
No dedicated weather station was commissioned for providing weather data for the mine. Only an A-pan which measures evaporation has been commissioned.

Figure 4. Image of A-Pan evaporation pan at Cape Cross salt pan

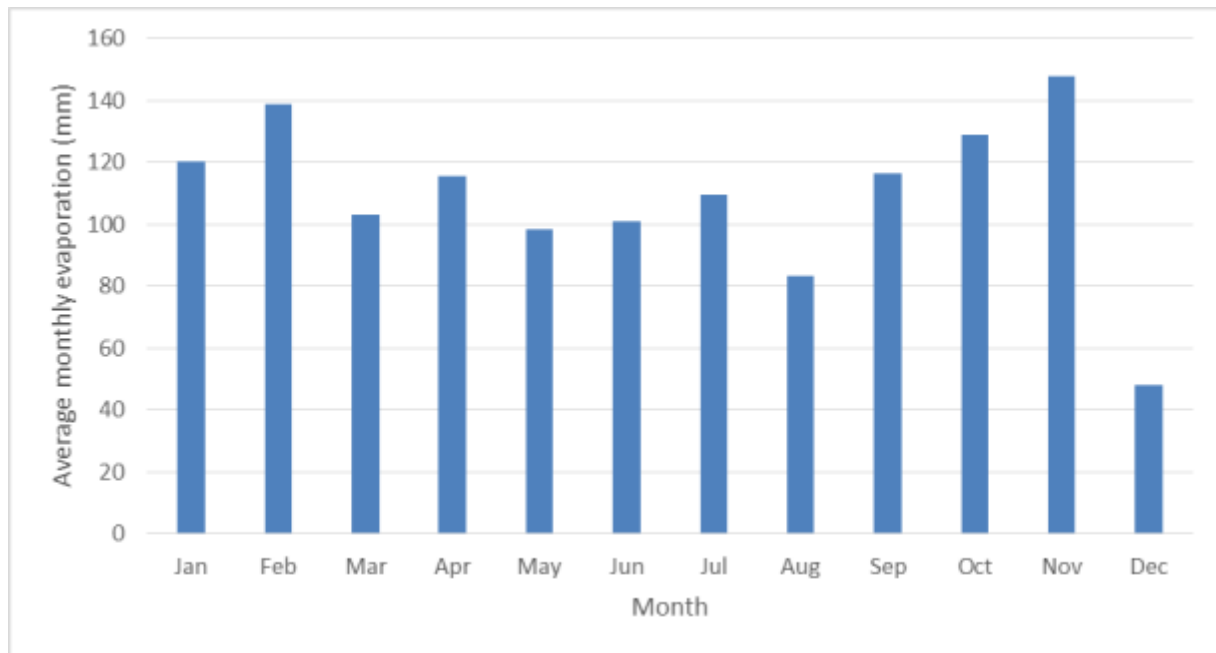
At Cape Cross, Gecko Salt, which operates a centralised salt wash plant within its Accessory Works area, regularly conducts continuous measurement of the evaporation rate using an A-pan. This information indicates the rate at which salt crystallises in the ponds. The evaporation A-pan data up to July 2018 is summarised in the following graph. Data collection started in April 2009. The average annual evaporation for the period was 1.3m/m<sup>2</sup> for a previous period for a full year of data. During the warmer and windy months evaporation rates are higher.

Figure 1. Monthly average evaporation from the A-pan at Cape Cross from 2009 to 2018

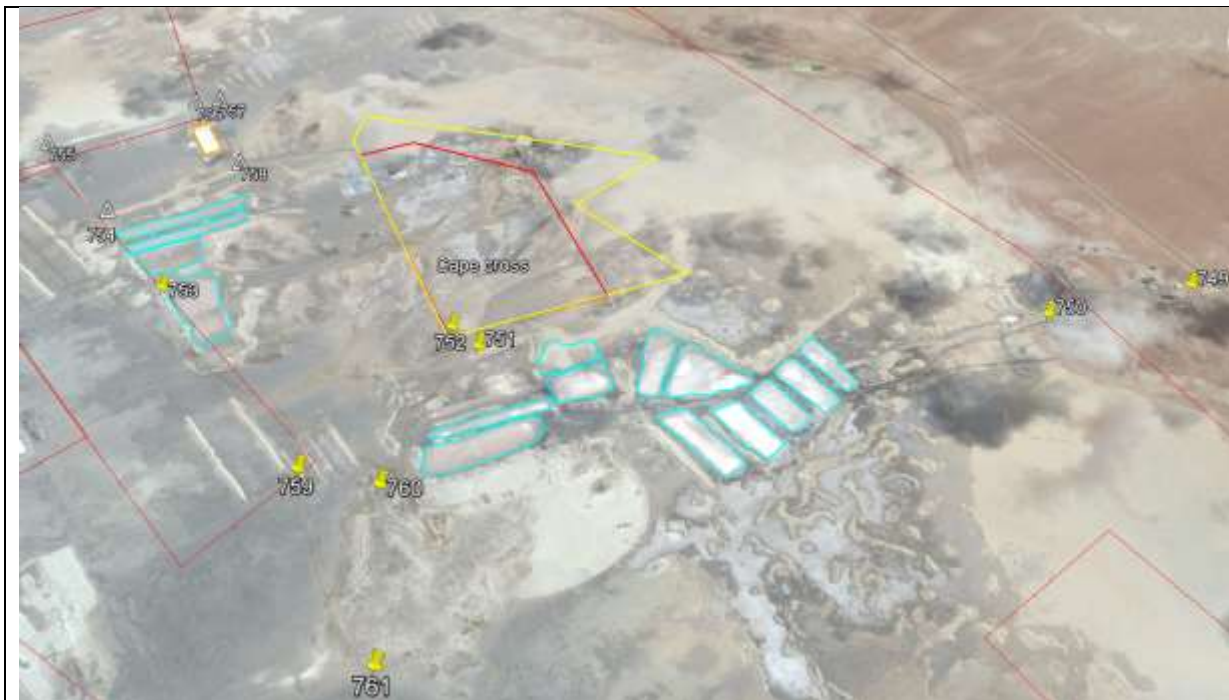
Figure 2: Satellite imagery showing the crystalliser within ML147. The yellow polygon is JD Salt's mining claim boundary according to a survey of the NEPL 2482 beacons. The red polygon shows mining claim 65980 as obtained from the MME website

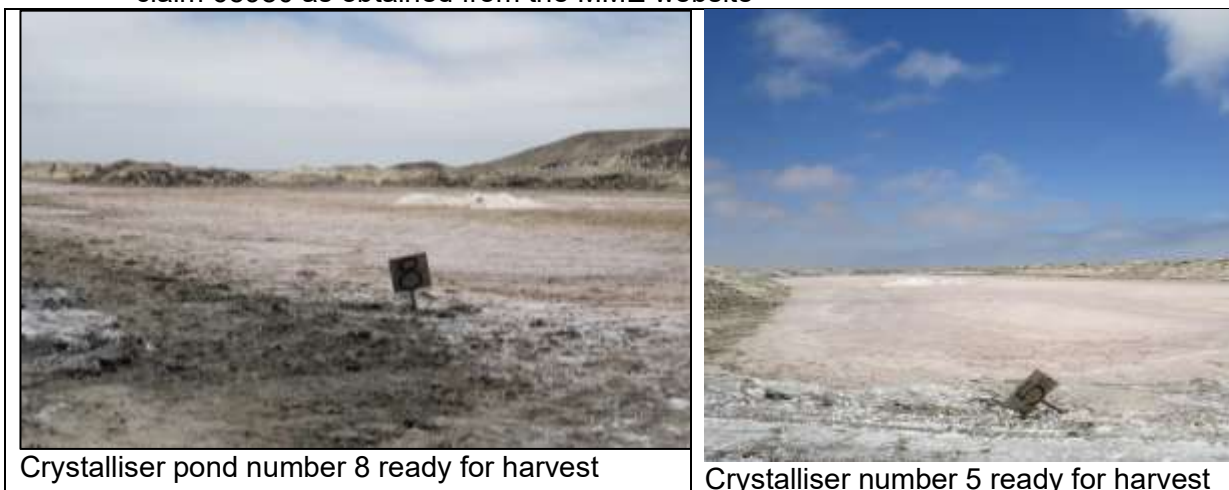
Figure 3: Images of the crystallisers 8 and 5

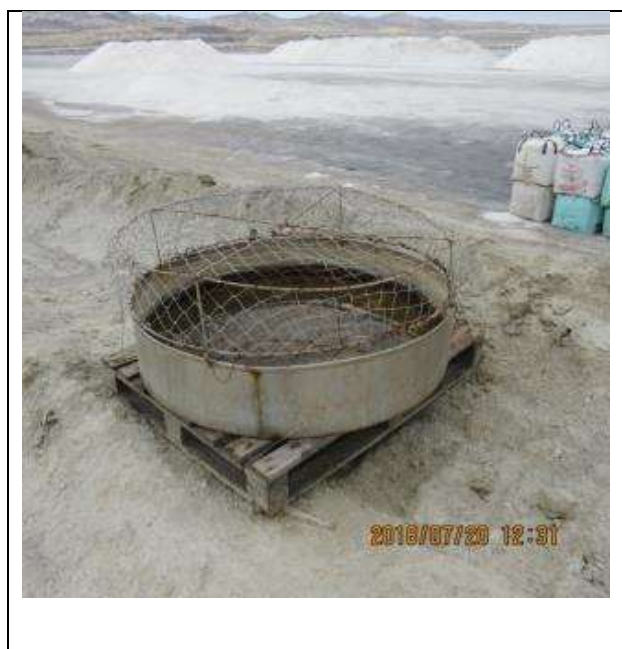
No dedicated weather station was commissioned for providing weather data for the mine. Only an A-pan which measures evaporation has been commissioned.

Figure 4: Image of A-Pan evaporation pan at Cape Cross salt pan

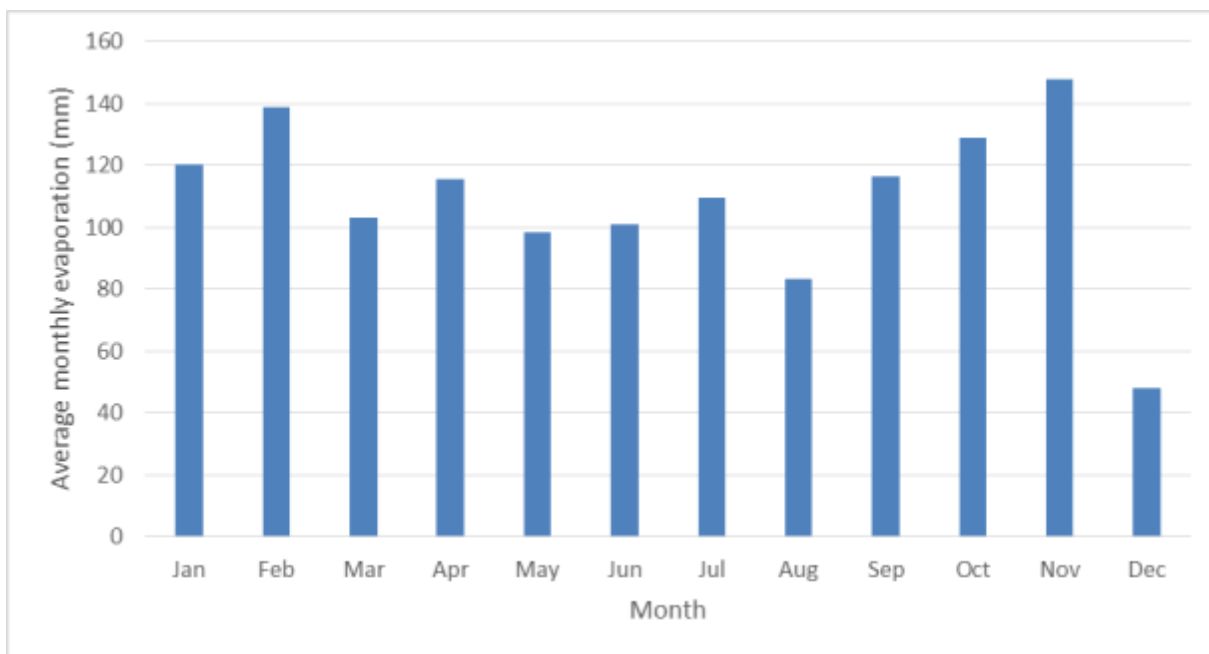
At Cape Cross, Gecko Salt, which operates a centralised salt wash plant within its Accessory Works area, regularly conducts continuous measurement of the evaporation rate using an A-pan. This information indicates the rate at which salt crystallises in the ponds. The evaporation A-pan data up to July 2018 is summarised in the following graph. Data collection started in April 2009.

The average annual evaporation for the period was 1.3m/m<sup>2</sup> for a previous period for a full year of data. During the warmer and windy months evaporation rates are higher.

Figure 1. Monthly average evaporation from the A-pan at Cape Cross from 2009 to 2018

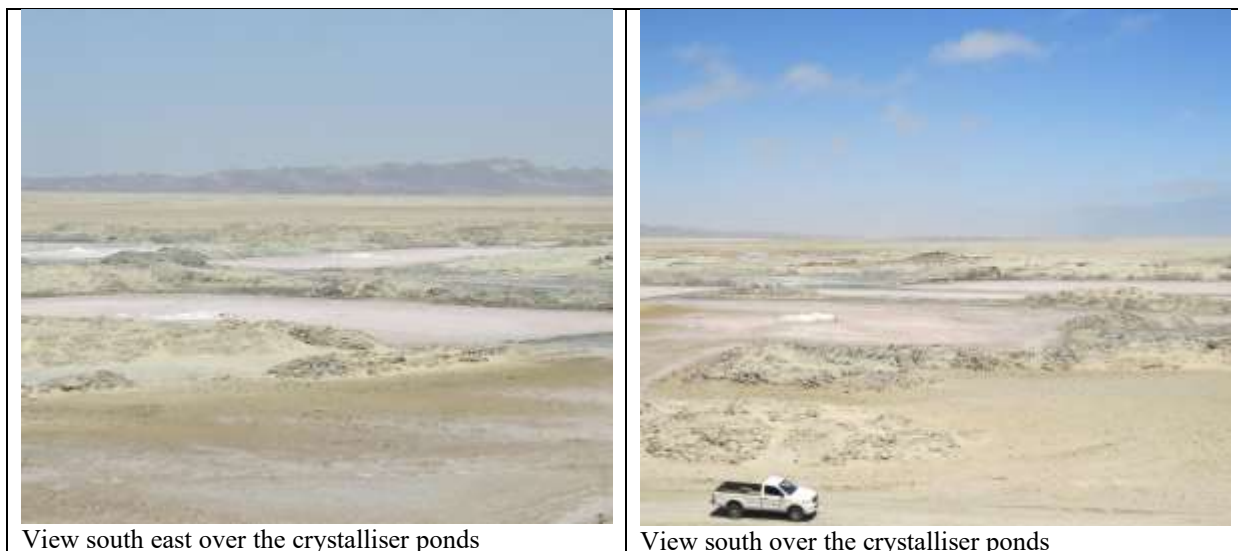
The report cover page shows the existing salt crystallizer pans, with numbers 1 to 16 within the Mining Licence. An existing track leading off the C34, past the derelict old works shops, onto the Cape Cross salt pan allow for regular access for mobile plant to enter the crystallizer area.

Figure 2. Photo imagery giving an overview on the crystalliser area within ML147

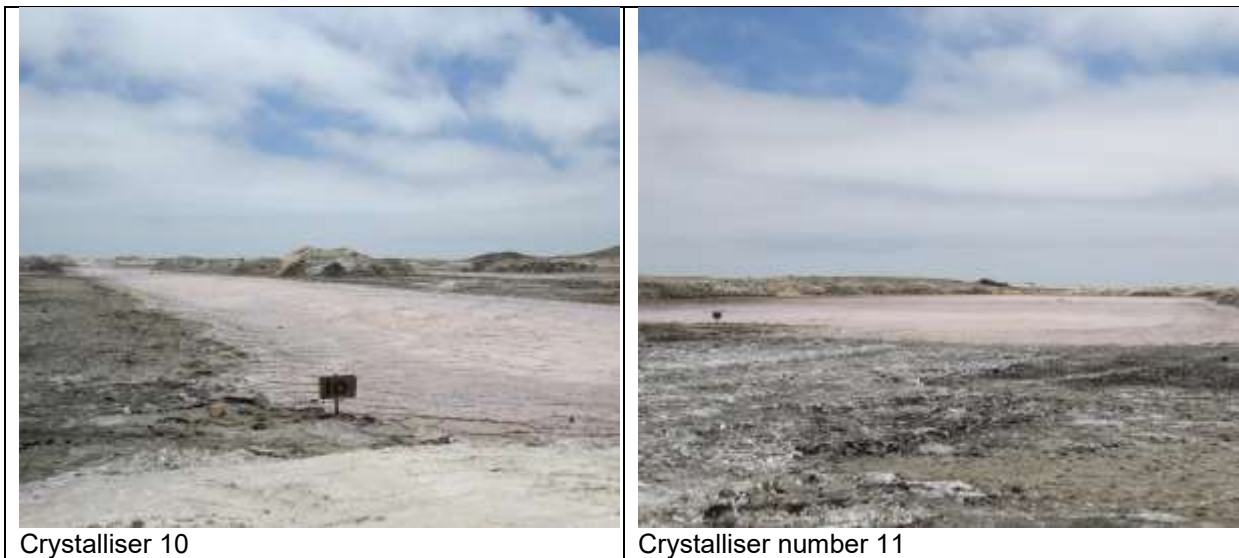
Figure 3. Images of the crystallisers 10 and 11.

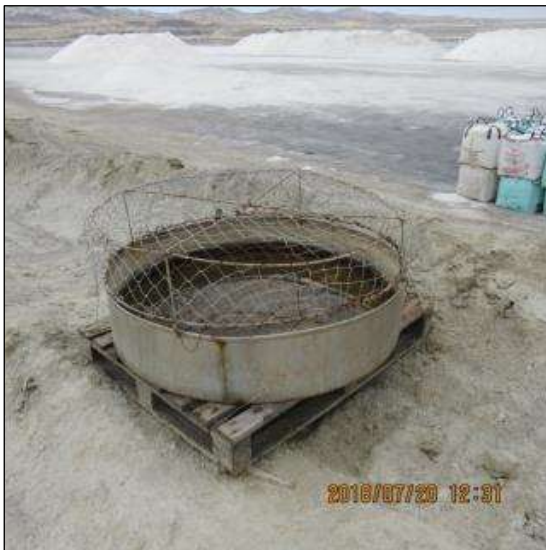
No dedicated weather station was commissioned for providing weather data for the mine. Only an A-pan which measures evaporation has been commissioned.

Figure 4. Image of A-Pan evaporation pan at Cape Cross salt pan
