# **ONDJOMBO LODGE**

## **Environmental Management Plan**

Prepared for Ondjombo Lodge for the Renewal of its Environmental Clearance  
Certificate

| <b>PROJECT NAME</b> | <p><b>An Environmental Management Plan for the Upgrading and Renovation as well as the day-to-day Operational Activities of a New Lodge at Omudhu-WaHauwanga, Ruacana Constituency, Omusati Region</b></p> <p><b>Renewal of an Environmental Clearance Certificate</b></p> |

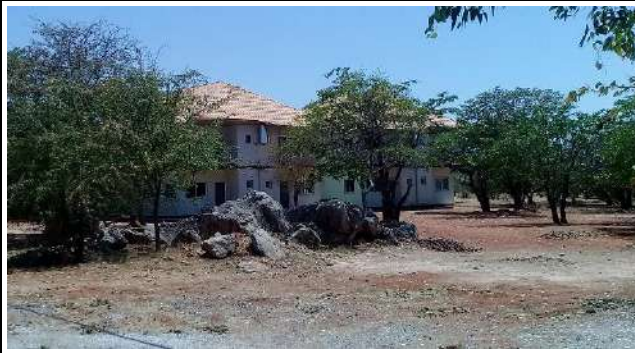
Figure 2: Guest Accommodation Section

- Guest room accommodation comprising of two double story buildings – each building consisting of eight bedrooms, four bedrooms on the ground floor and another four bedrooms on the first floor as more or less depicted in **Fig. 2**. All bedrooms are en suite and have built-in-cupboards. There is no furniture in the bedrooms.
- The kitchen is attached to the restaurant in which a small bar has been accommodated. This section is about 50 m from the guest room (**Fig. 3**). The kitchen is complemented by two fridge/freezer room and a storage room. Depending on the furniture configuration once installed, the restaurant is big enough to accommodate up to 50 guests. Outside the kitchen is a laundry and a drying yard (**Fig. 3**).

The sixteen (16) guest rooms were still empty and without any appliances and furniture. Metal roofing tile sheets have been used on the existing building which give the lodge property an attractive appearance and blending in fairly well with the natural environment (**Figures: 2, 3 & 4**). According to management, the lodge cannot start operating until the second phase has been completed.

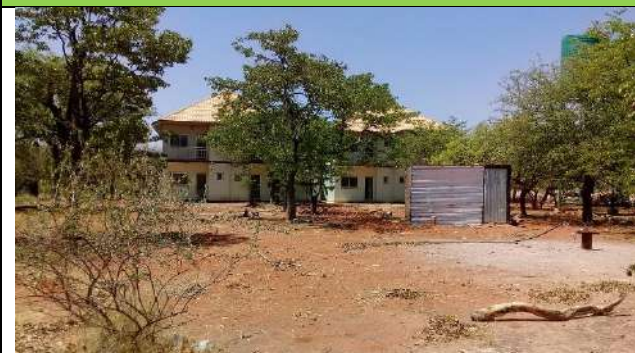
Figure 4: Borehole Drilled on the Property

| Aspect to be Monitored | What to Check/Monitor | Frequency | By Who |
|---|---|---|---|
| | Borehole – check and inspect pump connection, and any visible leaks | Monthly | |

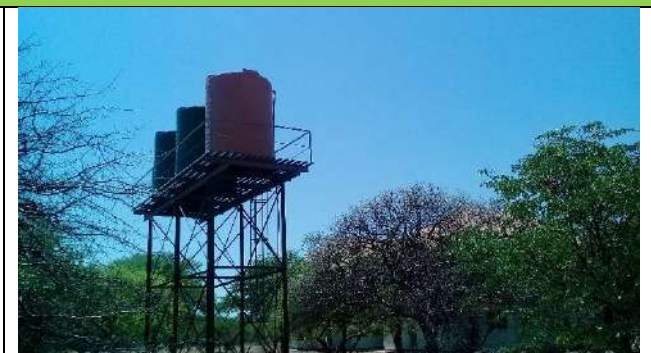
Figure 5: Water Storage Tanks

| Aspect to be Monitored | What to Check/Monitor | Frequency | By Who |
|---|---|---|---|
| | Check and inspect water storage tanks and distribution pipes for any leaks. | Monthly | |

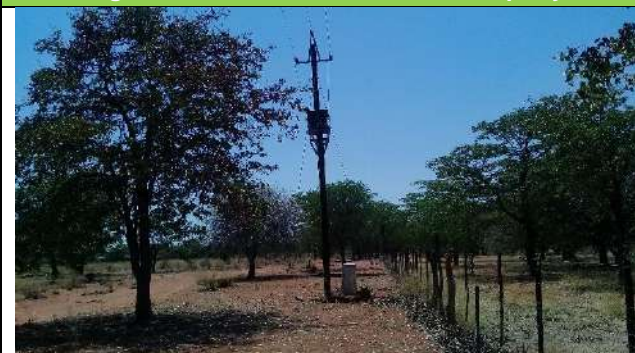
Figure 6: Electricity Supply

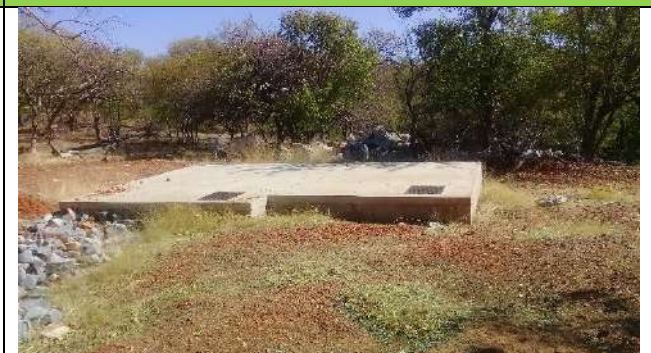
Figure 7: Sewage Drainage

| Aspect | Recommended Management Measures | Timing | Responsible Party |
|---|--|---|---|
| Sewerage Waste | <p><b>Maintenance:</b> Ensure that the sewerage system installed for the lodge is well maintained and kept in an operational state at all times. It is imperative to ensure that the facility is not overloaded and that it is allowed to function within its design capacity. If necessary output capacity should be reduced or increased. Removal of the sludge if required should be done by qualified personnel.</p> <p><b>Services:</b> Ensure that the sewerage system is maintained and serviced by qualified personnel in accordance with operating procedures.</p> <p><b>Leaks and Spills:</b> Ensure that measures are put in place to prevent the sewerage system from leaking or spilling its content. In the event of a failure or overflow situation at the sewerage system, implement a back-up system which will ensure that no sewerage is discharged into the environment.</p> <p><b>Monitoring:</b> Ensure that all treated effluent meets or exceeds water quality specifications. Conduct quarterly inspections of wastewater.</p> <p><b>Sewage Drainfield:</b> The drainfield where treated sewage water drains into the soil, could attract different bird species to the pond. This would have a positive impact on the birds and tourist pleasure in viewing the birds</p> <p><b>Bush Toilet:</b> Under no circumstances may employees resort to the use of the bushes on the property as 'toilet'. Employees or guests found defecating behind bushes should be given reprimands. Urinating of men in public is both uncivilized and unhygienic and should be discouraged.</p> | <p>At least once annually</p> <p>Once annually unless when broken</p> | <p>LM</p> <p>LM</p> |

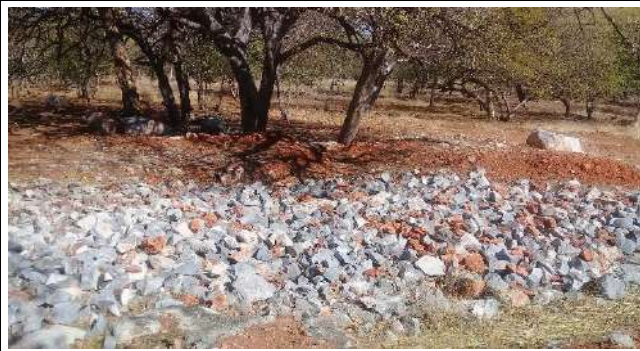
Figure 8: Sewage Drainfield

| Aspect to be Monitored | What to Check/Monitor | Frequency | By Who |
|---|---|--|---|
| | Check the baffles above the scum<br>Remove and clean outlet baffle filter<br>Check and inspect the drainfield of the septic tank and the perforated pipes.<br>Check for any bad smell (odour) and any damp areas<br>Soak-away – check and clean drainages<br>Check for any unintended leaks from the system | Yearly<br>Yearly<br>Yearly<br>Quarterly<br>Yearly<br>Quarterly | |

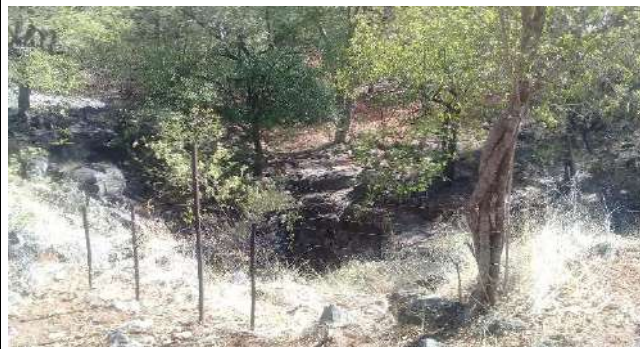
Figure 10: Vegetation around the Rock Fissure

The landscape is relatively flat to the northwest and northeast sections of the property, but has a gentle slope towards the southeast where a fracture has formed a significant wide, deep crevice (fissure) in which rainwater from a dry river stream is collected (**Figures: 10 & 11**). Site drainage is therefore towards this section of the property (**Fig. 15**)

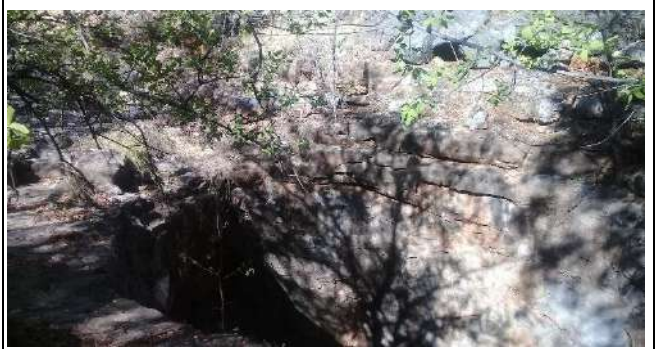
Figure 11: Rock Fissure Opening

| Aspect | Recommended Management Measures | Timing | Responsible Party |
|--|--|--|---|
| <p><b>Archaeological &amp; Cultural Heritage</b></p> | <p><b>Rock Fissure:</b> Whilst not specifically recognized as an archaeological site, the rock fissure on the lodge property should be preserved and protected against vandalism. It can be a great asset to the lodge. Rainwater from the dry river on the southern section of the property drains into this fissure creating a pleasing atmosphere to view during the rainy season.</p> <p><b>Walkway:</b> The integrity of this rock fissure should be upheld and protected. A paved footpath should be constructed leading from restaurant to the rock fissure and correct notices/signboards with instructions of what to do and not to do should be clearly displayed. Amongst the notices to the guests/tourists viewing the fissure could be:</p> <ul style="list-style-type: none"> <li>○ No dogs &amp; cats allowed</li> <li>○ No throwing objects around</li> <li>○ No children without supervision</li> <li>○ Do not cross the barrier fencing</li> <li>○ Do not enter the cave</li> </ul> | <p>Daily during the wet<br/>period</p> <p>Weekly</p> | <p>LM</p> <p>LM</p> |

| Aspect | Recommended Management Measures | Timing | Responsible Party |
|---|---|---|---|
| | <ul style="list-style-type: none"> <li>○ Do not harm reptiles &amp; other creatures</li> <li>○ No weeing</li> </ul> <p><b>Information:</b> Any known information on the rock fissure should be provided on a notice board. The Geological Survey of Namibia could have some background information on the rock fissure.</p> | | |

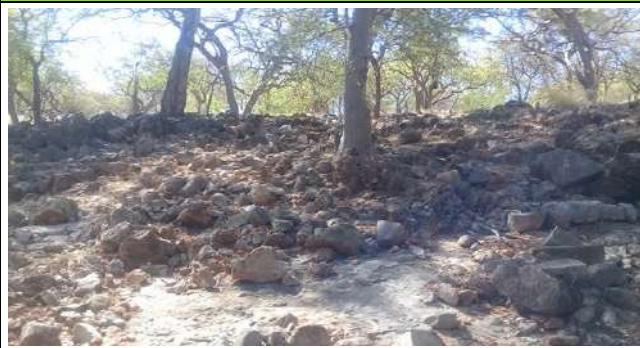
The southern area is quite rocky and construction in this part of the property could be a serious challenge. The fissure has been fenced in to prevent livestock on the property from falling into the gaping hole. Significant soil erosion around the fissure has taken place (**Fig. 12**).

Figure 12: Erosion around the Rock Fissure

| Aspect | Recommended Management Measures | Timing | Responsible Party |
|---|--|---|---|
| | <p><b>Maintenance:</b> Drainage and all other water catchment facilities on the lodge should be well maintained, inspected before the rainy period and cleaned after the rainy period. All erosion damaged areas should be repaired as soon as possible.</p> <p><b>Rehabilitated areas:</b> All rehabilitated areas should be monitored for at least one year following the construction phase. Vegetation re-planted should be monitored to establish growth.</p> | | |

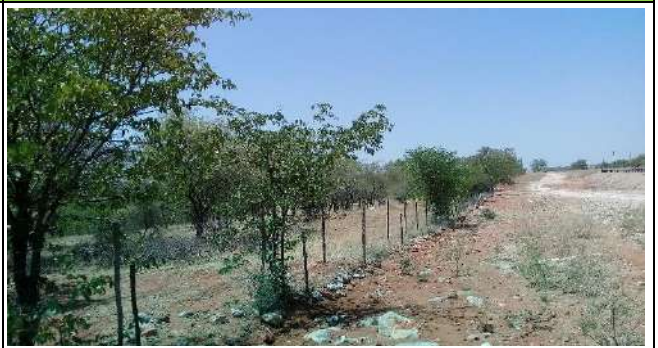
Figure 13: Fence around the Lodge

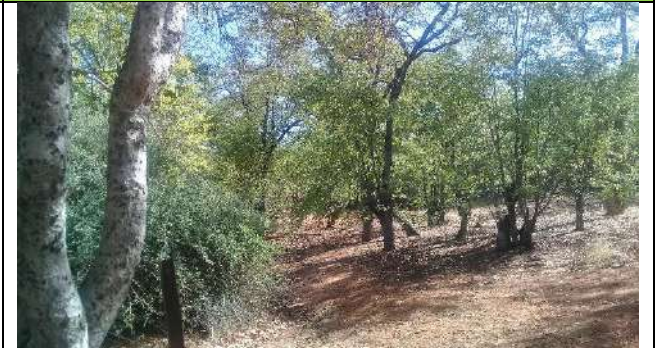
Figure 15: Natural water drainage

| Environmental Aspects | Recommended Mitigation Measures | Timing | Responsible Party |
|---|--|--|---|
| <p><b>Storm Water Management</b></p> | <p><b>Natural Water Channels:</b> Under no circumstances should the lodge buildings be constructed over the natural water channels on the property. All natural water channels should be retained, kept open and litter-free.</p> <p><b>Building Rubbles:</b> No waste such as building rubble (unused concrete, unused mortar, broken bricks, etc.) may be dumped and concealed in water channels on the property.</p> <p><b>Drainage:</b> Water drainage structures/facilities should be well designed, matched to the anticipated water flow and properly installed. Drains should direct water from the catchment</p> | <p>Throughout the renovation phase</p> | <p>SM</p> |

| Environmental Aspects | Recommended Mitigation Measures | Timing | Responsible Party |
|---|---|---|---|
| | <p>areas to the rock fissure on the southeast section of the property. Cascades may be installed to break the impact of water flowing in the drains.</p> <p><b>Maintenance:</b> Drainage and all other water catchment facilities on the lodge should be well maintained, inspected before the rainy period and cleaned after the rainy period.</p> <p><b>Soil Erosion:</b> Ensure that excavated materials are protected and not washed away into drains and rainwater channels. Loose soil should be compacted to minimise wind erosion. Under no circumstances may excavated materials be dumped into the natural water channels on the property.</p> | | |
