ECC-61-108-REP-23-A

**ENVIRONMENTAL COMPLIANCE REPORT:
WATER SUPPLY PIPELINE AND ANCILLARY WORKS INCLUDING A
POWERLINE TO OKANGUATI FROM THE OHAMAREMBA
AQUIFER, KUNENE REGION, NAMIBIA**

RENEWAL

SEPTEMBER 2021

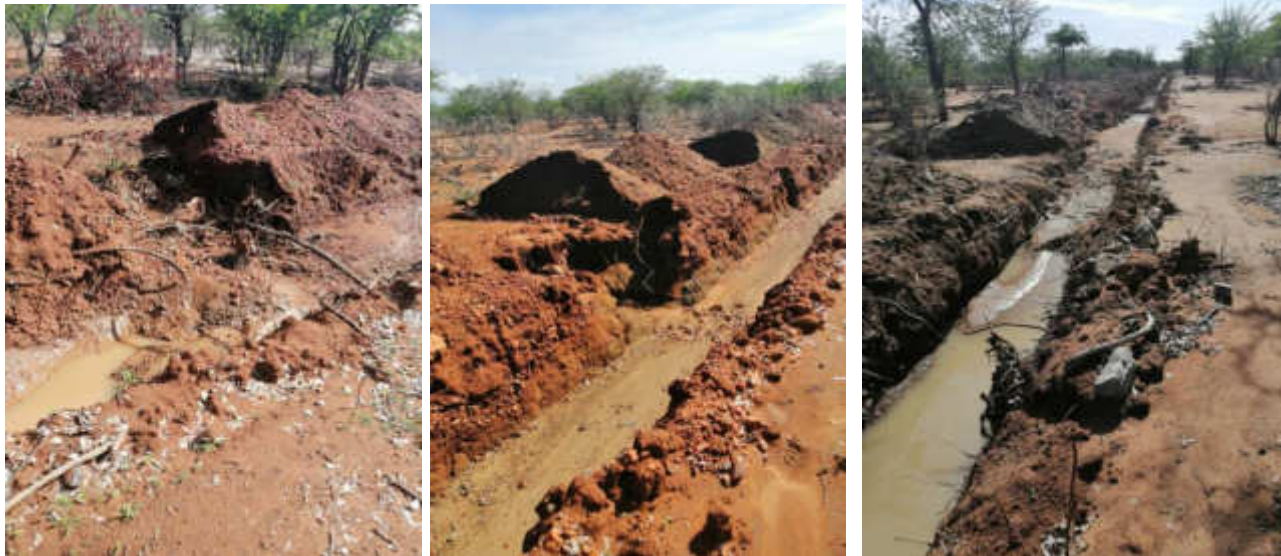
- i. **Rainwater collection in Trenches and erosion:** During the Christmas holidays, rainfall was recorded in Okanguati and this affected works that had been done already on the trenches. There surface water runoff because of the land clearings resulted in erosion around the trench areas. The trench sides were also collapsing due to high moisture content, thus they failed to hold. The following is recommended:
 - Re-excavation is recommended and to prevent further trench backfilling by rainwater, the pipes should be laid along with re-excavation works.
 - Where there are runoff water channels crossing the trenches, it is recommended that those sections that runoff water damaged, should be prioritized for pipe laying and backfilling to prevent further damage to the trenches as well as distorting environmental synergies within the locale.

Fig1. Massive erosion that occurred on site, as evidenced by the Image further left and right, water was breaking through the overburden materials. Center image also highlights circumstances of trench walls collapsing.

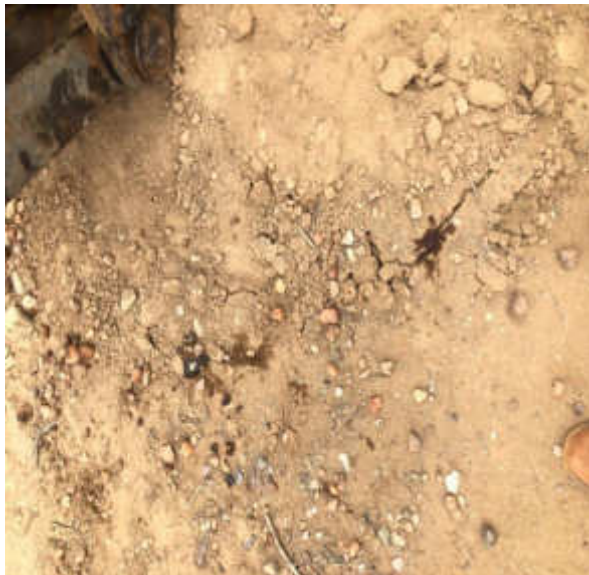
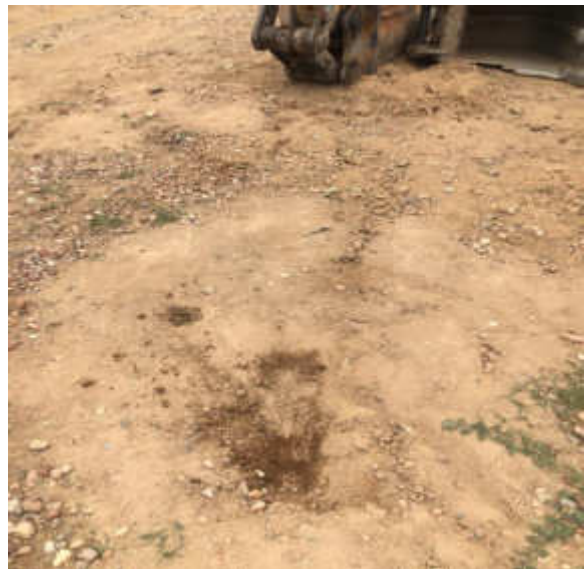
- Noted during site investigations were excavator lubricants dripping to the ground when the equipment is stationary. The following is recommended:

Fig1. Identified lubricant dripping from stationary excavator.

- Drip Trays should be used or temporary spill kit of a plastic sheet and sand to prevent environmental pollution. Contaminated sand clean-up exercise was ordered and conducted on 29/01/19.

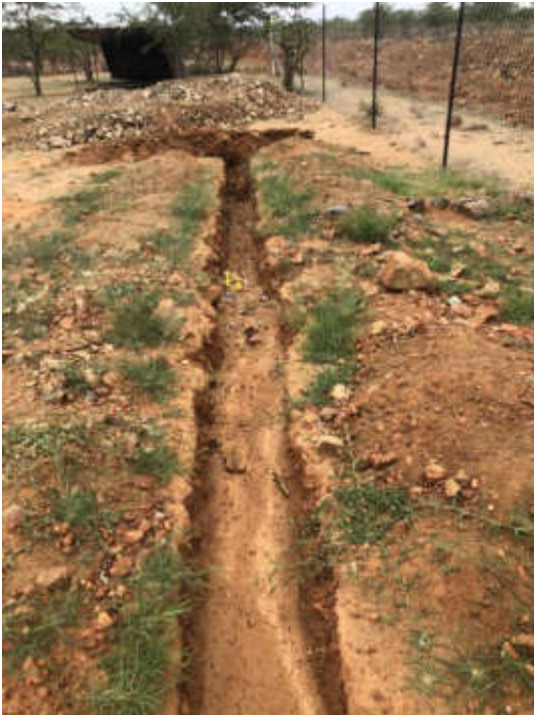
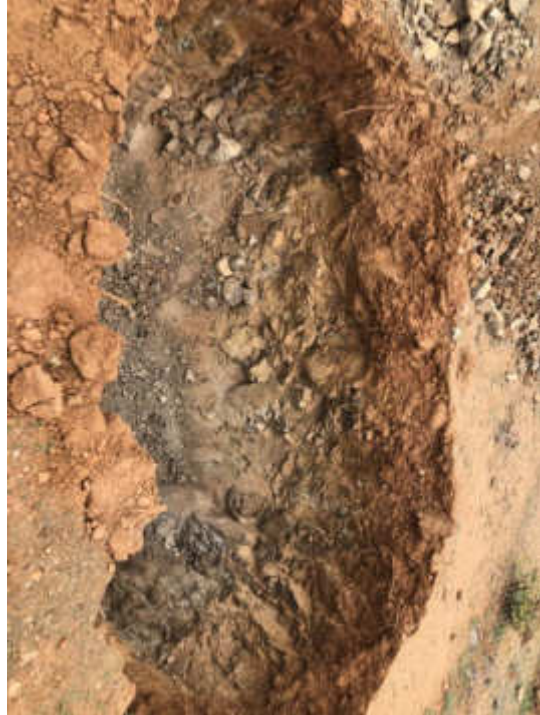
Fig2. Septic tank installation pit excavated poses a safety hazard to equipment and employees on site, a barricade tape has been recommended for installation ASAP until the tank is delivered for installation. Employees and the Site Agent have been advised to exercise extreme caution to ensure that no injuries and or fatalities may be experienced as a result of the pit.

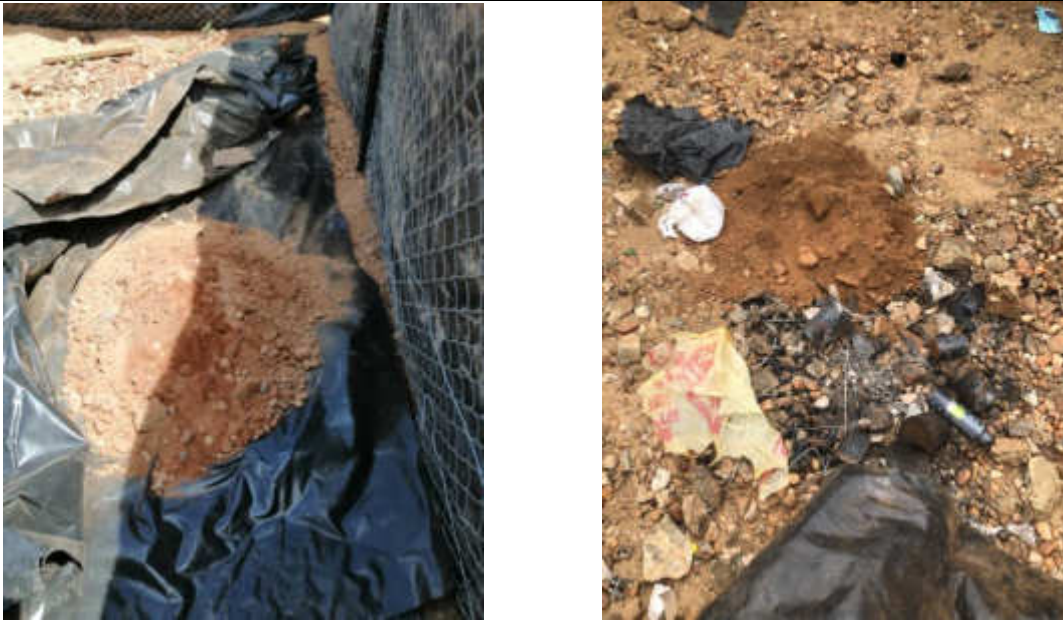
- Recommended bins/ waste storage containers have been ordered, awaiting delivery.
- Due to lack of hazardous waste storage container on site, all contaminated sand is being stored on a plastic sheet in the site waste storage site.

Fig3. Left: Current storage of contaminated sand from equipment oil leaks and refueling of equipment and vehicles. Right: Observed poor storage of contaminated sand because of unavailability of appropriate bins/containers.

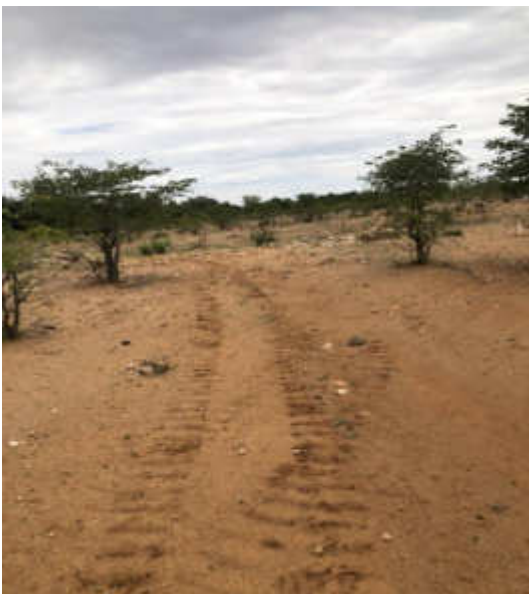
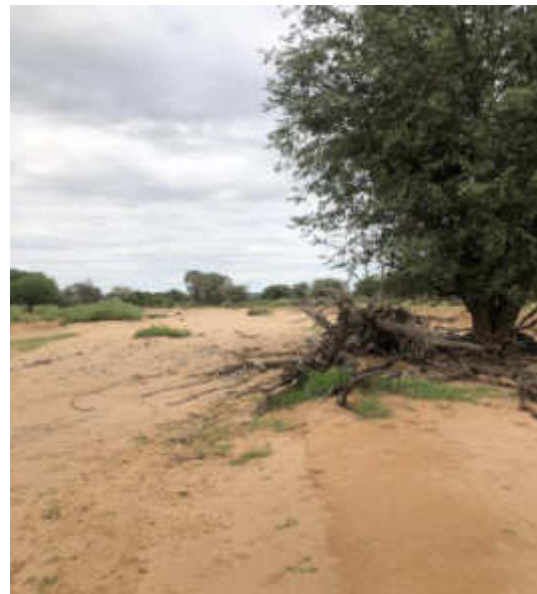
- A sand abstraction site along the river that was identified by the Environmental Consultants was inspected for abstraction.
- A notification will be given to the Village headman indicating proposed sand abstraction site and start date
- A homestead and a maize garden may be affected by the project through nuisance and proximity of access road. Notifications should be given to owners of the properties.
- ESMP implementation will be prioritized during sand abstraction activities.
- There is an existing access track to the river, thus no further land clearance is anticipated during sand abstraction and sand transportation.

Fig4. Left: Existing access track to the riverbed, Right: Deposited river sand from rain season.

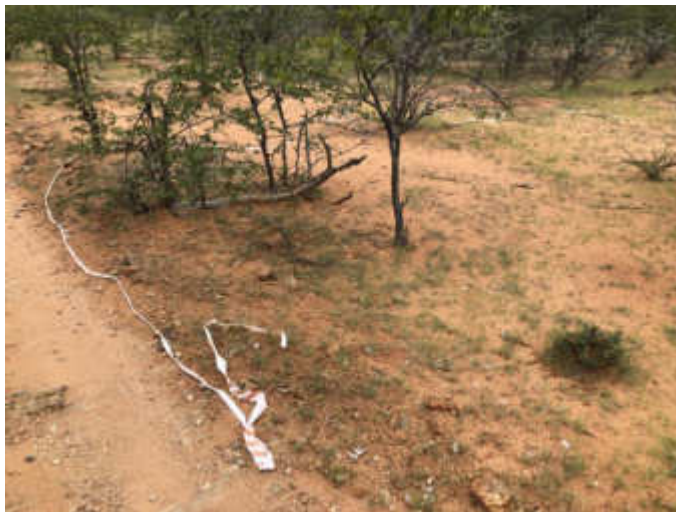
- Noted during site investigations were plastic danger tapes that were disused and resulting in general pollution of the surrounding area. The following is recommended:
 - Immediate clean-up of the construction right of way and access road areas.

Fig1. Identified danger tape pieces around the construction right of way.

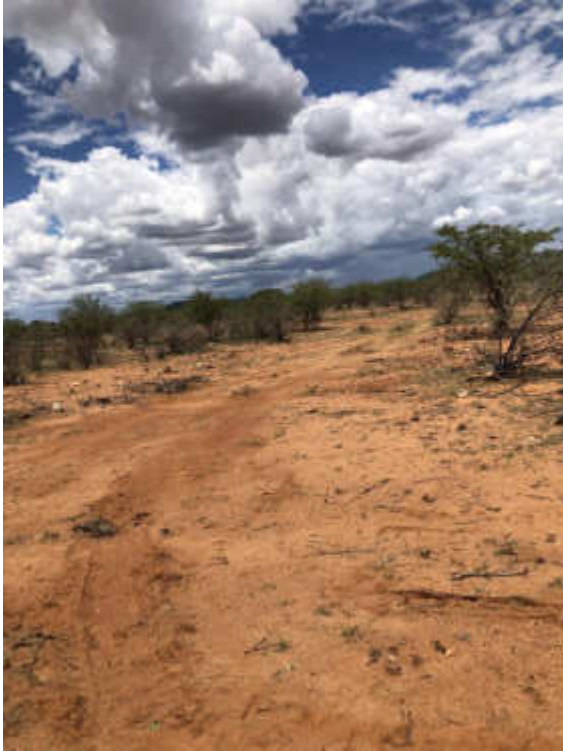
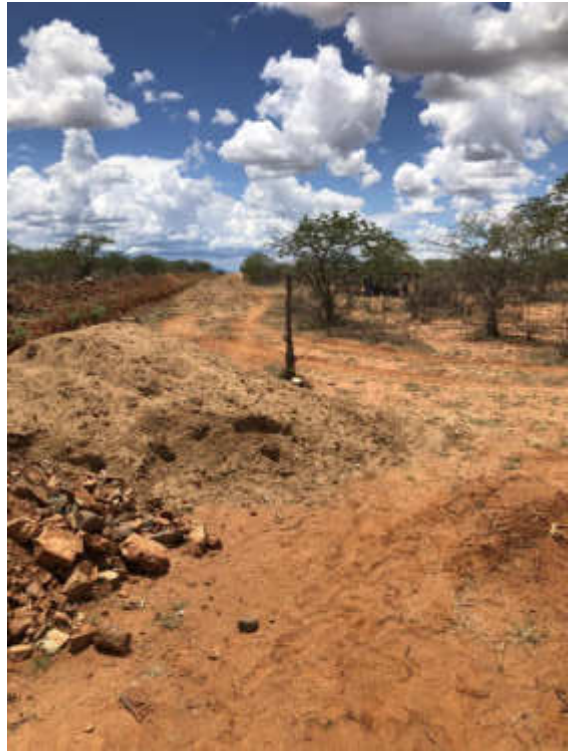
- It was noted that to bring in sand for trench backfilling, the trucks required access to the trench right of way and thereby several sections along the right of way have been opened to allow for trucks to access. The following was recommended:

Fig2. Access road opening to the pipeline right of way to enable sand delivery for backfilling. Extreme caution has been emphasized in access road establishment, through using the least vegetated path and minimizing access road openings by making maximum use of each opened site.

-Minimise access roads opening but rather use single opening and cover about 400m with that one access road. In addition, sections with little to no vegetation should be used for access.

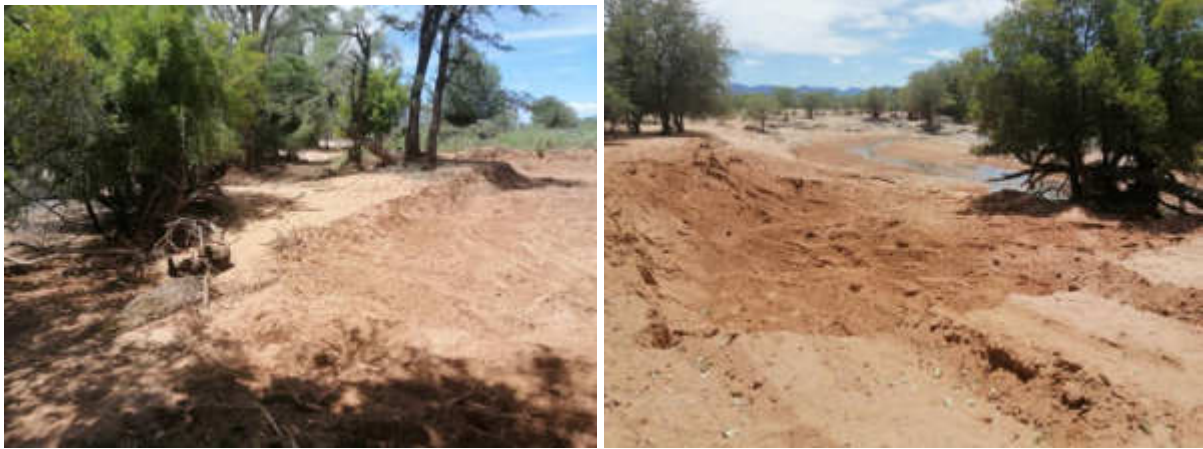
- Existing access roads to be abstraction site were used.
- Sand abstraction was extending too close to the river banks due to decrease in quality of sand in the main river. The following was done as corrective action:
 - Sand abstraction has been moved from the banks towards the center of the river bed which is a more sustainable area where backfilling rehabilitation can be done as soon as the next river flow occurs.

Fig3. Left: sand abstraction that was extending towards the river bank and threatening vegetation. Right: sand abstraction moved into the river, and trees were not being cut in the process.

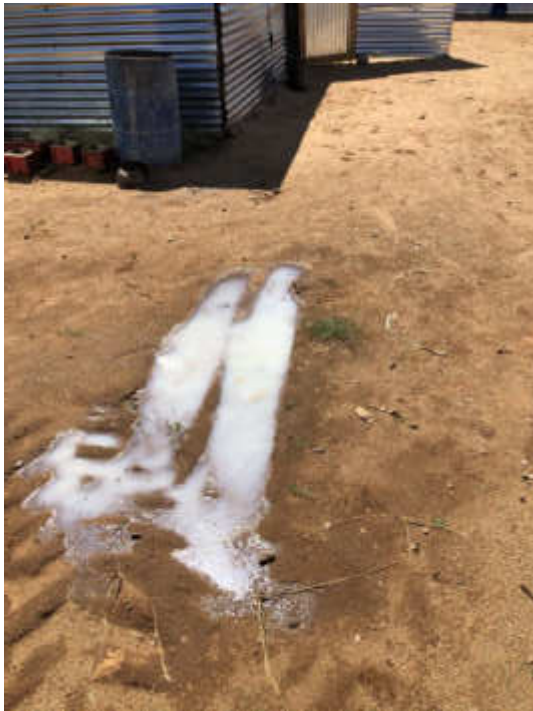
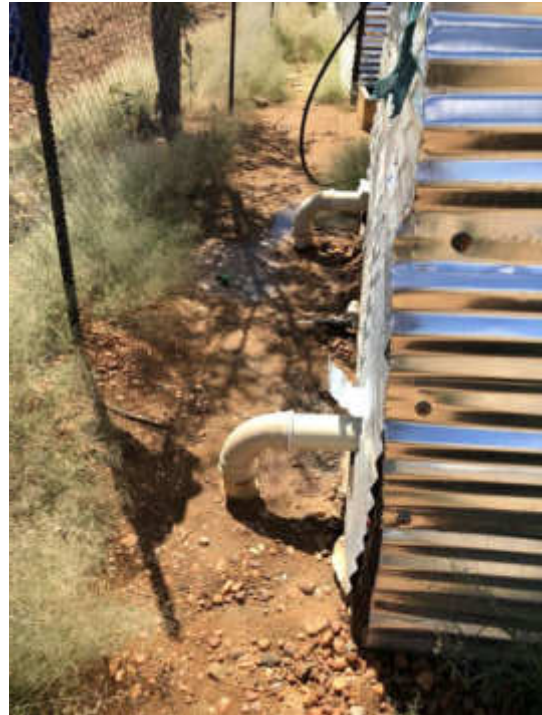
- The contractors Camp needs to be spruced up and cleaned daily, a daily cleaning roster has been recommended for cleaning and ensuring that the general camp state is not a health hazard.
- Since the project is nearing completion, before the contractors dismantle the camp, there is need for a camp decommission plan to come up with management plan of camp utilities, materials and site rehabilitation.

Figure 1: Current state of water puddle on site left uncleaned may result in pathogens, mosquito breeding and flies. To ameliorate the risk, site clean-up has been advised.

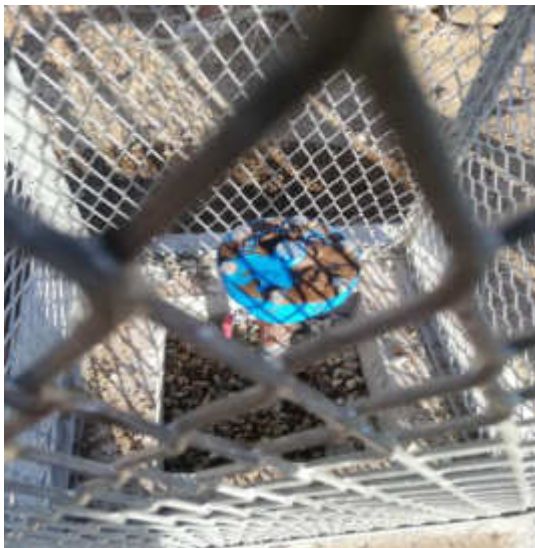
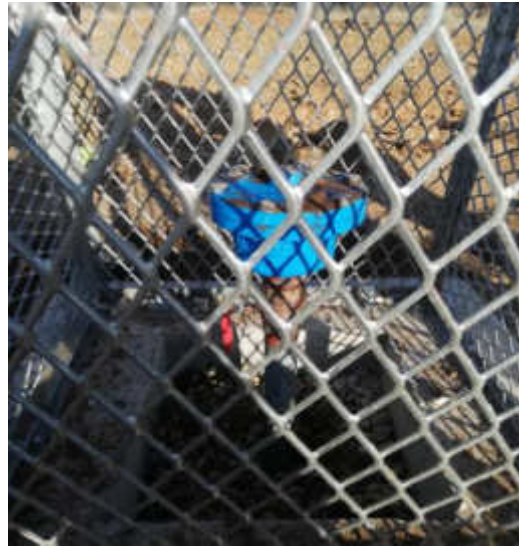
-Vandalism of recently constructed water valves by locals was observed and this has also affected progress of the project. A meeting with community members will be conducted and sensitize them on the importance of refraining from vandalism. **(Below are images of vandalized valves)**

-Notices in Otjiherero on pipeline safety will also be installed.

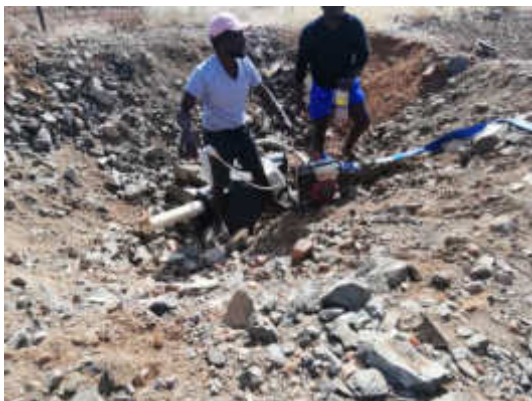
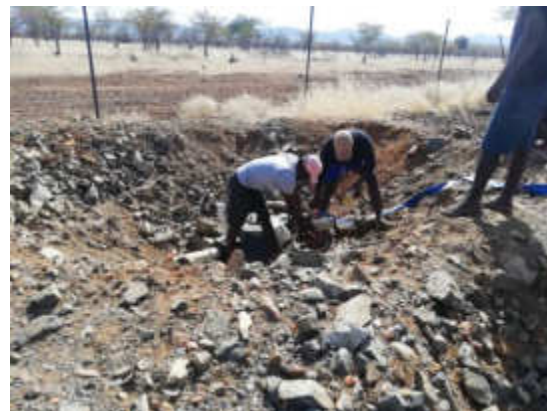
Table 1: Desludging of the sewage conservancy tank

- The sewage waste conservancy tank is monitored daily for leaks and overflowing. It was desludged and waste disposed off at Okonguati Oxidation Ponds. The waste disposal contractor's details are as follows:

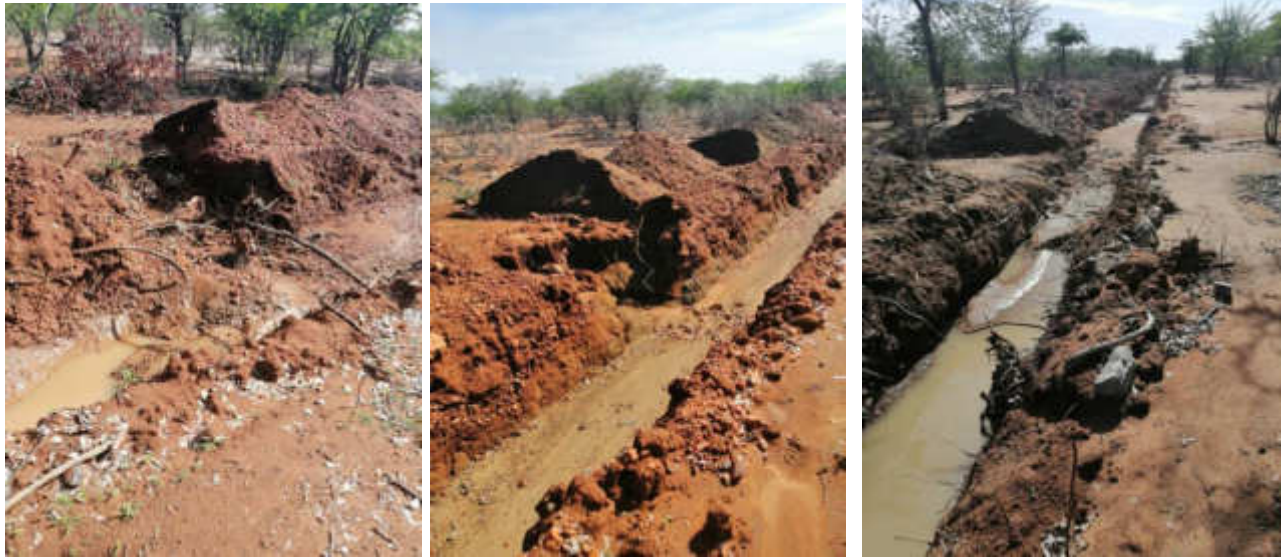
Fig1. Massive erosion that occurred on site, as evidenced by the Image further left and right, water was breaking through the overburden materials. Center image also highlights circumstances of trench walls collapsing.

- Re-excavation is recommended and to prevent further trench backfilling by eroded sand, the pipes should be laid along with re-excavation works in case of another rainfall event.
- Where there are runoff water channels crossing the trenches, it is recommended that those sections should be prioritized for pipe laying and backfilling to prevent further damage to the trenches in case of another rainfall event. This will also prevent distortion of environmental synergies within the locale.

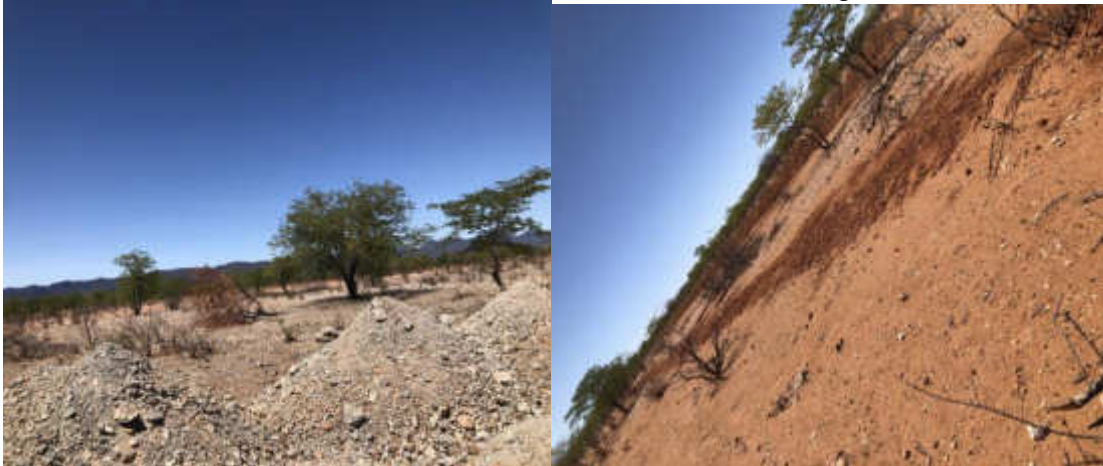
- i. **Land clearing:** Removal of Vegetation done in accordance to the approved right of way for Land Clearing by MAWF, however there are sections surrounding the Contractors Camp that were cleared unnecessarily, resulting in unsustainable land clearing. The Site Agent of site indicated that it happened due to miscommunication between the Site Agent and the construction foreman during the beginning of the project. This prompted the appointment of an Interpreter to also help in terms of communication were misunderstandings occur.

Fig1. Unnecessary Debushing that was conducted on site resulting in clearing of land not earmarked for construction activities.

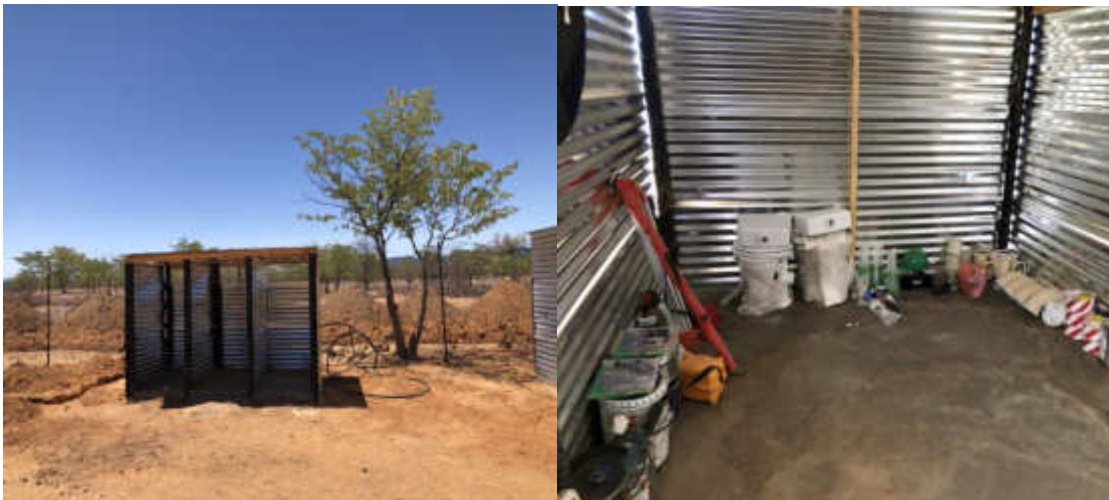
- ii. **Ablution facilities:** Ablution facilities on site were not fully constructed, because they were waiting for supplier to deliver the slurry holding tank. A nearby pit latrine is being used by the construction camp employees until the tank is delivered.

Fig2. Site toilets and materials awaiting tank from supplier.

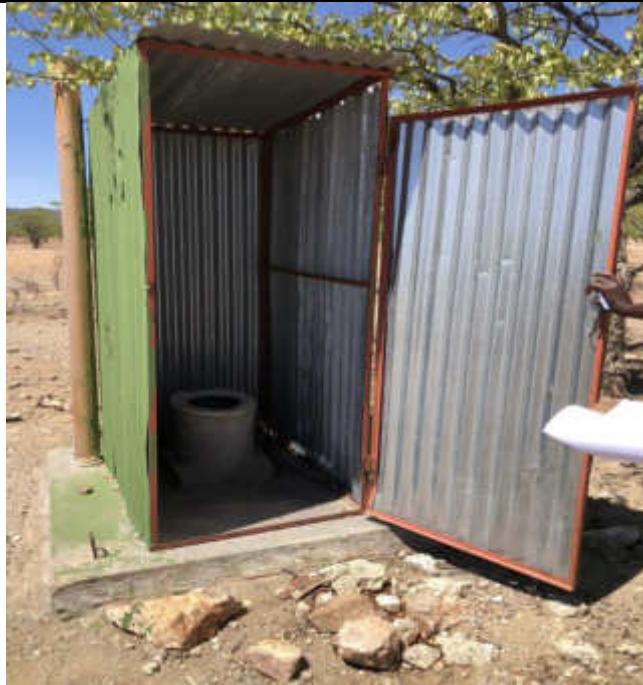
Fig3. Currently being used, a pit latrine toiled sited about 80m from the construction Camp

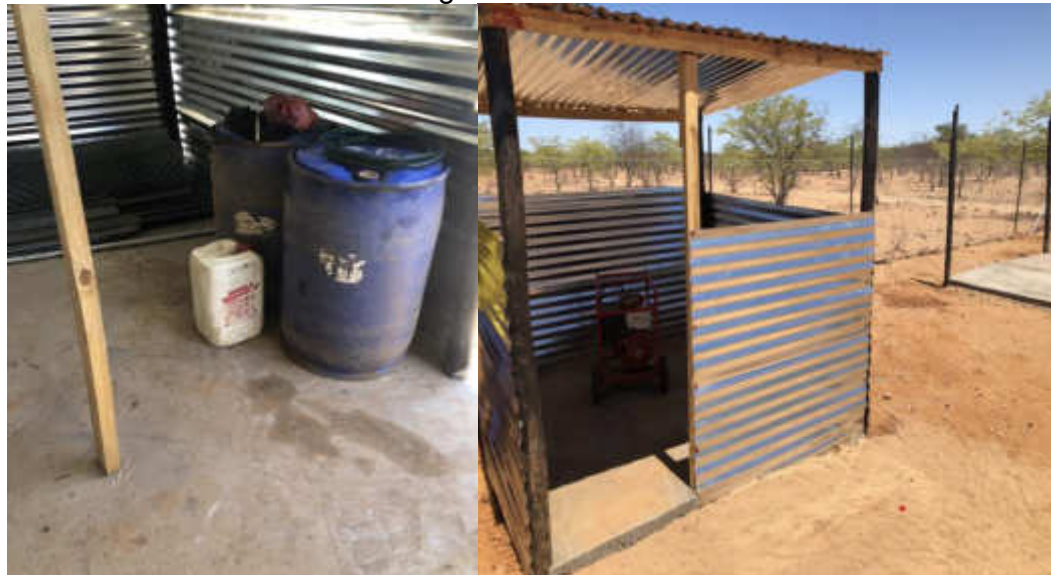
- iii. **Fuel storage and handling processes:** was not in accordance to ESMP guidelines and recommendations and the below table will give mitigation Actions. Temporary hydrocarbon spillage kit of using a thick plastic sheet and sand on top is recommended. If the sand is contaminated, it will be stored in the Hazardous Substance Storage Bin. In addition, the generator and fuel drums will be stored on a ventilated and bunded building outside.

Fig4. Left is showing current storage of fuel in the contractor's storeroom posing risk to property and life. Right is showing recommended fuel containers and generator storage Facility.

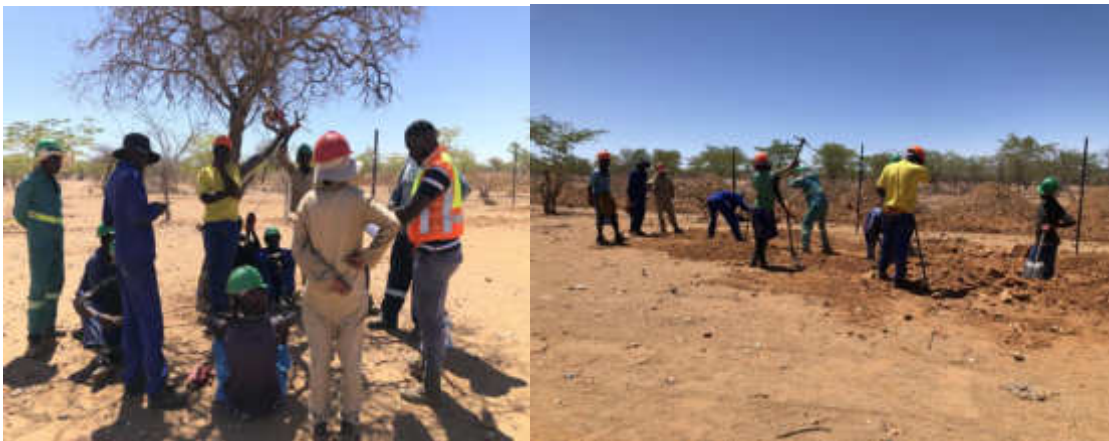
Fig5. Left is showing construction site Induction meeting conducted by the ECO and the Site Agent. Right is showing incomplete PPE worn by employees on site, necessitating need for PPE supply.

- All employees should be made aware of the legally binding provisions of the ESMP
- Littering and loud noises are unacceptable
- Toilets should be used at all times (employees had noted that culturally they do not use toilets)
- Bins should be used
- Copies of the environmental incident log should be provided and the use thereof explained (e.g. Incident observed by the Engineer when conducting site progress assessment)
- Spills should be collected and placed in a bunded container (All contaminated sand/soil is stored in a hazardous substance bin)
- Existing roads and paths should be used.
- EMP conditions discussions should form part of the toolbox talks

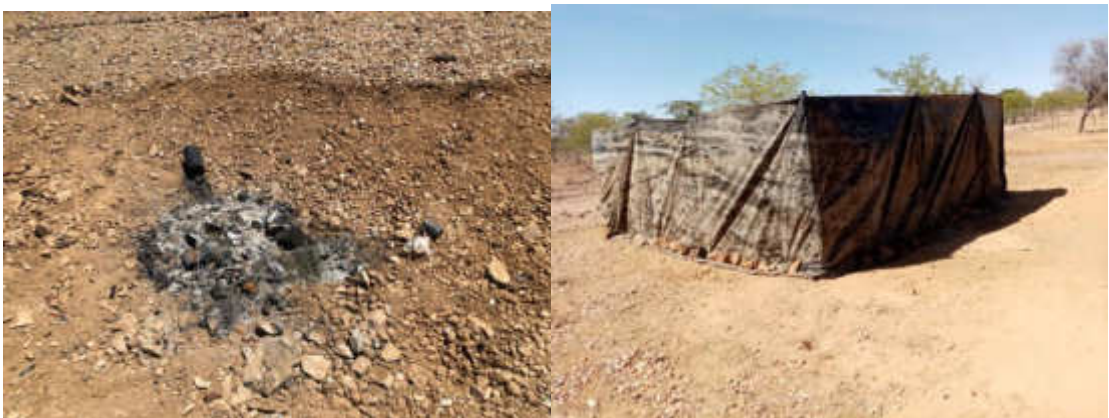
- v. A temporary solid waste disposal site was identified and being used, but it was not fenced and netted as recommended. In addition, labeled waste bins were not on site.

Fig6. Uncovered temporary waste storage site and waste burning was being done on site. Right is showing corrective action demarcating temporary waste storage site and covered with a net.

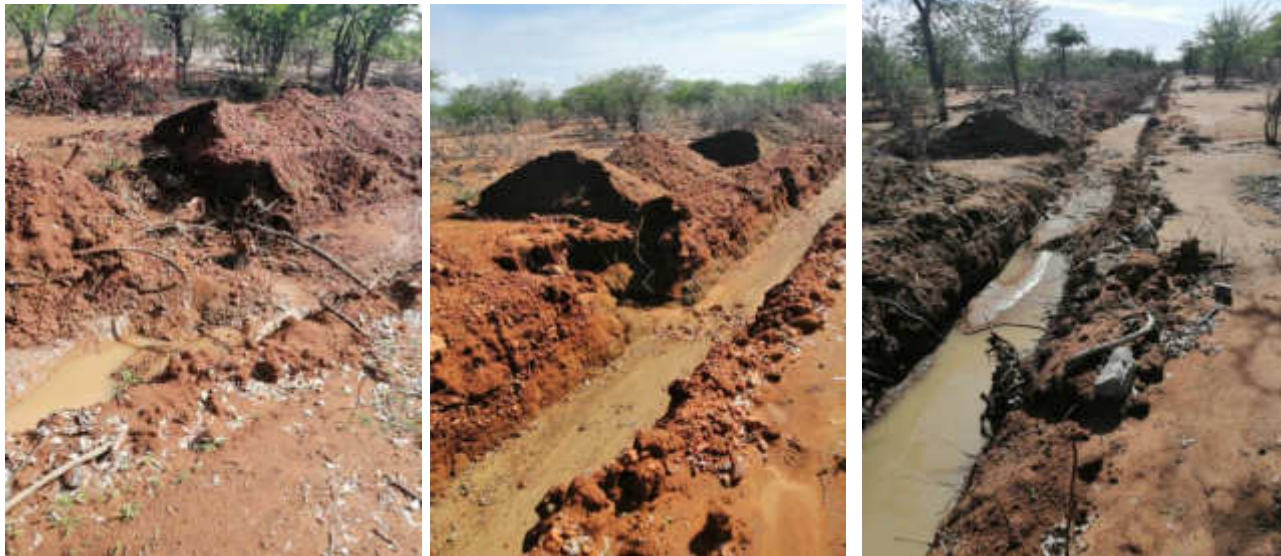
- i. **Rainwater collection in Trenches and erosion:** During the Christmas holidays, rainfall was recorded in Okanguati and this affected works that had been done already on the trenches. There surface water runoff because of the land clearings resulted in erosion around the trench areas. The trench sides were also collapsing due to high moisture content, thus they failed to hold. The following is recommended:
 - Re-excavation is recommended and to prevent further trench backfilling by rainwater, the pipes should be laid along with re-excavation works.
 - Where there are runoff water channels crossing the trenches, it is recommended that those sections that runoff water damaged, should be prioritized for pipe laying and backfilling to prevent further damage to the trenches as well as distorting environmental synergies within the locale.

Fig1. Massive erosion that occurred on site, as evidenced by the Image further left and right, water was breaking through the overburden materials. Center image also highlights circumstances of trench walls collapsing.

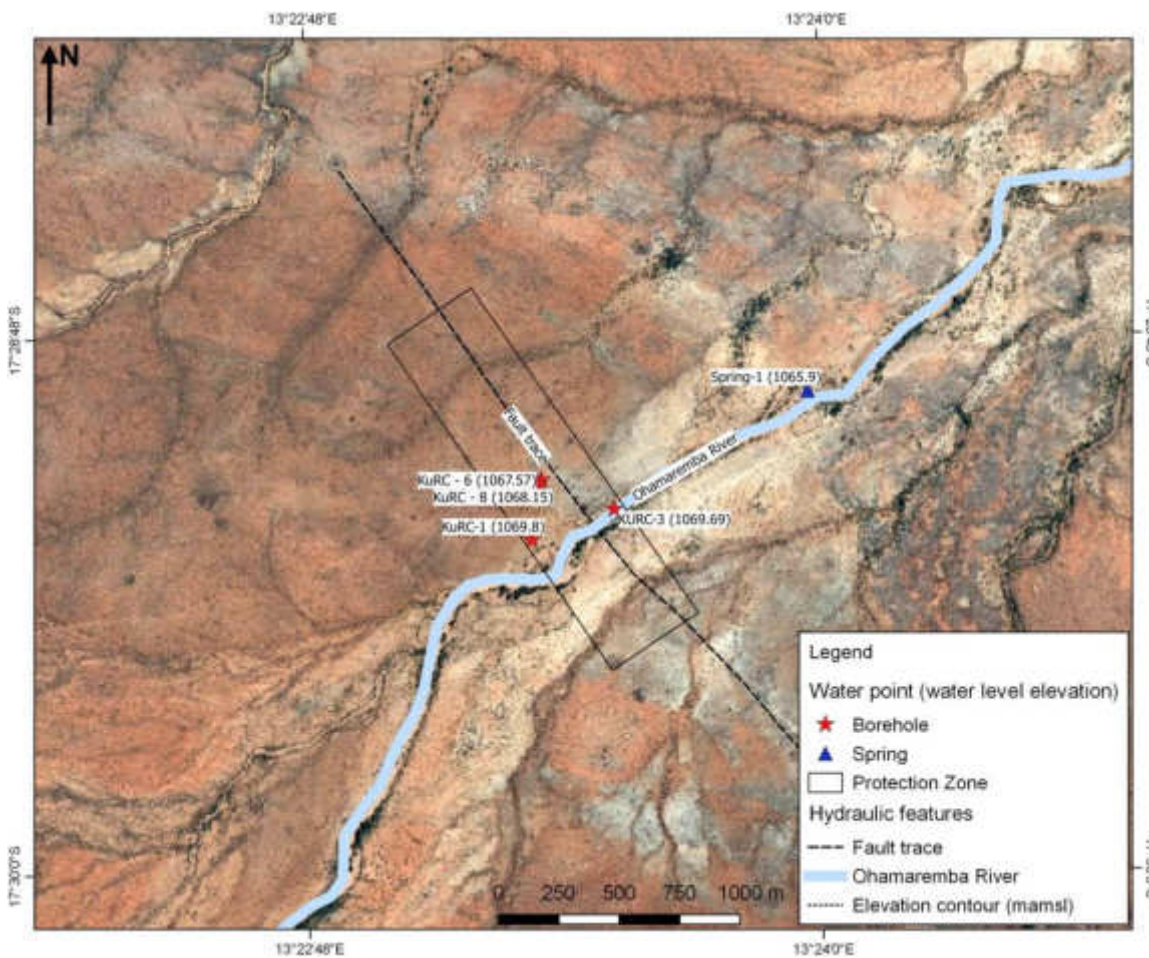
An aquifer protection zone along the fault zone of 150 m width shall be demarcated to protect the groundwater from pollution. Within this area, certain activities will not be allowed, including activities using oil, fuel or chemicals, storage of live-stock (animal kraals) and ablution facilities (including septic tanks and long-drop toilets).

Figure 2 - Aquifer protection zone along the fault zone of 150 m width
