Mushara LODGE

ENVIRONMENTAL MANAGEMENT PLAN

Application for Environmental Clearance
by Mushara Lodge (PTY) Ltd
for Mushara Lodge

PROJECT	Mushara Lodge: Application for renewal of Environmental Clearance
CLIENT	Mushara Lodge (PTY) Ltd
DOCUMENT NAME	Report and EMP
REVISION #	1
DATE	14 August 2024
AUTHOR	Henriette Potgieter PO Box 11867 Klein Windhoek

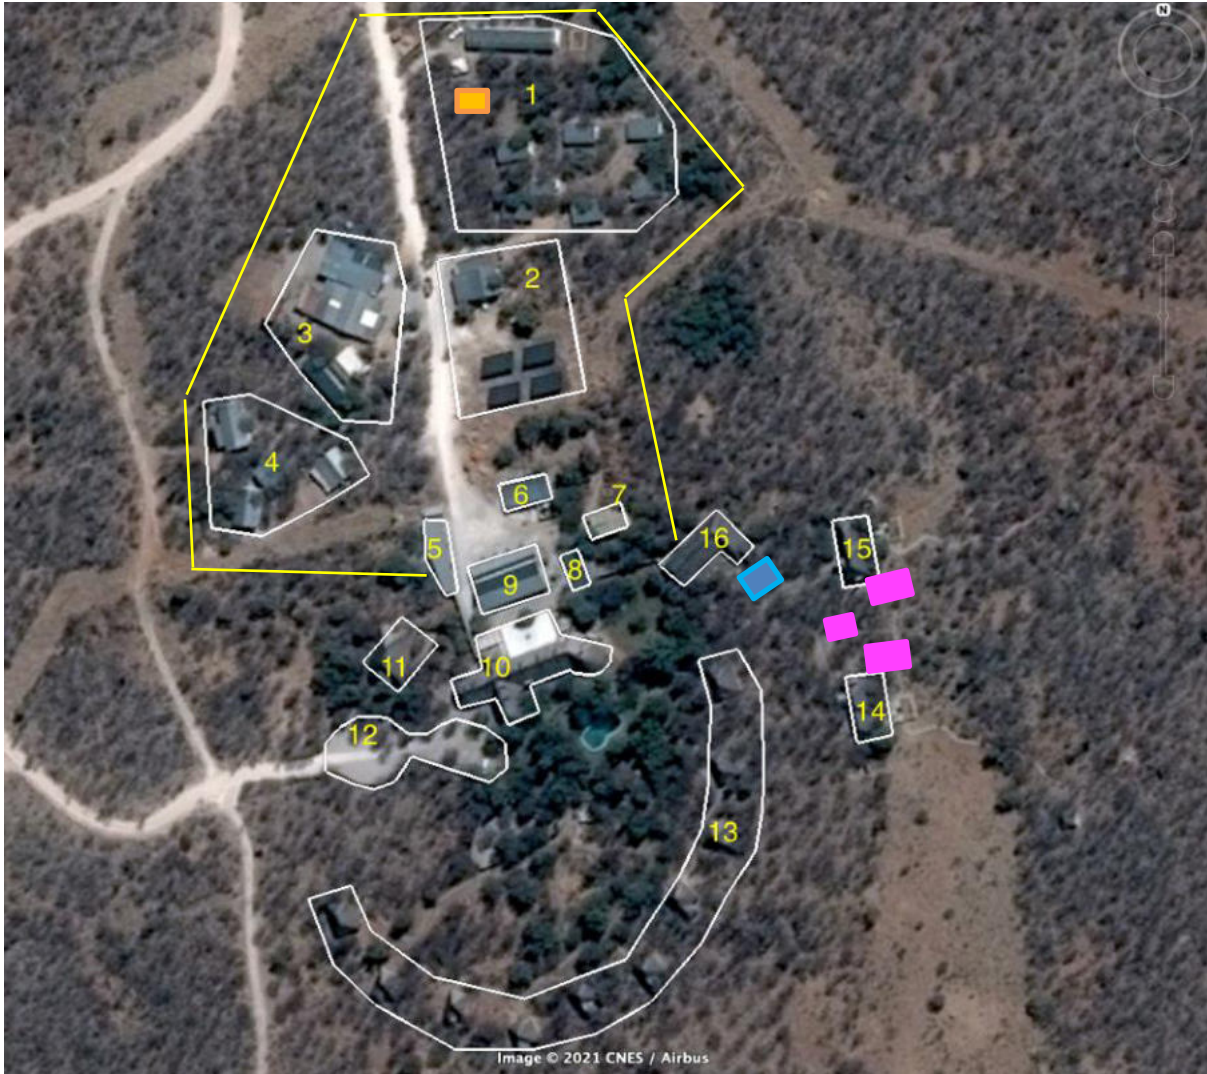
Figure 2. Layout of Mushara Lodge.

- 1 Staff village
- 2 Workshop and 4 solar panels
- 3 Game drive complex (rented out)
- 4 Management accommodation
- 5 Parking x8
- 6 Parking x6
- 7 Water tanks
- 8 Laundry and canteen
- 9 Storage shed
- 10 Main building
- 11 Family house (2 bedrooms)
- 12 Guest parking
- 13 Guest rooms (ten separate, free-standing units)
- 14, 15 Villa 1 and 2
- 16 Guest room complex (six rooms under one roof)

- Yellow polygon: electrified fence
- Orange rectangle: staff units
- Blue rectangle: spa
- Pink rectangles: Villa additions

1. A game-proof fence was erected around the staff village, indicated by the yellow polygon in Figure 2. The fence, stands 2.4 m high and has 0.9 m high, jackal-proof wire mesh at the bottom (Figure 3 and yellow polygon in Figure 2).

2. One new staff unit was constructed in July 2024 (orange rectangle in Figure 2), containing two bedrooms and a shower and toilet.
3. Two new staff units will be built in the staff village in 2025 (orange rectangle in Figure 2), each block containing two bedrooms and a shower and toilet.

4. A spa is proposed for construction in the next 8 months. A new spa reception will be built (blue rectangle in Figure 2), and two single rooms in the guest room complex (16 in Figure 2) will be converted into treatment rooms.

5. In January 2025 an extra bedroom will be added to each villa (14 and 15 in Figure 2), and a small satellite kitchen will be built between the two villas. The pink rectangles in Figure 2 indicate the location of this proposed construction.

The main area (#10 in Figure 2) is a thatched, plastered brick structure with a concrete floor and contains all the guest common areas as well as the kitchen and its storerooms (Figure 3). It is 950 m² in extent.

The staff village accommodates 35 staff members in separate blocks (#1 in Figure 2). Each block consists of a veranda, laundry basin, two bedrooms and a bathroom with shower, toilet and basin.

Next to the kitchen is a 180 m² plastered brick building with concrete floor housing the laundry and staff canteen (#8 in Figure 2).

The incinerator (next to #6 in Figure 2) is enclosed by a 1.8 m high wall with a secure sliding door and is inaccessible to mammals. The risk of fly-blown rubbish is eliminated by standard operating procedure: flammable waste is brought to the incinerator in closed bins; from the bins it goes directly into the incinerator and the door is then shut. The fire is never left unsupervised. No waste is stored in the incinerator enclosure: whatever is brought here, is burnt immediately. The ash is taken to the farm landfill every day.
