EXPLORATION ACTIVITIES ON EPL 4818-

COMPLIANCE REPORT

PROJECT NUMBER: ECC-143-537-REP-02-A

DATE: 2 SEPTEMBER 2024

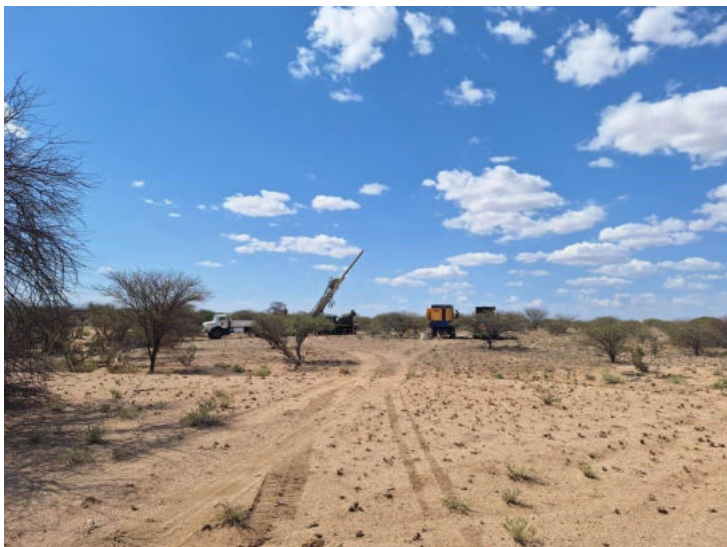
In addition to the various drilling campaigns, new tracks were created to allow access to the various drilling sites as shown in Figure 2 below.

Figure 2 - Creation of new tracks to provide access to the various drilling sites.

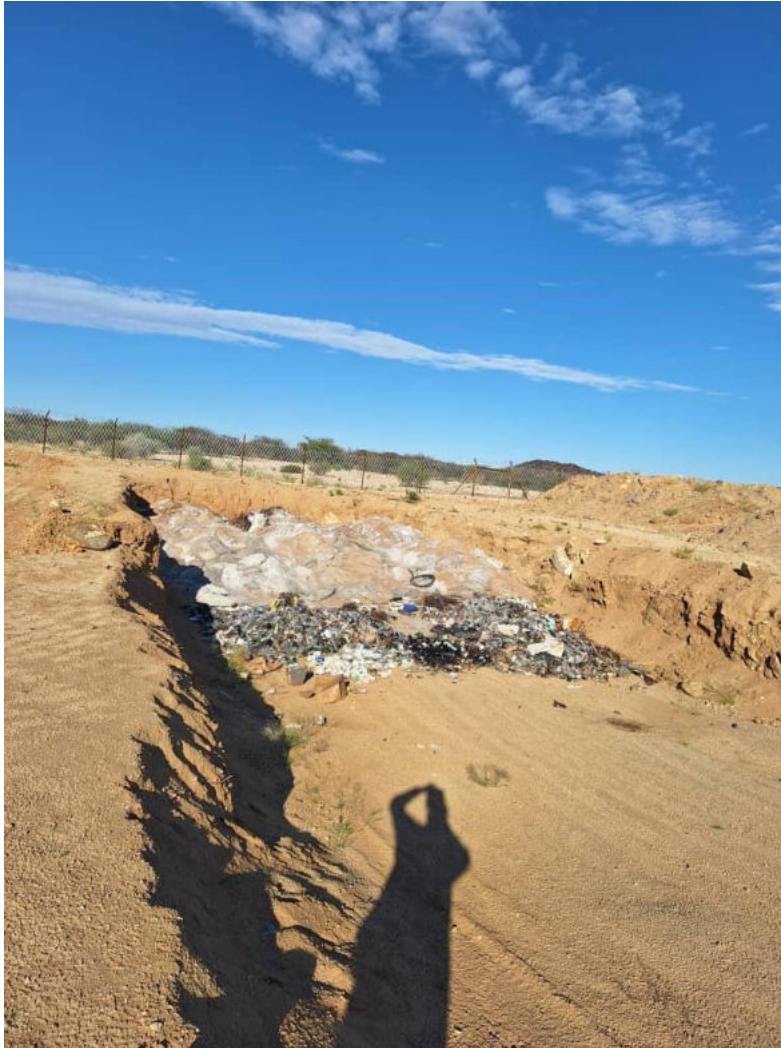
Figure 3 - Waste from site being disposed of at the Okombahe disposal site.

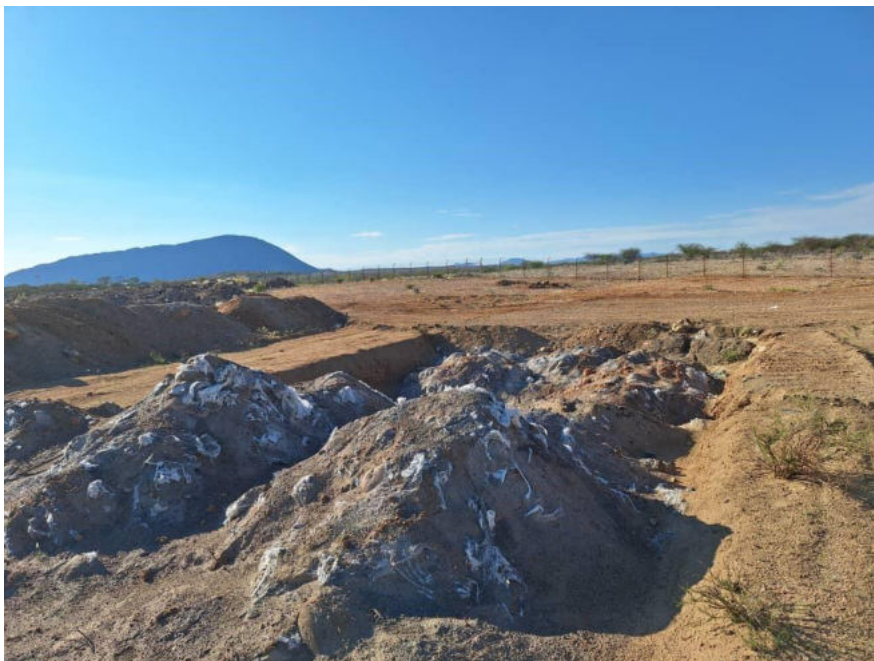
Figure 4 - Waste from site being disposed of at the Okombahe disposal site.

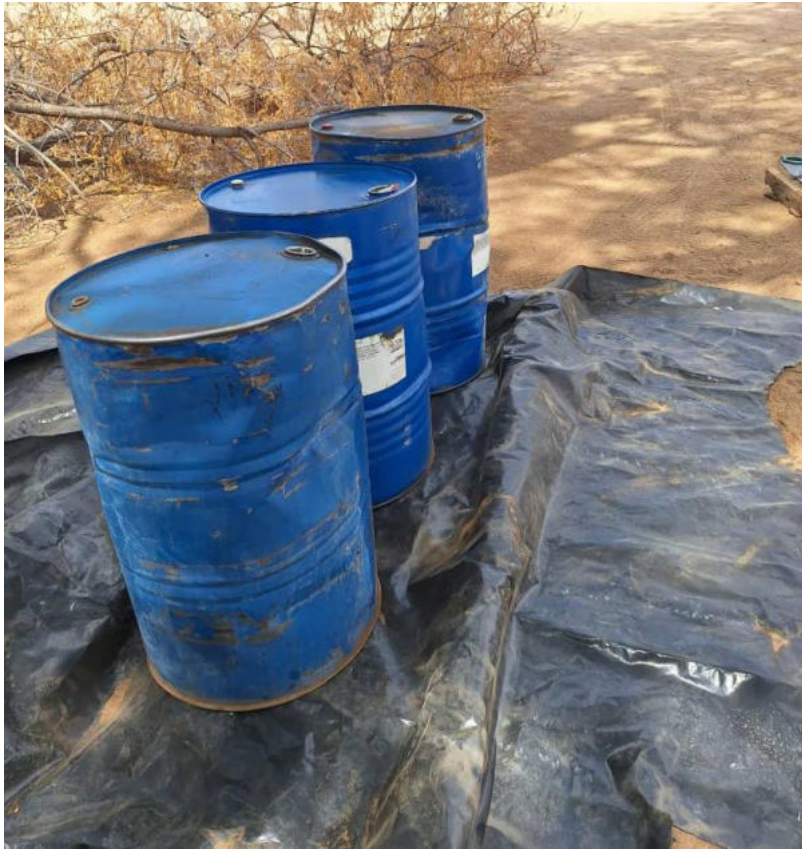
Figure 5 - Storage and utilization of hydrocarbons on plastic sheeting to prevent soil contamination.

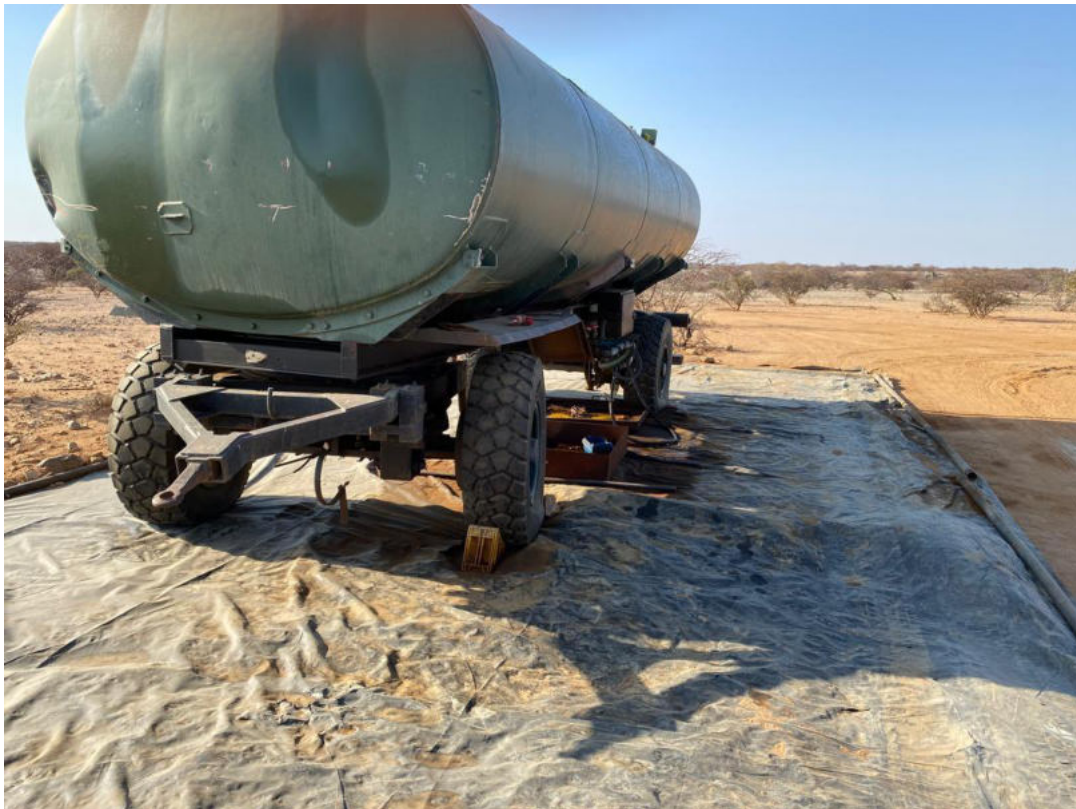
Figure 6 - PVC sheeting around diesel tank fuelling station in site

Activity	Potential impacts	Management/mitigation measures	Compliance	Comments
<ul style="list-style-type: none"> - Drill borehole. - Contain all drilling water in the sump and allow it to settle. - Log the drill core and place it on core trays - Maintain ablution facilities 	<ul style="list-style-type: none"> - Contamination of soils and hydrocarbon spillages. - Potential erosions through surface runoffs. 	<ul style="list-style-type: none"> - In all areas where there is storage of hazardous substances (i.e. hydrocarbons), there will be containment of spillages on impermeable floors and bunded trays that can contain 110% of the volume of the hazardous substances. - All refuelling and any maintenance of vehicles will take place on impermeable surfaces. - Pollution will be prevented through basic infrastructure design and maintenance of equipment. - Spill kits will be readily available on-site. Employees and/or contractors will be shown to use the spill kits to enable containment and remediation of pollution incidents. - Environmental awareness training of contractors. - Epangelo will establish environmental awareness in employees and contractors. 	<ul style="list-style-type: none"> - Partially Compliant 	<ul style="list-style-type: none"> - PVC lined sumps were not used for the collection of oil and silt contained in drilling water - PVC liners were placed under the fuel tanks to prevent leaks shown in Figure 6 - All areas where hydrocarbons are utilised or stored on plastic sheets.

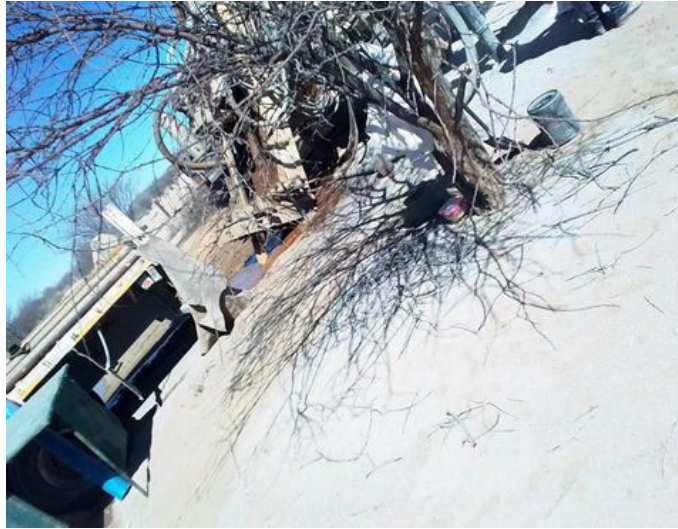
- No sign of speed limit of 30km/h enforcement on site
- No visible exits available for small animals when they fall into trenches
- No suitable receptacles for waste disposal are provided at appropriate locations on site.
- No receptacles marked for different waste types.
- Refuelling and maintenance of vehicles are not being conducted on impermeable surfaces.
- PVC lined sumps have not been used for the collection of oil and silt contained in drilling water.
- Spills are not being contained and cleaned up immediately.

Figure 8 - Oil spillage not contained or cleaned up immediately.

It is recommended that the proponent promptly apply for the necessary drilling and water abstraction permits from MAWLR and MME and adhere to the permit conditions. The site lacks signage to enforce the 30km/h speed limit and no smoking rules and has no visible exits for small animals in trenches. Additionally, there are no suitable waste receptacles, including those for different waste types. Lastly, the proponent should maintain records of engagement with the local community and traditional authority.

Upon renewal of the environmental clearance certificate, we strongly recommend the proponent address the non-compliances addressed in this report and adhere to all mitigation and management measures stipulated in their environmental management plan.
