Aggregates Quarrying Operation at Kangongo Village, Mukwe
Constituency, Kavango East Region

An Updated Environmental Management Plan for the Renewal
of an Environmental Clearance Certificate

An **Updated and Amended Environmental Management Plan** for an Aggregate Quarrying Operation at Kangongo Village, Mukwe Constituency, Kavango East Region

A Scoping Environmental Impact Assessment (EIA) Report for the Construction and Operation of an Evaporation Pond for the Purpose of Dewatering the Quarry Pit

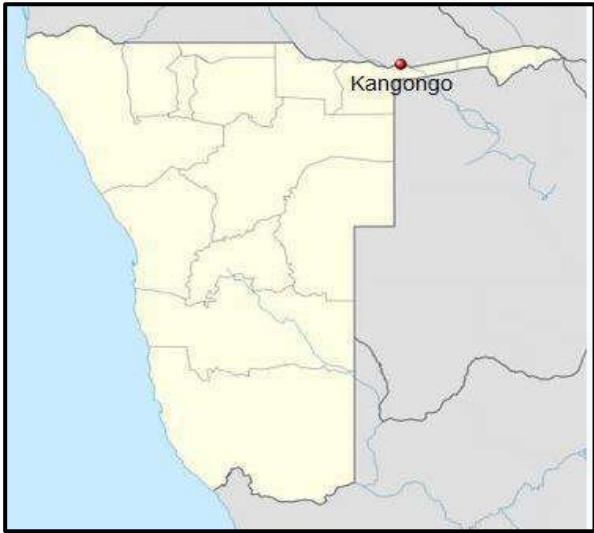
Figure 1: Quarry Location

The hard rock quarry is situated at Kangongo, a small village in the Mukwe Constituency, Kavango East Region (KER) (**Fig.1**). The village is to the northeast of Rundu about 160 km away. The Kangongo based quarry has been a major supplier of high quality aggregates for many years, supplying end-users in the three regions of Zambezi and Kavango East and West.

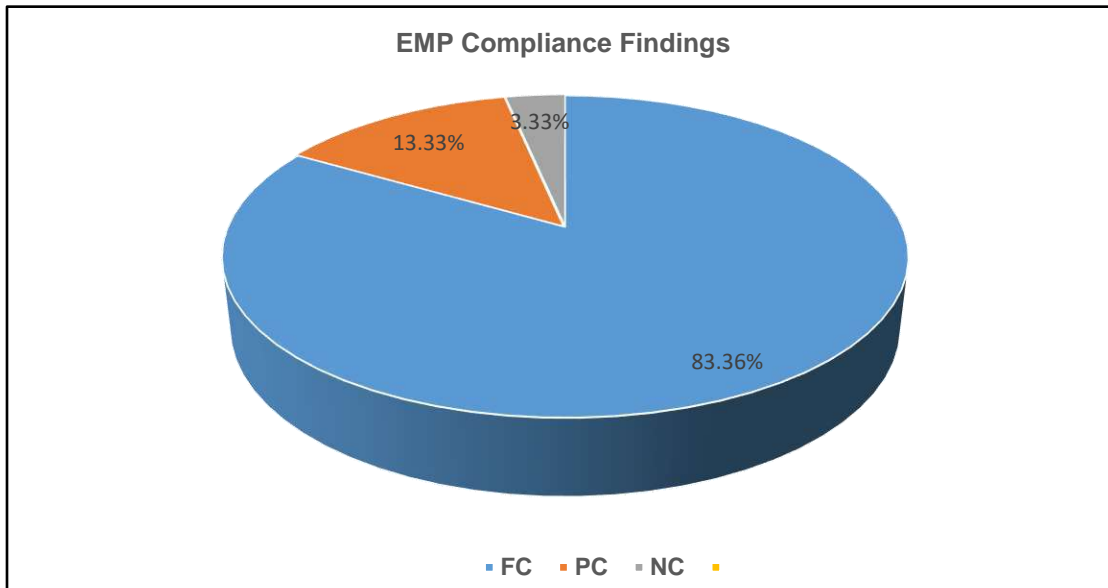
Figure 7: Compliance Findings

- Crushco was found fully compliant on 50 conditions, which equates to 83.34%.
- Crushco was found partially compliant on 8, which equates to 13.33%.
- Crushco was found non-compliant on 2 conditions, which equates to 3.33%.

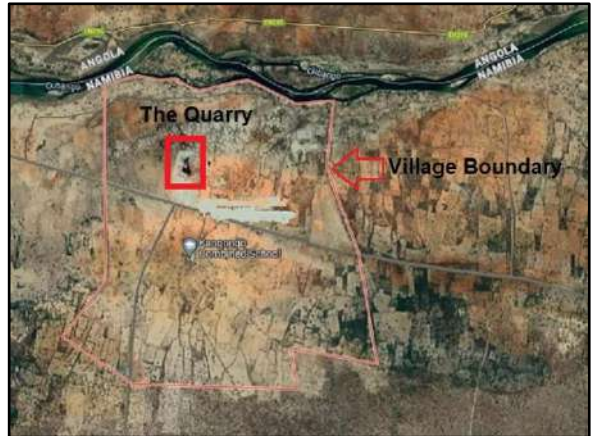
Figure 2: Quarry Location Village Context

Crushco Trading CC (henceforth 'Crushco'), an SME company is operating a hard rock quarry (HRQ) situated at Kangongo, a small village in the Mukwe Electoral Constituency, Kavango East Region (KER) (Fig. 2). Kangongo is approximately 160 km northeast of Rundu. The HRQ is approximately 800 m from the current banks of the Kavango River. Quarrying has been conducted at this site for over 40 years and was acquired by the current owner, Crushco, in November 2015.

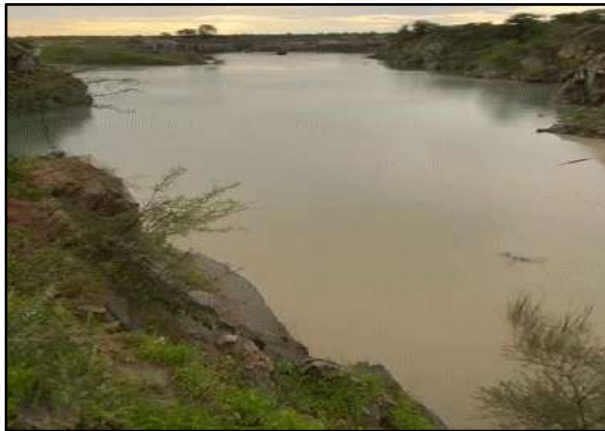
Figure 8: Quarry Pit – Feb 2020

Over the years, dewatering of the quarry pits has been managed by pumping water via a 25 mm diameter pipe to a silt retention storage pond located outside the quarry premises. The silting pond was not fenced in and during the public consultation held at the village, concerns were raised by some residents complaining that the water was not fit for livestock consumption. Two incidents of drowning have also been linked to the pond. Some residents have no problems with the pond saying that it has been there for over 30 years. There was even fish which the villagers caught and enjoyed eating.

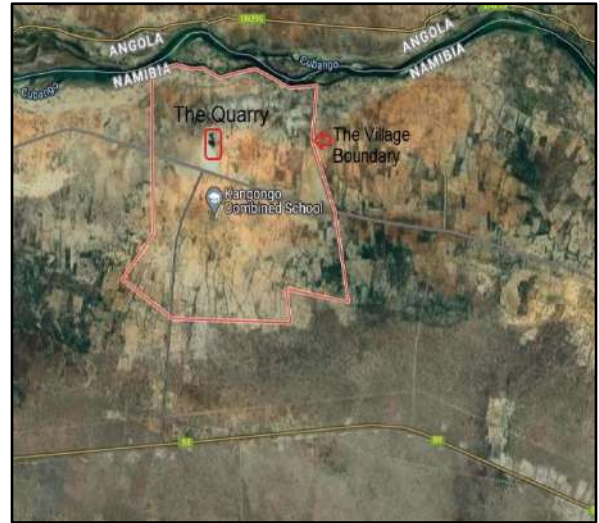
Figure 2: Quarry Location – Village Context

The quarry site itself is along the old Rundu-Divundu gravel road and about 800 m from the river (**Figures: 1 & 2**). The GPS coordinates are 17° 56' 49.0" Latitude and 21° 09' 43.1" Longitude. Access from the quarry to the B8 highway is provided by a well maintained gravel road of about 4 km.

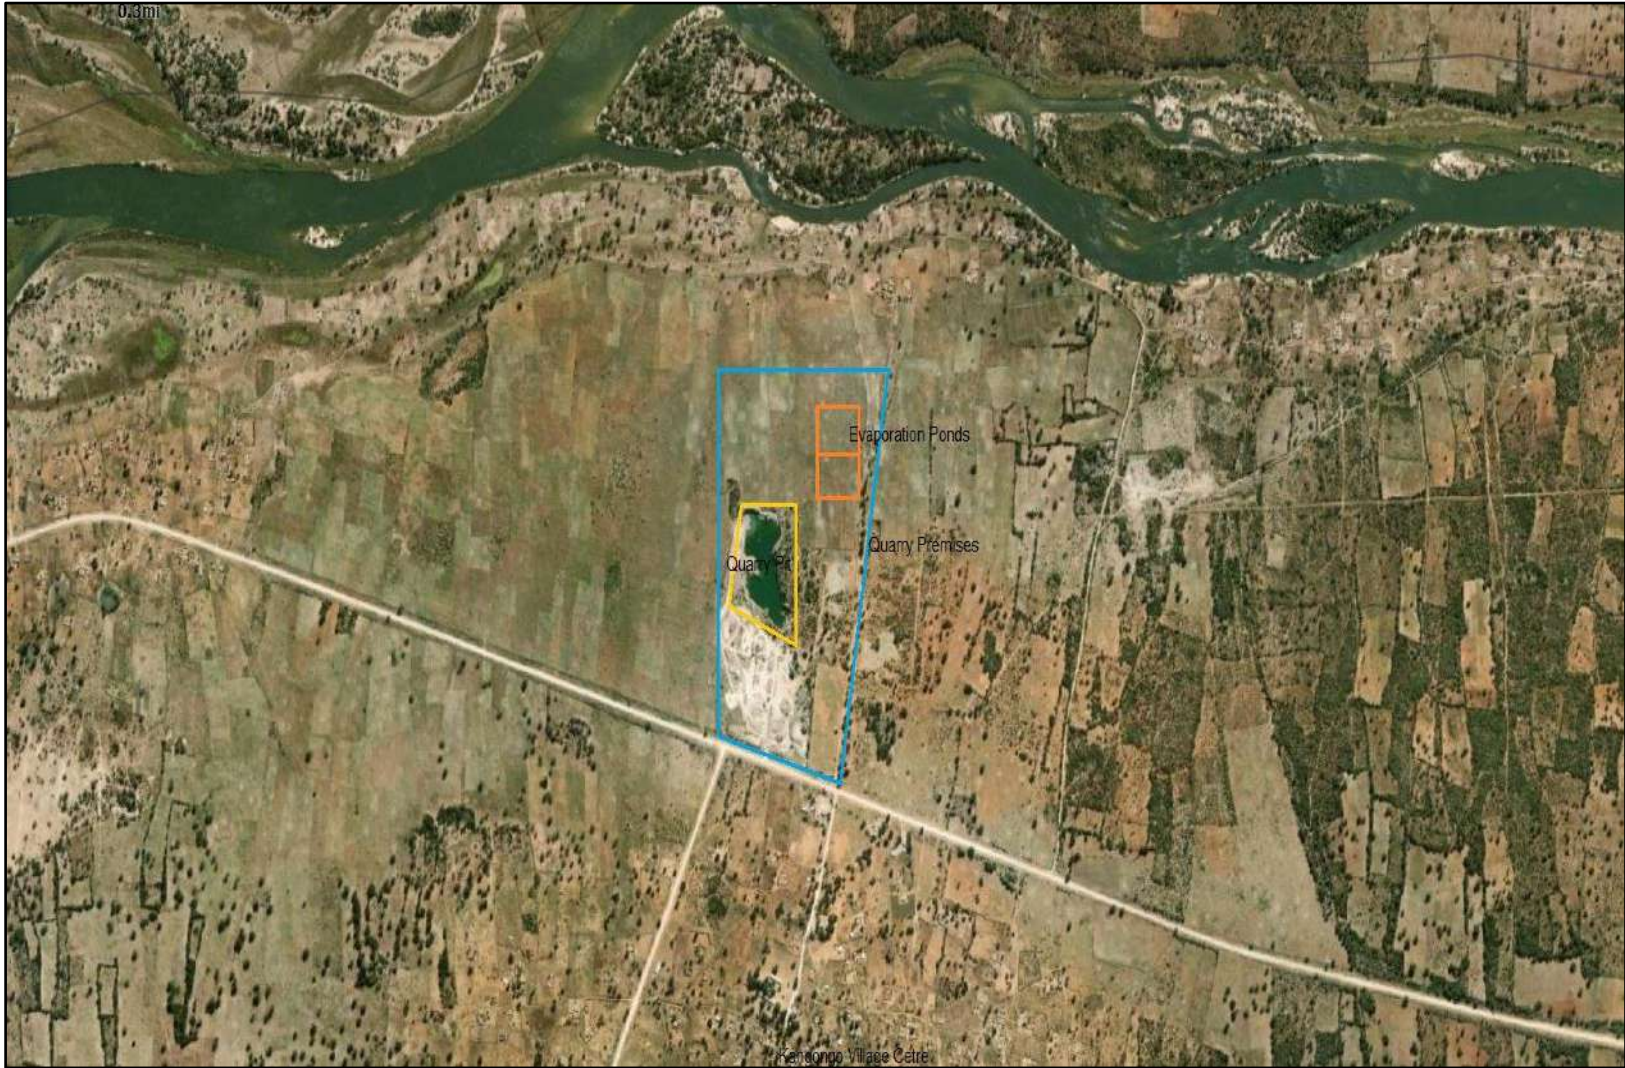
Figure 6: Proposed EP Site

The quarry has a surface area of 87 500 m² (350 m long by 250 m wide) and a floor depth of 15 m when measured from the land surface. Overburden thickness varies between 1.5 to 4 m. Taking the 1100 mm of rainfall received during the 2019-2020 rainy season, and assuming that 40% of the 1 100 mm rainfall entered the pit as surface run-off, then ±134 750 m³ of water could have collected in the quarry pit. Ideally, the dewatering pond should be developed to accommodate 25% more of this volume, i.e. 168 000 m³.
