**Updated Draft Environmental Management Plan (EMP) for:
The Operation of the Heavy Fuel Oil (HFO) Facility in Walvis Bay,
Erongo Region**

September 2022

Updated Environmental Management Report for the Operation of the Heavy Fuel Oil (HFO) Facility for NAMCOR in Walvis Bay in the Erongo Region

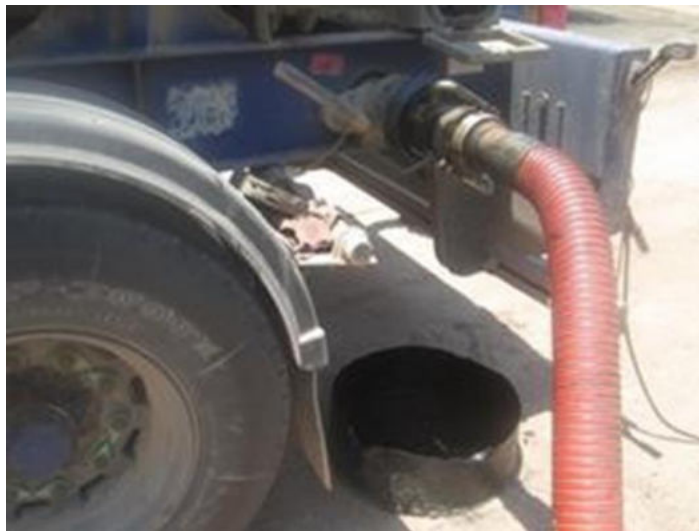
A previous environmental audit assessment of the Depot was conducted Outrun Investments CC in 2016. The report identified oil spills concern during the loading of trucks and recommended for small containers to be used to catch the drops which can be safely contained.

These issues from the previous audit could not be verified due to ongoing renovation works.

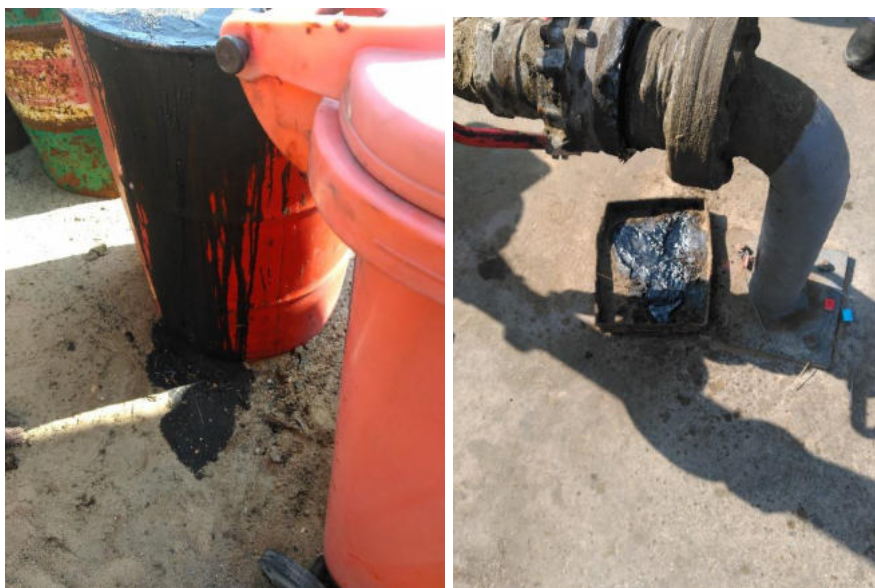
- ***Pools of Liquids***

Small pools containing liquids likely to be hazardous substances or petroleum products were observed or reported at the facility.

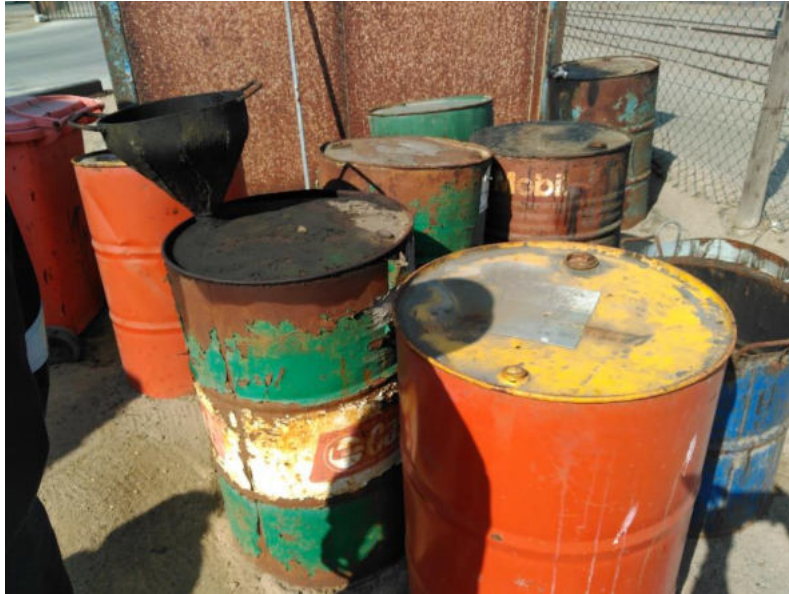
- ***Drums & Hazardous Substance, Petroleum Products and Unidentified Substance Containers***

Drums containing liquids likely to be hazardous substances or petroleum products were observed or reported on at the facility.

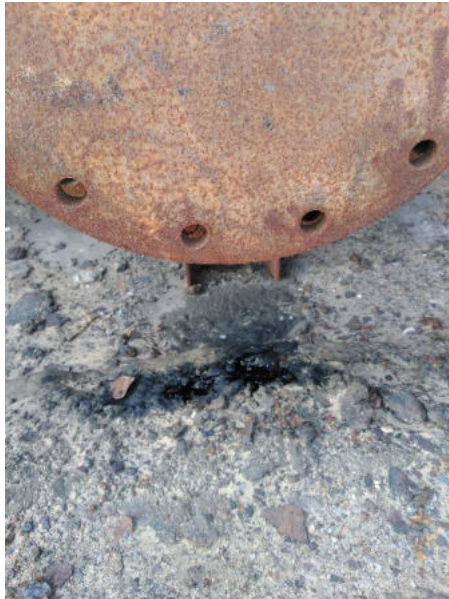
- ***Stained Soil & Pavement***

Stained soil or pavement was observed or reported at the facility.

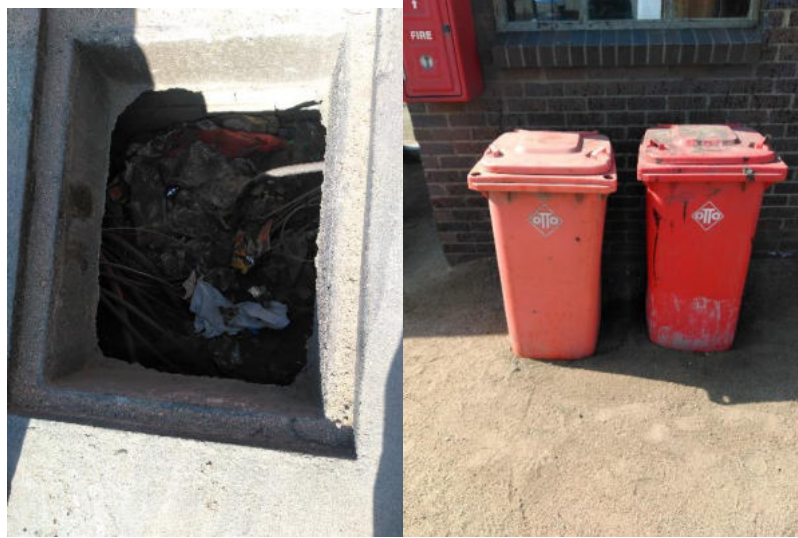
- ***Solid Waste***

EDS did observe any areas that appeared to have been filled or graded that would suggest the presence of waste including, but not limited to, construction debris, demolition debris or other solid waste. EDS observed and improper storage of solid waste at site.
