**Updated Draft Environmental Management Plan (EMP) for:  
The Operation of the Joint Bunkering Services (JBS) Facility in Walvis  
Bay, Erongo Region**

**Document Type: EMP**

**September 2022**

# Updated Environmental Management Report for the Operation of the Joint Bunkering Services (JBS) Facility for NAMCOR in Walvis Bay in the Erongo Region

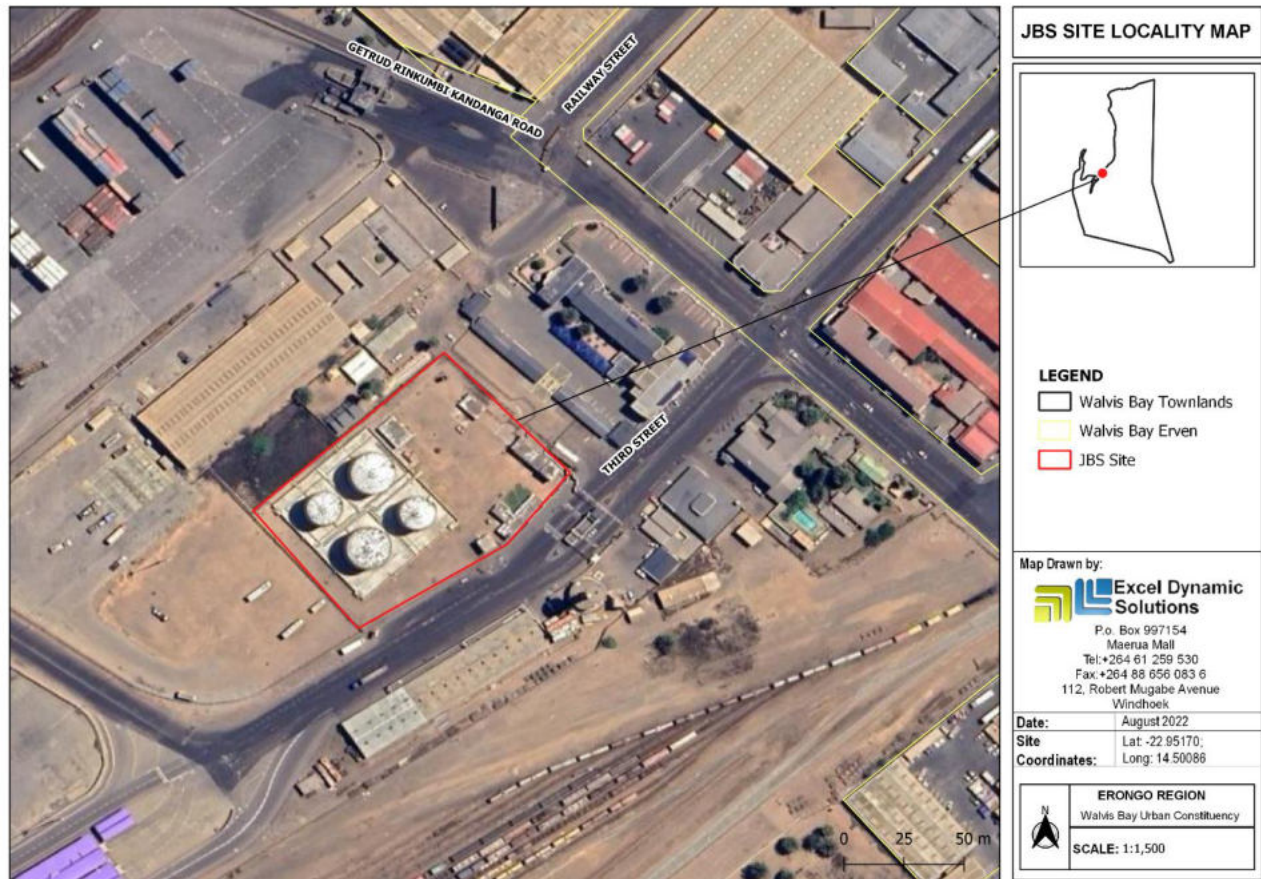
**Figure 2 Location of the JBS Facility in Walvis Bay**

As shown in Figure 2 the audited Facility covers land totaling 0.84 Ha (8,400 m<sup>2</sup>). The Facility comprises of a newly built tanker Jetty berths, building structures constituting a security room, reception area, kitchen, toilets, offices and a laboratory for conducting products quality tests.

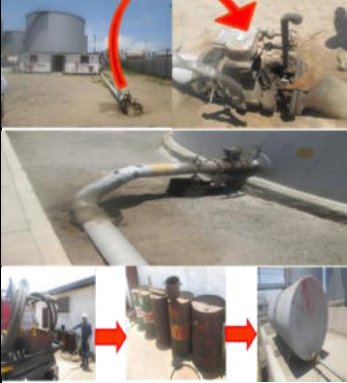
<p>Non-compliant</p>	<p>Drums are used to collect the residual / backflow from the pipes before being pumped to the recovery tank.</p>	<p>The recovery pump should be connected directly to the backflow collecting tank and pump directly to the recovery tank.</p>
<p>Human resources skills</p>	<p>Non Compliant</p>	<p>-The team did not receive basic training in environmental management.</p>	<p>Send employees for basic training in environmental management, its importance etc.</p>
