Draft Environmental Management Plan (EMP) for:

**The Operation of a Bulk Fuel Storage Depot for NAMCOR in
Otjiwarongo, Otjozondjupa Region**

Environmental Audit Report for the Operation of a Bulk Fuel Storage Facility for NAMCOR in Otjiwarongo, Otjozondjupa Region.

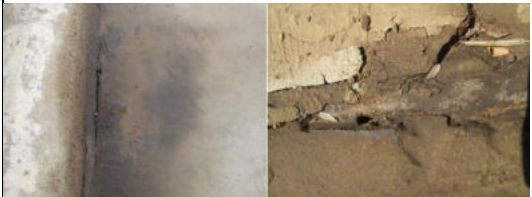
ACTIVITY / FACILITY	STATUS	OCCURENCE	COMMENT and / OR CORRECTIVE MEASURE(S)
<p>Concrete floor and bund walls containing storage tanks.</p>

<p>Non conformity</p>	<p>The bund-walled floor containing these fuel storage tanks are cracked. Reports from the Operator indicate that at least 2000 litres were lost after</p>	<p>The concrete floor should be sealed and protected by an organic resistant material.</p>
