# AN ASSESSMENT OF WATER SUPPLY AND SANITATION IN TSUMKWE, NAMIBIA

An Interactive Qualifying Project Report  
submitted to the faculty of WORCESTER POLYTECHNIC INSTITUTE  
in partial fulfillment of the requirements for the  
degree of Bachelor of Science

Sponsoring Agency: Desert Research Foundation of Namibia

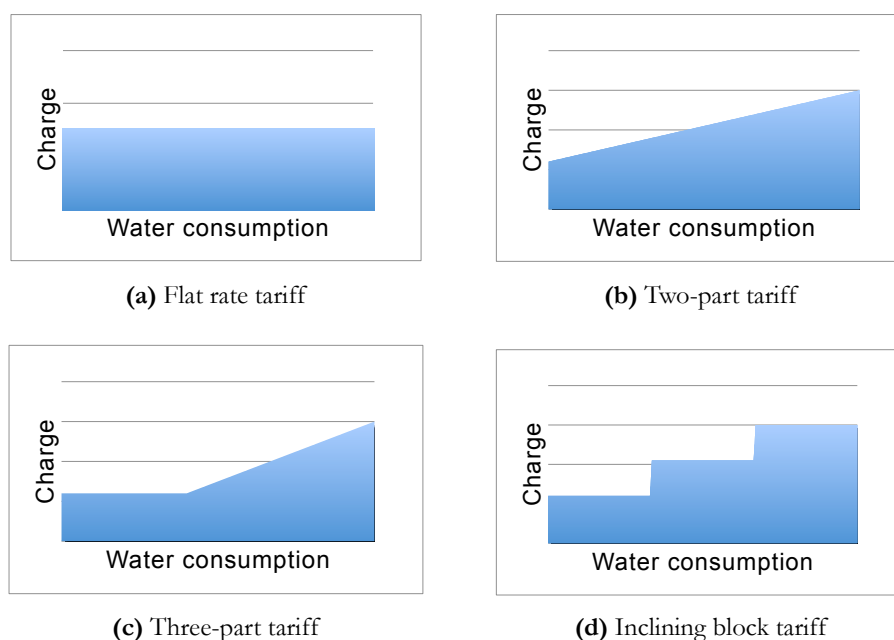
**Figure 2.3:** Schematic water tariff structures designed to discourage wastage and subsidize low-volume consumption

rate tariffs, in which each consumer pays a fixed rate on the volume of water used, are commonly implemented because they are easy to administer. However, they do not provide users with any incentive to conserve water. Three common types of tariffs serve to decrease water demand while remaining affordable to the consumers: the two part tariff, the three part tariff, and the inclining block tariff. In all three systems the charge increases with water consumption, as shown in Figure 2.3. This provides an incentive to conserve water, but the rates at which prices increase must be set such that sudden, drastic reductions of water consumption are avoided (McKenzie et al., 2003).

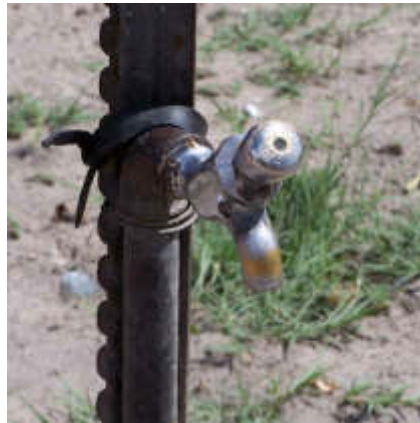
imal effects on the consumers. Devices such as the self-closing tap in Figure 2.4 do not allow the consumer to waste excessive amounts of water by accidentally leaving a tap open. Aerators and low-flow shower heads also reduce flow of water from taps with little effect on the consumer (McKenzie et al., 2003).

**Figure 2.4:** This self-closing tap opens only when the button is depressed, preventing it from being left open and forgotten

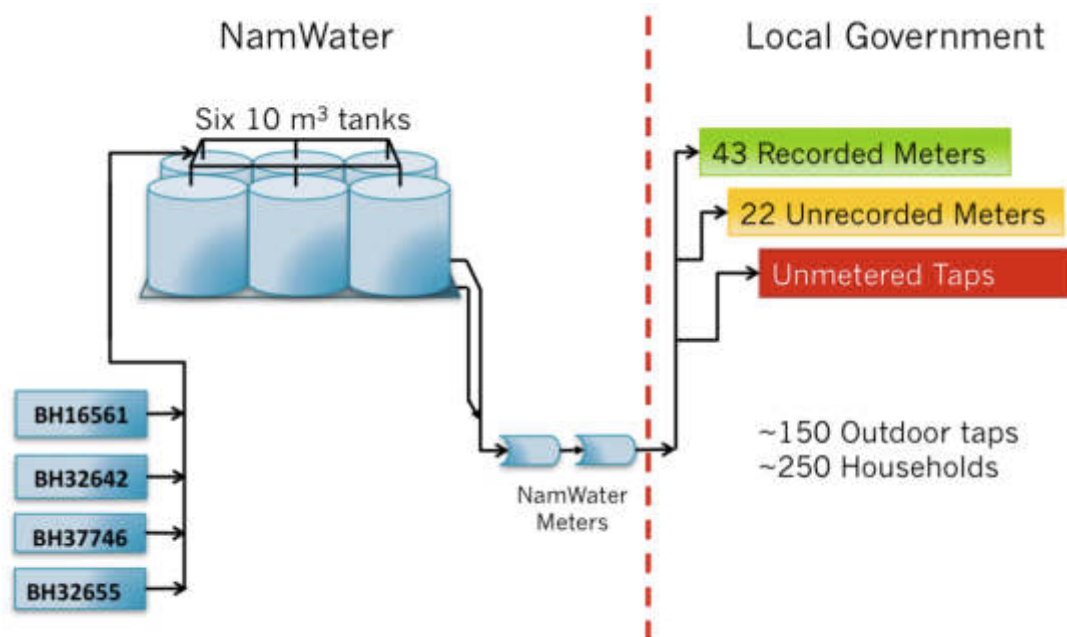
Bulk water supply in Tsumkwe is the responsibility of NamWater, which includes Tsumkwe's four boreholes (BH 32642, BH 16561, BH 37746, and BH 32655), an elevated water tower, and the underground pipes that connect the boreholes to the water tower. On the outlet of the water tower are two water meters that display the volume of water that has flowed out of the tanks. After the water has passed through these meters, it belongs to the Regional Council, which is billed by NamWater for the water supplied. Water distribution after this point is the responsibility of the Local Government and the Regional Council.

All boreholes are enclosed by metal cages, with boreholes BH 37746 and BH 32655 located on the west side of the main road inside stock-proof fences, while BH 16561 is located next to the elevated water tower inside a security fence. BH 32642 is located south of the water tower, and is not

**Figure 5.1:** Water is pumped from four boreholes into an elevated reservoir and then distributed to taps, toilets and personal storage tanks.

According to (NamWater, 2010), a 480 m long, 50 mm diameter HDPE pipeline connects boreholes BH 32642 and BH 16561 with the elevated reservoir, while a 350 m long pipeline connects boreholes BH 32655 and BH 37746 (it is assumed that this is also a 50 mm HDPE pipe). These pipes are estimated to allow a maximum flow rate of 7.5 m<sup>3</sup>/h. No significant leaks or breaks in these pipes have been reported or observed by our team. However, it should be noted that there are no maps at either NamWater or the office of the Local Government showing where these underground pipes are located and no surface markers.

The water abstracted by each borehole is pumped to an elevated water reservoir, which provides water to the settlement via gravity feed. A 12 m steel tower supports six UPVC tanks, each with a 10 m<sup>3</sup> capacity. For the several years, the middle tank on the south side has leaked out of a hole in its side, shown in Figure 5.2. By comparing the volume of water abstracted from the aquifers to the volume sold by NamWater, we determined that each day after about 15 hours of pumping, 170 L were lost through this leak, at an average rate of 12 L per hour. This amount is insignificant compared to the volume of water that passes through these tanks each day, but a NamWater employee stated that this has been a problem for at least a year, which demonstrates a lack of attention that could allow small leaks such as this one to develop into much more serious issues. The south-west tank has not been used since June 2009 due to a crack in its side, bringing the total capacity of the elevated water reservoir to 50 m<sup>3</sup>. However, as stated before, during our stay in Tsumkwe, these tanks never reached their full capacity because of the high demand for water and the short power generation cycle during the day.

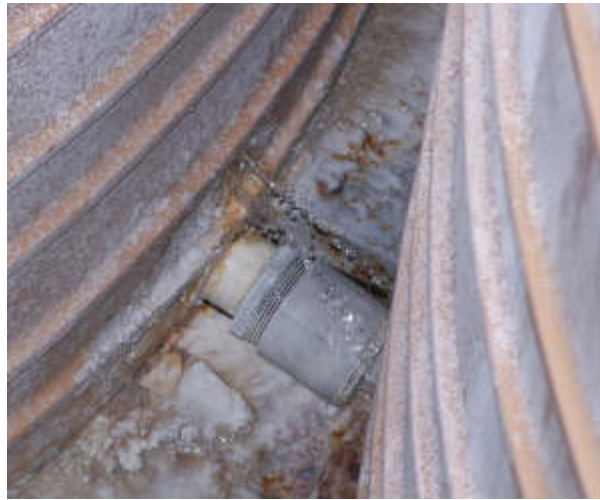
**Figure 5.2:** A leak in one of the NamWater storage tanks

The next step for NamWater and the Local Government is to determine where leaks occur and then repair these leakages. For NamWater, this will be namely in fixing leaks in the elevated water reservoir. For the Local Government, this will include replacing and repairing leaky or broken taps and pipes. The oxidation pond should also be repaired, clearly marked, fenced off and locked.

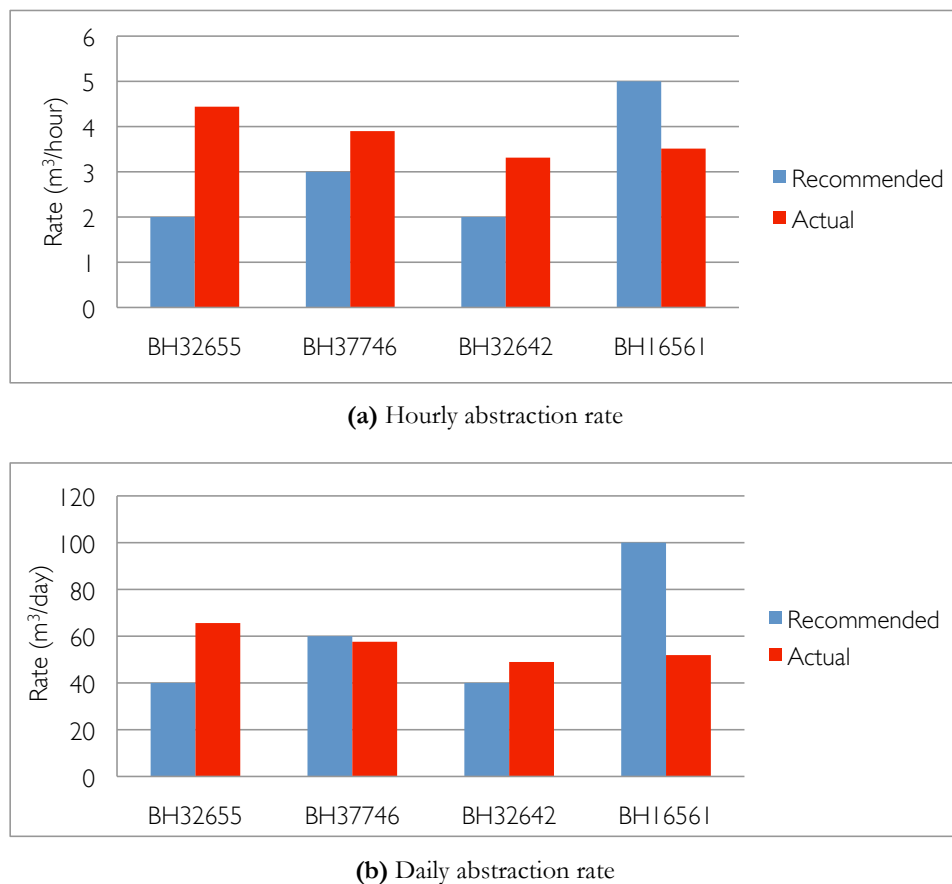
According to NamWater, boreholes BH 37746 and BH 32655 should not be operated simultaneously due to their close proximity (T'jyahura, 2010). However, during our team's two week stay in Tsumkwe, all four boreholes were operated daily, with three of the four boreholes either over-abstracting or operating very close to the limit recommended by NamWater's Department of Geohydrology. Also, while each borehole is supposed to turn on automatically, poor electronic

**Figure 5.3:** NamWater has recommended a maximum abstraction rate for each borehole, but nevertheless has installed pumps that exceed some of these limits.

NamWater and the Local Government need to improve and streamline record keeping. Records should be kept to determine whether the current boreholes are consistently being over-abstracted or if the abstraction rates are sustainable. The Local Government must document how much water is actually distributed to the users, and how much is lost to leakage. Additionally, the Local Government should conduct an accurate census of human and animal population in Tsumkwe in order to approximately determine the overall water demand. Understanding the potential

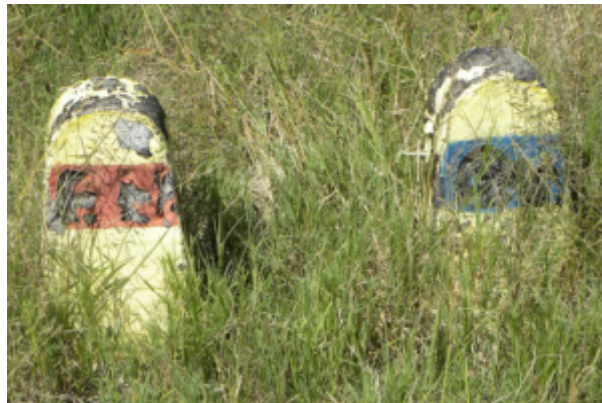
The most recent map of the water mains dates from January of 1987, and only shows the original water lines. Moreover, this map was improperly surveyed, as some permanent roads do not line up with those on the satellite imagery from Google Maps. There are a number of markers like those in Figure 5.4 in Tsumkwe, but nobody knows what they represent. Other markers have been stolen, and maintenance workers must use trial and error to locate the pipes when repairs are needed.

**Figure 5.4:** Markers like these can be found in some parts of the settlement

The settlement should identify the exact location of water and sewage pipes. A complete survey of the water lines, including informal connections, should be conducted. The precise locations of all lines can then be marked with surface markers to facilitate future repairs to the water lines.

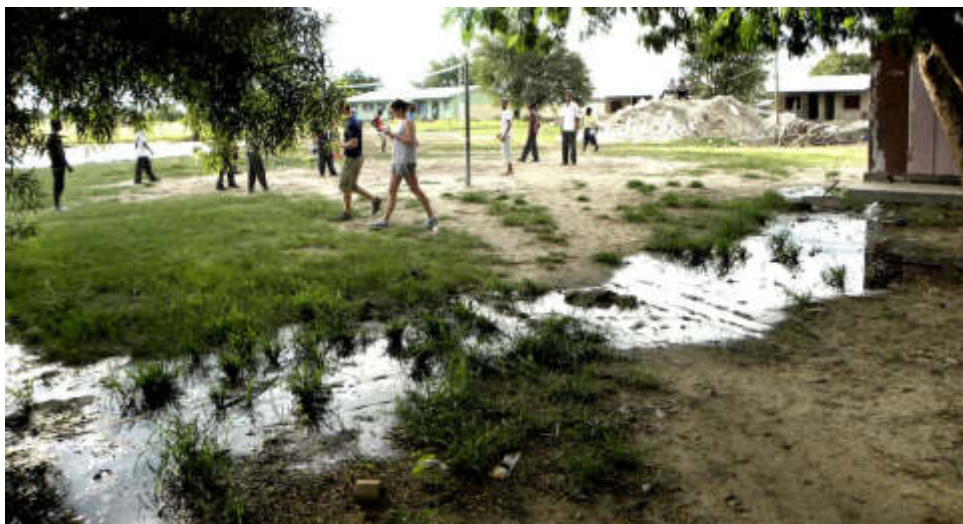
Tsumkwe's residents have three options available for defecation: flush toilets, dry toilets, or using the bush. For those with flush toilets, the Local Government is responsible for collecting and disposing of sewage. Periodically or upon request, the Local Government will send a truck that will pump septic tanks and dump the contents into an oxidation pond located in Tsumkwe South. However, at the time of our field work, the truck had been broken for the past four months and no septic tanks had been pumped in that time. As a result, over 80% of the 41 septic tanks in Tsumkwe are overflowing. This creates obvious health risks, especially to children who play right next to overflowing septic tanks in the schoolyard. Figure 5.5 shows children playing volleyball next to a pool of overflowing sewage. During an interview, an employee at the health clinic indicated that she had seen a recent increase in diarrheal disease and septic infection among children. In addition, the oxidation pond is not labeled or locked and does not yet smell. Children occasionally swim in the pond and many residents, unaware of the pond's purpose, cut pieces of the plastic lining out of the oxidation pond to rainproof their homes. This is clearly unsanitary, and the removal of the lining compromises the oxidation pond's ability to prevent ground contamination.

**Figure 5.5:** Children playing volleyball next to an overflowing septic tank

The first priority is an immediate repair of the septic truck to ensure that current sewage pumping demands can be met. This is the most pressing issue as raw sewage is presenting health risks to the community.

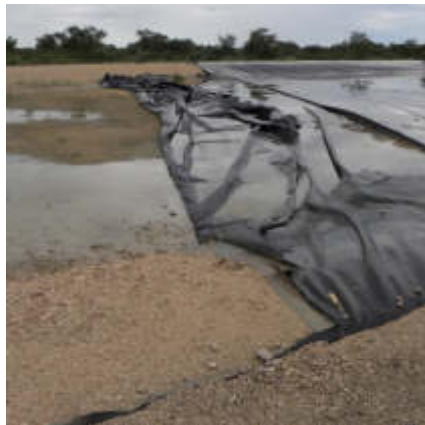
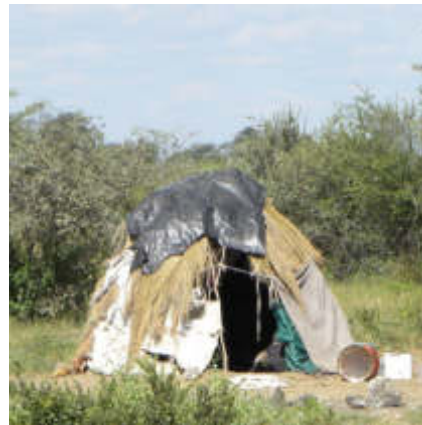
**(a)** Damage to the oxidation pond lining increases the risk of groundwater contamination

**(b)** The owner of this hut has incorporated a piece of the lining as rainproofing

**Figure 5.6:** The oxidation pond normally prevents sewage from seeping into the ground, but the lining has been damaged and no longer prevents ground contamination.

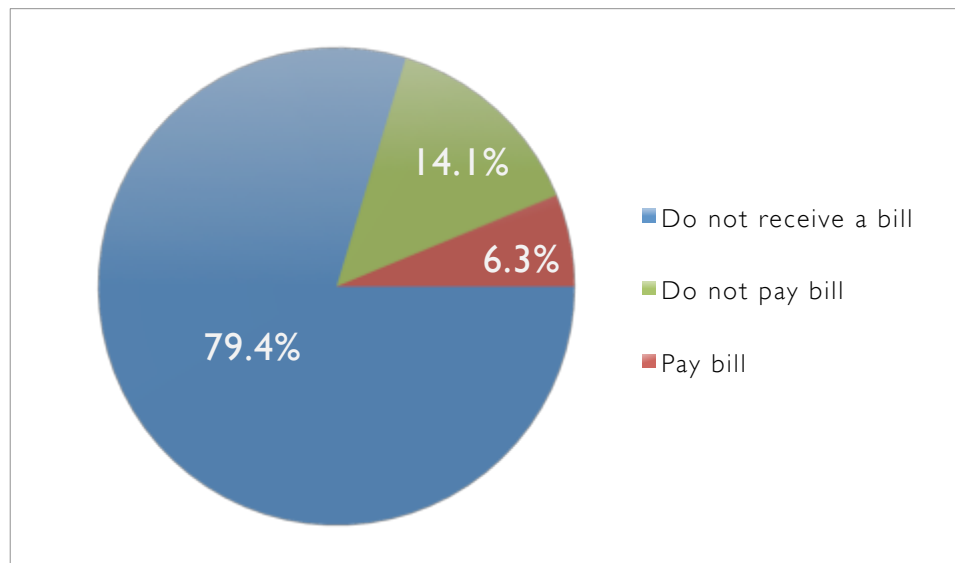
**Figure 5.7:** Percentage of households that pay for water usage

The financial records show no steady trends in water use. This leads us to believe that people generally are not concerned with their personal usage, most likely because most do not pay for their water. Of 64 people surveyed, only 20.4% receive water bills and only 6.3% pay their bills (see Figure 5.7). However, even institutions and businesses that do pay for water have significant and sporadic fluctuations in usage. This observation is in agreement with the financial standing of the wealthy business owners or government bill payers in that consumption is insignificant to their monthly income. Such fluctuations could result from misreadings or otherwise careless record keeping practices similar to those described in the previous section.

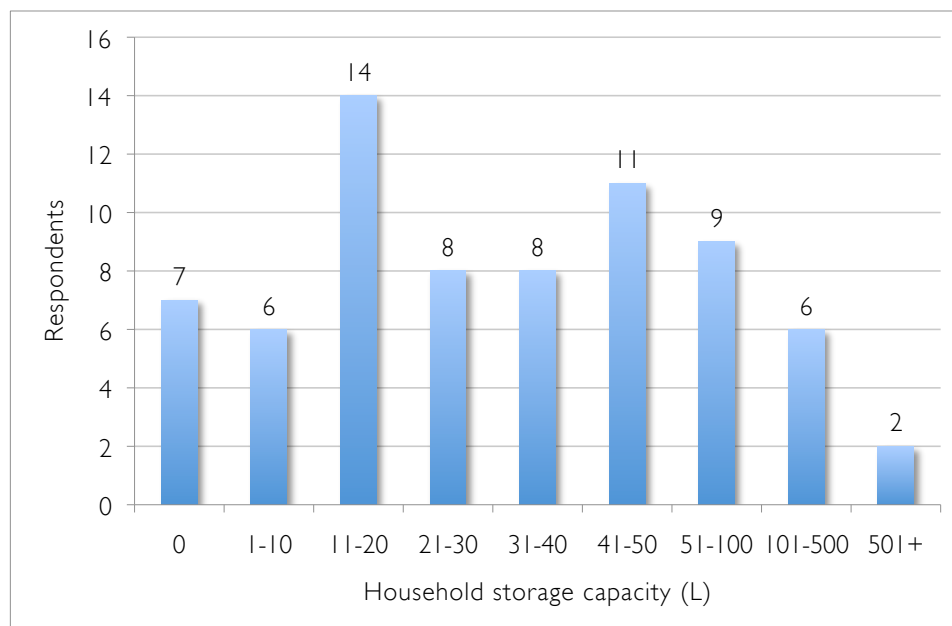
**Figure 5.8:** Volume of water typically stored each day in 64 households.

During our interviews with residents, it became clear that some of them simply do not plan for the future. Figure 5.8 shows that a significant number of households store no more than 20 L of water which, according to WHO, is the minimum quantity of water necessary for domestic uses for a single person for one day (Reed, 2002). Moreover, most of the households surveyed store fewer than 60 L, which is only enough for three people for one day. In Tsumkwe, three people is a very modest size for a family. Most homesteads house families of 10, 15, or even more. Our results are clear that most of those families do not have enough stored water to last for even one day during a shortage.

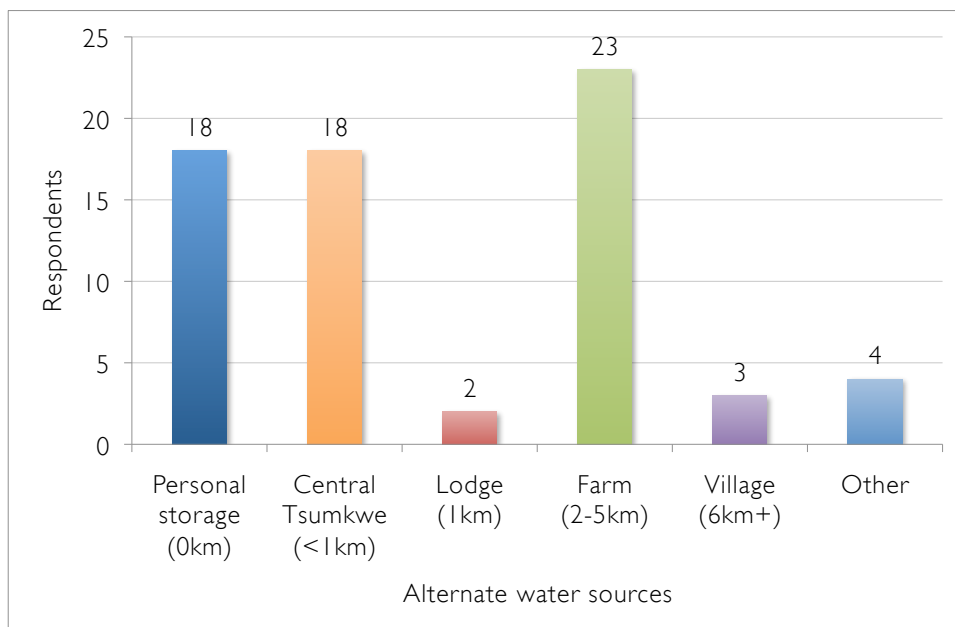
**Figure 5.9:** Alternate water sources used during a shortage of a day or more, and the distance of each from the center of the settlement

Furthermore, a large number of respondents said that they rely on their personal water storage in the event of a water shortage lasting a day or more. There are also a large number who obtain water from more than 1 km away during such a shortage, which is below the WHO standard for water availability. Very few people said that they ask for water at the lodge, which has its own borehole and generator. During an interview, the owner of the lodge said that he gives water to anyone who asks free of charge, but the data presented in Figure 5.9 makes it clear that very few people do this. There must be a reason that most people are willing to travel more than twice as far as the lodge to obtain water. We can draw three possible conclusions from this result:

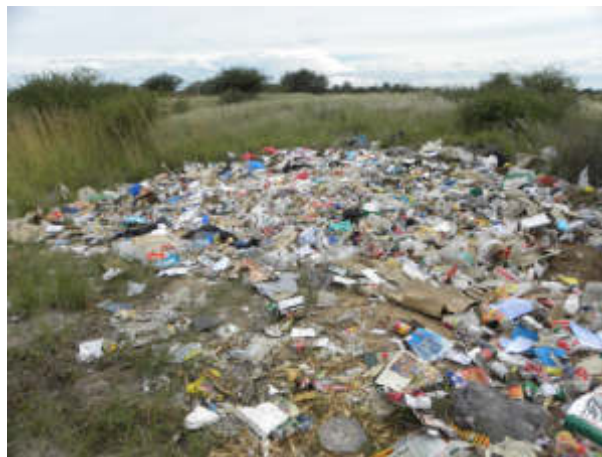
The dump site is not used by most of the population, and regardless it has no containment mechanism as is evident in Figure B.1. Any papers or plastic bags that are brought there dry out and are carried off into the bush by wind. This pollutes the Nyae Nyae Conservancy, which is home to a diverse range of wildlife.

**Figure B.1:** The waste dump site has no means of containing garbage

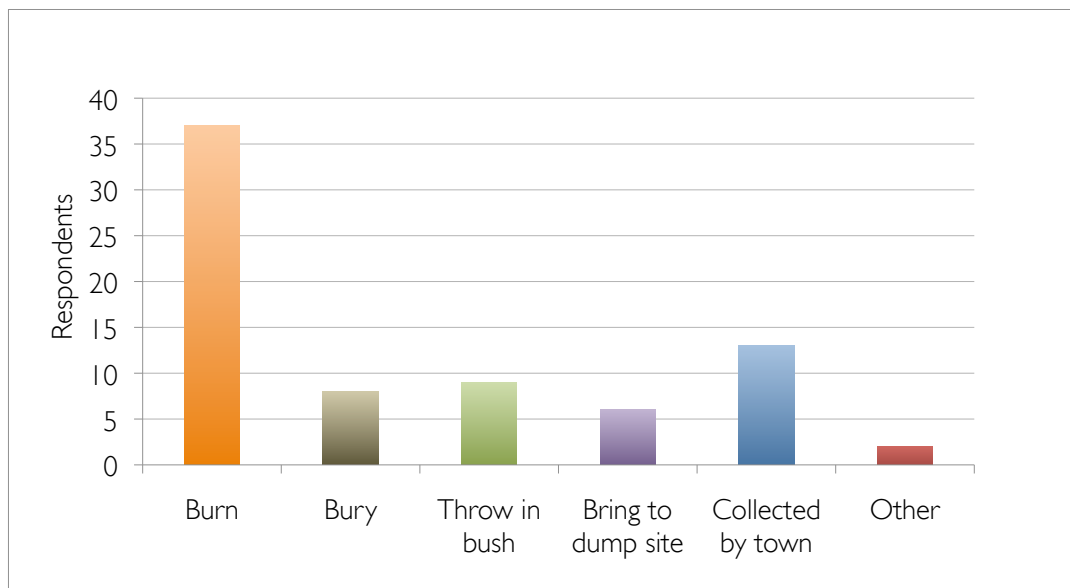
**Figure B.2:** Waste disposal methods in Tsumkwe (some respondents employed multiple methods)

It is clear from Figure B.2 that burning is by far the preferred method of waste disposal. Furthermore, several respondents said that they burn any combustible material, including plastics. Even when asked directly, few people said that they burn only paper. This poses several health risks, especially to the San who are very susceptible to tuberculosis (Jenkins, Lehmann, & Nurse, 1974). Burning plastics can release carcinogenic chemicals that damage the immune, nervous, endocrine,
