# Climate change and adaptive land management in southern Africa

Olivier, G., Helmschrot, J. & de Clercq, W.P. (2018) Are large classical gully systems inactive remnants of the past? A field-based case study investigating sediment movement. In: *Climate change and adaptive land management in southern Africa – assessments, changes, challenges, and solutions* (ed. by Revermann, R., Krewenka, K.M., Schmiedel, U., Olwoch, J.M., Helmschrot, J. & Jürgens, N.), pp. 146-154, *Biodiversity & Ecology*, **6**, Klaus Hess Publishers, Göttingen & Windhoek. doi:10.7809/b-e.00317

# Are large classical gully systems inactive remnants of the past? A field-based case study investigating sediment movement

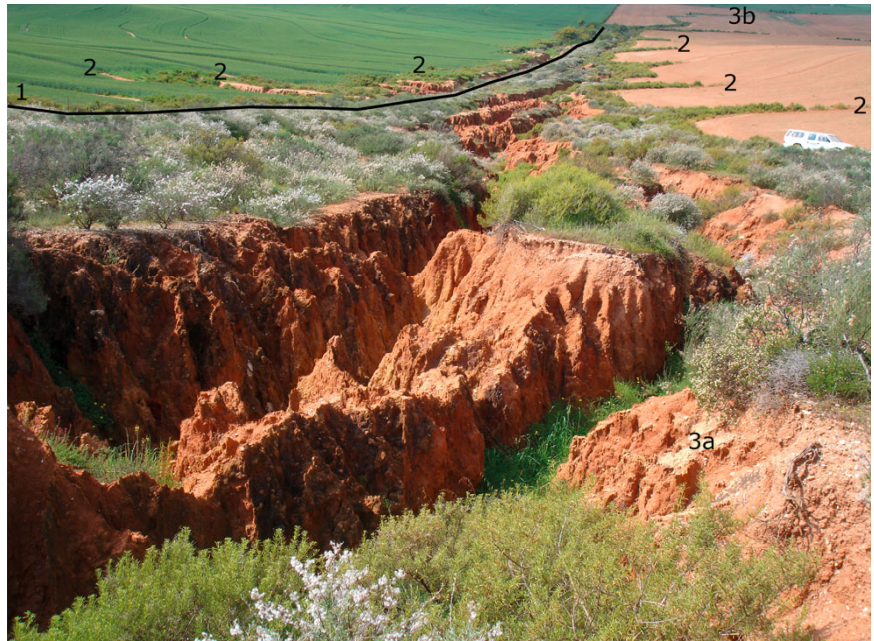
Figure 2: Gully network at Malansdam and initial observations: 1) *Boundary fence could have led to initial gully formation*, 2) *Gullies are currently expanding behind contour banks*, 3) *Tillage method used can cause increase amount of runoff leading to the gully expansion behind contour banks*, 4) *numerous gully channels at steep slope (4b) when compared to gentle slope (4a)*.

A discontinuous, split channel gully network on Malansdam farm (Figure 2) was selected as the case study site. The gully network is located on a commercial wheat farm, within a thin sliver of Renosterveld. From initial observations, the gully shows signs that its origins are of anthropogenic nature. The main gully channel is found along the main drainage line where a fence was installed (Figure 2, along line drawn at position 1) – most likely during the 1930's during the land-use change to wheat cultivation. The fence line is hypothesized as the origin of the gully network, which contributed to gully erosion in two ways: 1) Livestock and vehicles moving along the fence; 2) Contour construction. Cattle and vehicles moving along the fence line would have compacted soil increasing vulnerability to soil erosion by limiting infiltration resulting in a higher volume of overland flow. Ploughed contours were introduced as a measure to curb soil erosion by reducing slope length on cultivated fields, but

resulted in the generation of channelized overland flow towards the main drainage line. A higher volume of water would therefore have accumulated and flowed along the main drainage line at the fence, where soil was compacted. Ploughed contours, a measure implemented to prevent soil erosion by farmers, influenced gully evolution and appear to have played a key role in initiating this gully network. Observational evidence suggest that ploughed contours are continuing to influence gully evolution, discernible by bank gullies extending behind contours into the cultivated field (Figure 2, various positions labelled 2). The effect of slope on gully erosion is also evident in Figure 2, with numerous gully channels at the forefront of the picture (Position 3a), with the gully network fading into one channel where slope is gentle (Figure 2, position 3b).

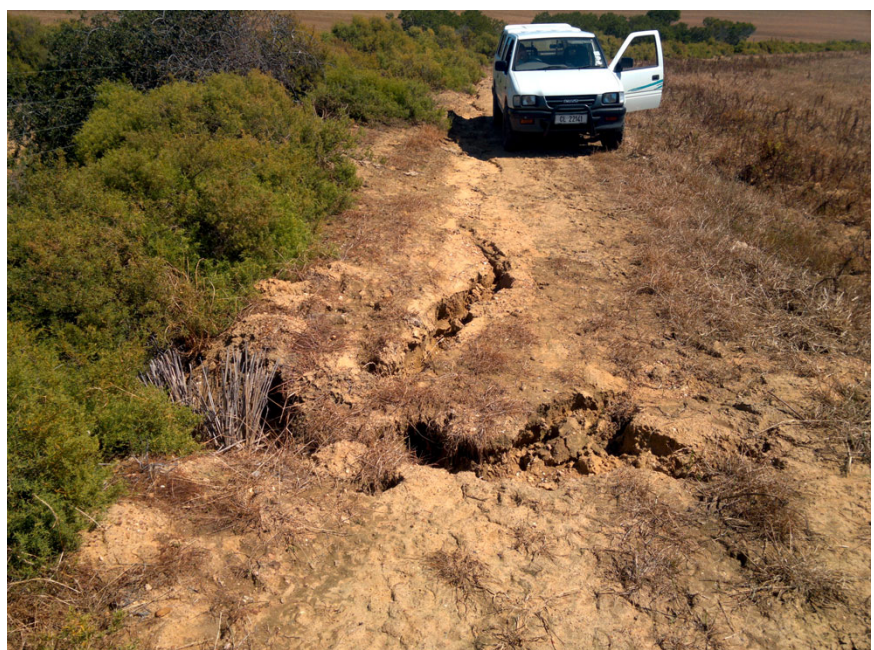
Figure 4: Bank gully expansion along farm dirt road

paring the 1944 topographical map and the time series, no change in base level was evident, as the discontinuous gully fades into a depositional zone near farm dwellings that had to be erected prior 1944. In-field observations indicated that gully processes were active. Figure 4 shows a bank gully extending away from the primary gully on a dirt farm road. Recent activity is noticeable from both gully channels, looking at the collapsed soil found in the gully along the walls and the head. The bank gully has a channel extending towards the vehicle most likely fed by increased overland flow, due to the compaction of the soil on the dirt road.

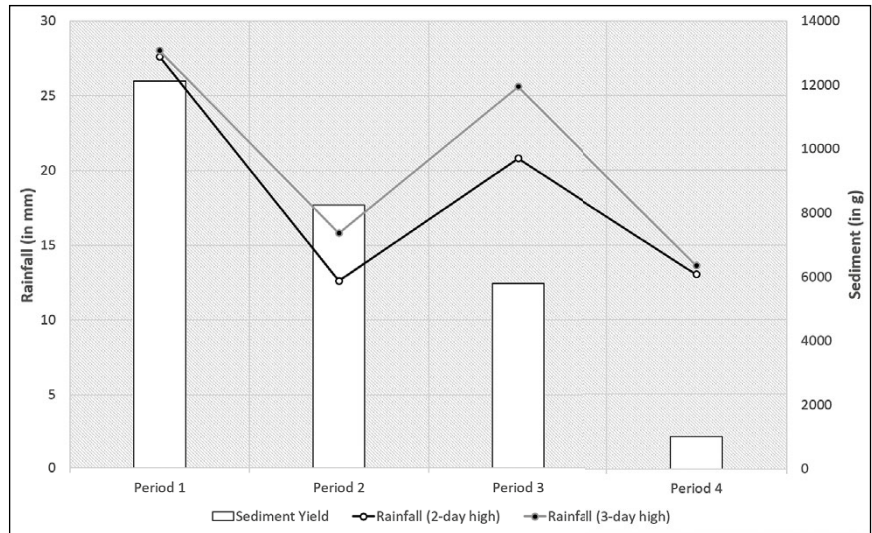
Figure 7: Sediment yield versus highest continuous rainfall depth for 2 and 3 consecutive days per period
