**Environmental Impact Assessment on the proposed
330kV Power Line from Katima Mulilo to Ngoma:**

Impact on the Vegetation

Ben Strohbach
November 2011

for:
Enviro Dynamics cc and NamPower
Windhoek

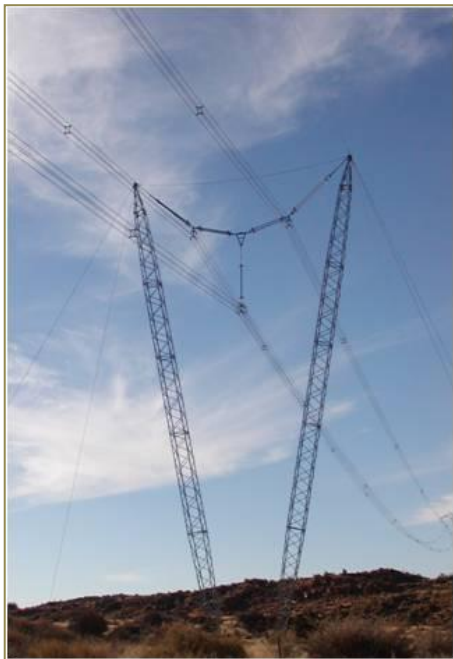
Figure 2: An example of the proposed structures to be used for this transmission line.

The structures to be used on the proposed line will either be a guyed or a self supporting structure, or a combination of both. An example is illustrated in **Figure 2**.

The spacing between the pylons will be between 400 and 500 metres depending on the wind and weight spans.

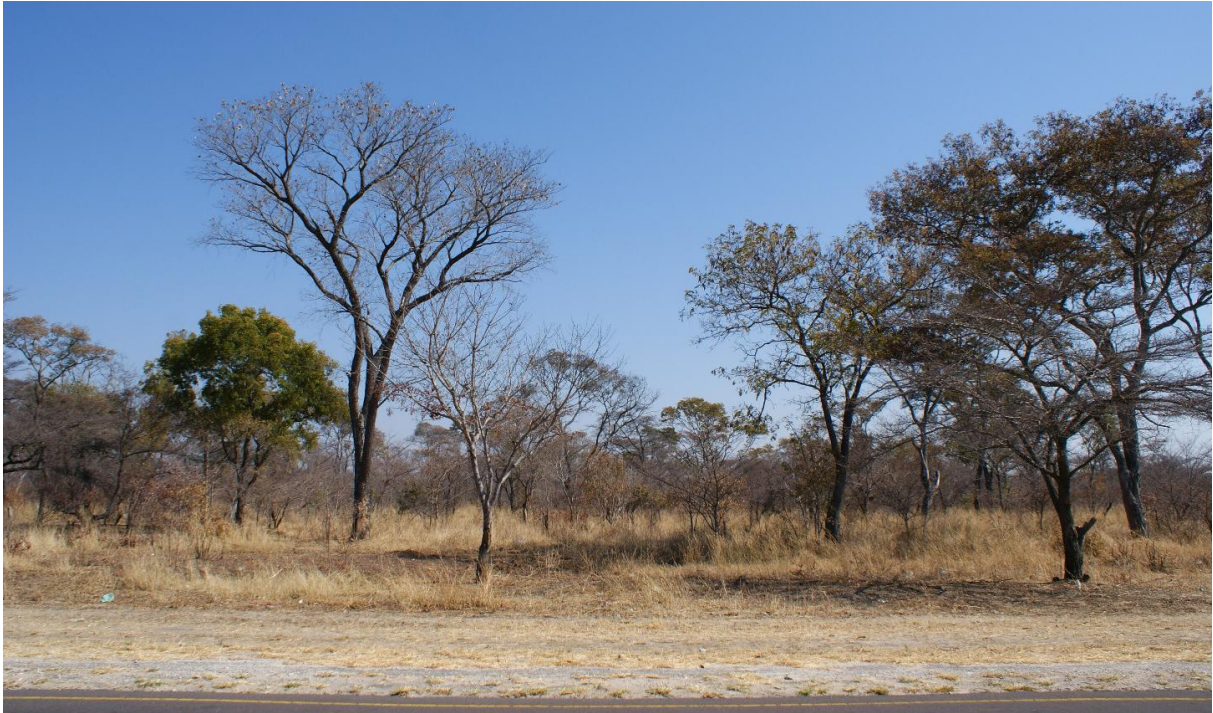
Figure 4: *Baikiaea plurijuga* – *Pterocarpus angolensis* bushlands as seen at plot C1, along the B6 main road SW of Katima Mulilo.

These bushlands occur on the deep sandy soils in the north-western part of the powerline route, between the Katima Mulilo power station and the quarantine camp. Here a large number of timber tree species occur, including *Pterocarpus angolensis*, *Guibourtia coleosperma*, *Baikiaea plurijuga* and *Burkea africana* (**Figure 4**).

Several species in the area are known to coppice strongly. Especially *Dichrostachys cinerea*, *Colophospermum mopane* and *Combretum collinum* are known for their coppicing ability (Strohbach, 1998, 2000a, 2000b). *Dichrostachys cinerea* is also known as the most aggressive encroaching species in Namibia, encroaching especially in disturbed areas (Bester, 1998; De Klerk, 2004). *Clerodendron uncinatum* is less well-known as encroacher (mainly because of its relative low growth, and often not persisting shoots), but has been observed to encroach extensively in disturbed areas like road verges and old fields (own observations, Figure 4).

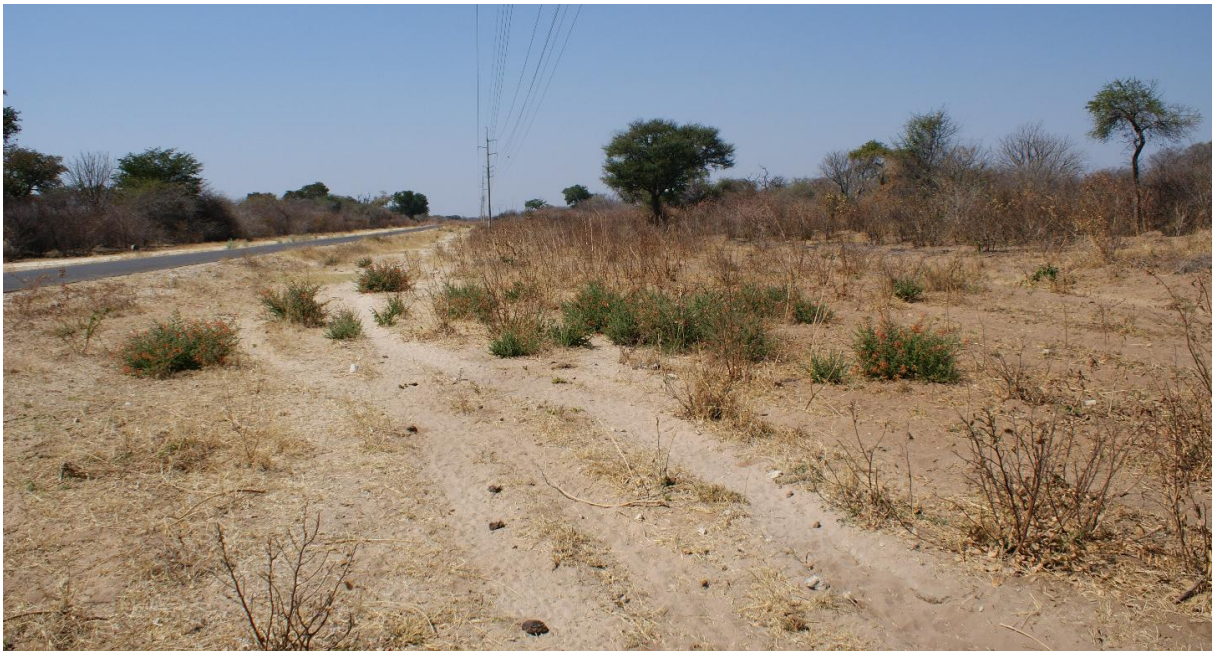
Figure 5: *Baikiaea plurijuga* – *Pterocarpus angolensis* bushlands after being cleared, under the powerline towards Katima Mulilo (plot C5). Note the relative low regrowth of shrubs.

Clearing of the *Baikiaea plurijuga – Pterocarpus angolensis* bushlands will result in extensive bare patches, which will be recolonized only slowly with annual grasses like *Aristida stipitata*, as well as the low shrub *Clerodendron uncinatum*. Depending on the clearing technique, extensive coppicing of *Combretum collinum* and *Bauhinia petersiana* can be expected. These cleared patches will be encroached by *Dichrostachys cinerea* shrubs as well (**Figure 5**). *Clerodendron uncinatum* is a weedy species, typically encroaching disturbed areas, and can be expected to encroach into all cleared areas along the powerline route (**Figure 6**).

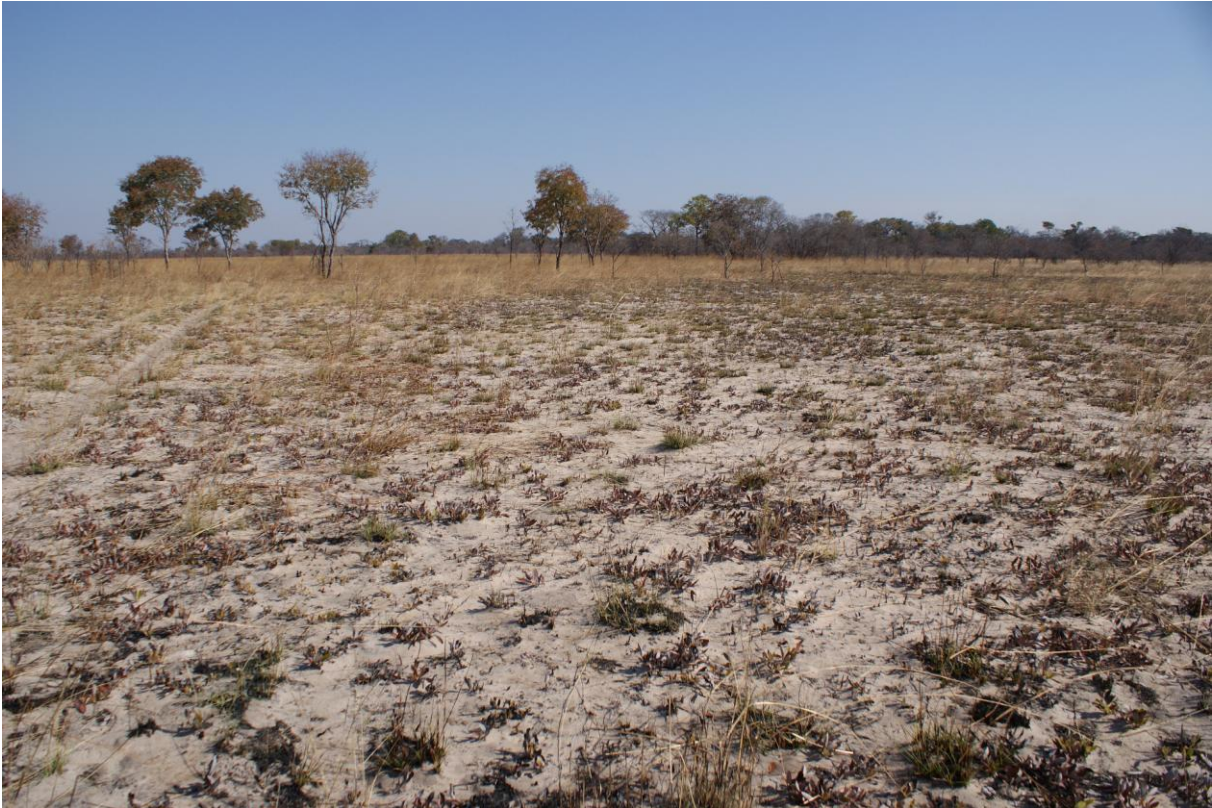
Figure 7: The grasslands of the Gunkwe mulapos at plot C6 in the quarantine camp.

A single plot was surveyed in the grasslands of the Gunkwe mulapos at the quarantine camp. These are essentially grasslands, characterised by the grasses *Aristida meridionalis*, *Eragrostis cimicina*, *Eragrostis pallens*, *Hyparrhenia hirta*, *Perotis patens*, *Pogonarthria squarrosa*, *Schizachyrium sanguineum*, *Tristachya superba*, *Vernonia poskeana* as well as the prostrate dwarfshrub *Dichapetalum rhodesicum*. Tree and shrub species are rare, mostly short shrubs of *Terminalia sericea*, which are a result of bush encroachment due to infrequent fires (**Figure 7**).

As the grass layer is unlikely to be disturbed during the clearing for the powerline, and limited trampling is expected during construction, this vegetation unit is regarded as having a low sensitivity in terms of biodiversity. The fact these mulapos form a water course, however, means that any herbicide used here will likely spread downstream and thus damage other ecosystems. For this reason, these grasslands have a moderate sensitivity with a rating of 174 (Table 1).

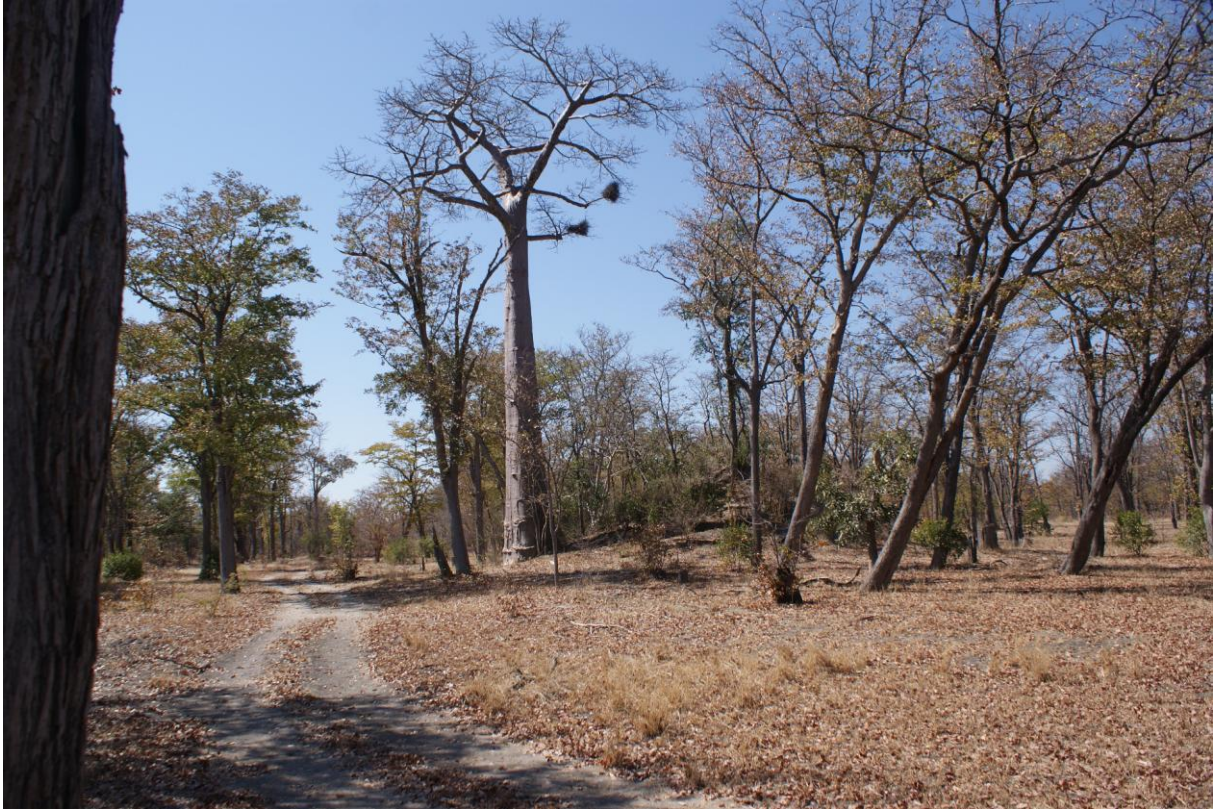
Figure 8: The *Philenoptera violacea* – *Colophospermum mopane* woodlands are dominated by mopane trees, but host a large variety of other tree species as well, as can be seen at Plot C13.

These woodlands form the typical form of the Mopane – *Aristida* woodlands *sensu* Mendelsohn & Roberts (1997). Although these authors state that mopane is often occurring as the only tree, a large variety of tree species have been found here. This community is characterized by *Aristida adscensionis*, *Balanites aegyptiaca*, *Colophospermum mopane*, *Croton menyharthii*, *Euclea undulata*, *Philenoptera violacea*, *Monechma divaricatum*, *Sansevieria pearsonii*, with *Ximenia americana* occurring constantly as well (**Figure 8**).

The diversity of species occurring here is relatively high, with 53 species being recorded, of which 10 are protected either by the Forestry Act or by the Nature Conservation Ordinance (Figure 9). Being part of an extensive floodplain system towards Lake Liambezi, the sensitivity of this community is rated as high (score of 222) (Table 1).

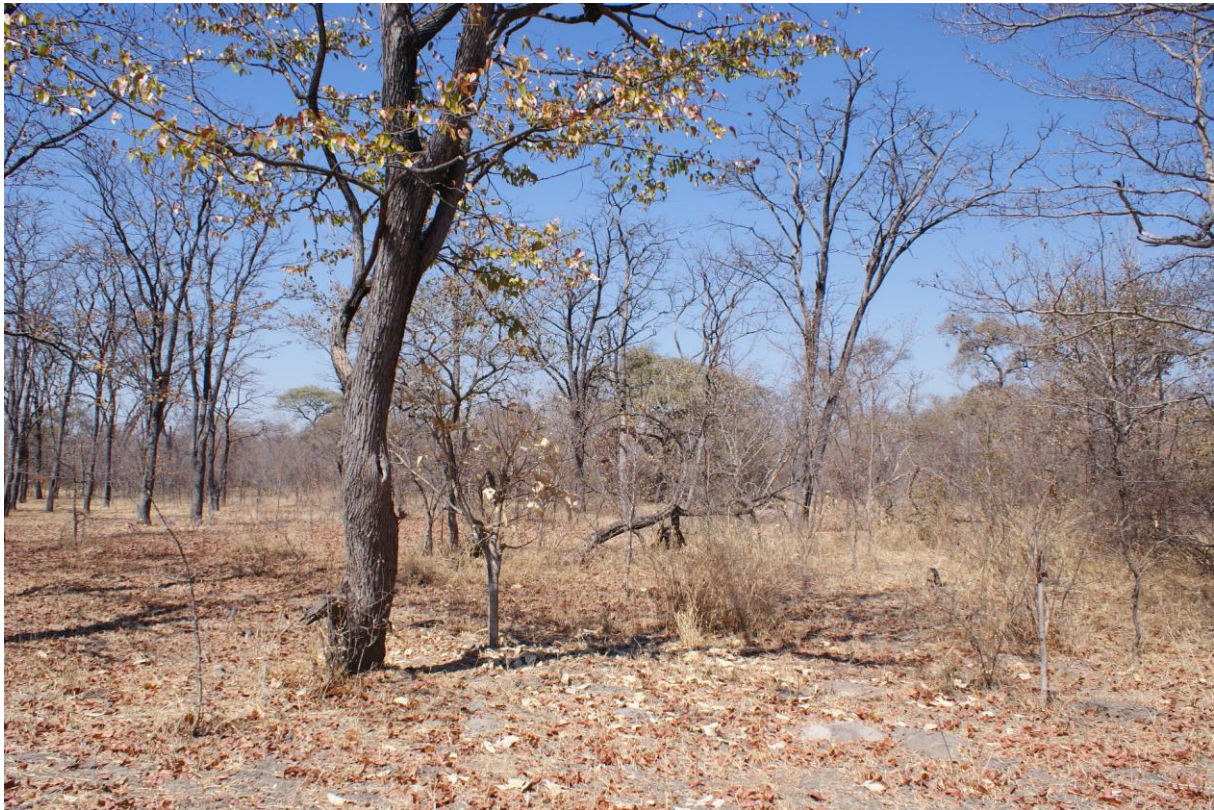
Figure 10: *Colophospermum mopane* – *Terminalia sericea* bushlands form an ecotone between the northern heavier soils and the southern sandy soils, here seen at plot C26.

These bushlands are characteristic for the Mopane – Terminalia woodlands *sensu* Mendelsohn & Roberts (1997), but occur in mosaic with the *Philenoptera violacea* – *Colophospermum mopane* woodlands to the north as well as the *Burkea africana* – *Terminalia sericea* shrublands further south. These bushlands are characterised by the species *Aristida stipoides* and *Colophospermum mopane*, which are constantly associated by the species: *Aristida stipitata*, *Burkea africana*, *Combretum collinum*, *Grewia retinervis*, *Hibiscus* sp., *Pogonarthria fleckii* and *Terminalia sericea* (Figure 10).

The habitat is typically ecotonal of nature, being a mosaic of sandy plains and patches of loamy sands. Because of this ecotonal nature of this community, a relative high number of species (54 species) have been observed. The relative low number of protected species (8) and the fact that these bushlands occur on relative sandy plains downgrades the sensitivity though to moderate with a sensitivity score of 194 (Table 1).

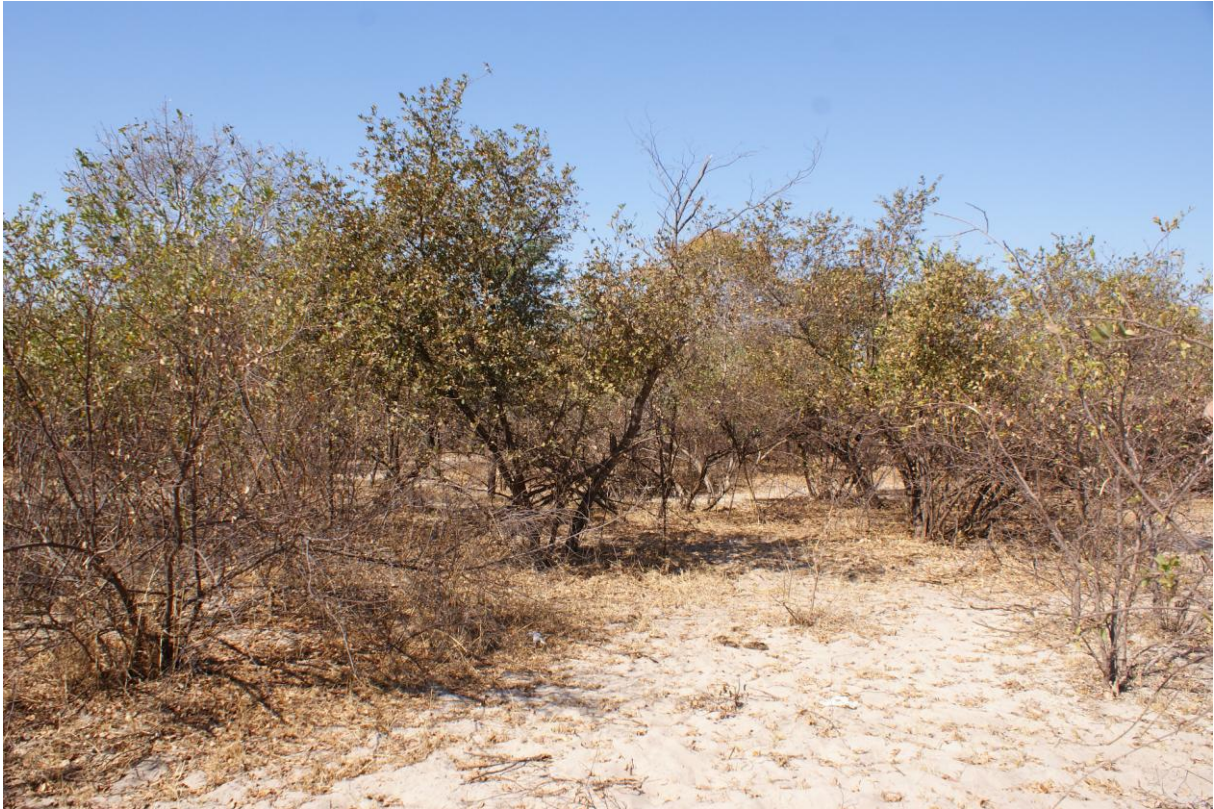
Figure 11: Typical *Burkea africana* – *Terminalia sericea* shrublands, as seen at plot C27.

These shrublands occur on deeper, sandy soils south of the Bukalo – Liambezi channel, in mosaic with the previous community. They are characterised by the presence of *Acacia erioloba*, *Combretum collinum*, *Commiphora tenuipetiolata*, *Phyllonoptera nelsii*, *Ochna pulchra*, *Tapinanthus oleifolius*, *Vangueria infausta* and are constantly accompanied by *Aristida stipitata*, *Digitaria seriata* and *Terminalia sericea* (**Figure 11**).

Forming a lower shrubland, with less large trees, the species diversity is also lower with only 32 species observed, of which only four species are protected (Table 1). Being a plain, with both sandy and loamy soils, also lowers the sensitivity rating to “moderate” with a score of 135.

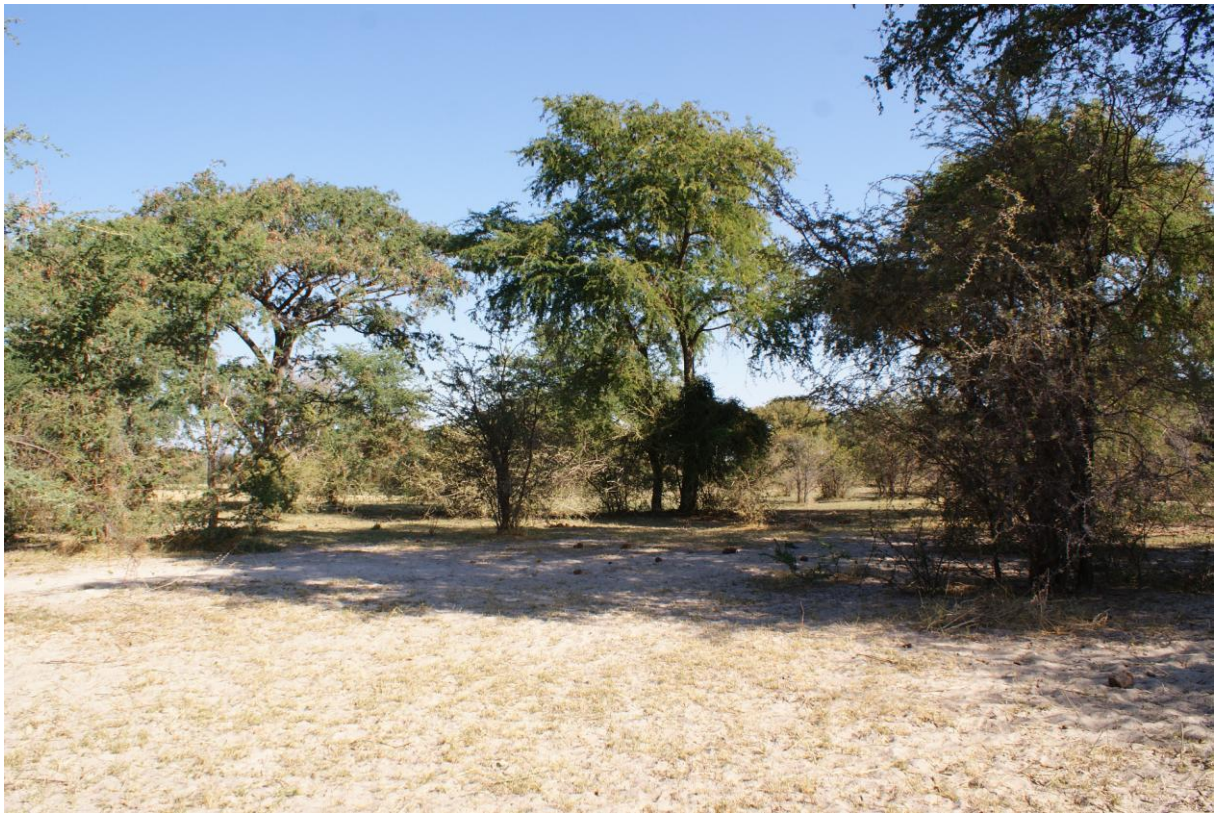
Figure 12: Typical *Cynodon dactylon* – *Faidherbia albida* open woodlands near Ngoma at plot C28.

These woodlands are found as typical vegetation in the Chobe grassland – hummock mosaic *sensu* Mendelsohn and Roberts (1997). Other than stated by these authors, though, the dominant tree species is *Faidherbia albida* (ana tree). Other characteristic species include *Cynodon dactylon*, *Flueggea virosa*, *Hyphaene petersiana*, *Marsdenia* species, *Gymnosporia senegalensis*, *Trichilia emetica*, *Vetiveria nigritana* and *Ziziphus mucronata*, constantly associated with *Acacia erioloba*, *Combretum imberbe*, *Dichrostachys cinerea* and *Terminalia sericea* (**Figure 12**).

These woodlands are under threat from especially human land use (clearing of fields, cattle grazing) but also animals, as elephants constantly cross these woodlands to reach the waters of the Chobe. Relative little elephant damage has been seen, though – mainly on the few *Grewia* shrubs occurring in these woodlands.

The diversity is relative low, as only 24 species have been recorded. One of these, *Eucalyptus camaldulensis* (blue gum) is an exotic, and likely an escapee from the nearby Ngoma Forestry Research Station. Being part of the flood-plain system of the

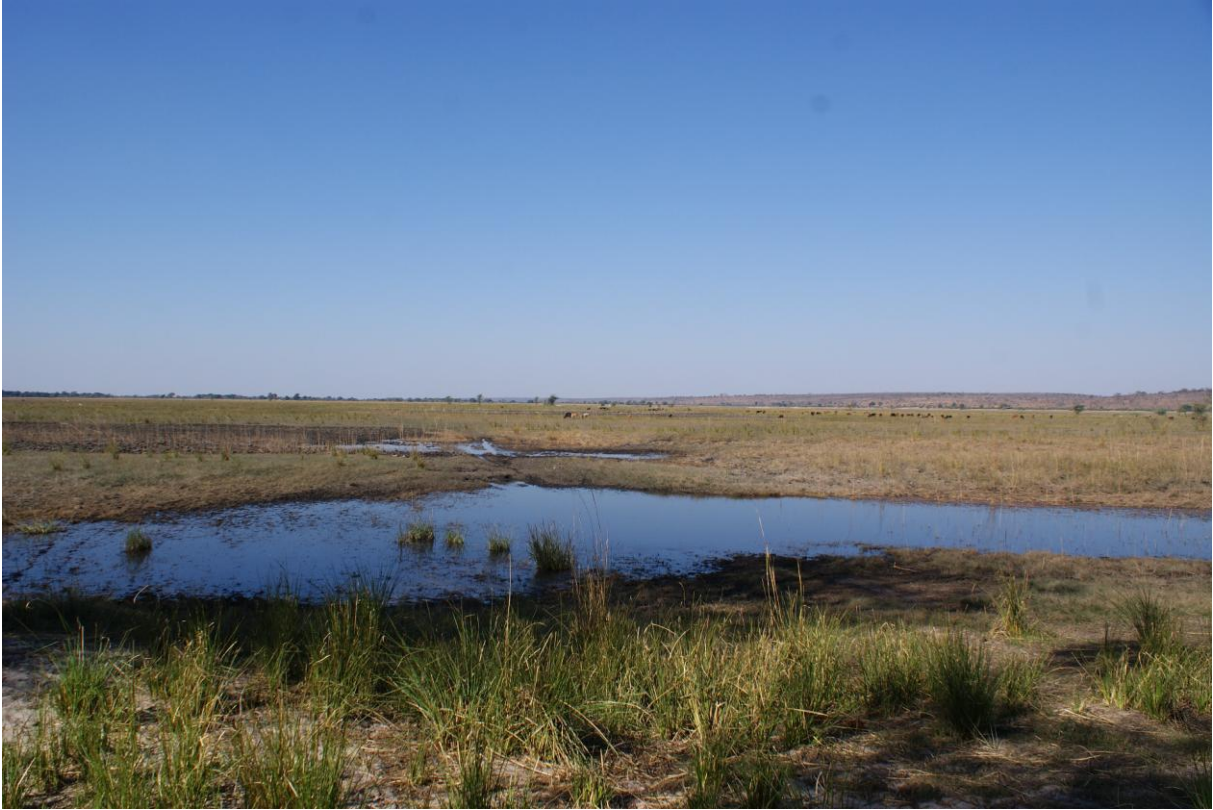
Figure 13: The Chobe Wetlands at Ngoma.

These wetlands form around the Chobe river channel as the final part of the route. Due to time constraints, no sample plot was done here. According to Mendelsohn and Roberts (1997), woody plants are rare. The vegetation is mainly dominated by wetland grasses and sedges. Prominent amongst these is the reed-like grass *Veteveria nigritiana*. During the dry season (no flooding), these grasslands are used extensively for cattle grazing (Figure 13). Construction of the powerline should have little impact on the vegetation here.
