# Climate change and adaptive land management in southern Africa

Zimmermann, I., Pringle, H., Madibela, O. & Kahl, U. (2018) Initial experiments on intensified use of rangelands through enhanced water and nutrient cycling. In: *Climate change and adaptive land management in southern Africa – assessments, changes, challenges, and solutions* (ed. by Revermann, R., Krewenka, K.M., Schmiedel, U., Olwoch, J.M., Helmschrot, J. & Jürgens, N.), pp. 226-234, *Biodiversity & Ecology*, **6**, Klaus Hess Publishers, Göttingen & Windhoek. doi:10.7809/b-e.00328

# Initial experiments on intensified use of rangelands through enhanced water and nutrient cycling

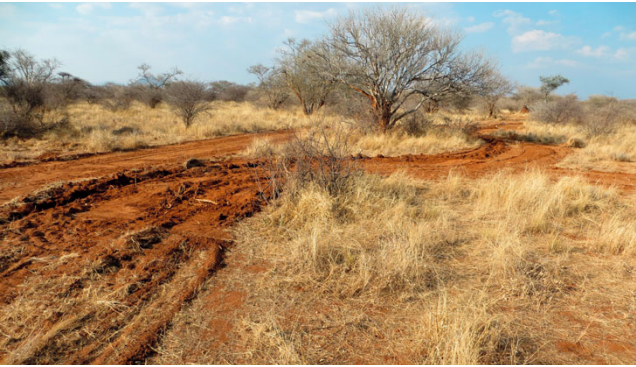
Figure 2: Contour strips are cleared, except for large trees that are left in place.

On a 30 ha portion of the farm, 12 contour lines were marked out by laser or dumpy level in 2014 at 0.5 m height intervals. Two strips were bulldozed along the contour lines while avoiding large trees to leave them in place (Fig. 2), and a line was ripped (Fig. 3) for later key-

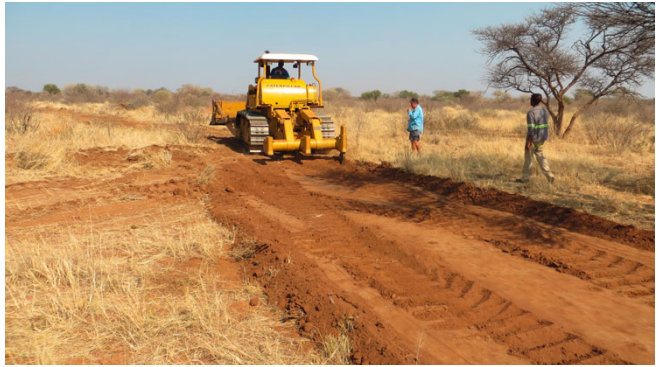
Figure 3: A line is ripped where soil dug from the ditch will be heaped to key in the bund to better secure it with the ground below.

ing in of soil heaped over it to form a bund (Stanton & Waterson, 2007). A grader was then used to dig a ditch along each contour line while heaping the dug soil on the downslope side over the rip line to form the bund. The combined depth of ditch and height of bund could hold water approximately 0.5 m deep to slowly infiltrate and moisten the soil below (Fig. 4). At each end of the ditch, the grader made an upward turn to hook the ditch and bund upwards by approximately 2 m to prevent water from spilling around the ends of the bund. The hook connected with a hump across the road (Fig. 5) in cases where it was considered worthwhile to divert water flowing down the road into the ditch, or from a ditch outside of the fruitful landscape to bring water across the road and into the ditch. Initially, spillways of 10 m width were made by removing soil from the top of the bund (Fig. 5), with the positions of spillways staggered between successive ditches, aimed at getting spilled water to zigzag its way down the landscape and increase infiltration time. In 2017, it was decided to install a second spilling ditch below each contour ditch, which would spread excess flow from spillways along the contour and then release it widely

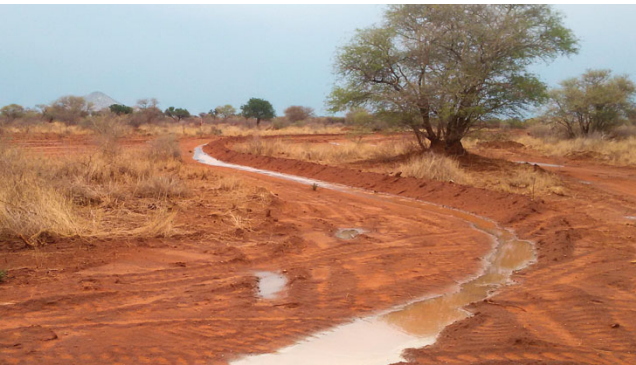
Figure 4: Water infiltrates in a contour ditch after a rain shower of 11 mm.

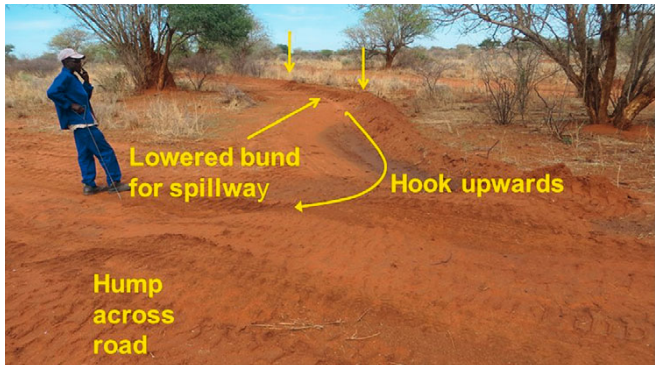
Figure 5: Upward hook to avoid spillage at end of ditch, and hump to divert water from road.

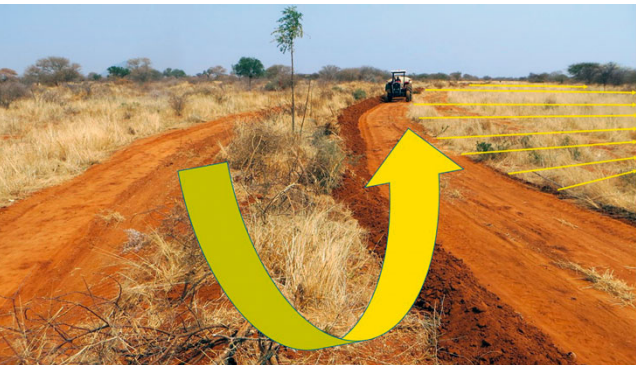
Figure 6: When grading a new ditch below the old contour ditch, the dug soil is heaped upslope so that water spilled from the upper ditch will first spread out to fill the lower ditch before spilling as wide sheet flow over the lower edge at ground level.

(Fig. 6), rather than as a concentrated release that then ‘hit’ the next contour ditch and bund downslope. We did this because it was felt the system was not accommodating major storm events effectively and that such events may increase in magnitude and frequency.

Spillage from contour ditches tended to occur as concentrated flow, either at designed spillways or at breaches through weak points in the bund. This required some maintenance work to repair bunds after intense rain and led to spreader ditches being dug in 2017 (Fig. 6).

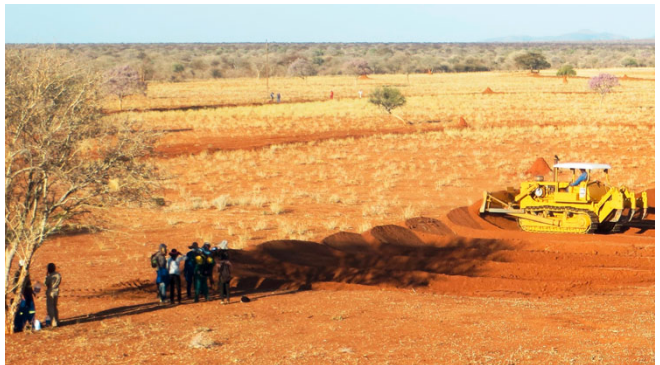
Figure 7: A ponding bank is built in September 2016 by scraping soil from above the bank.

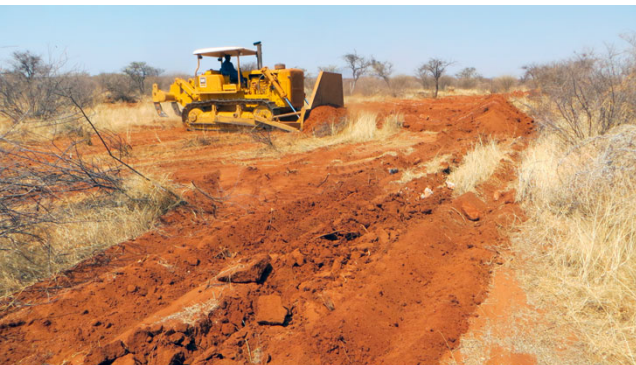
Figure 8: A ponding bank is built in September 2017 by scraping soil from below the bank.

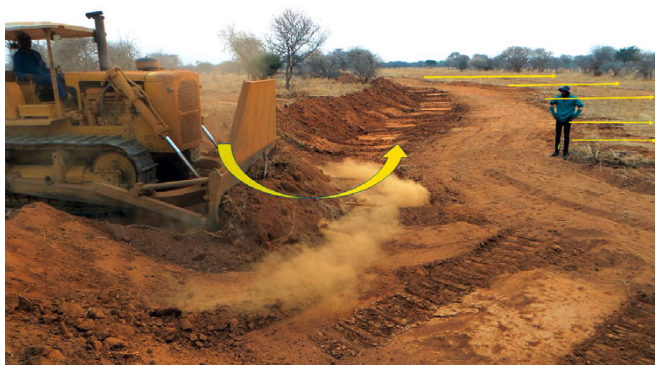
Figure 9: The bank is pushed down at its highest positions to allow spillover from ponding banks on each side to first fill the ditch below before excess water spills as wide sheet flow over the lower edge of the contour ditch.

over the next 30 m to rejoin the contour for another 80 m. After soil was bulldozed upwards along this wavy line, thereby digging a ditch below, the resulting bank was broken through from above (Fig. 9) and heaped below the ditch for water to spill from banks into the diversion ditch to flow into the contour sections of the ditches and later spill as sheet flow over the lower edge (Fig. 10). Deep ripping above and below the bank created a calming 'sponge' and prevented any tunnelling, respectively. Some wetland grass species were brought onto the farm and transplanted into the homestead garden for multiplication and eventual transplanting of propagules into the ponded areas above the banks.

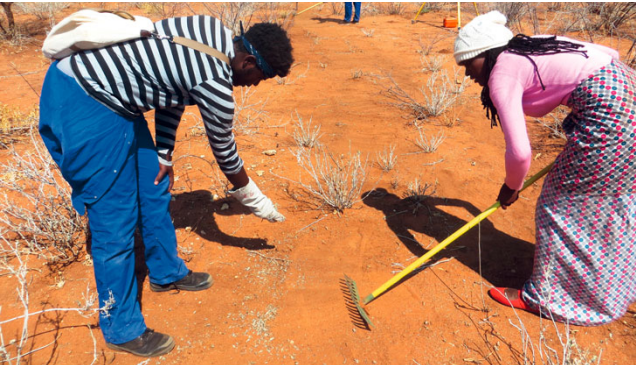
Figure 11: Grass seed is scattered and lightly raked in along a contour line before being covered with thorn branches.

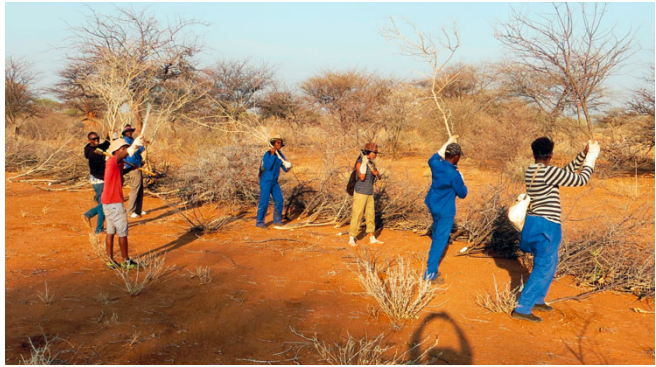
Figure 12: Branches are stacked to form a filter along the contour.

On yet another portion of Farm Middelplaats of approximately 20 ha, two contour lines of several hundred metres each were marked out in 2016 and a longer one in 2017. Old grass seed was scattered along the lines and lightly raked in (Fig. 11) before being covered with branches cut from nearby thorn bushes with the cut stem facing downslope (Fig. 12). Different sections of these bush filters were experimentally constructed at two levels of intensity. The light filter comprised a single layer of

medium-sized branches, while the dense filter had tightly packed small branches below medium-sized branches, followed by larger branches on top.

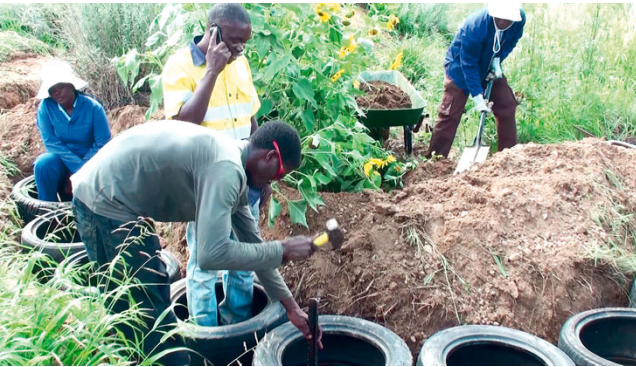
Figure 13: Old tyres are secured by steel posts to create a leaky weir.

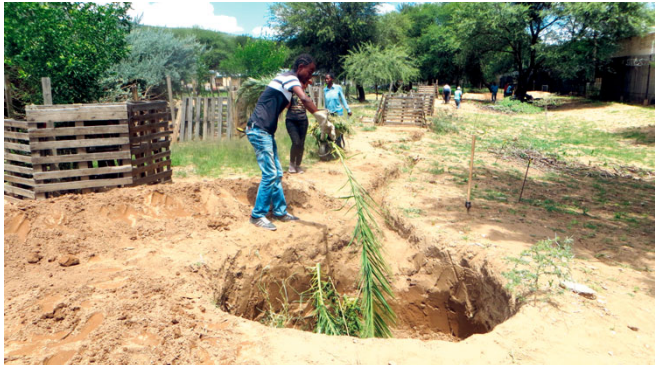
Figure 14: Organic material is thrown into a pit at the end of a contour ditch to improve fertility of infiltrating water.

In 2017 at the campus of Dagbreek School, the soil dug from a contour ditch of approximately 40 m was heaped to form a large bund across a shallow gully to divert its water into the ditch. At the other end, a pit was dug 1.5 m deep for organic material to be thrown in (Fig. 14) for improving fertility of spilled water.

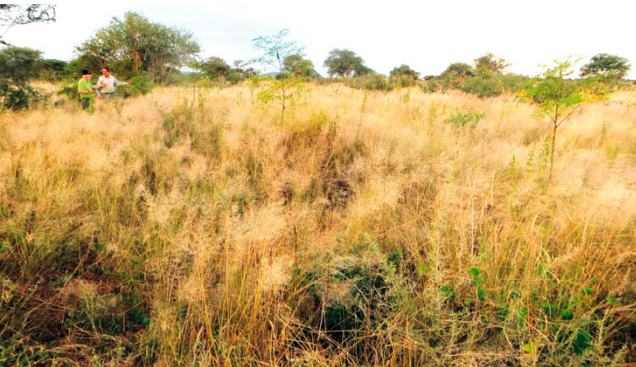
Figure 15: *Moringa oleifera* trees grow below a contour ditch.

By the end of the 2017 dry season, 315 planted tree saplings survived in the 30 ha fruitful landscape, mostly of *Moringa oleifera* (Fig. 15). More will be planted now that the surrounding fence has been strengthened by adding two wires and replacing some worn droppers and posts to keep out oryx and hartebeest, while horses are no longer allowed to graze there.

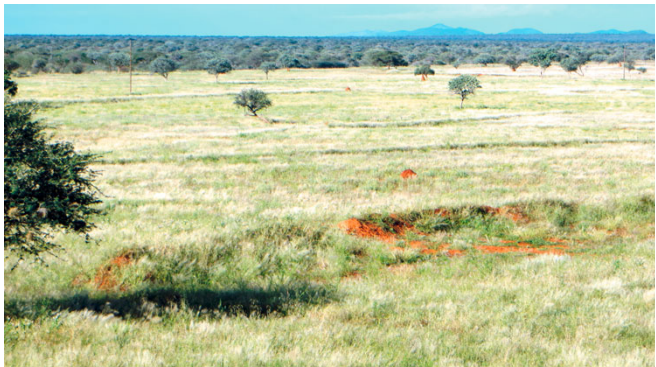
Figure 16: View in April 2017 of the same ponding banks as in Figure 7.

The 2017 rainy season resulted in a good vegetation response above the ponding banks (Fig. 16), where a dense cover of creeping legumes had established itself (Fig. 17). It was interesting to observe that the abundant wild melon plants were fruiting only where creeping legumes covered the soil underneath them. This was attributed (Hugh Lovel, Quantum Agriculture Consultancy, pers. comm.) to the organic acids exuded by legume roots releasing the tightly bound calcium-complexed minerals in the soil for uptake by both legumes and melons, to

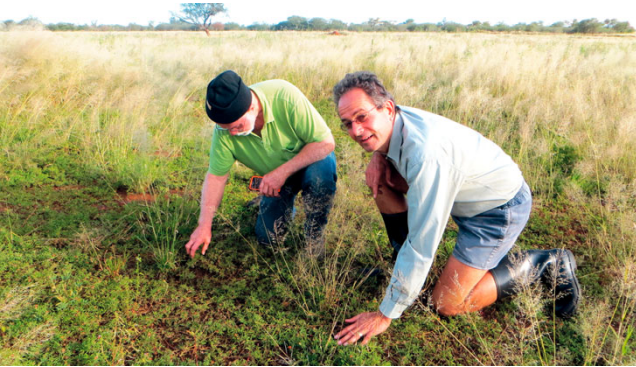
Figure 17: Creeping legumes densely cover the ponded area above a bank.

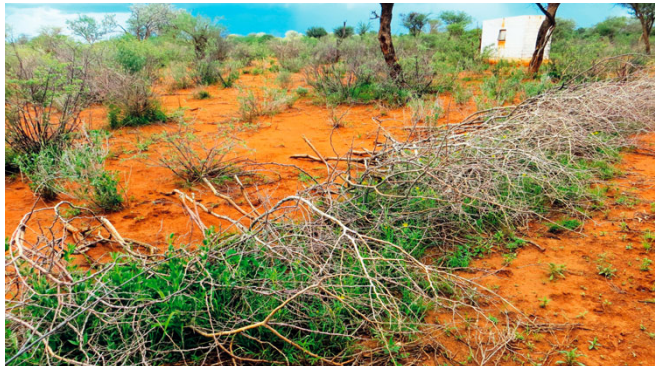
Figure 18: Herbaceous plants establish under a bush filter line on contour.

Herbaceous plants established better under the dense filters (Fig. 18) than under the light filters, although forbs tended to dominate grasses. Termites started to consume many of the branches and animal paths crossed some of the light filters, as this portion of the farm was still exposed to high pressure from both wild animals and cattle.

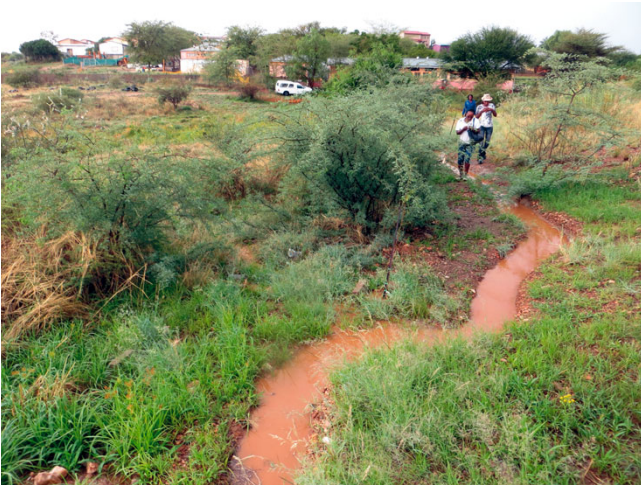
Figure 19: Rainwater spills over a slightly lower edge of a contour ditch.

age that required some maintenance after intense rain. The contour ditch without a bund often filled with extra water from the tar road outside. The initial spillage took place over the slightly lower sections of the lower edge of this ditch (Fig. 19), resulting in denser grass growing in that moister soil (Fig. 20). This initiates self-reinforcement as used to occur in nature when the denser grass traps more sediment and puffs up the soil underneath because of the greater activity of soil organisms until water starts spilling more elsewhere, leading to a 'wind-screen wiper' effect over the long term.

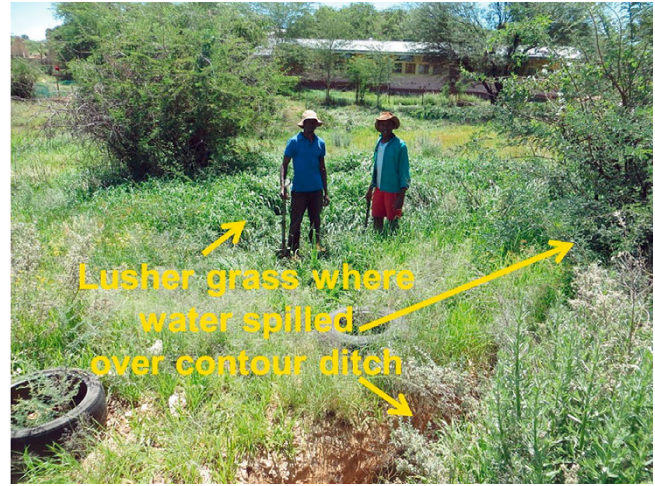
Figure 20: Denser grass grows where water spilled previously, thus trapping more sediment and puffing up soil underneath to achieve self-reinforcement.
