THE NAMPOWER/NNF STRATEGIC PARTNERSHIP: TWO YEARS DOWN THE LINE

POWER LINE SURVEYS

Power line survey Kokerboom-Aries 400 kV (12 October 2010)

POWER LINE/WILDLIFE INCIDENTS

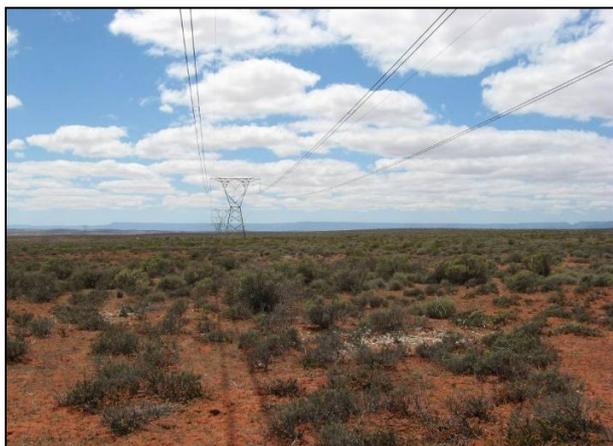
On my October 2010 survey of transmission power lines in the Karoo, I recovered a huge number of Ludwig's Bustard mortalities on one section of the 400kV Helios-Juno line. In three months, at least 34 bustards died in just 20 spans, which highlights their extreme vulnerability to collision. The section is on top of a ridge, and has a few broken old-style flappers on one earth wire, so has clearly been a problem in the past. While the bustard numbers in the area have been high in the last few months, it is still an exceptionally high collision toll, and is a minimum estimate – most remains had been completely scavenged so it is probable that we didn't count all birds that died.

The collision hotspot from Jessica's last survey: unfortunately there were mostly only feathers left but three feather "sprays" can be seen (photo Jessica Shaw).

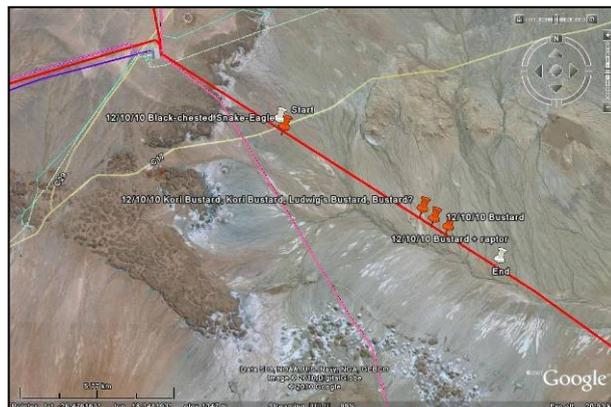
Google image of the area investigated, showing sites of eight incidents (see below) that are clustered mainly in an area where the 400 kV power line (red) runs parallel to a water-course; other colours represent different power lines/roads (based on a Google map generated by Alice Jarvis [EIS]).

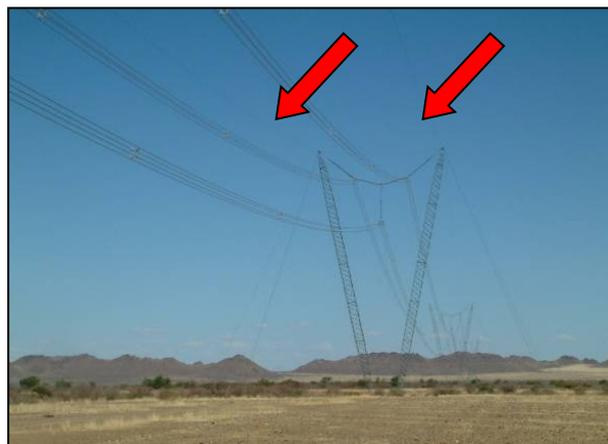
Structure of the 400 kV Kokerboom-Aries line; near-invisible earth wire and optic cable are indicated by arrows (photo Ann Scott).

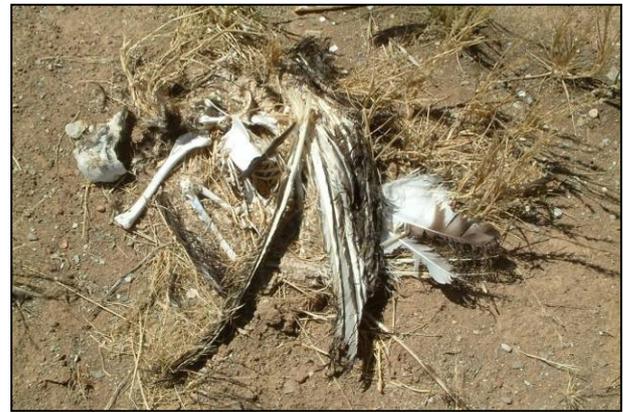
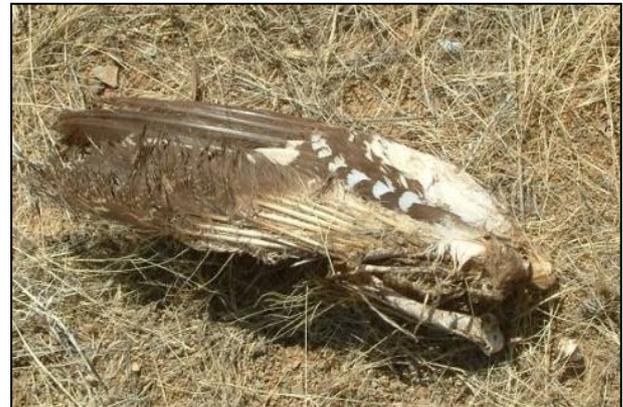
Mortalities on the Kokerboom-Aries 400 kV line survey included a Kori Bustard (adult female; above) and an unidentified bustard (below; photos Ann Scott).

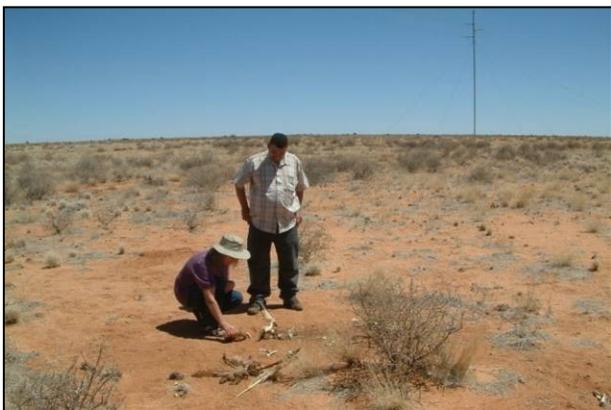
The line has a high potential for wildlife/power line interactions due to its structure, with a relatively invisible earth wire above the three more visible conductors. Five of the poles collapsed in January 2010 and three carcasses were found by NamPower personnel who visited the site on 14/1/10: two Lappet-faced Vultures and one other large bird (bustard).

Centre: Structure of the 132 kV Harib-Rock line; near-invisible earth wire is indicated by arrow (photo Ann Scott).

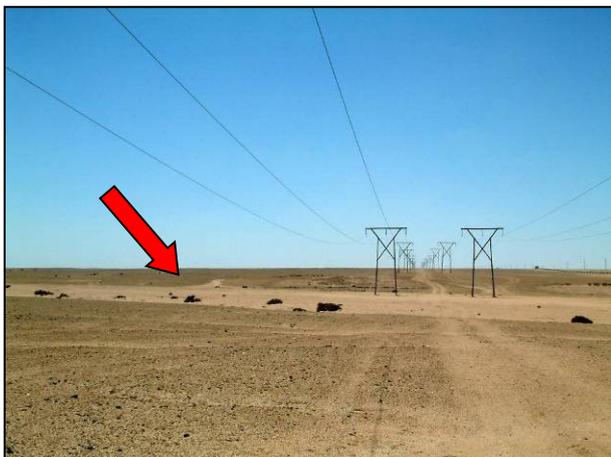
Structure of the 66 kV line with wooden poles and three large conductor wires, east of Walmund S/S. In this typical coastal desert habitat, dry water courses (red arrow) may be used as flight paths by nocturnally flying species such as flamingos, where power lines would be a potential collision threat (photo Ann Scott).

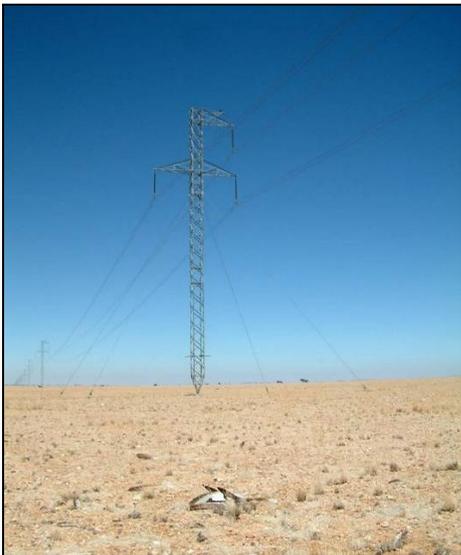
Centre: Remains of one of three bustards that had collided with the 220 kV power line.

Bustard x3 (23.07856E 15.56656E, Tower 606-607; feathers only, fresh: 1x Ludwig's Bustard; 1x Kori Bustard; 1 unidentified bustard)

Mitigation of this section of line with a suitable marking method is considered urgent (existing broken flappers should be replaced); see also p11.

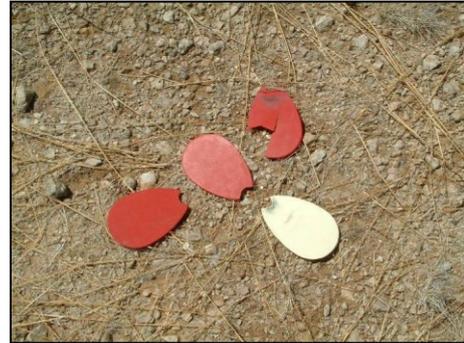
Red and white flappers have been fitted to most of the line surveyed; however, the majority have snapped off on the plastic part (see above); the fittings were still secure and evenly spaced). The terrain is open with good visibility of the line; however, the thinner earth/optic wire above the main conductors is a collision threat to both bustards and vultures.

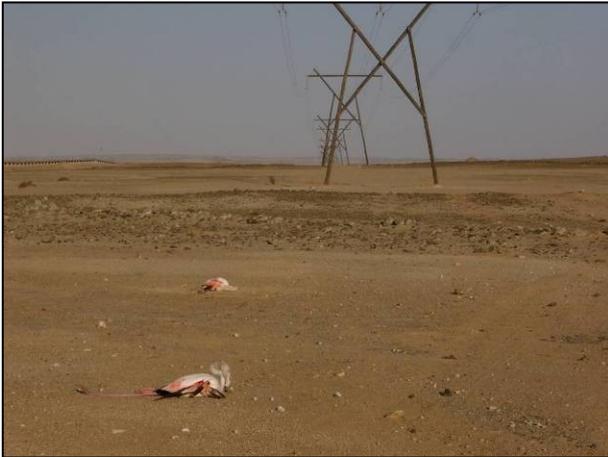
On 11/11/2010 at 17h00 two (Greater) Flamingos were found under the power line, about 100 m east of the generators at the NamPower substation next to the Wlotzkasbaken desalination plant. They appeared to have collided with 132 kV line, more or less midspan. The birds were still (just) alive when found, and taken to Dr Sandra Dantu in Swakopmund to see if they could be rescued. One died during the night, the other with a broken wing had to be put down the next morning.

What can be done to prevent such incidents? Seeing that flamingoes fly at night, is there a possibility of fixing lights to sections of the power line? I don't know if they are available here, but in Europe you get cheap solar-powered lights that store energy during the day and shine most of the night.

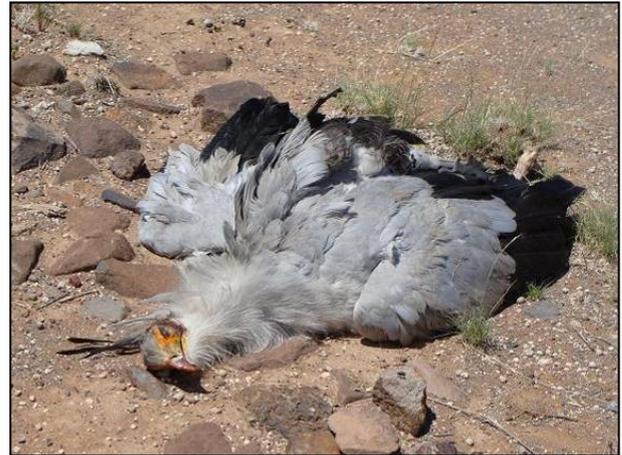
The 400KV Auas - Kokerboom/No: 6 line was inspected on 9 March 2010. The Secretarybird was found midspan between pole 498 – 496, next to border fence 251. The line route runs from north to south. The area is very flat, like a pan, and the bird was travelling from east to west. The carcass was very fresh (1-2 days). Must be in area between Hardap Dam (Fish River) to Maltahöhe tar road. A dead cow was also found on the same line at Tower 637 on 6 March 2010; it was at midspan under 400 KV line next to border fence 251, on the western side. (A second incident involving a cow was handled by Mariental District.)

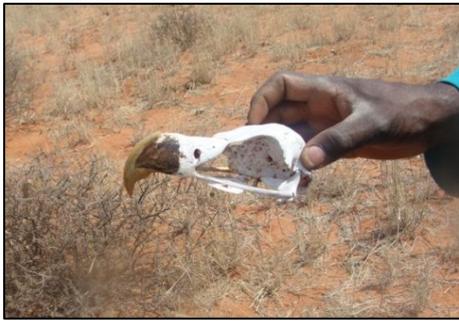
On 18/10/2010 two (Lappet-faced?) vultures collided with the Kiris 33 kV HLPCD retic. near Aroab (S26 27.861 E 19 37.224 – 200 m north of this reading). Only the skeletons of the birds were left. No. 1 collided midspan and No. 2 was on the pole.

Top: The first vulture collided midspan on the Kiris 33 kV retic. near Aroab (see p11).

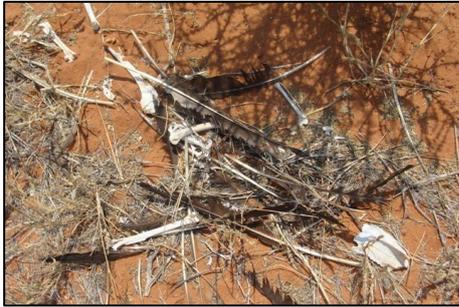
Centre: The remains of the second vulture were found nearer to the pole;

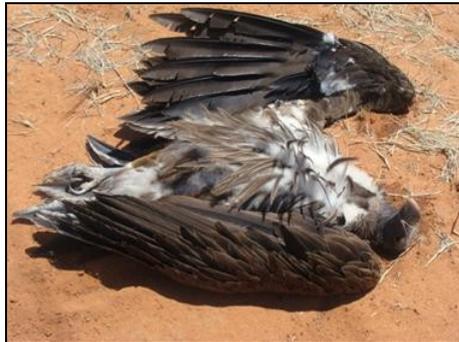
*On 18/12/08, another vulture mortality (White-backed Vulture) was found on this line about 1 km away.

Bottom: A fresh White-backed Vulture carcass was found on the same line, 1 km away from the above two vultures, on 18/12/2001 (photos Pieter Cloete).

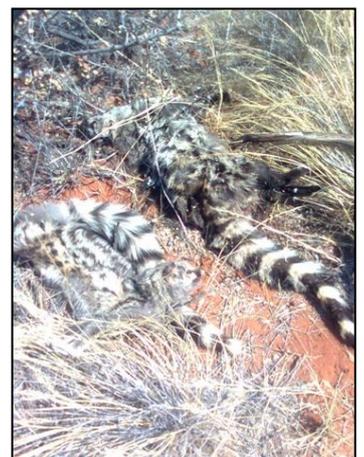
On 12/8/2010 at the Karas T-off S/S near Grünau, Karasburg district (S27°47'04,09" E18°29'00,4") a genet climbed onto the 22 kV jumpers and was electrocuted (see photo on right), causing a power outage.

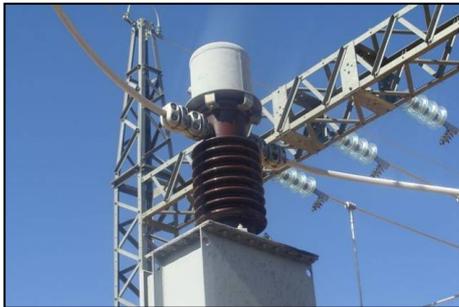
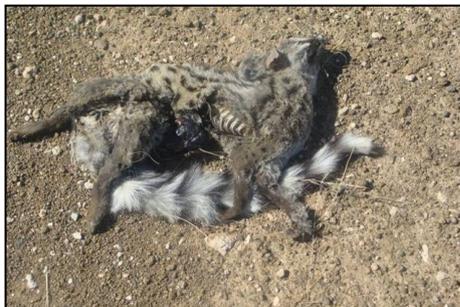
On 12/10/2010 at the Kokerboom S/S, Keetmanshoop district, one genet climbed onto the 33 kV CTs of transformer 31, was electrocuted and caused an outage (see photos below).

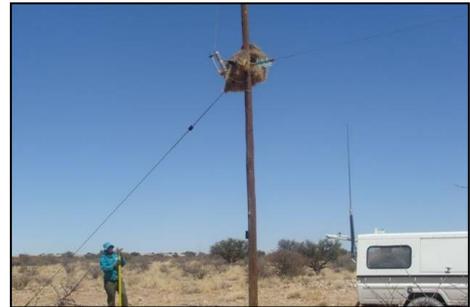
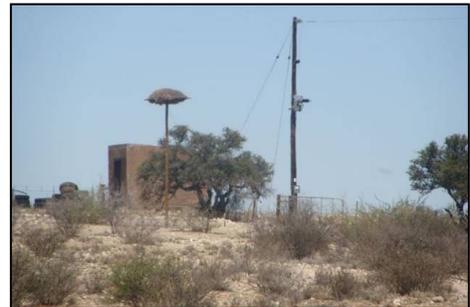
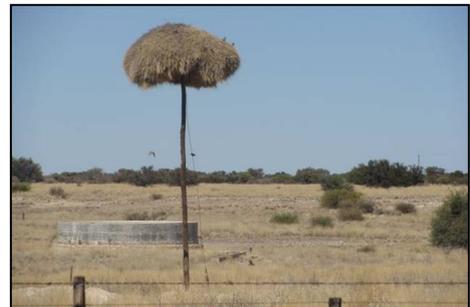
Dummy poles were used with success on an overshot 19 kV reticulation line (see photos below).
