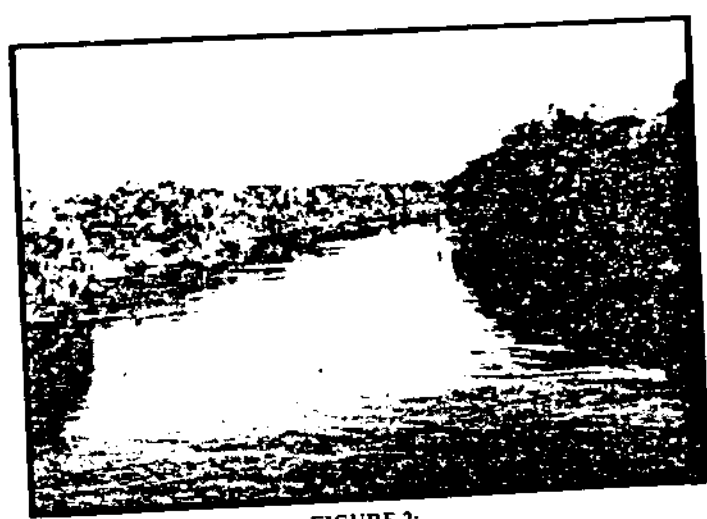
FIGURE 2: A typical channel in middle reaches of the delta.

Historical records indicate that the section of the Nqoga under discussion was transformed over a period of forty years from a typical channel such as shown in Fig 2, to complete dryness. The immensity of the transformation is perhaps best visualized with the aid of Fig.4; prior to the blocking of the channel, the person in this photograph would have been standing in mid-channel, probably at least chest deep in water, with papyrus culms towering above his head.

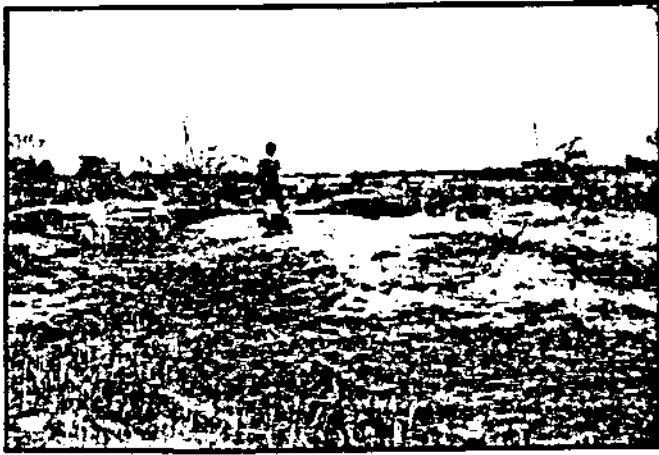
FIGURE 4:
Sand bar in the centre of the old Nqoga channel.

3). The channel bed is very irregular. It is punctuated along its length by hummocky sand bars, elongated parallel to the channel. These sometimes lie central to the channel (Fig.4) but more commonly lie against one or other margin. Stretches of the channel are characterized by these bars alternating on opposite sides with a depression representing the former thalweg, (deepest part of channel) winding between them (Fig.5). The margins of bars flanking the thalweg are usually steep while the upstream and downstream slopes tend to be more gentle. The sinuous thalweg depression is of variable depth and the deeper portions typically contain shallow pools of seepage water. The maximum topographic relief between depressions and bar tops exceeds two metres.

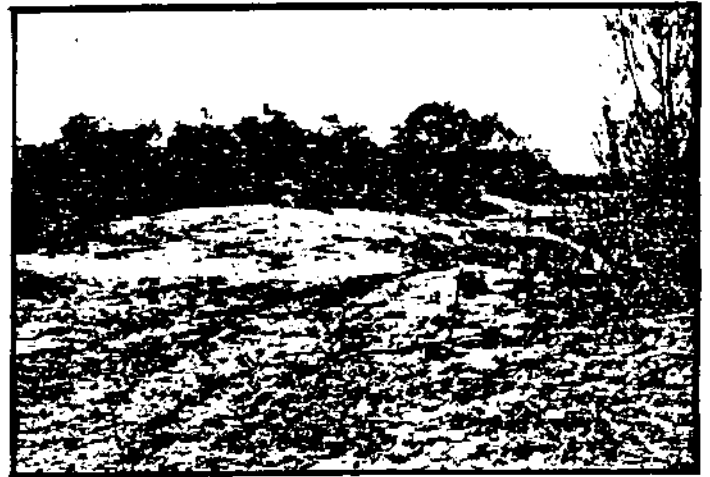
FIGURE 5:
Side bars in the old Nqoga channel. The thalweg runs from left to right between alternating marginal bars.

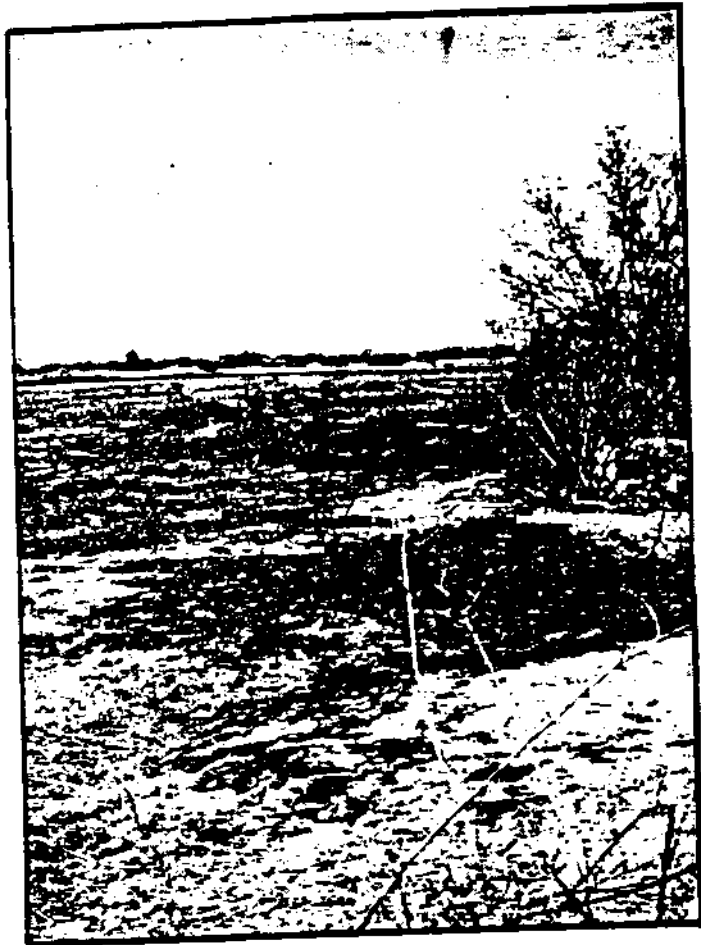
FIGURE 8:
Marginal channel to the old Nqoga, represented by a sinuous, raised sandy mound

Sinuuous, sandy mounds, usually originating in elevated channel margins, extend away from the channel into the surrounding area (Fig.7). These undoubtedly represent former small side branches to the main channel. At their intersection with the main channel, the crests of these mounds may rise a metre or more above the burnt out peat flanking the channel, but elevation gradually decreases away from the channel and the mounds ultimately merge with the surrounding terrain (Fig.8). These former side channels are of variable length, occasionally exceeding two hundred metres. They are usually highly sinuous. Sometimes they form a complex network (Fig.9), separating from the main channel, connecting with other similar mounds, sometimes rejoining the main channel or simply terminating in a number of separate branches.
