Spotlight on Agriculture

No 109 July 2008

RESTORATION OF A GULLY SYSTEM IN A KEY UPLAND FERTILE VALLEY

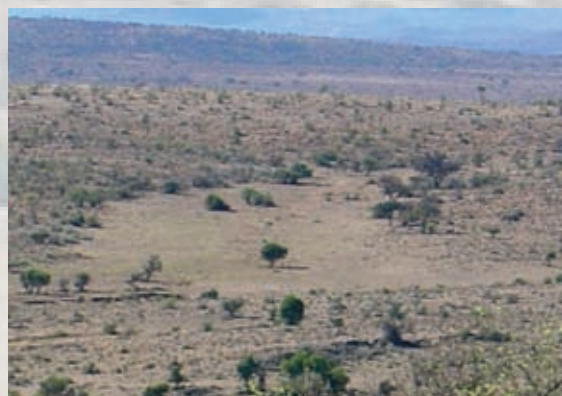
Figure 1. An intact grassy upland fertile valley acts as a benchmark, providing a vision for restoration of eroded valleys.

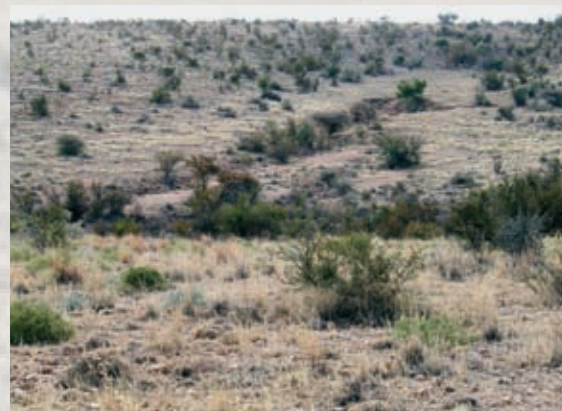
have been cut by gullies that drain them and allow bushes to encroach (Figures 1 & 2). The restoration site is on sandy loam, with a mean annual rainfall of roughly 300 mm. The eroded valley, with a slope of about 1:70, was treated in March 2007 with filters made of branches cut selectively from *Acacia mellifera* that was growing in dense stands nearby. The branches were packed at strategic locations to slow down flowing water and trap sediment, while allowing excess water to pass through. Sometimes the branches were woven with wire and tied to trees or steel posts. Ten of the treated features are compared with ten similar features in other unfiltered gully systems. The sampled features were measured, by landscape function analysis (LFA) (Tongway & Hindley, 2004), with transects running across rills or gullies. The measured features consist of four gully confluences and

Figure 2. Gully erosion drains an upland valley, allowing bushes to take over where temporary waterlogging had excluded them.

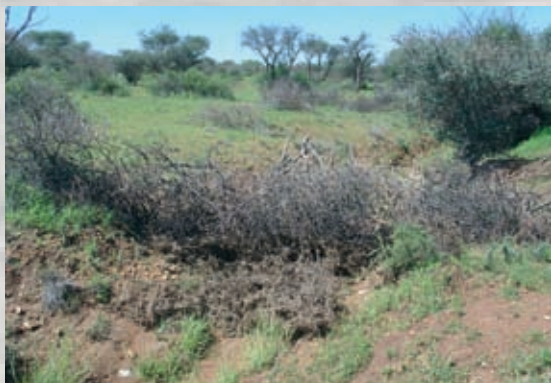
No effective rain fell in 2007 after the filters had been put in place, and the following rainy season in 2008 started very late. However, in March 2008, a storm during which about 50 mm fell in 30 minutes, resulted in filters trapping some sediment (Figure 3), while lush grass later grew under many of the filters (Figure 4). Cross sections across rills and gullies showed variable results. At the biggest gully confluence in the treated system, soil was deposited above the filter, where the soil surface condition also improved. Below the filter the gully eroded further and the soil surface condition worsened in this zone (Figures 5 & 6).

Figure 3. Soil and mulch are trapped on the upslope side of a filter.

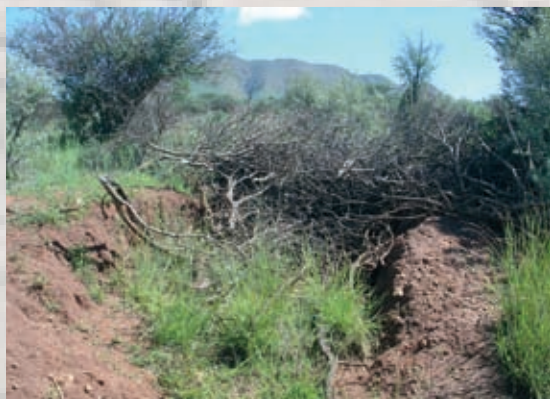
Figure 4. Lush grass establishes on the downslope side of a filter.

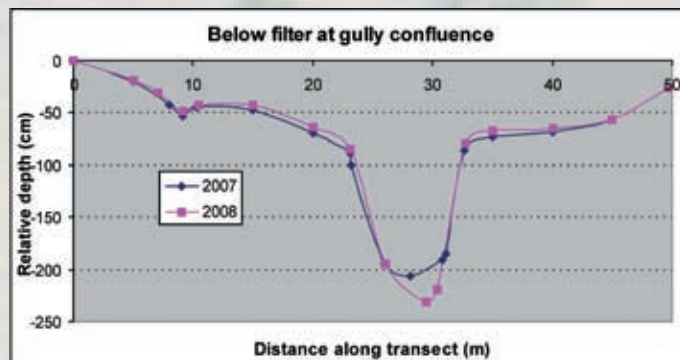
Figure 5. Changes in exaggerated cross section above the confluence of two gullies, over a year after treatment with filters.

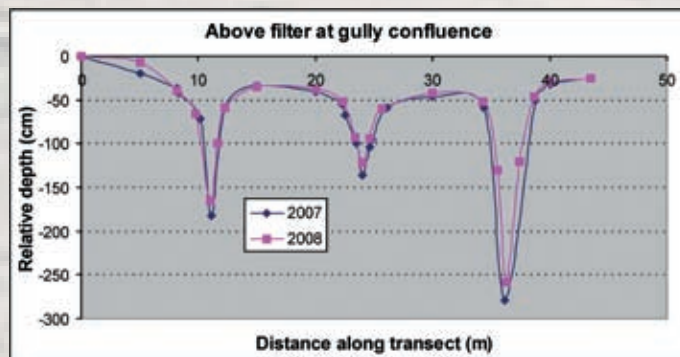
Figure 6. Changes in exaggerated cross section below the confluence of Figure 5.
