### THE ENGINEERING GEOLOGY OF SWAKOPMUND

B.G. Bulley

#### ABSTRACT

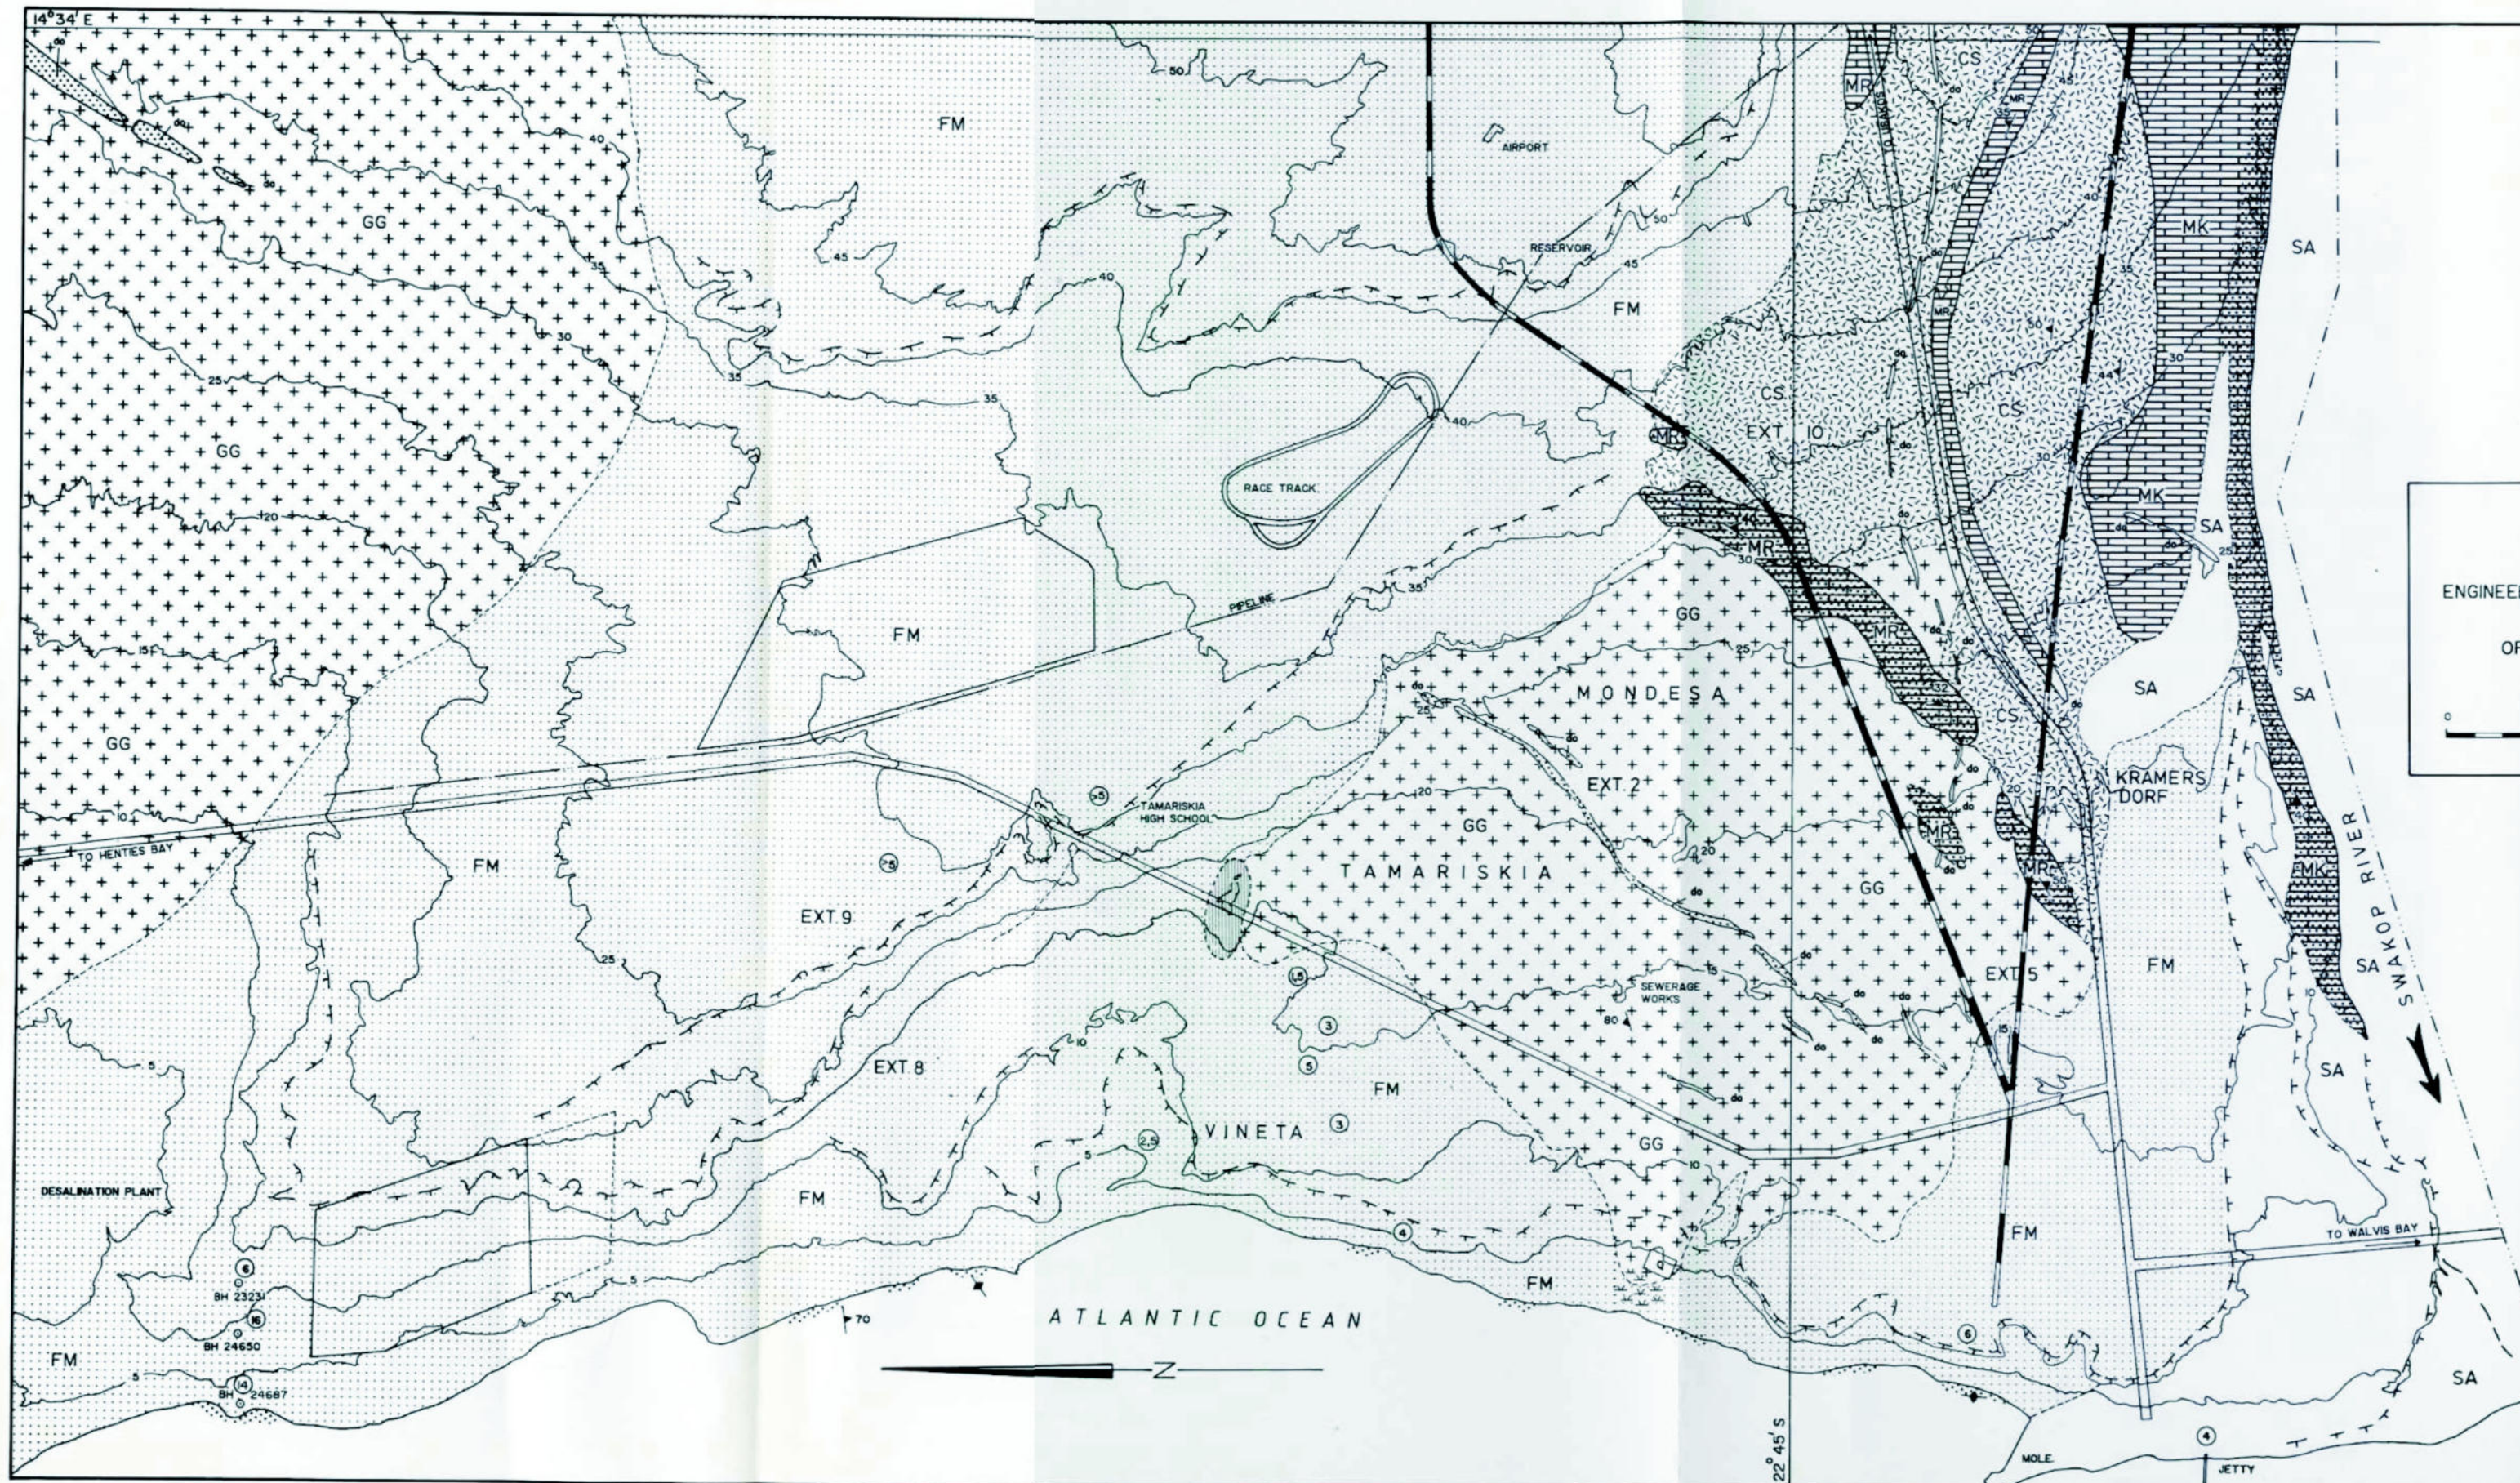
FIG. 1  
ENGINEERING GEOLOGICAL MAP  
OF SWAKOPMUND

| <p>SA</p> <p>FM</p> <p>do</p> <p>CS</p> <p>MK</p> <p>MR</p> <p>GG</p> <p>do</p> <p>do</p> <p>do</p> <p>do</p> <p>do</p> <p>do</p> <p>do</p> <p>do</p> <p>do</p> | <p>Light grey, loose to medium dense, gravelly, fine to medium SAND containing lenses of yellowish brown, firm, finely laminated consolidated, micaceous, fine sandy SILT and occasional layers of coarse sandy rounded GRAVEL. Localised development of gypcrete.</p> <p>Light grey to brown, loose to medium dense but locally strongly cemented by gypsum, gravelly fine to medium SAND with the localised development of moderately hard GYPCRETE layers. Zones of brown, firm, micaceous, fine sandy SILT occur in some parts of Vineta (indicated on map by lines). Thickness as indicated on map, generally &gt;1m.</p> <p>Dark grey, slightly to moderately weathered, fine-grained, high strength rock, DOLERITE with closely spaced, red stained, sub-vertical joints. Generally forms prominent rock outcrops or ridges.</p> <p>Grey, slightly weathered, medium-grained, high strength CALC-SILICATE ROCK with close to medium spaced, calcite stained joints. Contains occasional mica-rich layers. Generally intermittent surface outcrop with a sparse cover of greyish brown, loose subangular gravelly SAND - colluvium.</p> <p>Light grey to white, slightly weathered, coarse-grained, medium strength rock-MARBLE with medium to widely spaced, light orange stained joints. Generally forms prominent outcrops with a thin cover of loose, sandy GRAVEL-colluvium.</p> <p>MARBLE, as for Karibib Formation marble above, but generally a light grey to greenish colour and containing the minerals serpentine and olivine.</p> <p>Highly variable, light grey to red, moderately weathered, coarse grained, medium strength rock-RED GNEISSIC GRANITE with closely spaced, tight, red-stained joints contains large veins of pink PEGMATITE and layers of grey, medium grained MICA SCHIST. Outcrops as flat rock pavements or with a thin cover of reddish-brown loose, gravelly SAND-colluvium containing angular fragments of gneissic granite and quartz.</p> <p>Prominent surface outcrop of rock or outcrop of rock on beach</p> <p>Area of shallow water table or surface seepage</p> <p>Terraces of fluvial and marine origin</p> <p>Observed geological contact</p> <p>Approximate geologic contact</p> <p>Dip and strike of foliation/bedding</p> <p>Approximate depth (m) of superficial deposits overlying bedrock</p> <p>Location of borehole (at desalination plant, Mile 4)</p> <p>Approximate location of infilled quarry</p> | <p>SWAKOP RIVER ALLUVIUM</p> <p>FLUVIO-MARINE DEPOSITS</p> <p>POST-KAROO INTRUSION</p> <p>KARIBIB FORMATION</p> <p>KARIBIB FORMATION</p> <p>RÖSSING FORMATION</p> <p>DAMARA SEQUENCE</p> |

| <p>SA</p> <p>FM</p> <p>do</p> <p>CS</p> <p>MK, MR</p> <p>GG</p> | <p>Well - drained areas of granular soils conditions generally favourable for foundation constructions, but settlement can occur on loose sand or silty material. Gypcrete layers or boulders may hinder excavation in parts.</p> <p>As above</p> <p>Prominent dolerite outcrops present excavation and site-leveling difficulties. Zones of deep weathering may occur along the contact with country rock.</p> <p>Bedrock generally occurs at shallow depths and founding conditions are good. Difficulties can be experienced with excavations for trenches.</p> <p>Areas of prominent outcrop presents difficulties with excavations and site levelling. Founding conditions are generally good.</p> <p>Founding conditions are generally good, but highly variable nature of the rock results in zones of deeply weathered materials. Care should be taken to remove such zones (normally schists) during excavation for foundations. Blasting normally required for excavation of services trenches.</p> |

The broad sandy bed of the ephemeral Swakop River, occurring along Swakopmund's southern municipal boundary (Fig. 1), forms a natural barrier between the coastal dunes of the Namib Sand Sea to the south and the sand and gravel plains to the north. The geomorphology

A summarised stratigraphic column for the area is given in Table 1 and a description of each unit, with an engineering assessment, is provided in the legend of the geological map (Fig. 1).
