The Failure of the Nqoga Channel Between Hamoga and Letenetso Islands, Northeastern Okavango Delta

by T S McCARTHY and W N ELLERY

Abstract

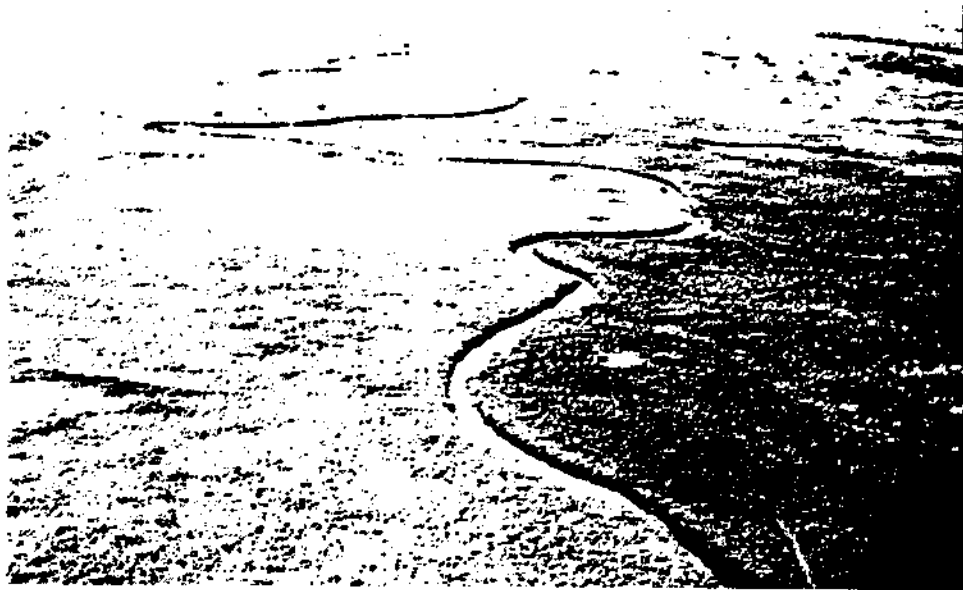
Figure 8: Channel upstream of Letenetso Island in 1985. See Figure 6 for location.

The Cross-cut Channel and the Nqoga Channel between Hamoga and Letenetso Islands varied between 10 and 25 metres wide and from 3 to 4 metres deep (Figure 2b and Table 1). Flow velocity varied between 0.3 and 0.6 m/s, and discharge was of the order of 25m³/s (Table 1). The channels were flanked by dense stands of papyrus up to 4m tall with small abundances of the fern *Thelypteris interruptus* growing around the culms (Ellery *et al*, 1990). Hippo grass (*Vossia cuspidata*) occurred as a narrow ribbon along one margin of the channel, usually on inner channel bends. Figures 8 and 9 show the channel at this stage.

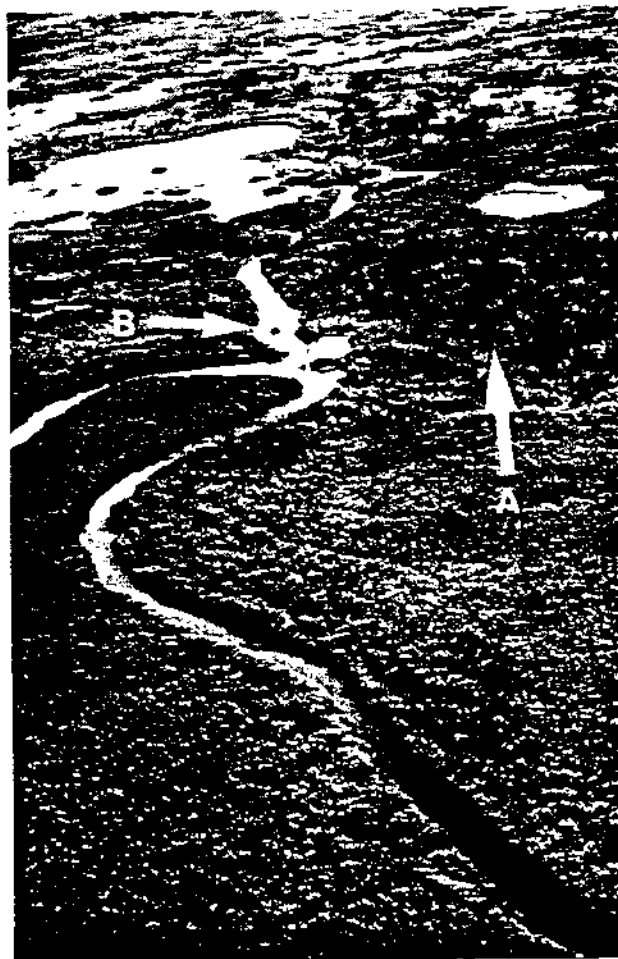
Figure 9: A view of the Nqoga Channel in the vicinity of Hamoga Island (arrow A) and Smith's Channel (arrow B) in 1985. See Figure 6 for location.

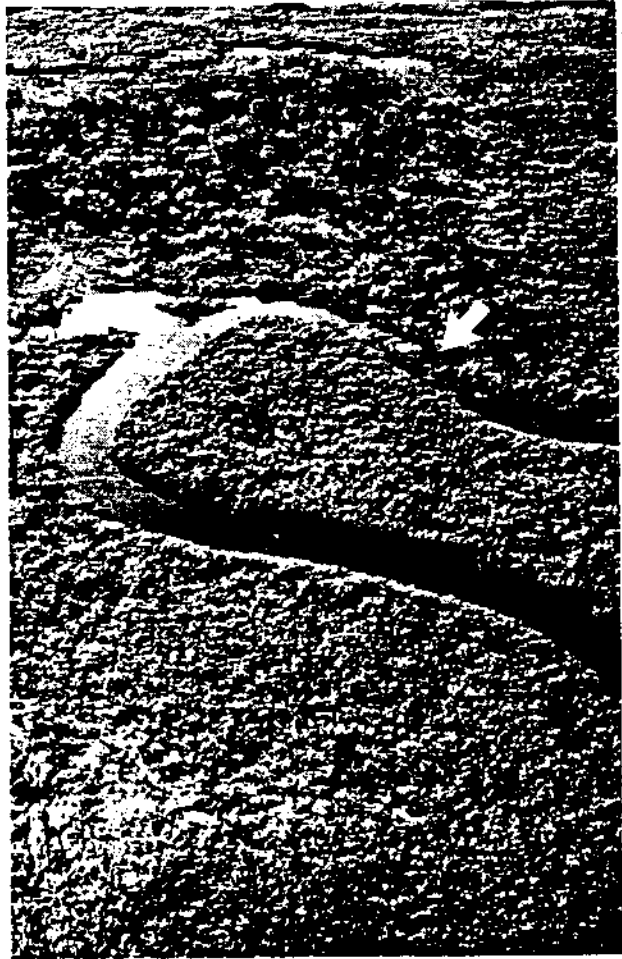
Figure 11: Aerial view of a papyrus debris blockage (arrowed) on the Nqoga Channel at Hamoga Island (1985). See Figure 6 for location.

typical blockage during this phase is shown in Figure 11.

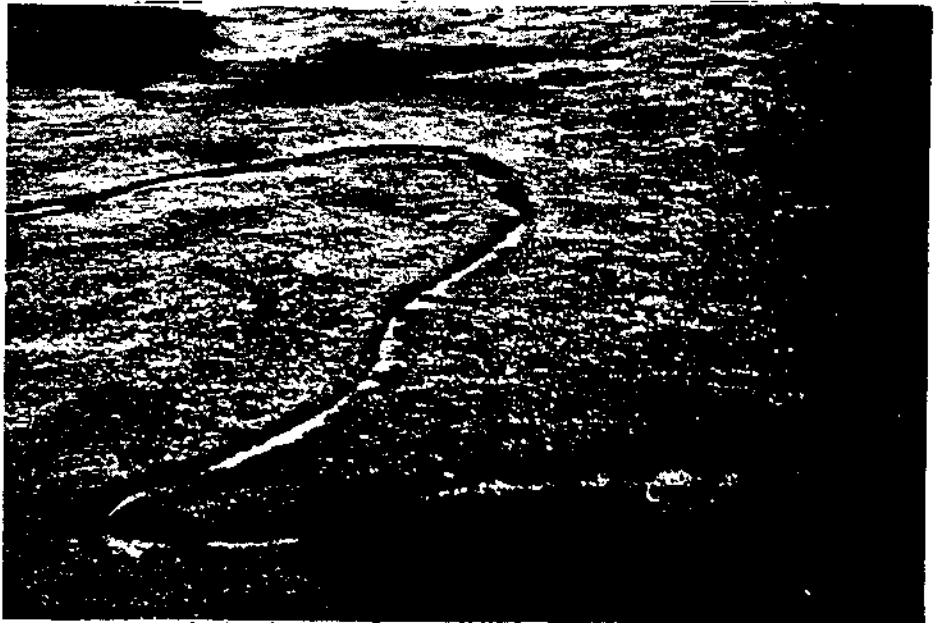
Figure 15: Detailed view of the Nqoga channel in April 1993, severely encroached by hippo grass. In certain areas, papyrus has completely overgrown the channel. See Figure 6 for location.

Over the following years, the width of the hippo grass fringe gradually increased (Figures 12, 13) in the lower reaches below Hamoga Island, severely narrowing the width of open water (Figures 14, 15). By the late 1980s the hippo grass had become sufficiently dense to support papyrus rhizomes which extended from the margins across the former channel (Figure 15). Near Hamoga Island, constriction of the channel by hippo grass was less pronounced, but papyrus debris blockages were of substantial length (Figure 16). Discharge in the Cross-cut Channel had been reduced to $9\text{m}^3/\text{s}$ (Table 1).

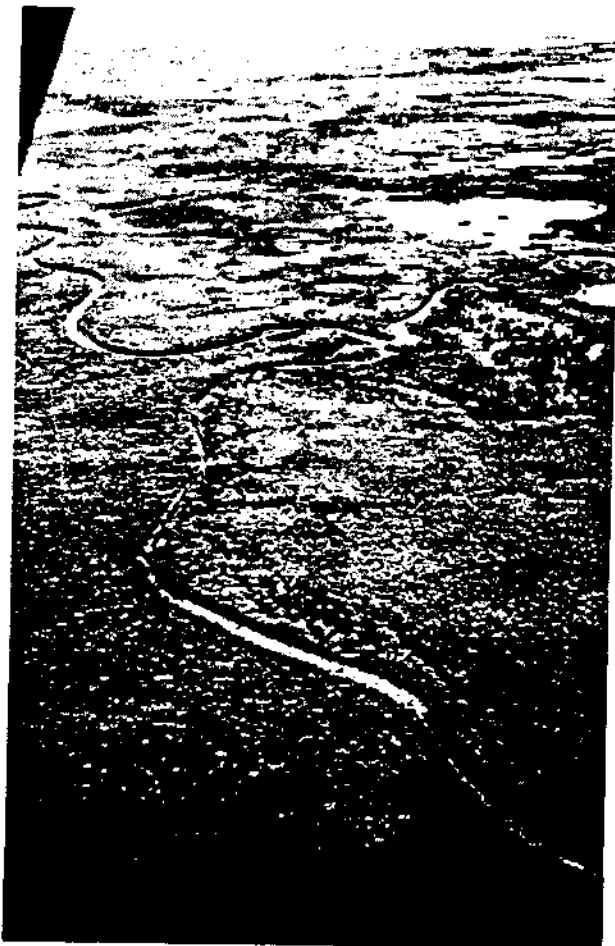
Figure 16: A view of the Nqoga channel below Hamoga Island, showing the increased length of papyrus blockages (1993). See Figure 6 for location.

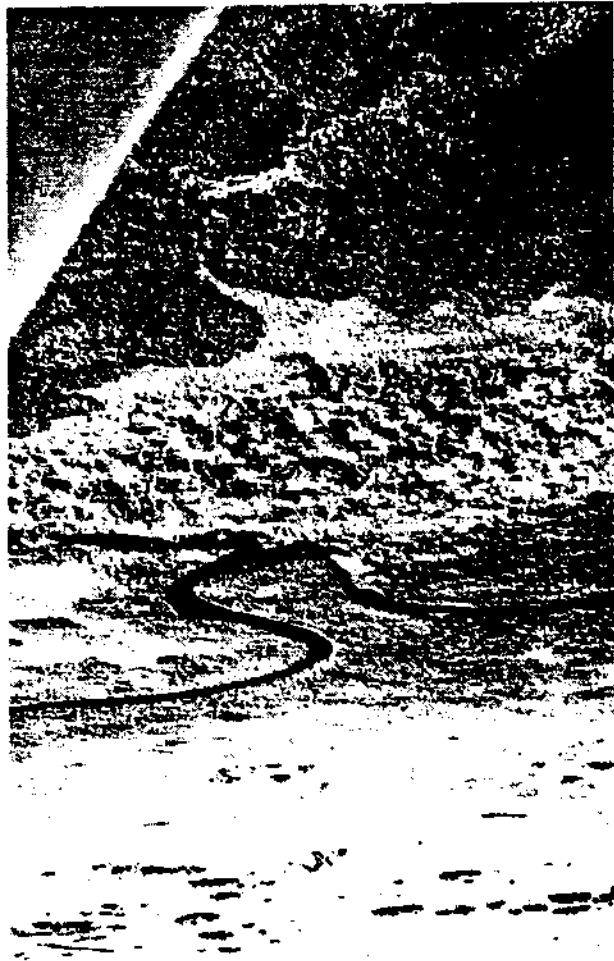
Figure 19: Aerial view of Hamoga Island in August 1985, showing grassland fringe around the island and many dead trees on the island itself. Papyrus is restricted to a position beyond the flood plain grassland.

The gauge record for Hamoga Island from 1977 to 1990 (Figure 4) shows a steady rise in water level and reflects a total rise of just over 50cm during the recording period. The effect of this rise on island vegetation has been catastrophic, especially for the broad-leaved trees. Many of these plants had already died prior to 1985, but a few survived in the centre of the island (Figure 19). Palms, (*Hyphaenae ventricosa*) were at this stage unaffected. By 1993, however, virtually all of the broad-leaved trees had died (Figure 20). Many palms, especially those closest to the island fringe adjacent to Smith's Channel, had also died. The grassland fringe surrounding the island had become inundated and had been invaded by papyrus (Figure 21) as the island fringe was replaced by permanent swamp.

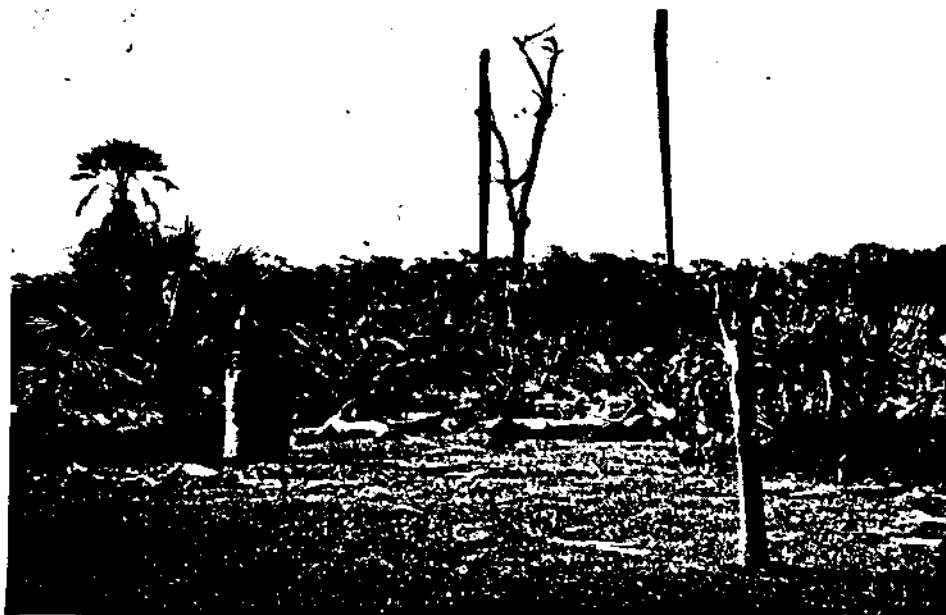
Figure 21: Hamoga Island in August 1993. The trunks of dead palms and a broad leaved tree are surrounded by papyrus.

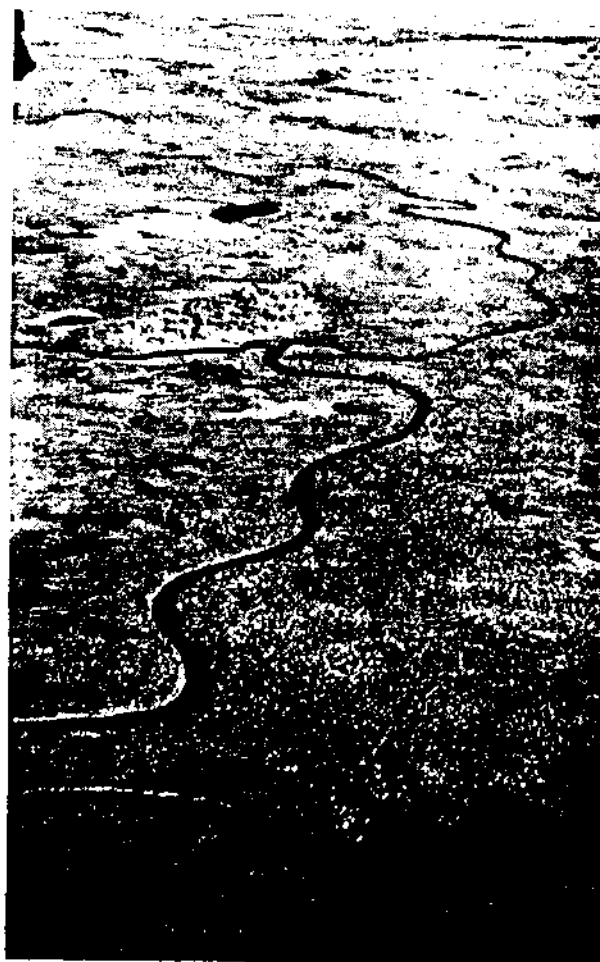
Figure 22: The Nqoga Channel looking south east towards Hamoga Island (centre) in September 1985. Smith's Channel diverges to the left at Hamoga Island. It is probable that this reach of the Nqoga will fail in the near future.

Channel failure has been progressing steadily from the lower reaches of the Nqoga, and it is probable therefore that the Nqoga Channel upstream of Hamoga Island (Figure 22) will start to fail next. The early signs of this process are already evident at Xaenga Island, situated some 12km upstream of Hamoga island, where water level has been rising at a rate of about 2cm/year (McCarthy *et al*, 1992) and the island is being inundated (I Muzila, pers comm, 1993).
