Tolerances of Raptors to Blasting and Construction Activity during Hydroelectric Expansion on the Susquehanna River A Year of Success

Holtwood Expansion

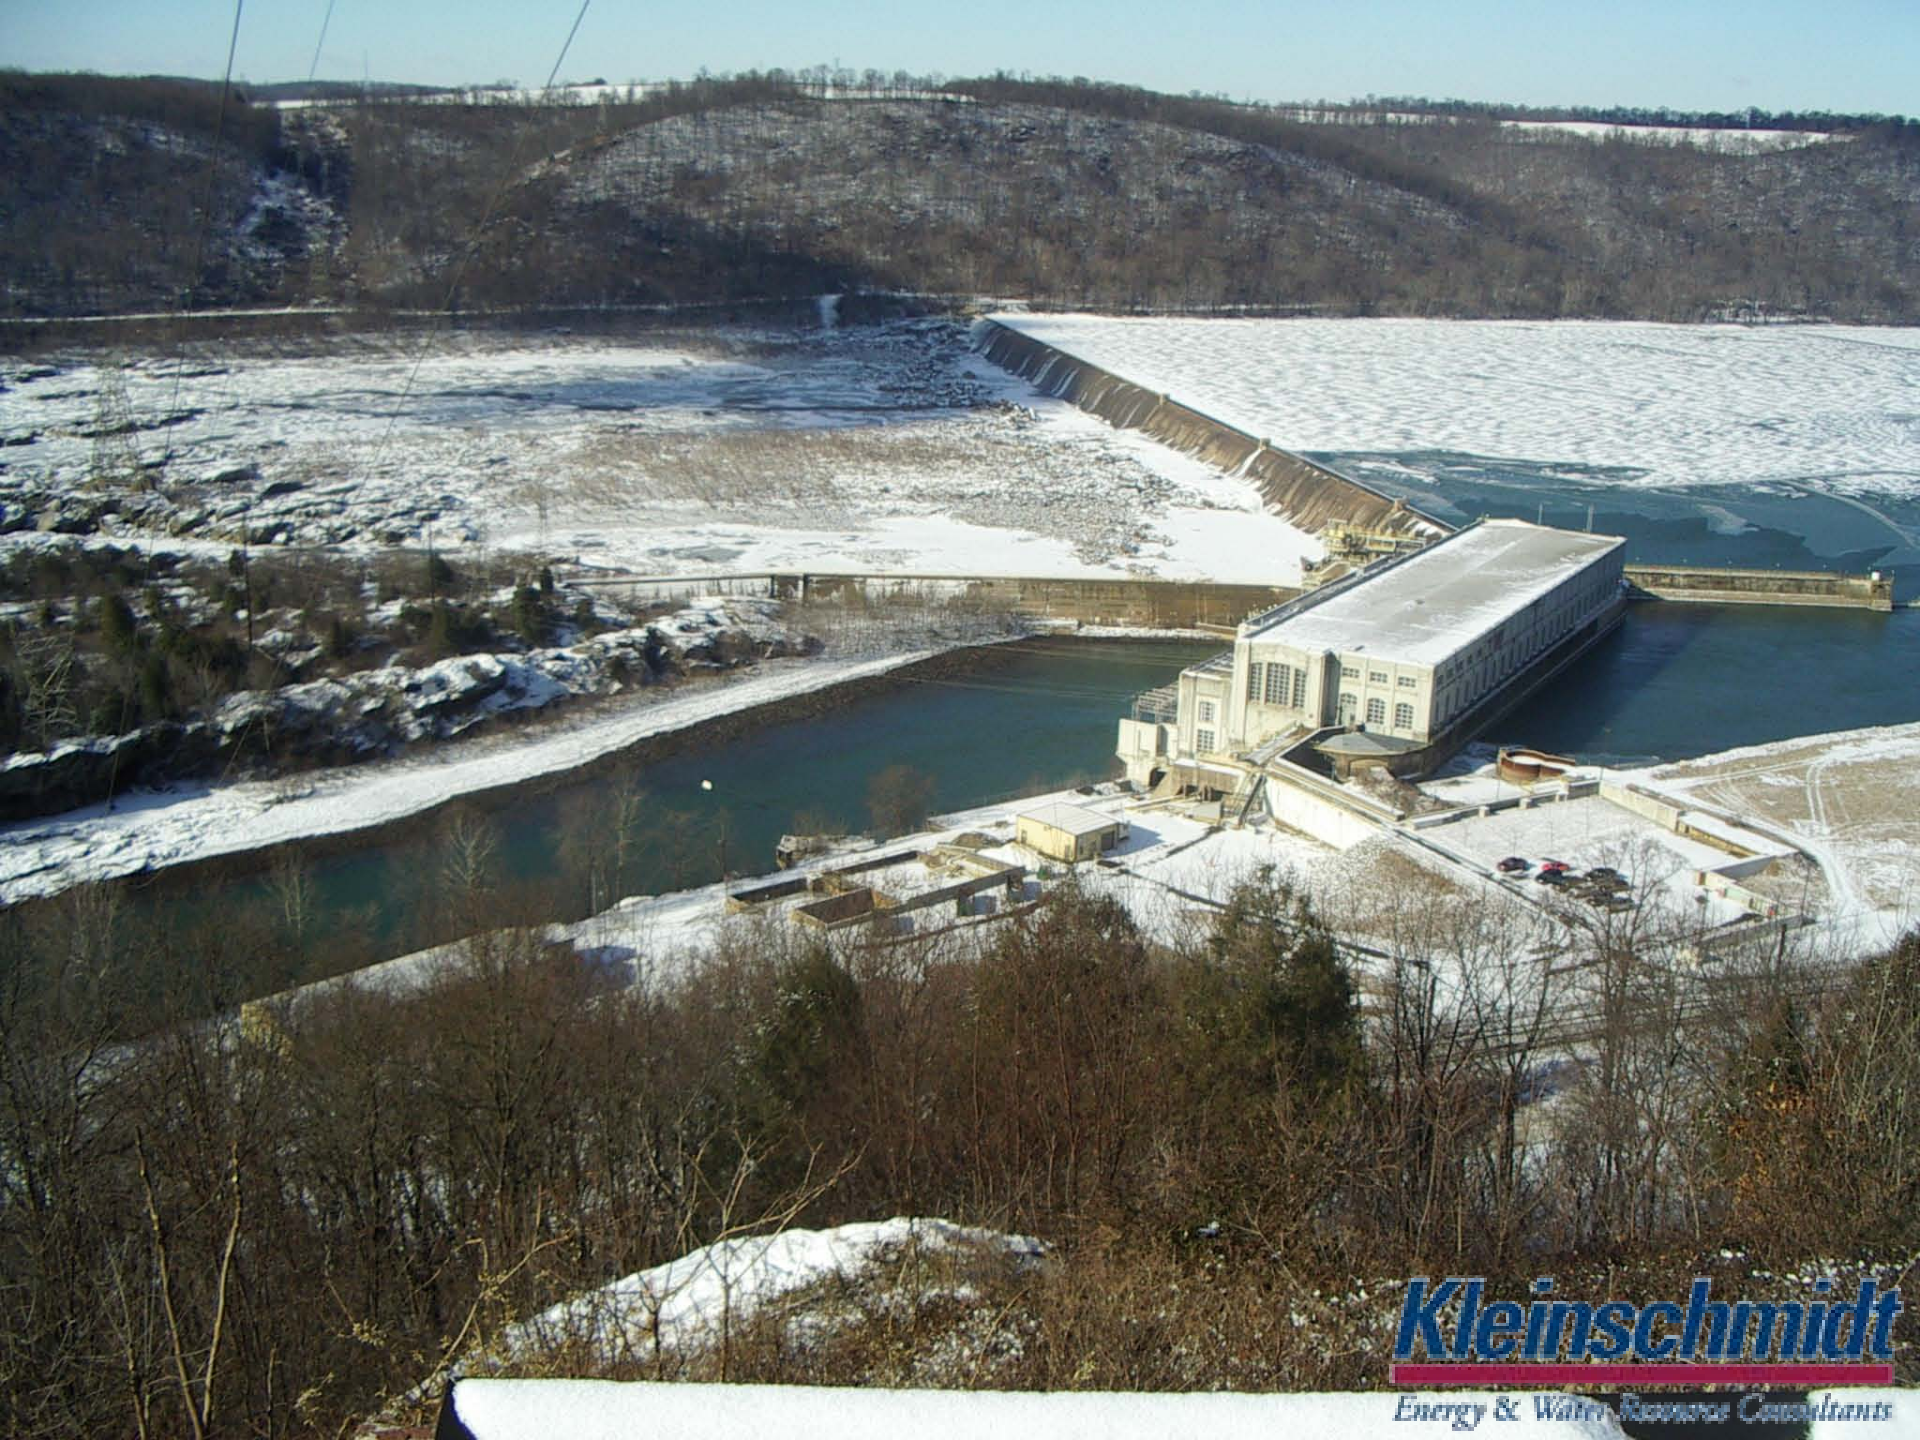
- 3 Years of Construction
- Excavate over 1.6 million cubic yards
- Double the Powerhouse Capacity
- Improve Fish Passage

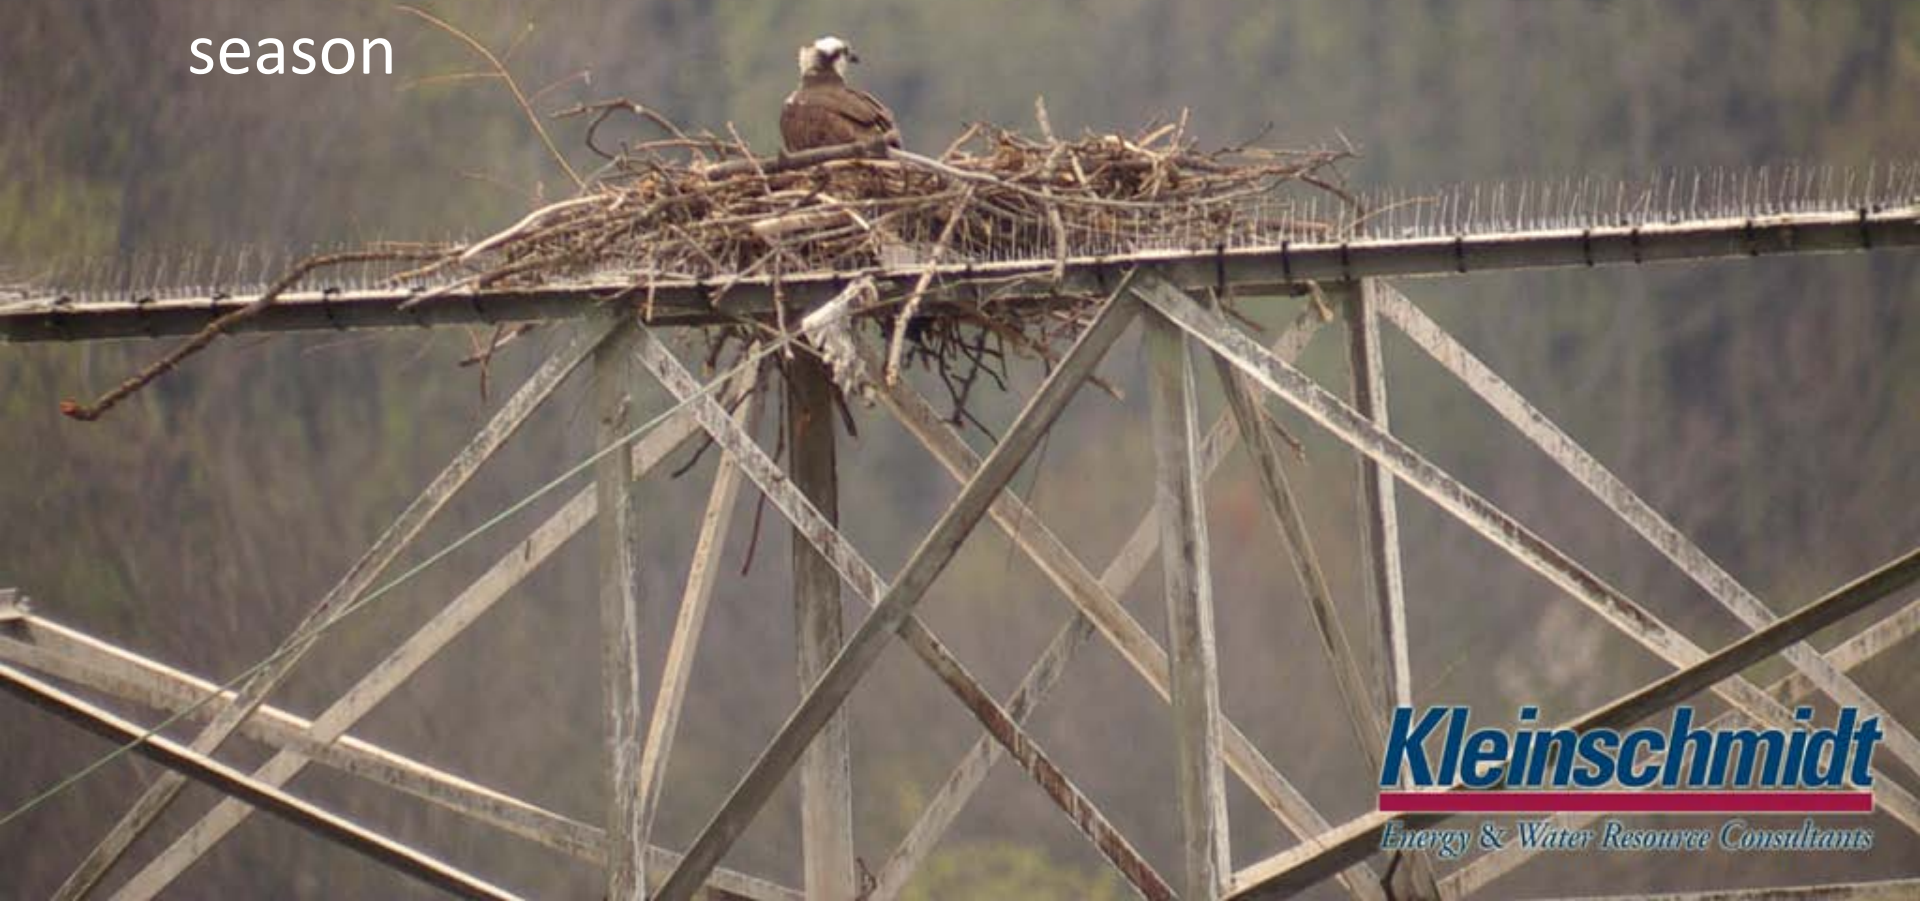
- Three Nests
- Recommended 500 ft buffer during the nesting season

- Active Bald Eagle Nest
- Active Osprey Nest
- Osprey- No Construction 500 ft (March 25- July)
- Proposed Construction Roads
- ▧ Excavation Bounds

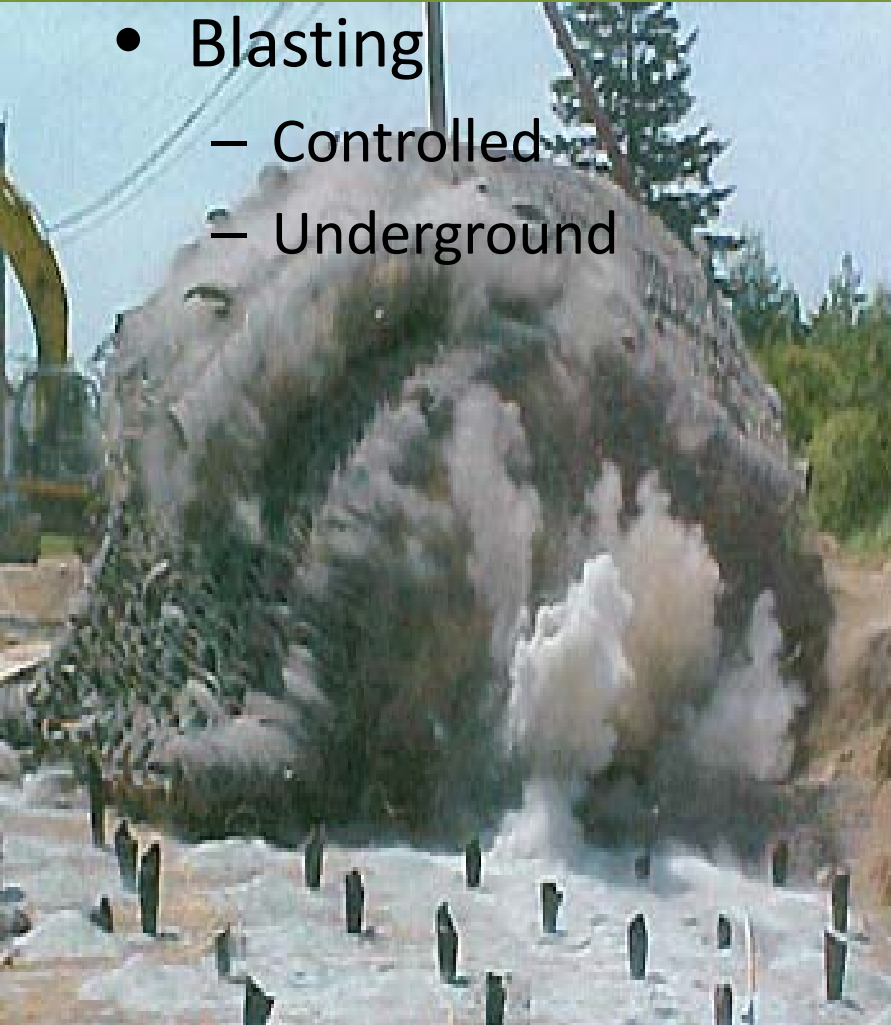
- Blasting
 - Controlled
 - Underground

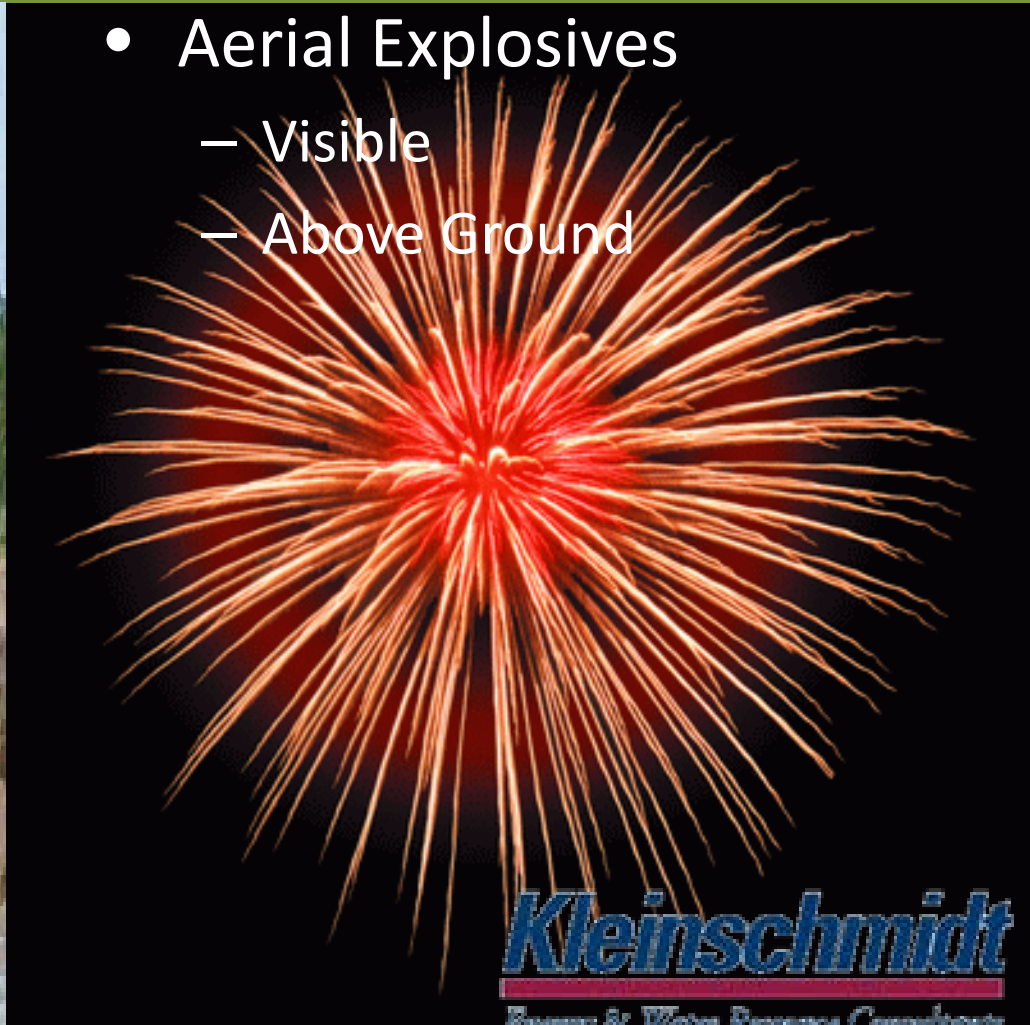
- Aerial Explosives
 - Visible
 - Above Ground

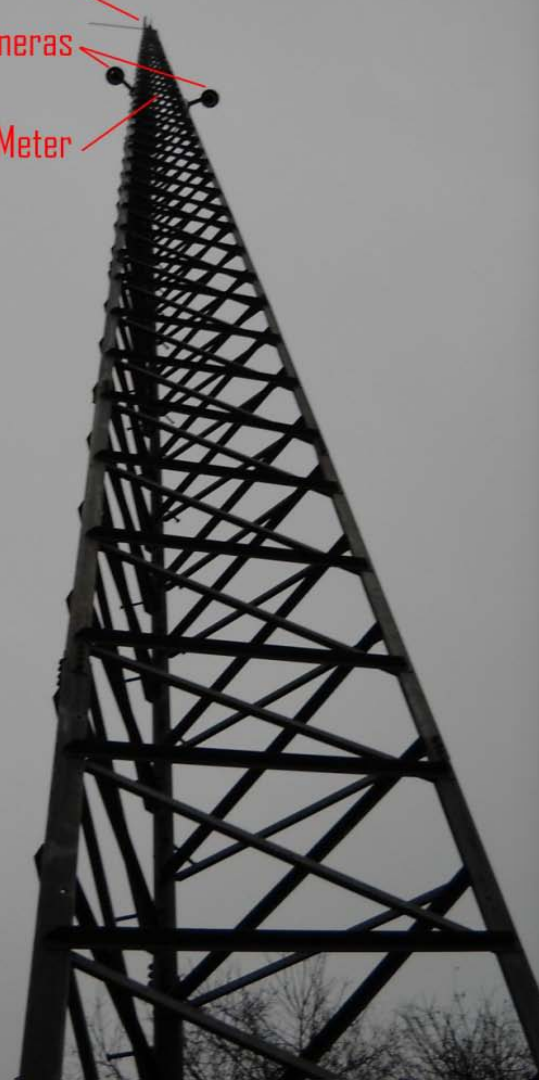
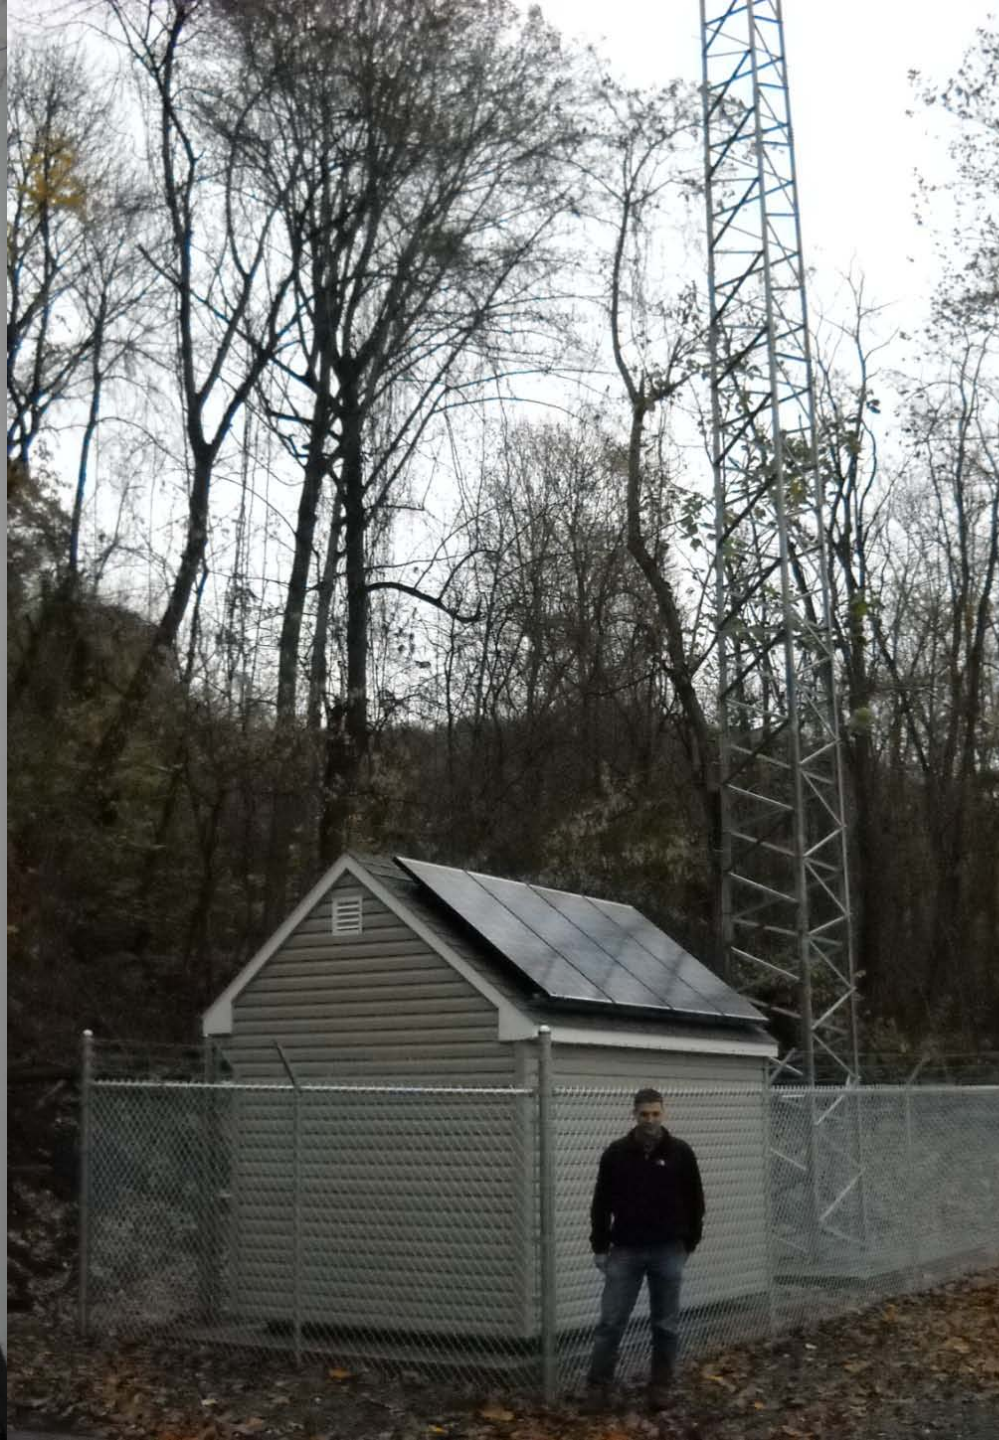
Antennae
Two Cameras
Sound Meter

- Video- Behavioral Observations
- Audio- Decibel Recordings and Noise Analysis
 - A-weighted (Human Range)
 - Peak Decibels (Unfiltered)
- 30 minutes before and after each blast

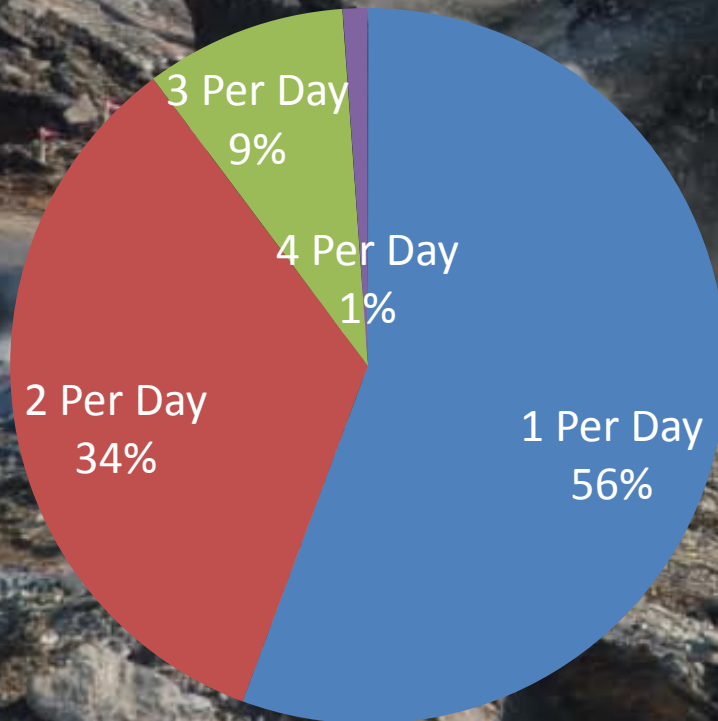
Number of Blasts Per Day

- Started Blasting in January
- Completed in June

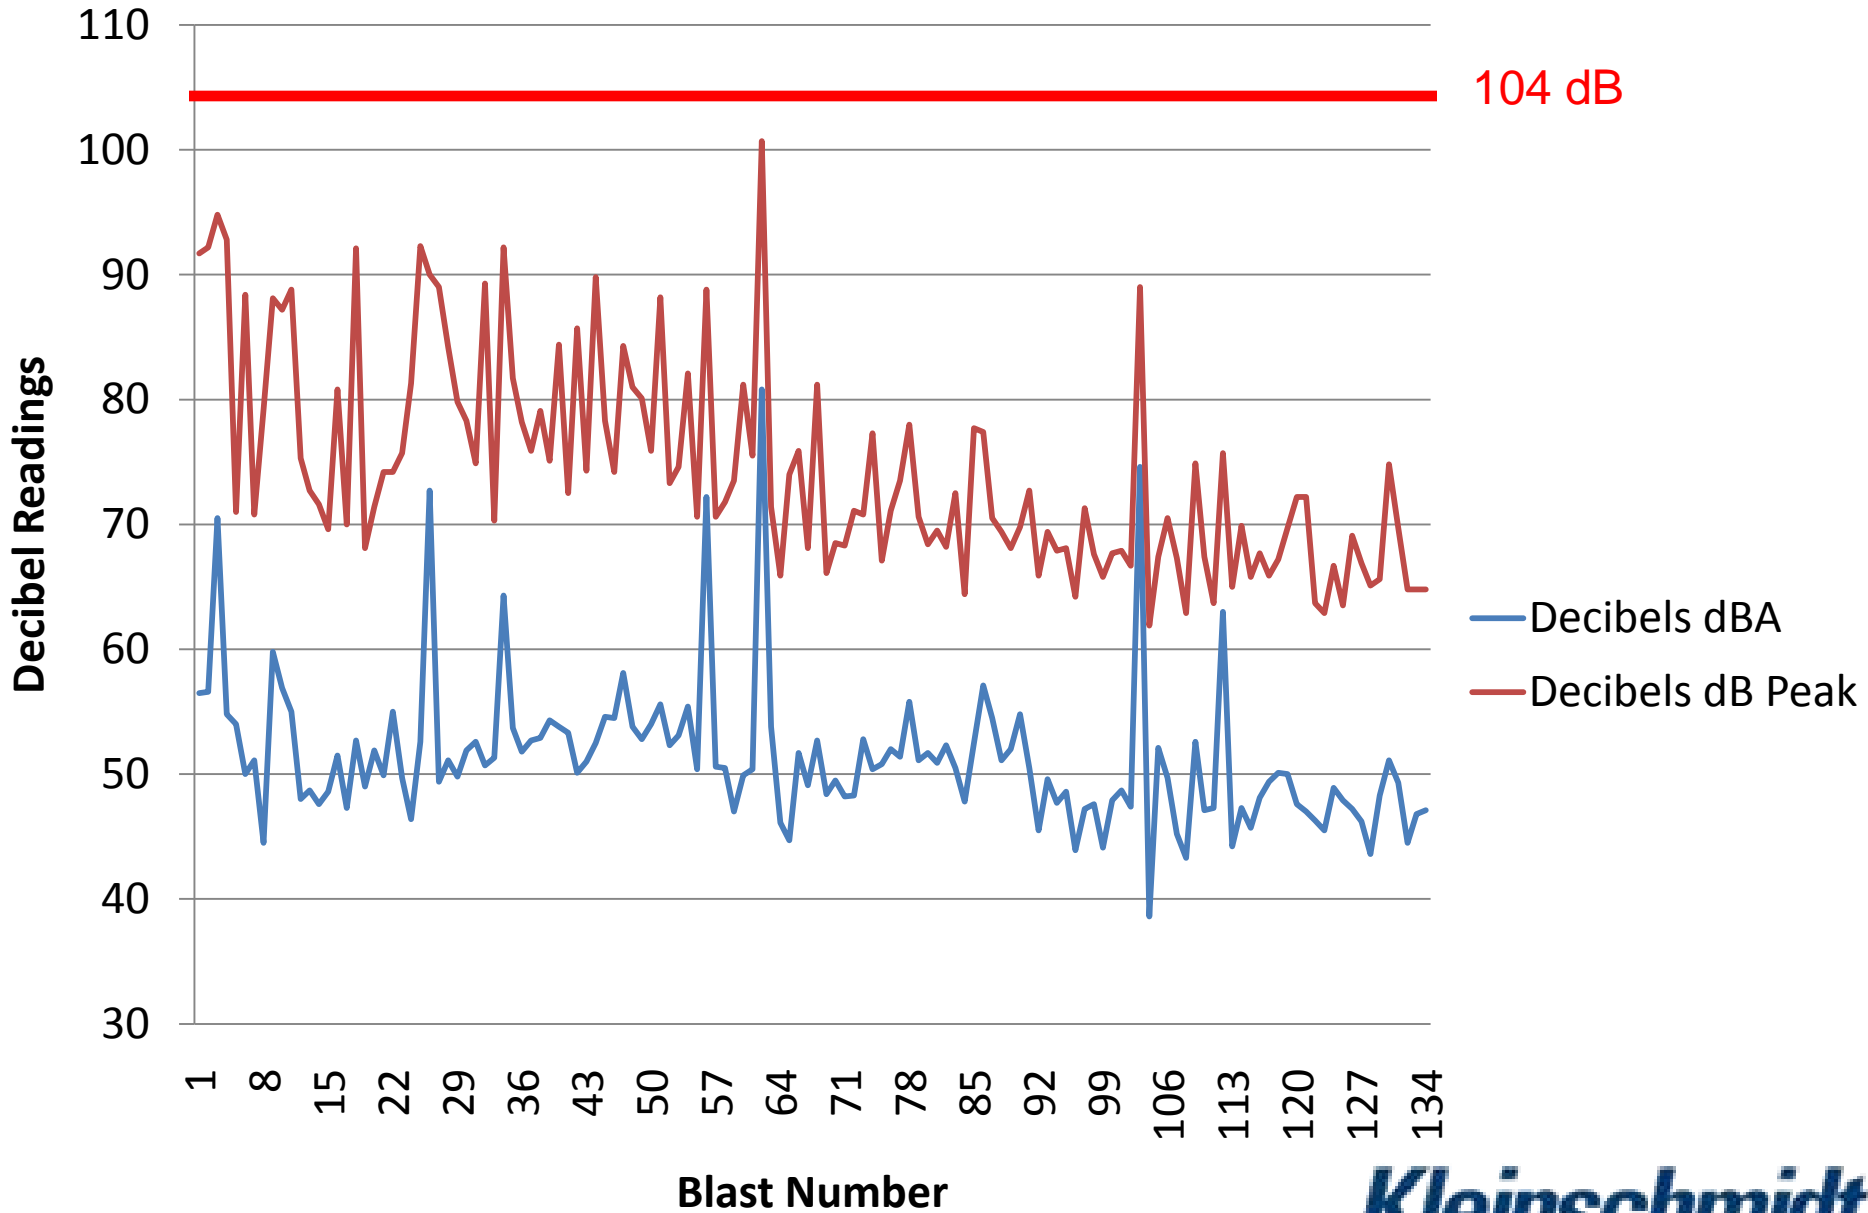
Decibel Readings at Blast Time

- Construction Was Not Visible from the Nest
- Blasting Occurred at Approximately 0.5 miles
- Blasting was Slowly Increased
 - Number per day
 - Charge Size
- Peak Decibels were <104 dB
