ENVIRONMENTAL AND SOCIAL MANAGEMENT PLAN (ESMP)

FOR THE PROPOSED **MULTI-METAL RECYCLING (MMR) PROJECT AT SINOMINE
TSUMEB SMELTER, TSUMEB, OSHIKOTO REGION**

Sinomine Tsumeb Smelter (Pty) Ltd

14 February 2025

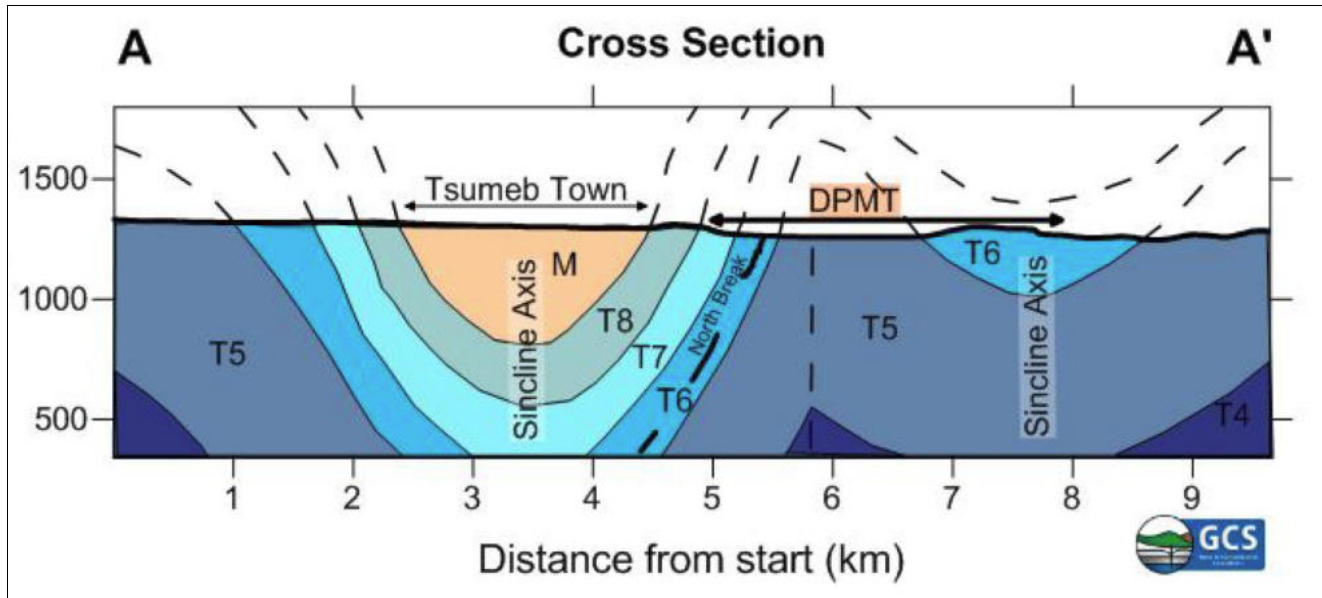
Figure 2-2: SW-NE Cross section through the Tsumeb Town and Smelter Site area

The town falls within the Etosha Basin Hydrogeological Region. Groundwater occurs in the Tsumeb Dolomitic Aquifer with the Mulden Sandstone/Shale acting as an aquiclude. The Smelter site is located on the Elandshoek and Hüttenberg Formation litho-zones, both are aquifers, in an ESE-WNW sloping valley formed as part of an anticlinal structure. The groundwater is expected to move in fold axes, pressure relief joints, faults or on lithological contact zones (see Figure 2-1 above). The average natural groundwater levels in Tsumeb are at approximately 1 210 m amsl (60 m below the land surface in the town area) with little seasonal fluctuation in the levels.

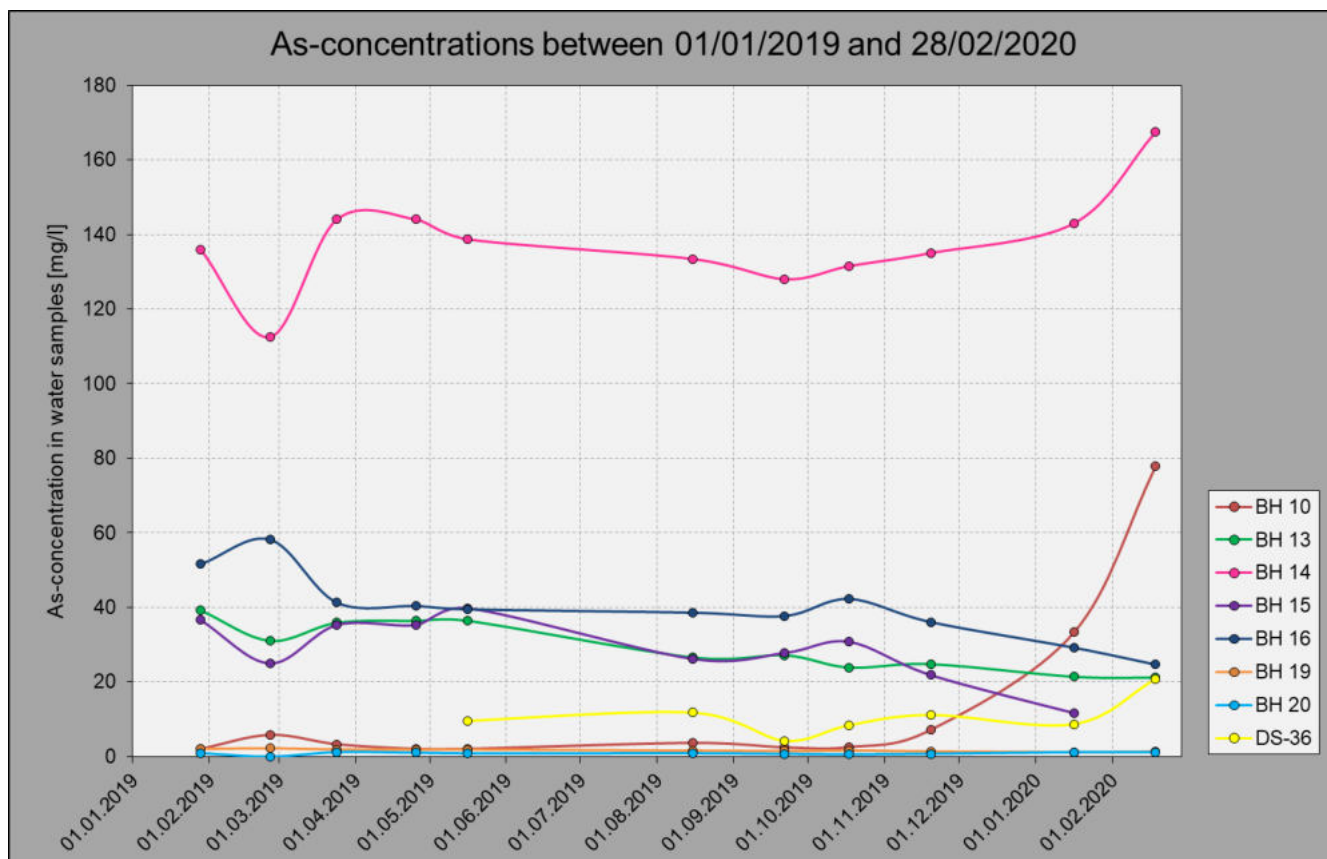
Figure 3-1: Arsenic-concentration between 2019-2020 for selected DPMT monitoring boreholes

However, potential contaminant sources currently related to the site include more than 100 years of smelter operations with two (2) tailings dams and various storage areas of slag and calcine. It appears that runoff from the site has, occasionally, accumulated away from the site, acting as an additional (secondary) source of groundwater contamination. On site, As is regarded to be the most important potential contaminant both in terms of potential length of transport and hazardousness. Figure 3-1 is showing As-concentration between 2019-2020. Towards the beginning of 2020 an increase of As was observed in boreholes DS-36, BH14, and BH10. This increase is as well observed to correlate with Sulphate (SO₄) concentrations.

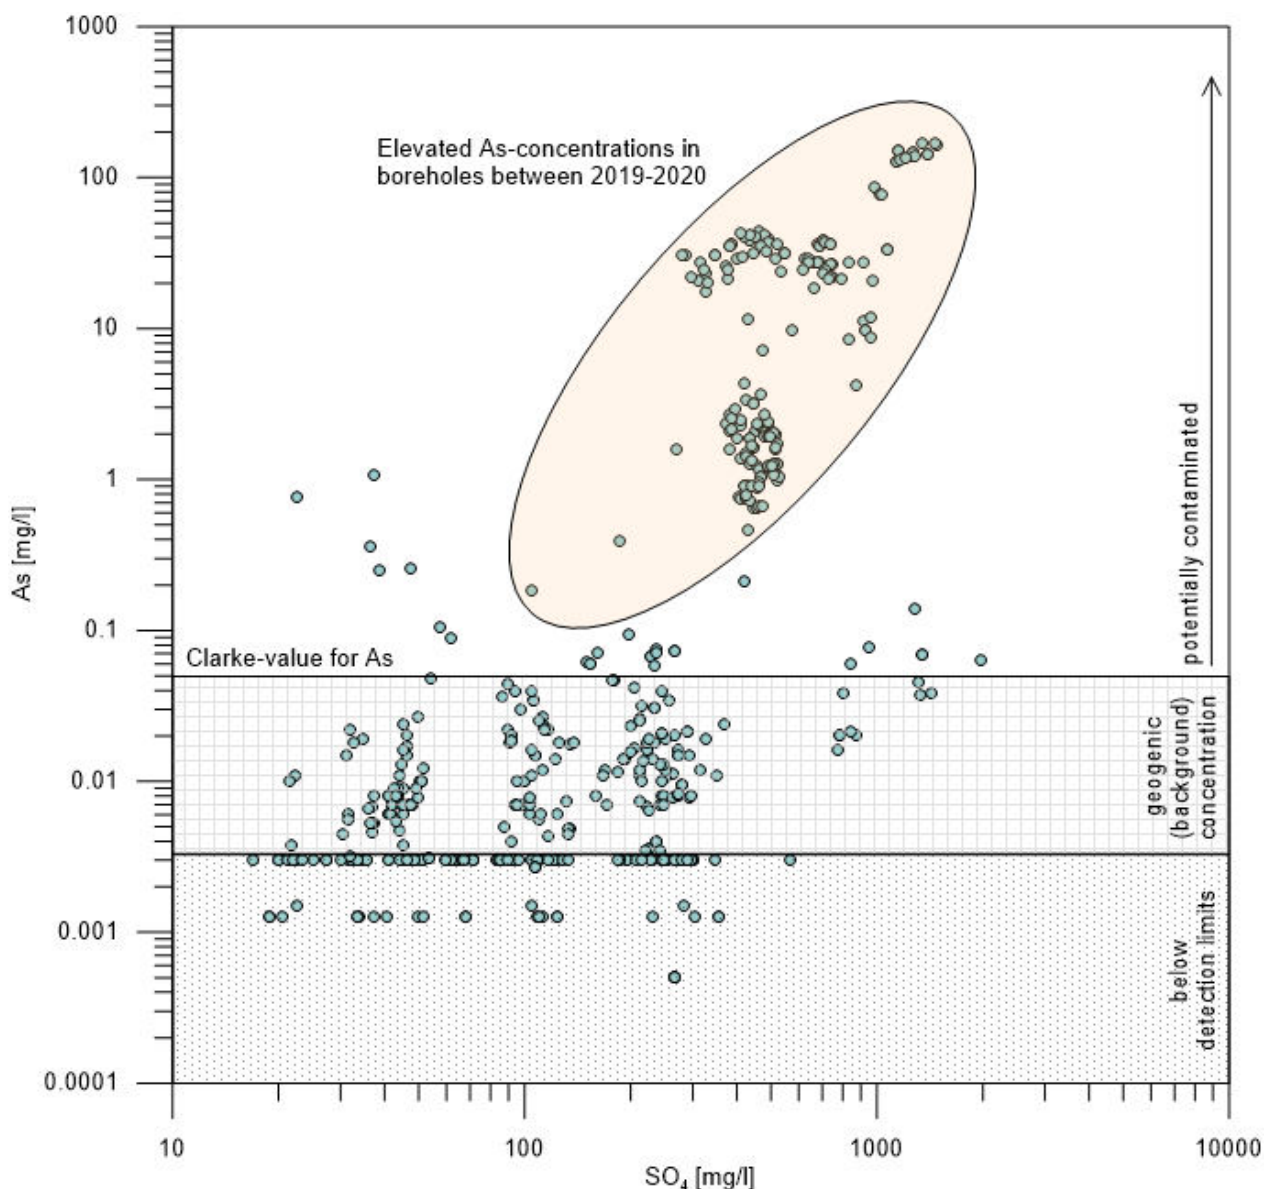
Figure 3-2: Scatter-plot of Arsenic against Sulphate concentrations

The Clarke -Value which is the natural concentration of elements in the earth's crust is generally used to distinguish between natural and anthropogenic concentrations. To that effect it was used to distinguish between those boreholes that have been affected by pollution and water from boreholes which only shows natural (geogenic) background concentration in Figure 3-2 were a scatter-plot was produced, showing Arsenic against Sulphate concentrations. It should be observed that samples collected from 2019-2020 are above the Clarke – Value and thus represent an anthropogenic source of arsenic. Some samples were also observed to plot below detection limits. However, due to different detection limits from the laboratories that were used to analyse the samples, a clear distinction between detection limits was observed through the scatter plot.

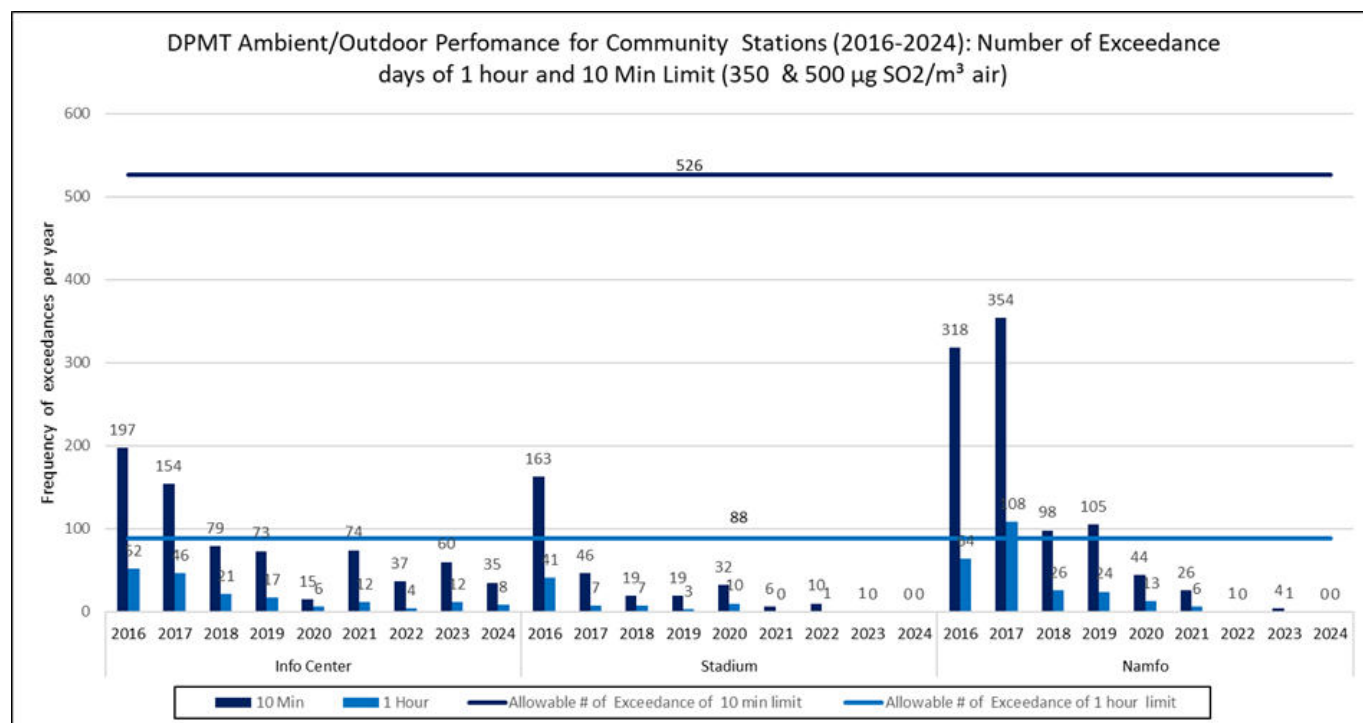
Figure 3: Community Stations (10-min and 1-hour) SO_2 Exceedance Performance 2016-2024t

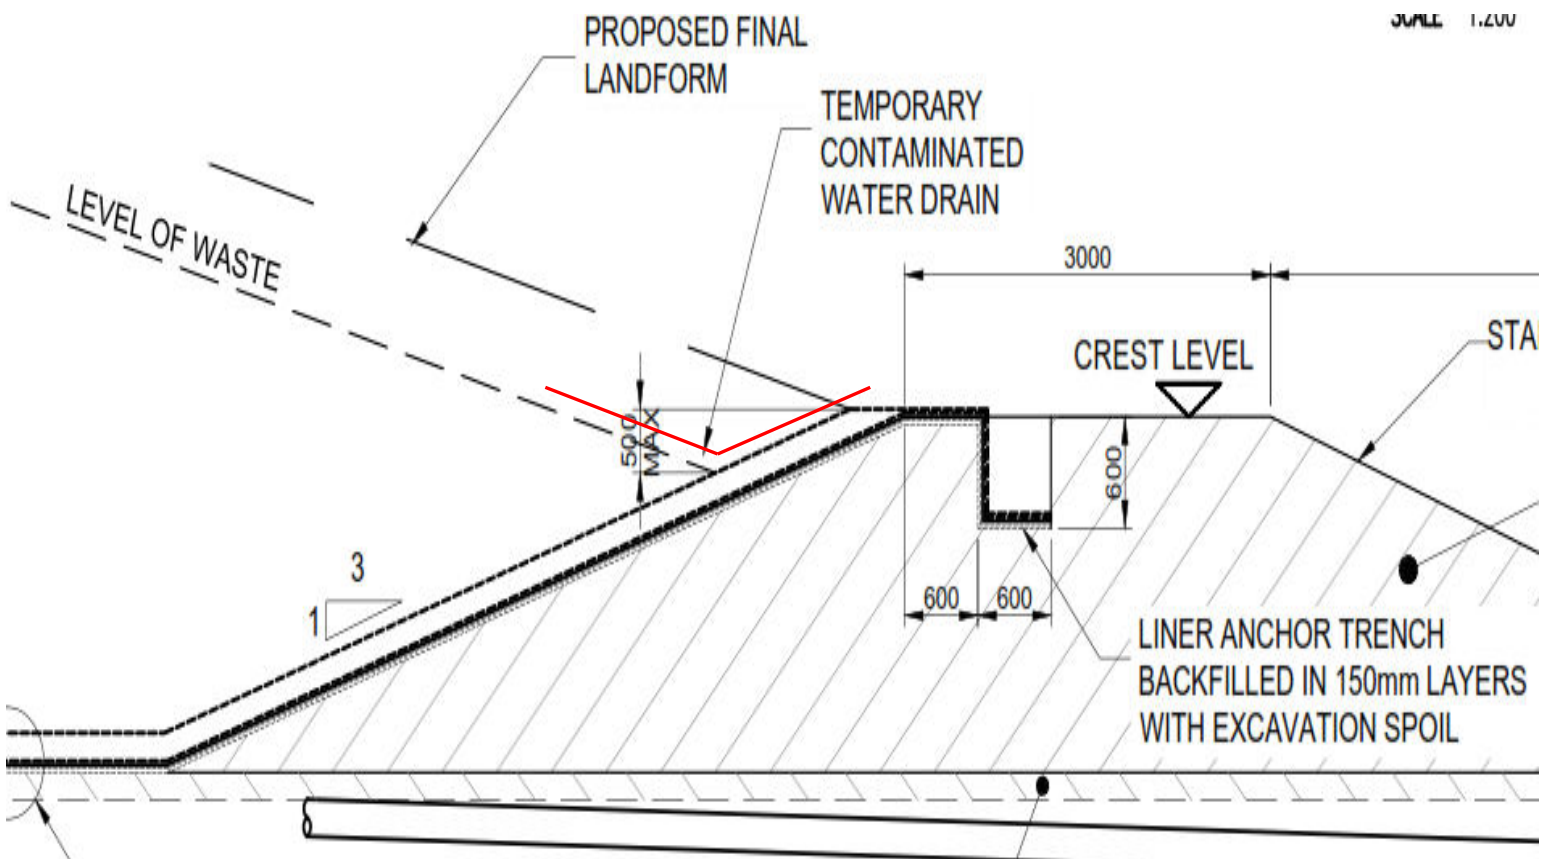
<p>This channel should be inspected daily to ensure that it is clean.</p>

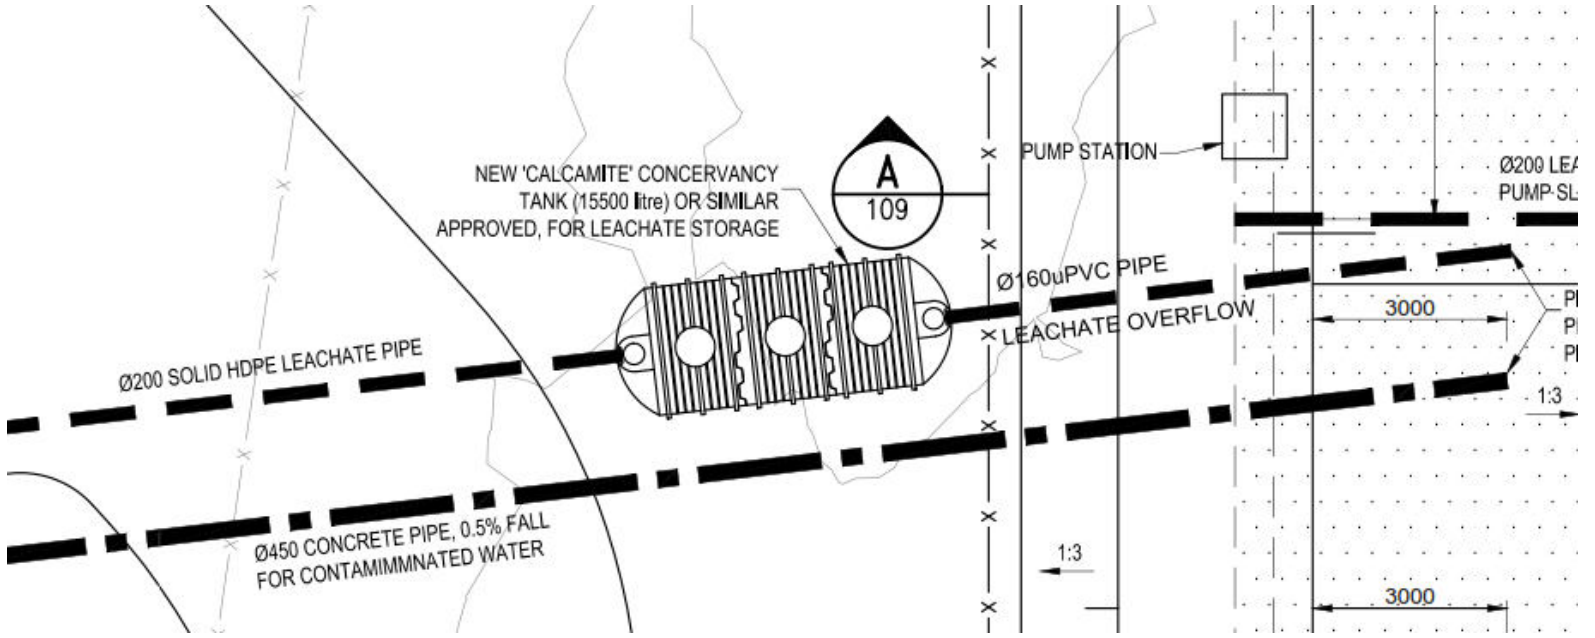
Description	Action required
<p>Graphic of the pipe layout for the leachate collection system</p>

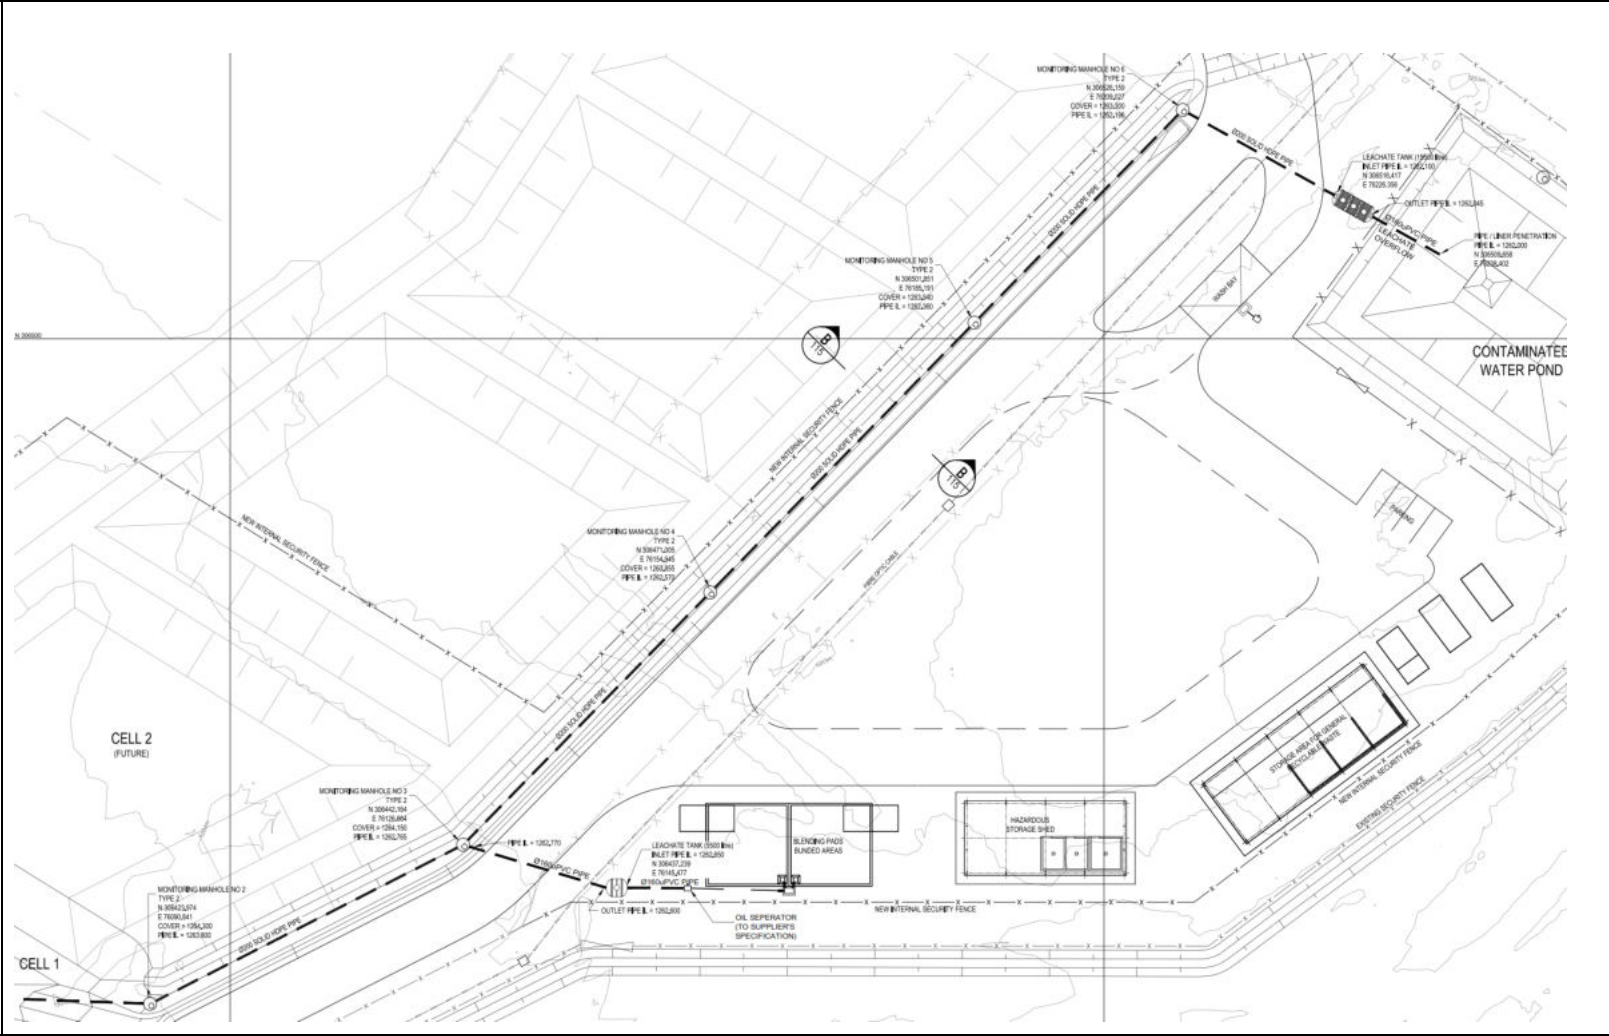
Description	Action required
Sump	The leachate sump should be kept clean and open until the waste body reaches the same height as the retaining berms after which it should be backfilled with waste. As far as possible fines should not be allowed to accumulate in the sump as this may clog the sump.
Monitoring manhole	The monitoring manhole should be checked once a week to ensure that it is functioning (draining), checked visually from surface. Note that methane levels need to be monitored before the manhole is accessed. If methane is detected the manhole should be flushed by blowing fresh air into the manhole until no methane is detected before the manhole is accessed. The flushing should continue during the time the manhole is being accessed and personnel should wear respirators as a safety precaution. Ropes should also be tied around the person/s entering the manhole to assist with evacuation should the person faint. Adopt “Confined Space SOP”.

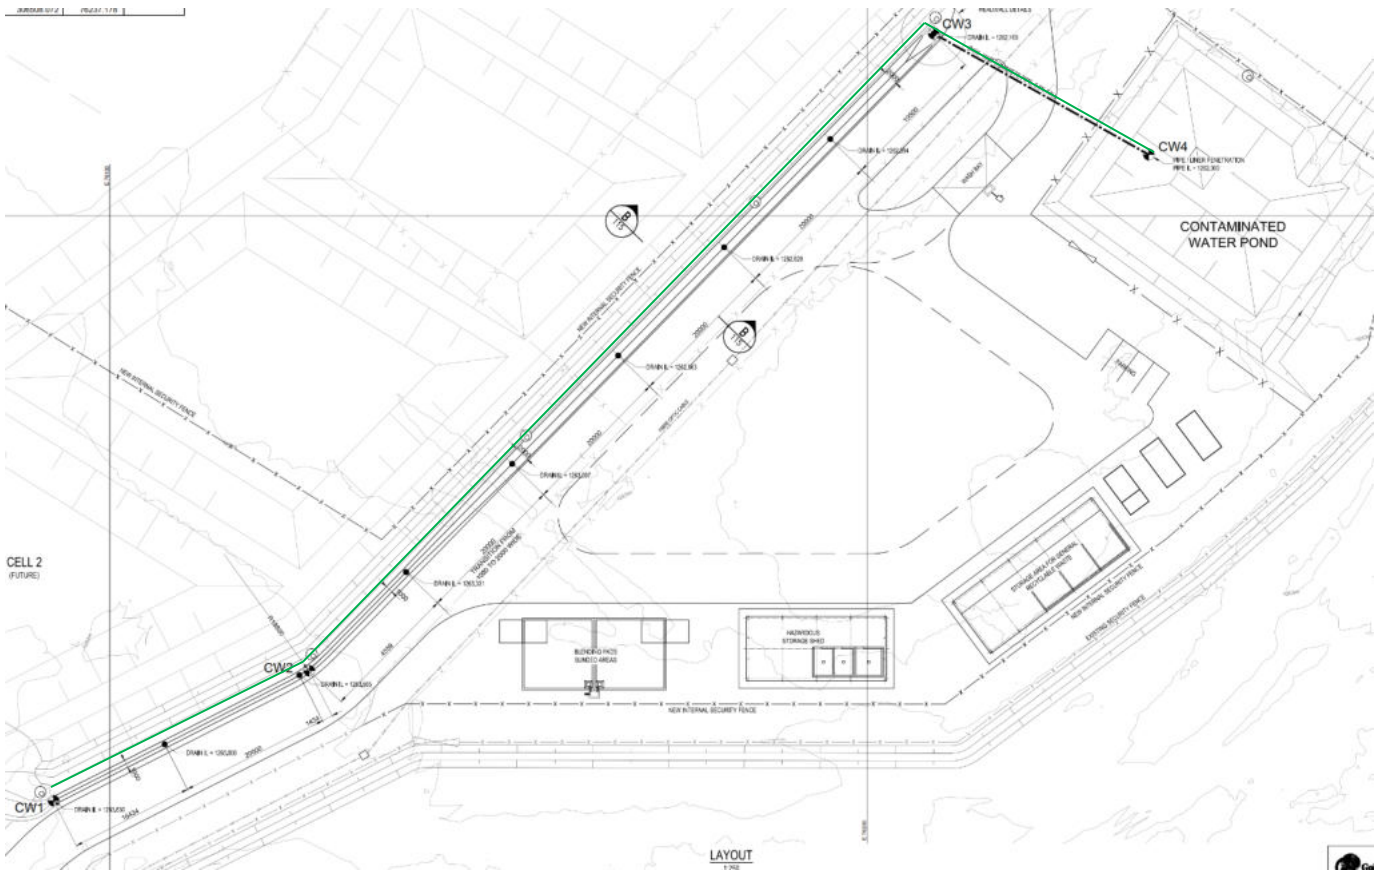
Description	Action required
Contaminated water channel	<p>The main channel and spillway should be inspected on a weekly basis to ensure that the channel is free from any obstructions.</p> <p>After every rain event any silt build-up should be removed from the channel and the pipe leading to the channel should be cleaned.</p> <p>Any damage to the channel should be repaired immediately to ensure that contaminated water does not spill into the environment.</p> <p>The spillway should be inspected on a weekly and after every rain event for any damage. Damage to the spillway should be repaired immediately.</p>
Discharge pipe	<p>The discharge pipe should be inspected on a weekly basis during the rainy season and any silt should be removed as soon as possible to ensure continuous flow of contaminated water.</p>

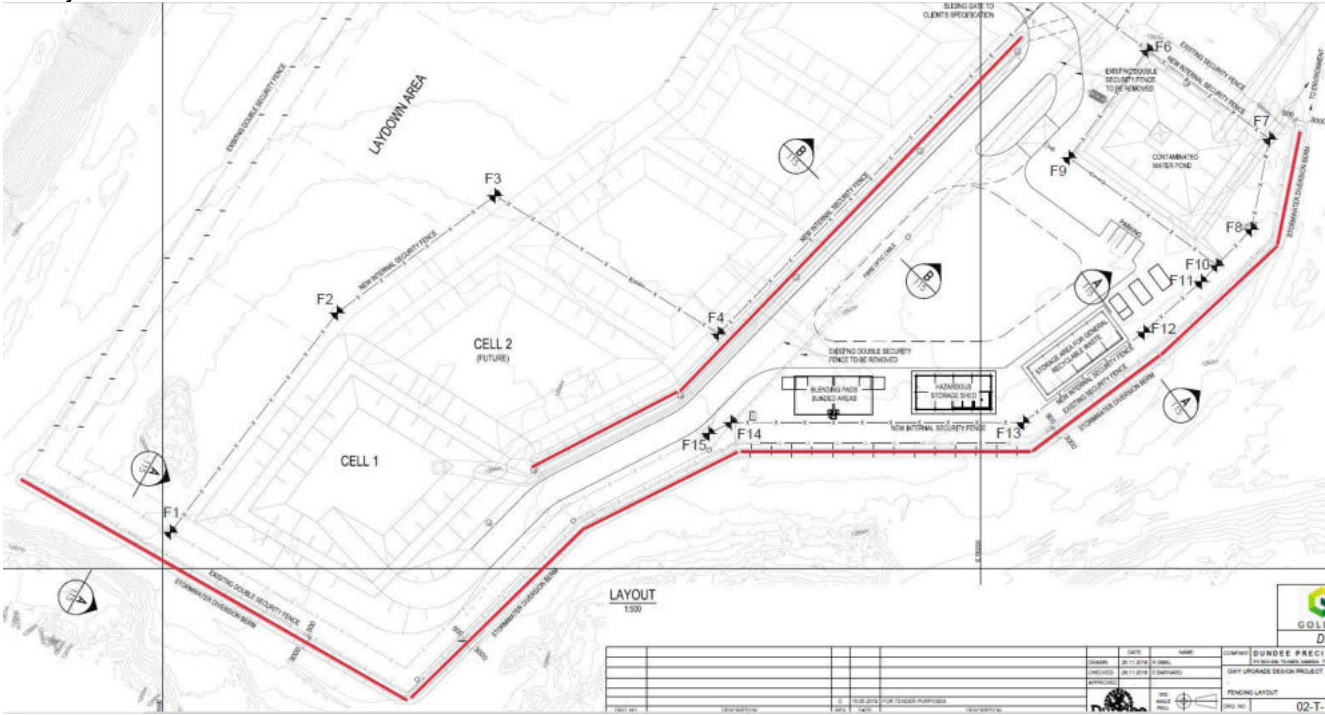
<p>These berms should be inspected monthly and / or directly after any rain event and any damage should be repaired immediately.</p>
<p>Storm water outlet adjacent to contaminated water dam</p>	<p>The storm water outlet adjacent to the contaminated water dam should be inspected after every rain event and any silt should be removed.</p>

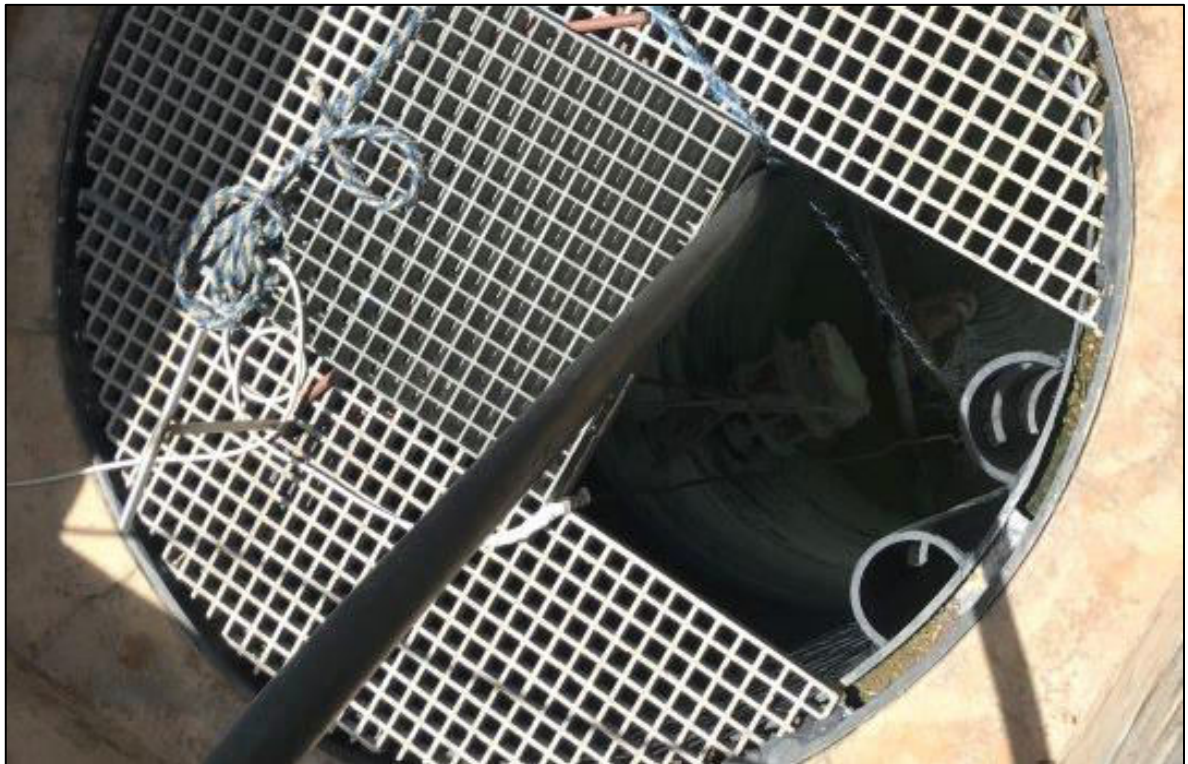
Figure 14-1: Pond 1 pipe outlets into HDPE sump

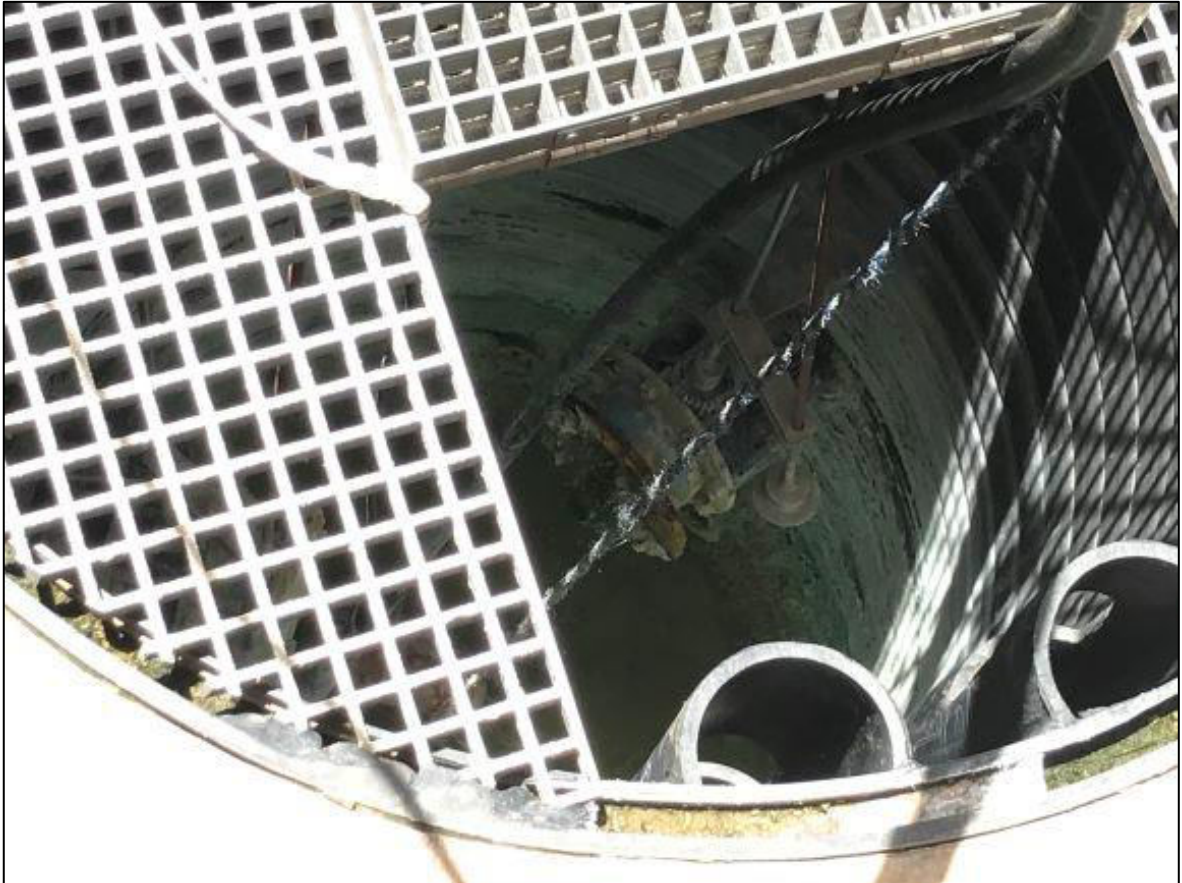
Figure 14-2: Cell 1 outlet pipes into HDPE sump
