APPLICATION NO: 250818006254

**RENEWAL of Sand Mining Environmental Clearance Certificate For
Eenhana Town Council In Eenhana Townland, Ohangwena Region**

DOCUMENT INFORMATION	
DOCUMENT STATUS	FINAL
APPLICATION NO.	250818006254
PROJECT TITLE	RENEWAL of Sand Mining Environmental Clearance Certificate For Eenhana Town Council In Eenhana Townland, Ohangwena Region
CLIENT	Eenhana Town Council
LOCATION	Eenhana Townland, Ohangwena Region
AUTHORS	Mr. Ipeinge Mundjulu

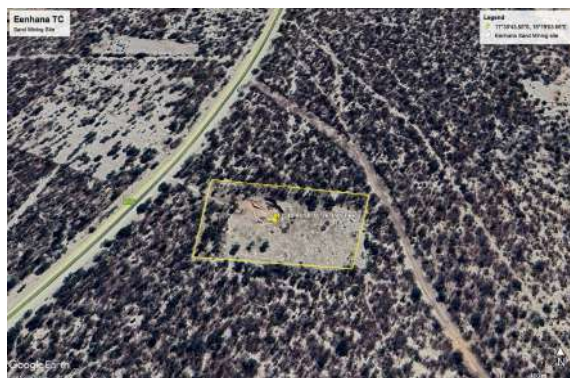
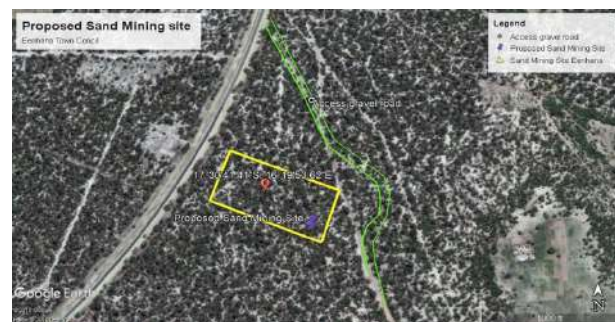
Figure 1. Eenhana Town Council Sand Mining Site: Two images showing before and after sand mining

The sand mining is taking place on 4-hectare (Figure 1) piece of land, on the periphery of the main Oshigambo-Eenhana tarred road (GPS Coordinates -17.512083° E, 16.331572° S).

(Google image 18 August 2025)

(Google image 16 June 2019)

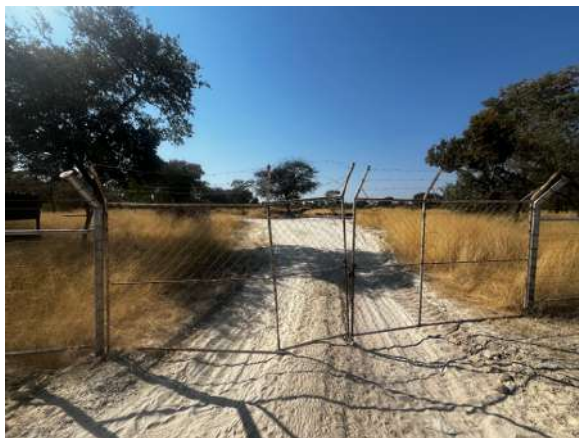
Entrance with Locked Gate

- **Security and access control:** The site perimeter is fenced and access is restricted to authorised personnel. Security personnel monitor the fence to prevent unauthorised entry and to maintain safety protocols.

2. Safety controls for open pits
 - Maintain and reinforce perimeter fencing and signage; restrict public access and maintain guard until the site is stabilised or converted to a managed reservoir.

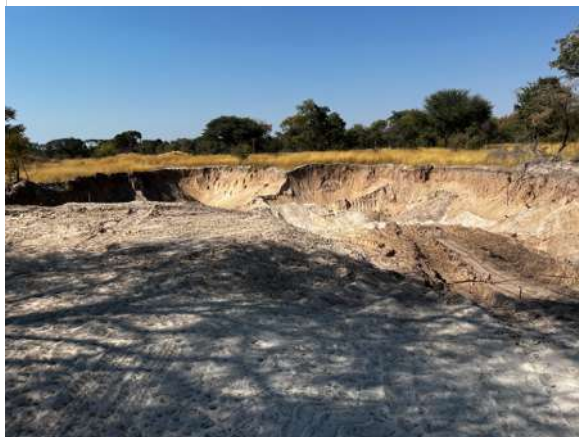
Sand Mining Area / Footpring

- **Extent of disturbance:** The site has been cleared and excavated over an area of approximately 0.28 hectares. Excavations reach depths of about 3–4 metres (see Figure 2).

- **Geology and terrain:** Eenhana Town lies within the northeastern Kalahari Woodland, a landscape characterized by deep, loose sands. The audit observed that the mining area reflects these natural sandy conditions, which influence erosion risk and groundwater recharge characteristics.

1. Stabilisation and progressive rehabilitation
 - Rehabilitate and stabilise exposed areas progressively where practicable. Regrade slopes to the recommended 1:3 ratio, replace with topsoil where available, and begin revegetation using native species.
