# PROPOSED 50MW SOLAR PHOTOVOLTAIC PLANT ON 150HA, NORTH WEST OF ARANDIS, ERONGO REGION

## FINAL SCOPING REPORT

- 50MW Photovoltaic Solar Plant
- 0.5 km 33 kV Power line

**August 2022**

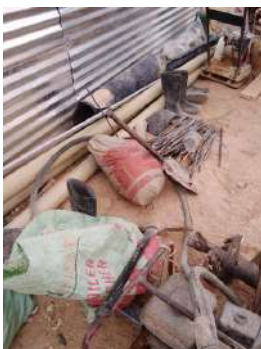
Photo 6

Is all spilled concrete (wet or dry), treated as hazardous waste and disposed of by the end of each day, in the appropriate hazardous waste containers?

No

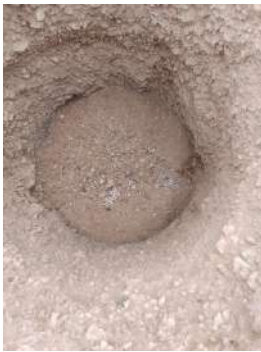
Photo 10

However, they are left for longer than 24 hours which causes smaller animals to fall in.
