# REPORT:

## GROUNDWATER ASSESSMENT AND DEVELOPMENT – FARM GAI KAISA NO. 159

PROJECT NUMBER: ECC-118-611-REP-02-A

DATE: 22 OCTOBER 2025

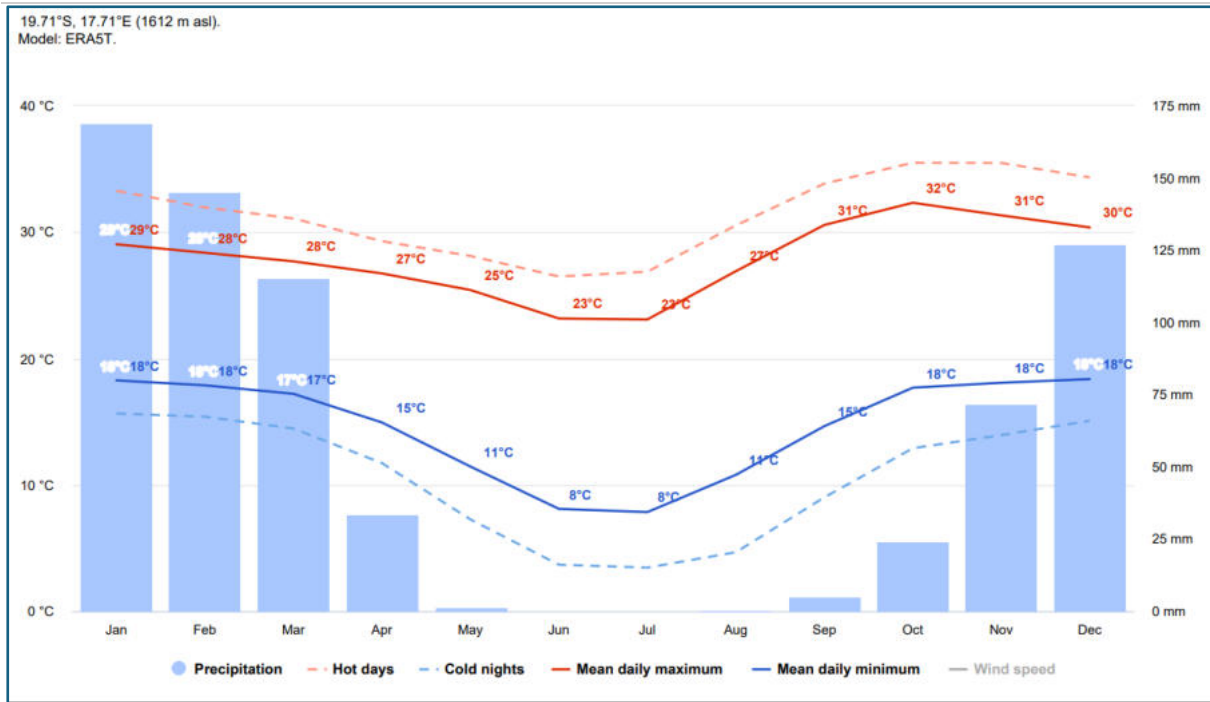
Figure 2 – Precipitation and mean daily maximum and minimum temperatures for the area of Farm Gai Kaisa

Farm Gai Kaisa occurs in the BWh region of the Köppen-Geiger classification which is hot arid desert climate characterised by low annual precipitation (450-500 mm per annum, Figure 3) and high temperatures throughout the year (23.9°C mean annual temperature). Mean annual evaporation (MAE) is reportedly between 3000 – 3200 mm; exceeding MAP by an order of magnitude and resulting in a hydrological deficit for the region. Climatic data from the nearby area of Kombat is shown as representative of the farm in Figure 2.

Rainfall is predominantly in the summer months of November to March and is experienced as brief but intense downpours, often resulting in localised flooding. The rest of the year is relatively dry, with minimal rainfall and low humidity levels. Rainfall distribution and evapotranspiration are important factors to consider in developing the crop water requirements.

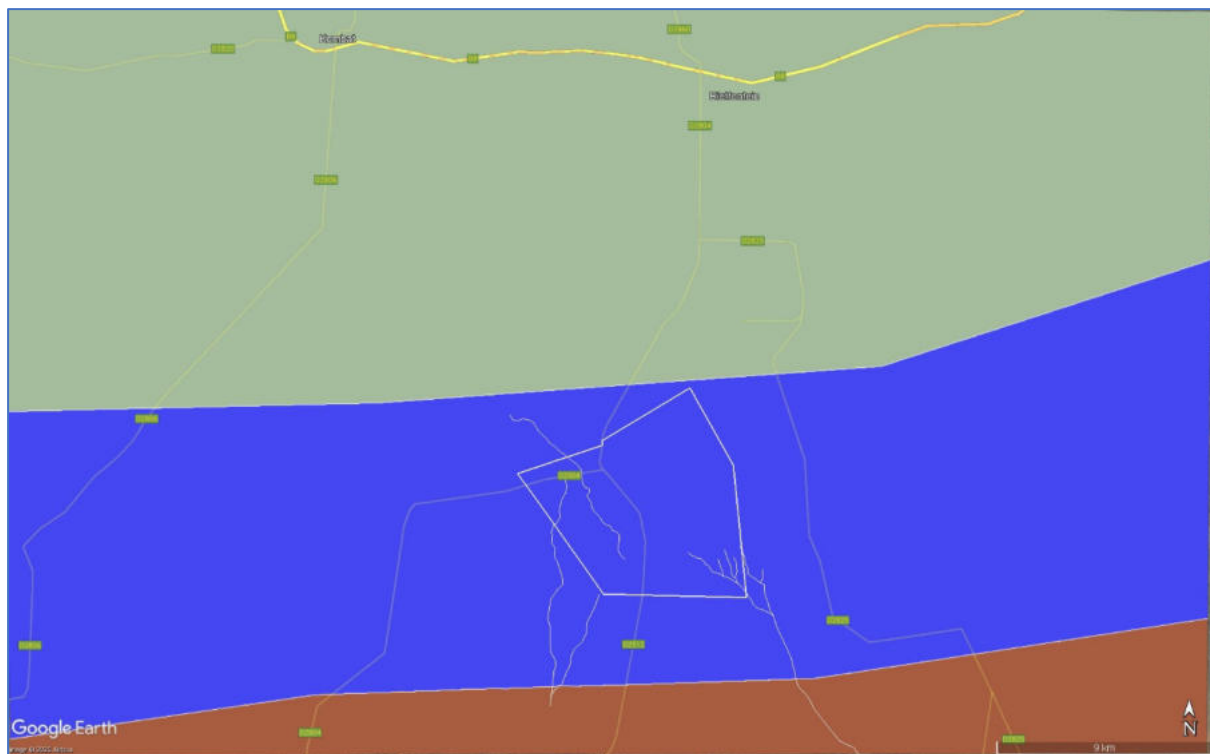
Figure 3 – Mean Annual Precipitation map for Farm Gai Kaisa (blue band = 450 – 500 mm/a)

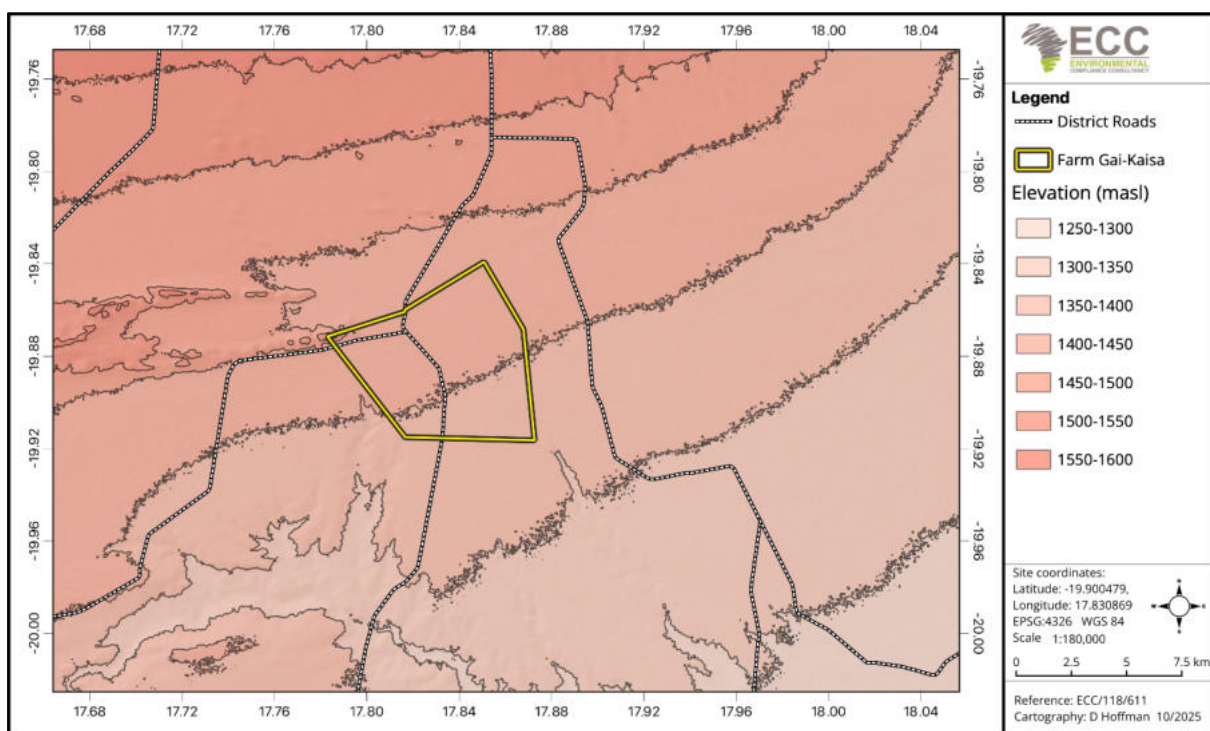
**Figure 4 - Terrain map of the study area showing decrease in elevation to the south east**

The general topography of the area (Figure 4) shows a gradual decrease in elevation from north to south, ranging from approximately 1430 meters above mean sea level (mamsl) to 1381 mamsl. Similarly, the elevation decreases from west to east, ranging from ~1414 mamsl to 1398 mamsl resulting in a regional south easterly gradient. The north western corner of the farm boundary abuts an area of high relief formed by folded outcrop of resistant marble and calc-silicate rocks. The terrain is influenced by the underlying geology, with variations in elevation shaped by geological structures and natural erosion processes. Further north, the Otavi Mountains dominate the landscape, serving as a notable topographical feature in the region.

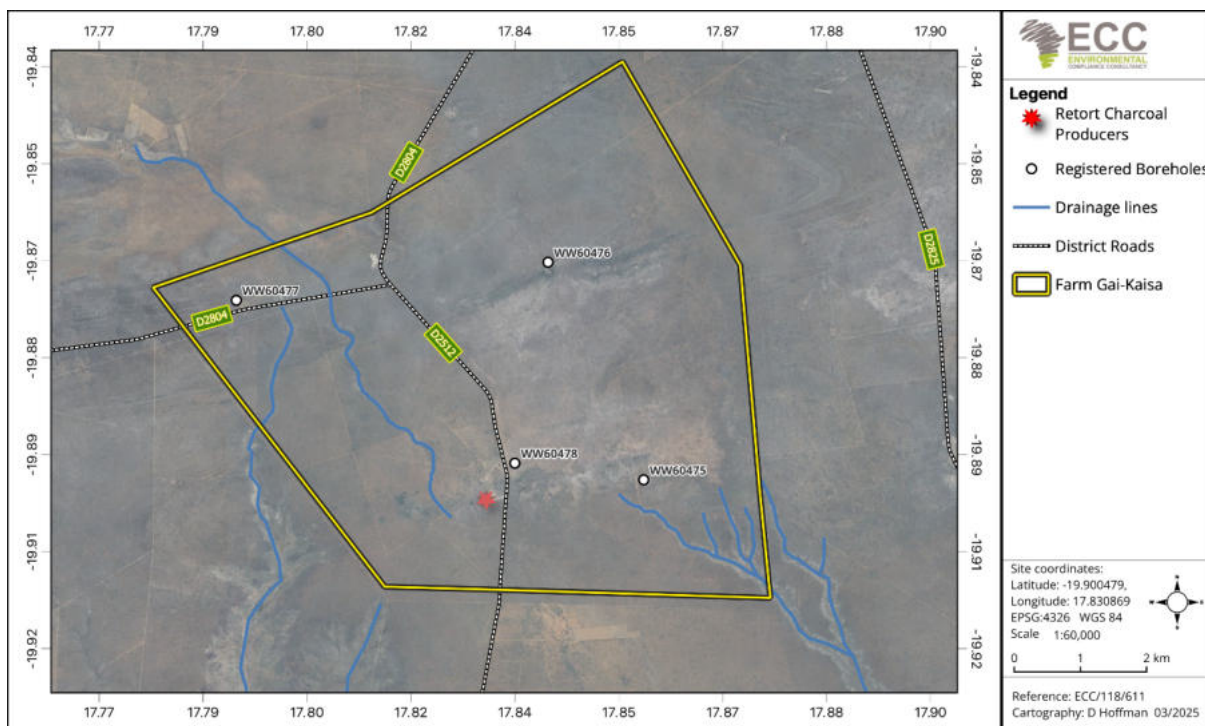
Figure 9 – Map of existing borehole locations derived from GROWAS and DWA databases

There are four existing registered boreholes on the farm, however, an additional five boreholes (EB1-EB5) require registration and are planned for abstraction (Table 1). Work undertaken to develop groundwater on the farm (i.e. from the five aforementioned boreholes) is described in subsequent sections.

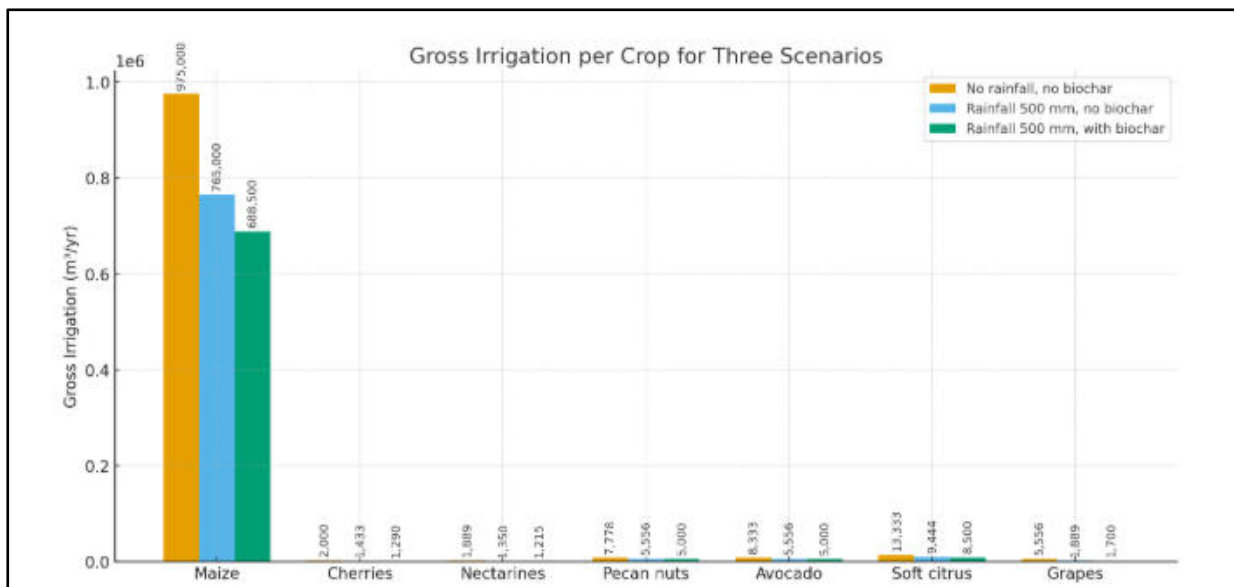
**Figure 10 – Gross volume of water to abstract (includes losses) under various cultivations and rainfall scenarios**

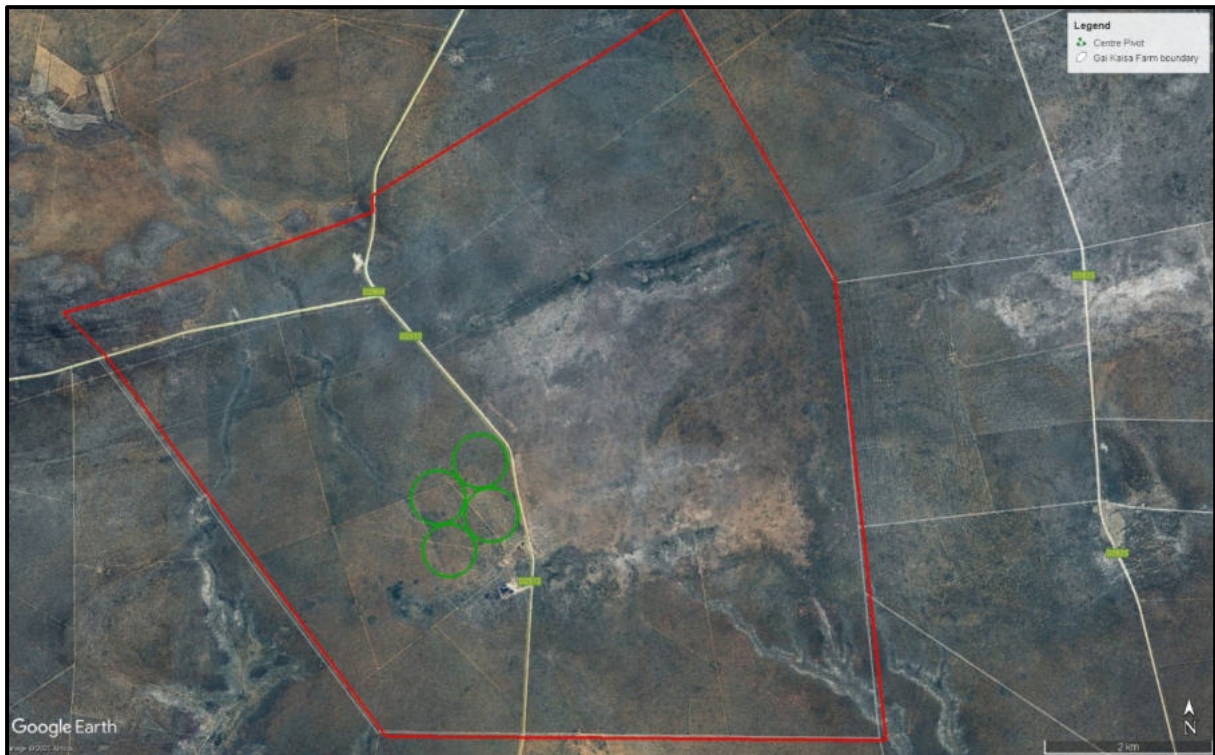
**Figure 11 – Area on Farm Gai Kaisa (red polygon) planned for centre pivot irrigation (green circles)**

Based on existing use and typical crop water requirements, Phase 1 has a water requirement of ~1 million m<sup>3</sup> per annum. Phase 2 includes an increased hectarage to ~260 ha and motivates a total groundwater requirement of 2 million m<sup>3</sup> per annum. As shown in Table 3, actual volumes are anticipated to decrease depending on rainfall conditions and the efficacy of the biochar application. Values given are typical/representative seasonal or annual CWR estimates — local evapotranspiration, crop variety, management, phenology, planting density, and seasonal rainfall timing will influence values.

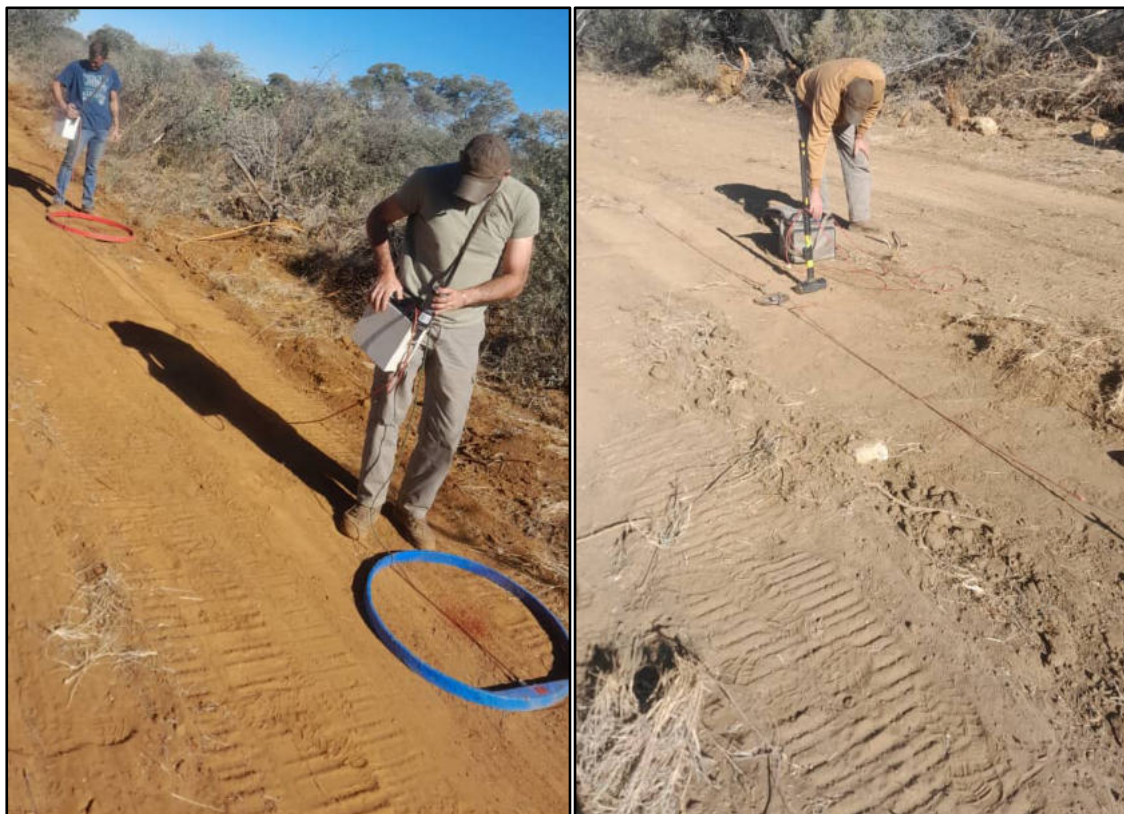
Figure 12 – Photos taken during the EM survey on Farm Gai Kaisa

A geophysical contractor undertook a survey using the Electromagnetic (EM) technique (Figure 12) targeting lineaments, potential structures and contacts presumably identified during desktop mapping. Results of the MLEM survey identified several areas of increased potential and boreholes were sited, however, for unknown reasons, boreholes were drilled in different locations, not coinciding with the locations of increased potential (Figure 13).

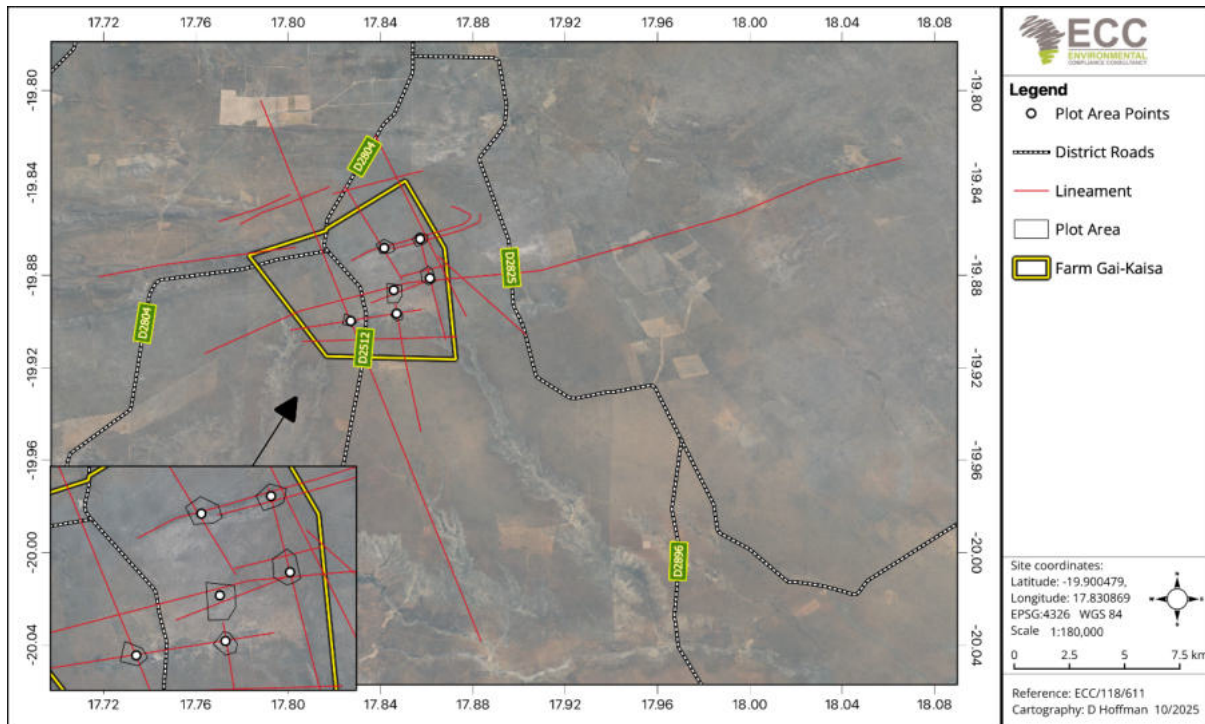
Figure 13 – Lineament mapping, areas of increased groundwater potential and proposed borehole drilling locations

It is noted that while mapped as a lineament or single linear feature, it is likely that the OL incorporates a larger area or zone along which increased groundwater potential may be expected, likely resulting in the positive outcomes obtained during borehole drilling.

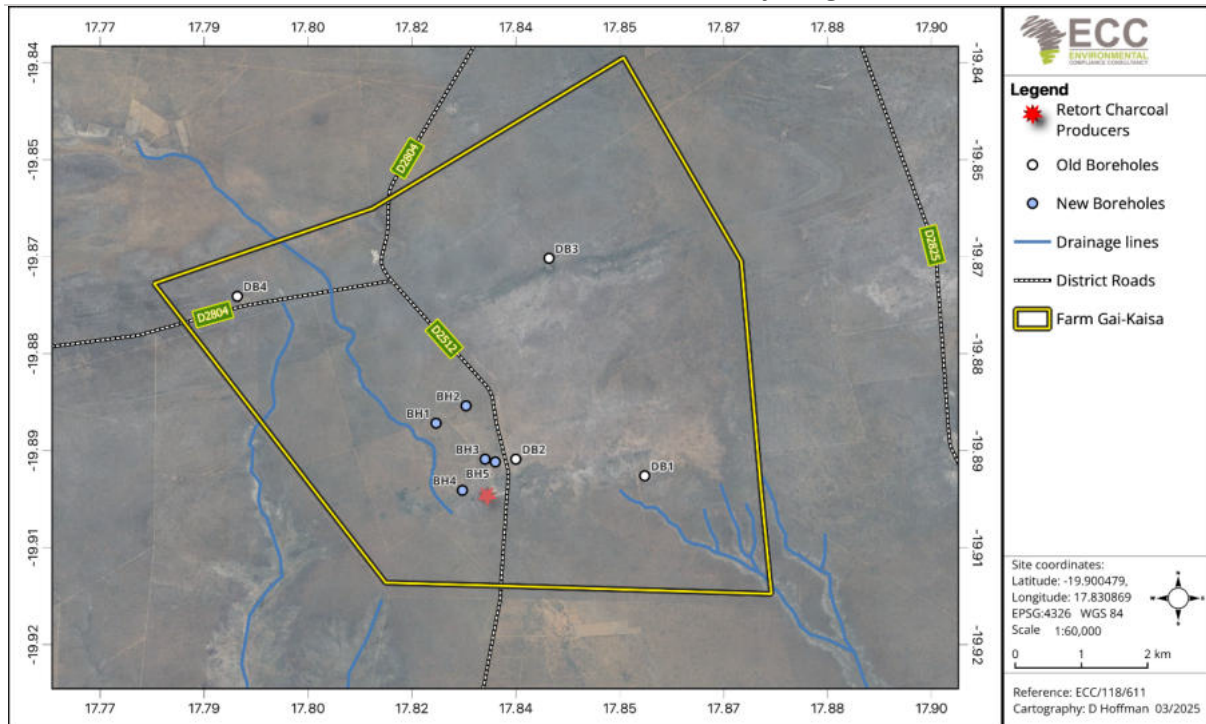
**Figure 14 – Map of drilled borehole locations (note DB denotes existing, registered boreholes)**

Table 4 provides a summary of the borehole drilling details, Figure 14 shows borehole locations and drillers / borehole completion reports are provided in Appendix A.

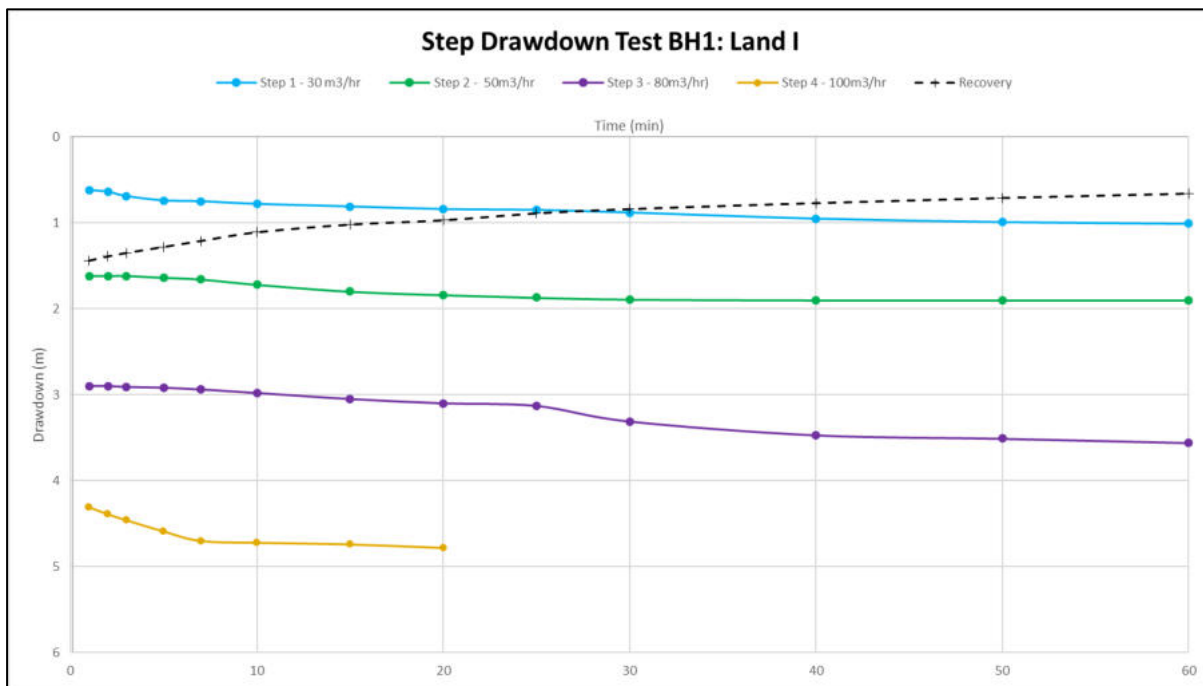
**Figure 15 Step test at BH Land I**

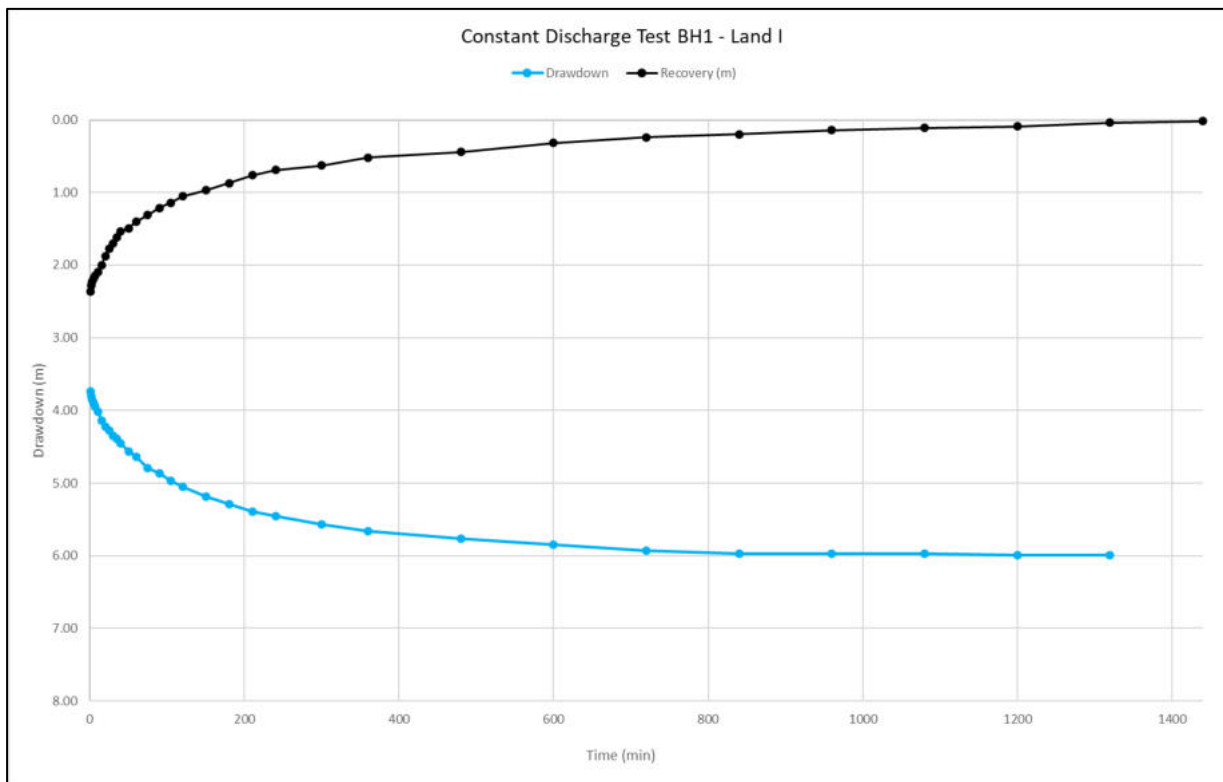
Figure 16 – CDT at BH1 – Land I at a rate of 100 m<sup>3</sup>/h for 24 hours

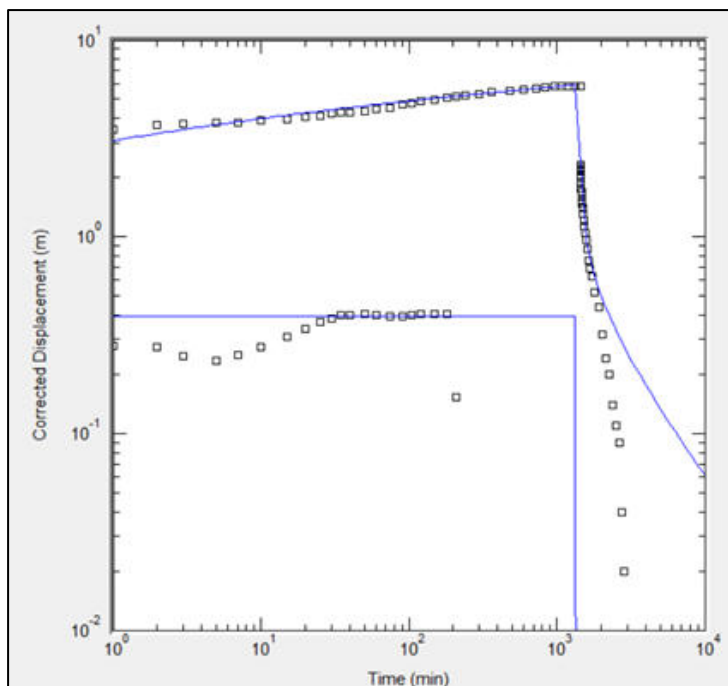
Figure 17 – Curve matching drawdown vs time and derivative data with the Theis (1934) solution for aquifer parameter estimation

Applying a combination of the Theis (1935) and Neumann (1974) analytical solutions (Figure 17), a Transmissivity value of 379 m<sup>2</sup>/d was determined. The recommended yield of 65 m<sup>3</sup>/hr is determined based on subjective information related to flow boundaries, a two year forward modelling of drawdown and the assumption of zero recharge entering the system. It is recommended that the borehole be allowed to recover for at least 24 hours per week. A

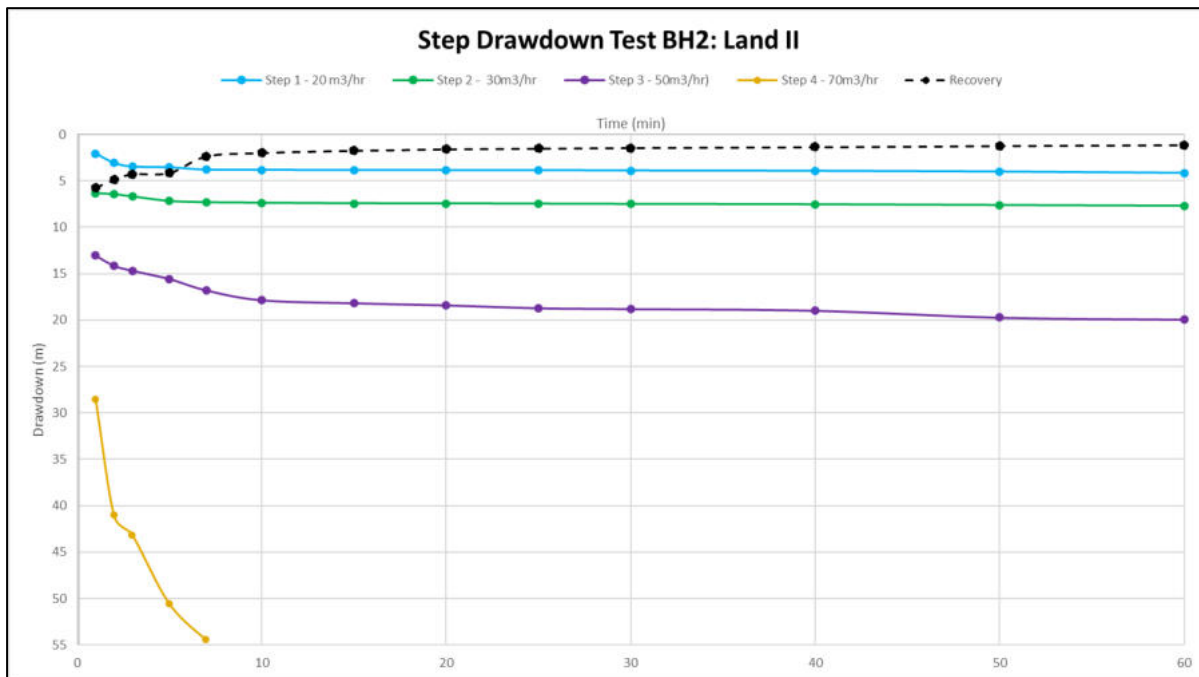
Figure 18 - Step test at BH2 – Land II

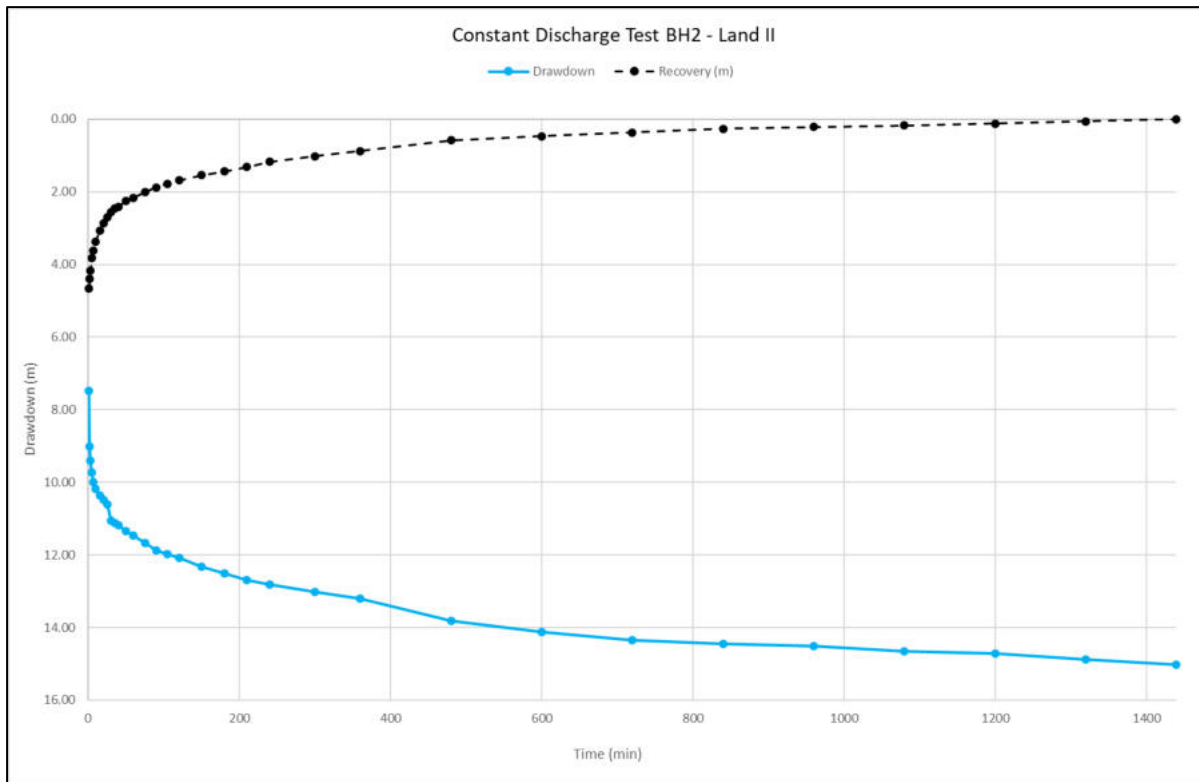
**Figure 19 – CDT at BH2 – Land II at a rate of 40 m<sup>3</sup>/h for 24 hours**

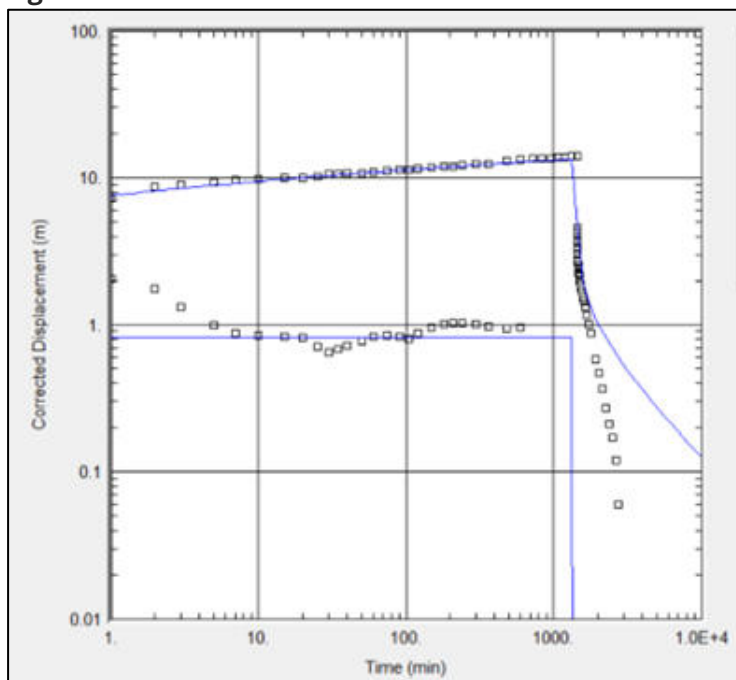
**Figure 20 - Curve matching drawdown vs time and derivative data with the Theis (1934) solution for aquifer parameter estimation**

Applying a combination of the Theis (1935) and Neumann (1974) analytical solutions (Figure 20), a Transmissivity value of 93 m<sup>2</sup>/d was determined. The recommended yield of 25 m<sup>3</sup>/hr is determined based on subjective information related to flow boundaries, a two year forward modelling of drawdown and the assumption of zero recharge entering the system. It is recommended that the borehole be allowed to recover for at least 24 hours per week. A summary of results and recommendations is provided in Table 6.

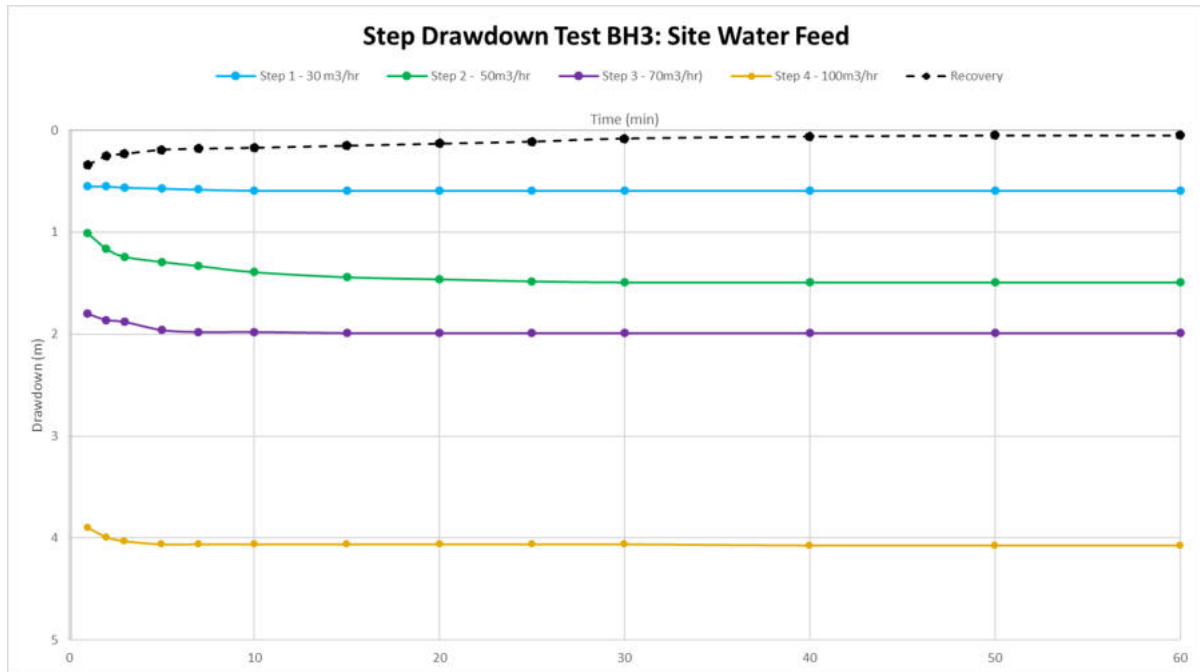
Figure 21 - Step test at BH3 – Site Water Feed

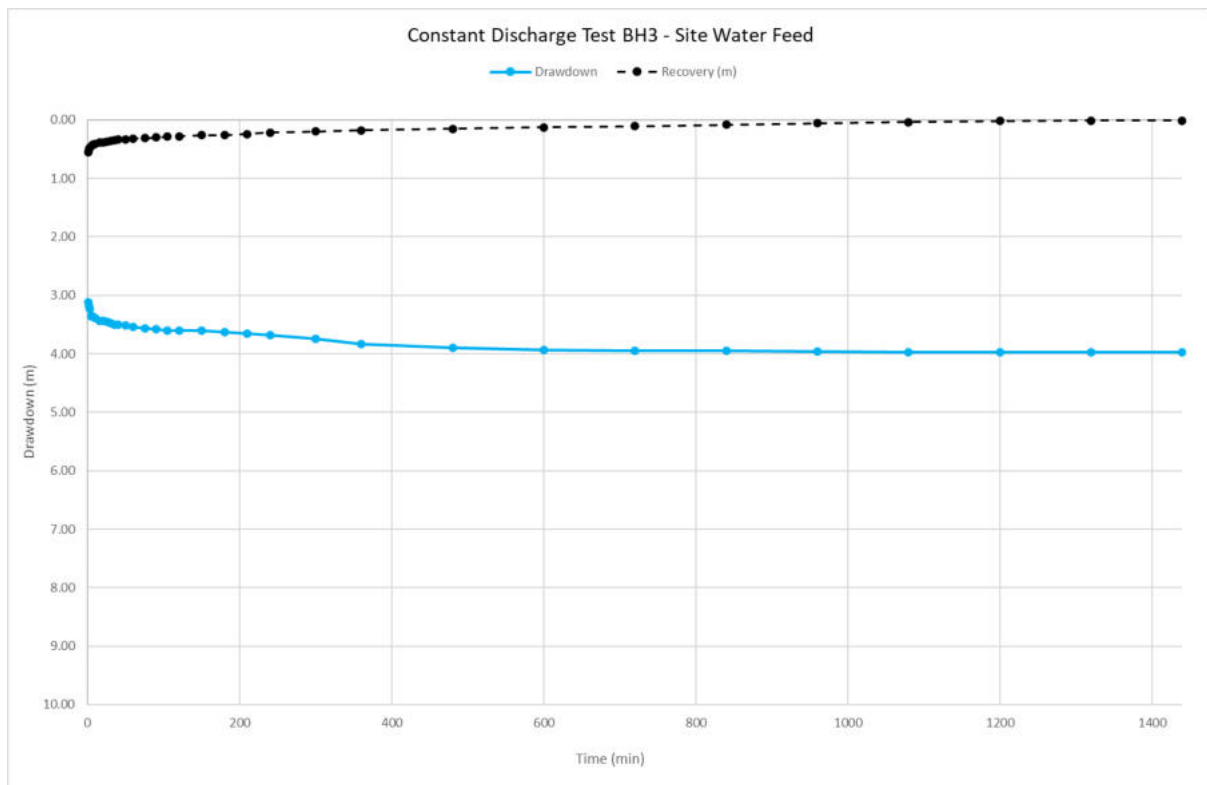
Figure 22 - CDT at BH3 – Site Water Feed at a rate of 100 m<sup>3</sup>/h for 24 hours

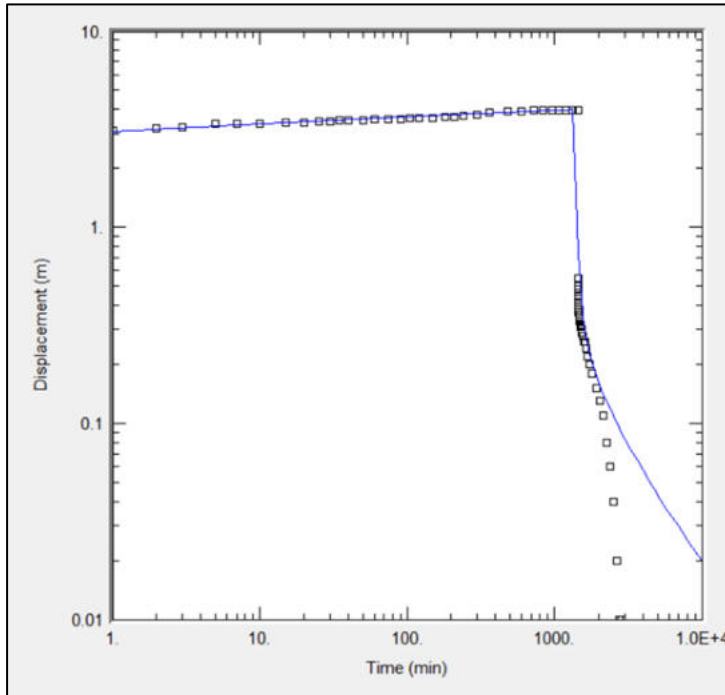
**Figure 23 - Curve matching drawdown vs time and derivative data with the Theis (1934) solution for aquifer parameter estimation**

Applying a combination of the Theis (1935) and Neumann (1974) analytical solutions (Figure 24), a Transmissivity value of 3250 m<sup>2</sup>/d was determined. The recommended yield of 80 m<sup>3</sup>/hr is determined based on subjective information related to flow boundaries, a two year forward modelling of drawdown and the assumption of zero recharge entering the system. It is recommended that the borehole be allowed to recover for at least 24 hours per week. A summary of results and recommendations is provided in Table 6.

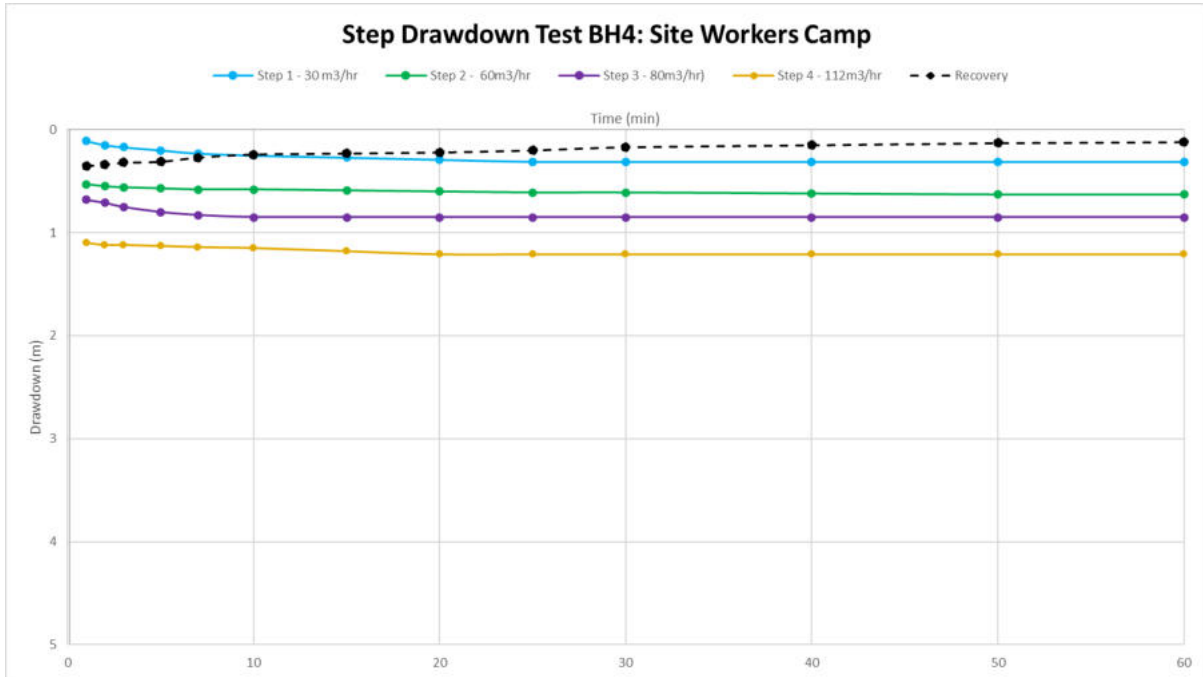
Figure 24 - Step test at BH4 – Site Workers Camp

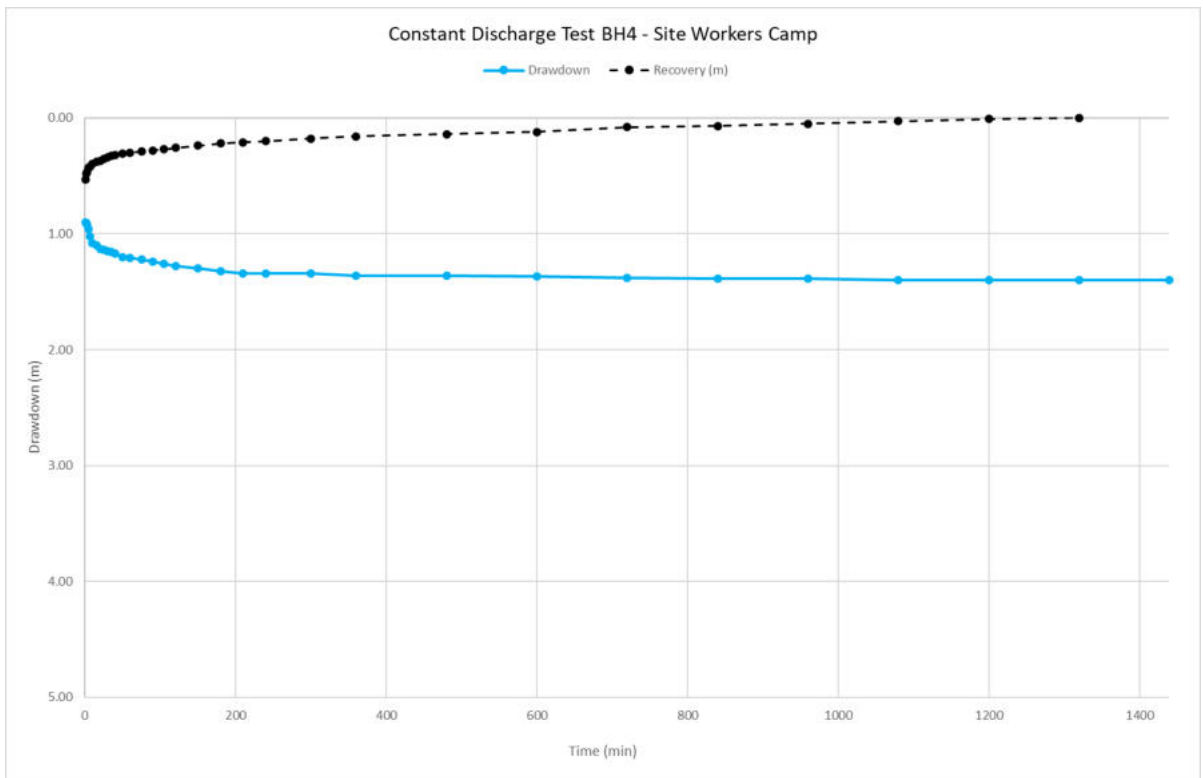
**Figure 25 - CDT at BH4 – Site Workers Camp at a rate of 110 m<sup>3</sup>/h for 24 hours**

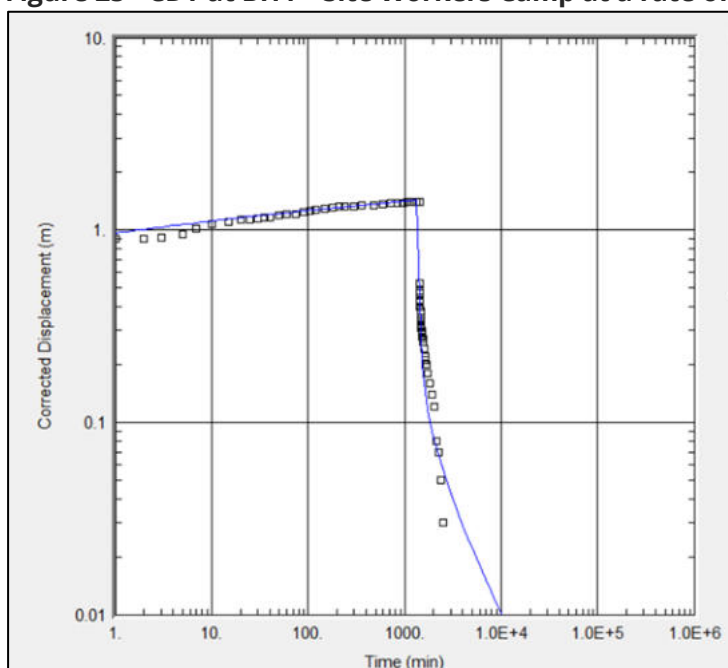
**Figure 26 - Curve matching drawdown vs time and derivative data with the Theis (1934) solution for aquifer parameter estimation**

Applying a combination of the Theis (1935) and Neumann (1974) analytical solutions (Figure 26), a Transmissivity value of 2700 m<sup>2</sup>/d was determined. The recommended yield of 90 m<sup>3</sup>/hr is determined based on subjective information related to flow boundaries, a two year forward modelling of drawdown and the assumption of zero recharge entering the system. It is recommended that the borehole be allowed to recover for at least 24 hours per week. A summary of results and recommendations is provided in Table 6.

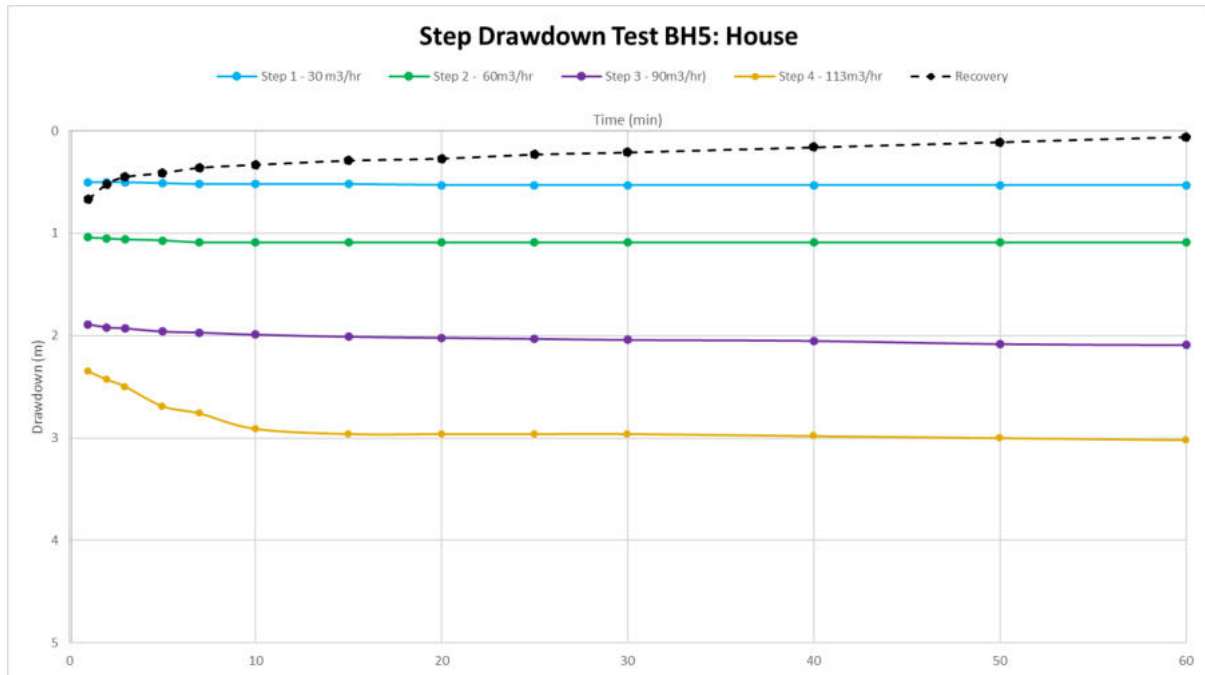
Figure 27 - Step test at BH5 – House

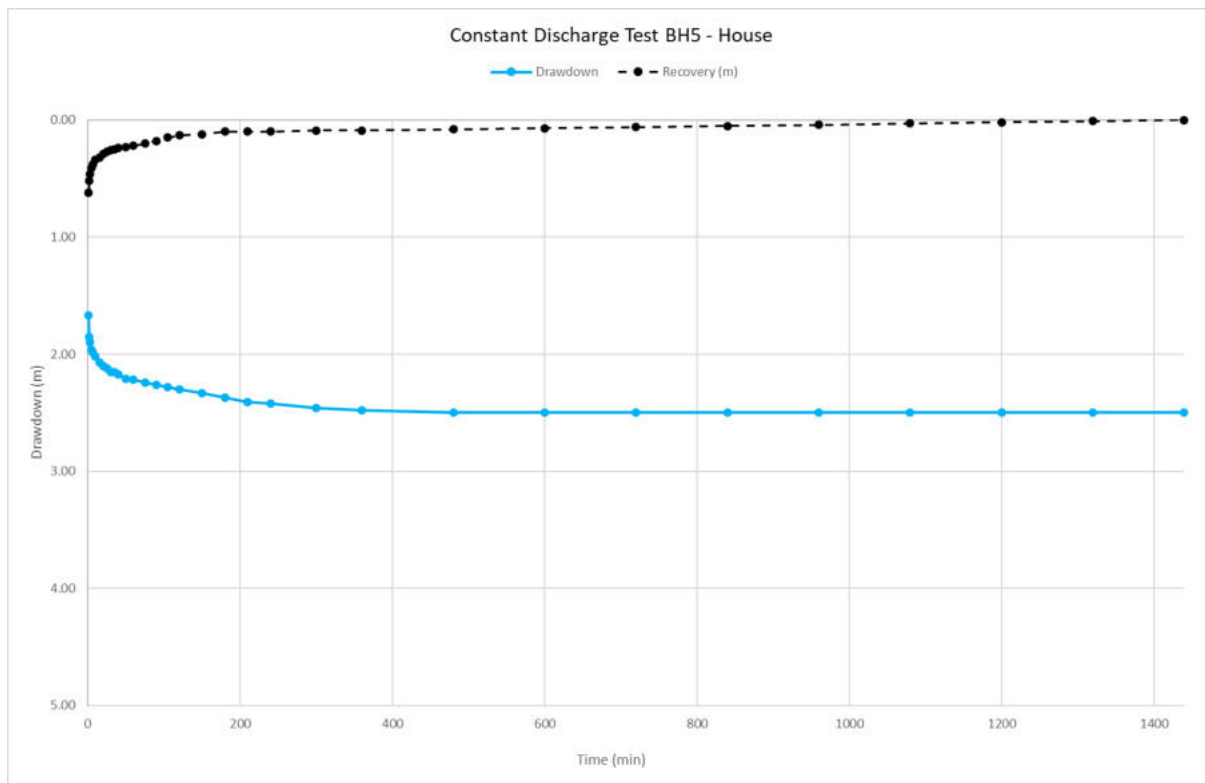
Figure 28 – CDT at BH5 – House at a rate of 105 m<sup>3</sup>/h for 24 hours

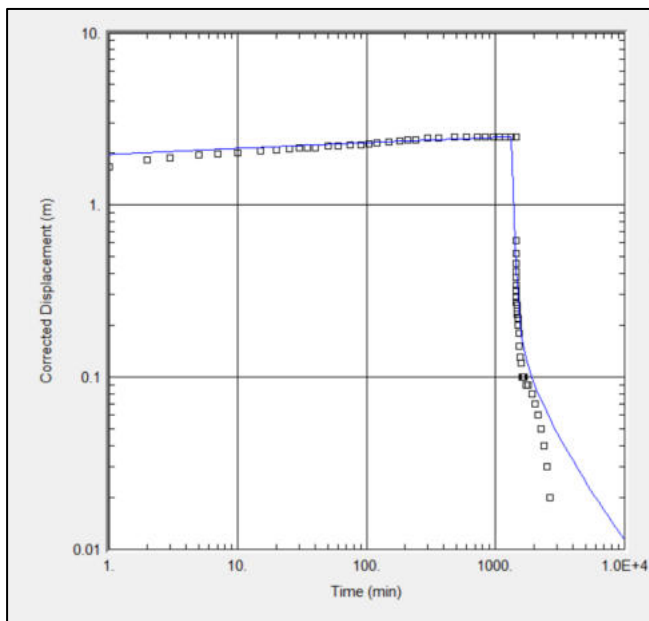
Figure 29 - Curve matching drawdown vs time and derivative data with the Theis (1934) solution for aquifer parameter estimation

Applying a combination of the Theis (1935) and Neumann (1974) analytical solutions (Figure 29), a Transmissivity value of 1440 m<sup>2</sup>/d was determined. The recommended yield of 90 m<sup>3</sup>/hr is determined based on subjective information related to flow boundaries, a two year forward modelling of drawdown and the assumption of zero recharge entering the system. It is recommended that the borehole be allowed to recover for at least 24 hours per week. A summary of results and recommendations is provided in Table 6.
